## Compliance Assessment Report CAR\_NRW0040911

**Permit being assessed:** BN0008101

For: Cellan Wastewater Treatment Works, held by DWR CYMRU CYFYNGEDIG

**Type of assessment carried out:** Site Inspection, Reason: Routine.

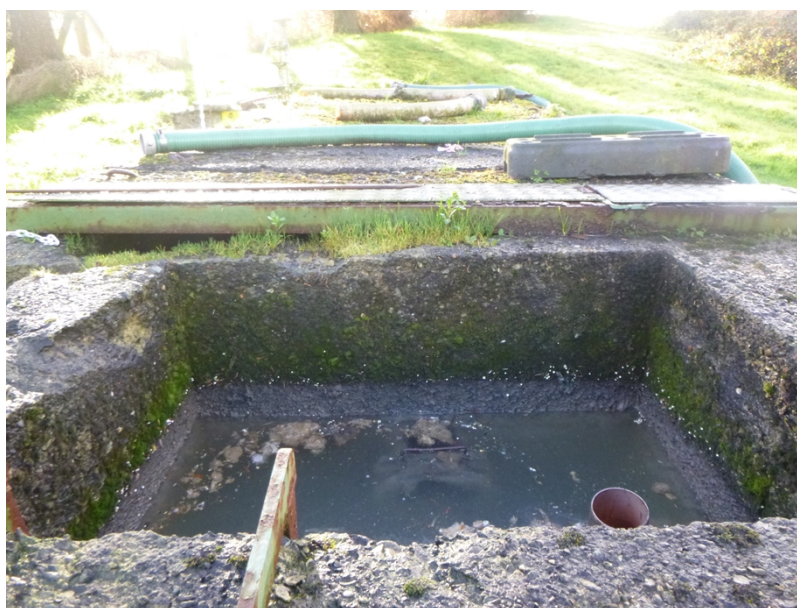
The treatment process at Cellan WwTW is undertaken by gravity. Flows arriving at the inlet first enter a septic tank as shown in the background of photograph 1 below, which separates out solid matter. Flows discharging from this septic tank enter a chamber as shown in the foreground of photograph 1, where flows are either sent to a single stone media filter bed as shown in photographs 2 and 3 below, or directly to an outfall without further treatment if a certain level is reached within the chamber. The latter can be described as a storm overflow activity. It is currently unclear whether flows discharging to storm via this overflow point, discharge at the same or different location to the final effluent.

*Photograph 1: Septic tank (background) and chamber (foreground)*

As can be seen from photograph 1, solid matter was observed within the chamber receiving effluent from the septic tank. This may be indicative of an issue with the septic tank given that it is responsible for removing solid matter from the flows received at the inlet. Solids which are not captured by the septic tank are likely to result in a greater number of blockages within the filter bed's rotating arms, and thus periodic deteriorations in final effluent quality. Solids carried over from the septic tank may also find their way into the final effluent discharged at the outfall. Although not entirely clear, as shown in photograph 4 below, small solid particles may have been present in the final effluent discharging from the filter bed on the day of the inspection. As Cellan WwTW's permit is descriptive, solid carryover from the septic tank and its associated impacts are unlikely to represent a breach of permit, however we recommend that DCWW investigate and resolve any issues with the septic tank at the earliest opportunity to prevent further deteriorations in final effluent quality.

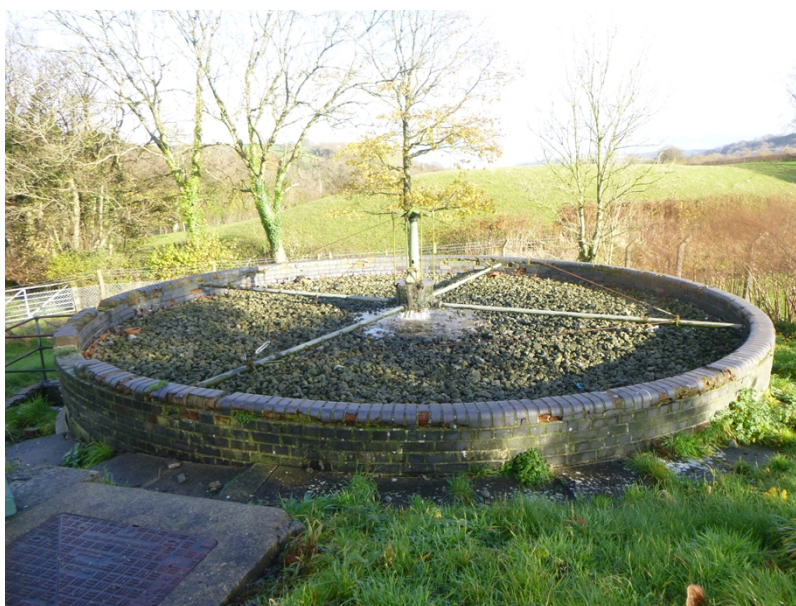
As can be seen from photographs 2 and 3 below, very little vegetation was observed at the surface of the stone media filter bed at the time of the inspection. The wall of the filter bed appeared in a slight state of disrepair, however no effluent was found to be leaking from the filter bed, therefore this was not of concern. As can be seen from photograph 2 however, at the time of the inspection, effluent was initially found to be pooling at the centre of the filter bed. This was caused by blockages in the arms forcing effluent downwards through the central column. This issue was immediately resolved when DCWW Operative Daniel Williams cleared the inside of the arms using a rod. The arms began to rotate unhindered distributing effluent equally across the surface of the filter bed as shown in photograph 3. Daniel Williams explained that this issue occurred sporadically at Cellan WwTW.

*Photograph 2: Stone media filter bed (prior to arm clearing)*

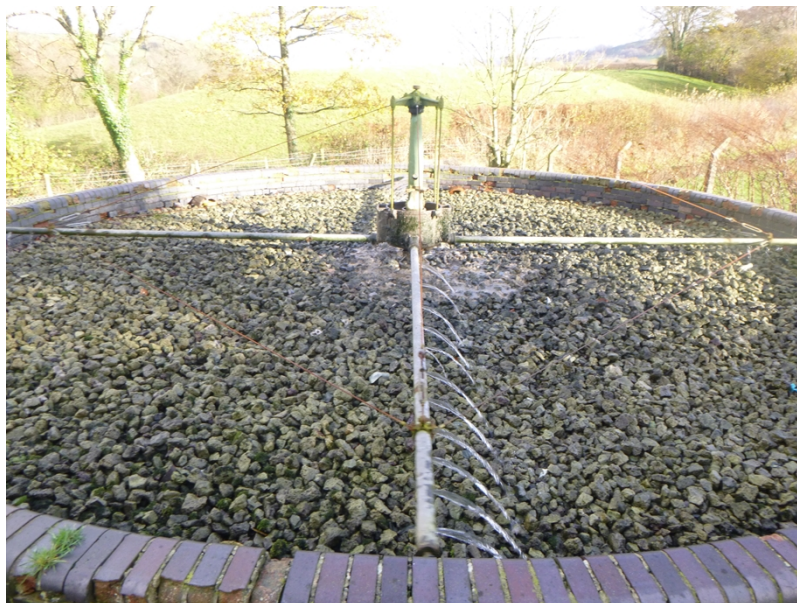
*Photograph 3: Stone media filter bed (post arm clearing)*

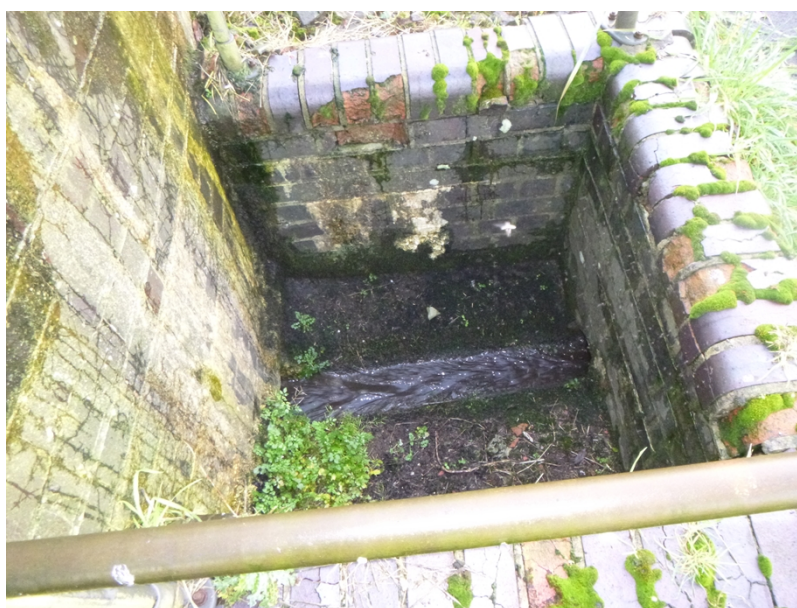
*Photograph 4: Final effluent discharging from the filter bed*

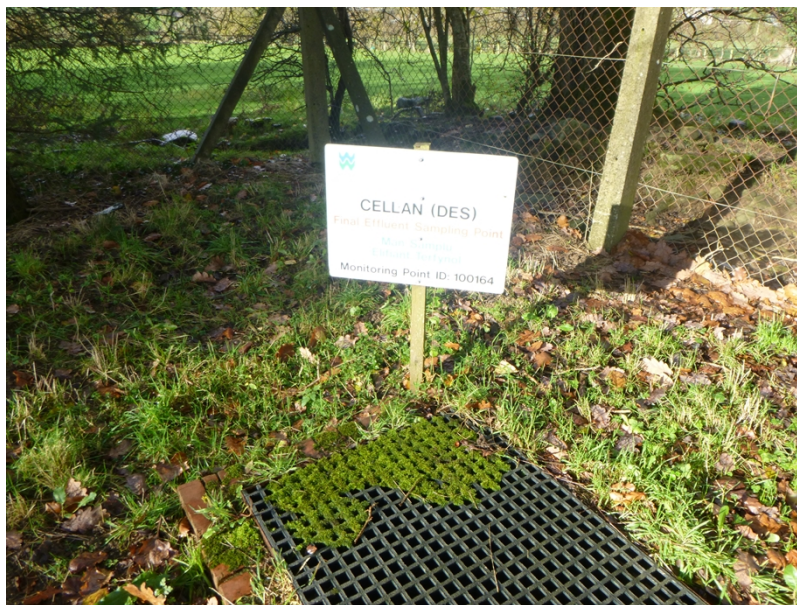
An accessible final effluent sampling point with appropriate signage is located on site as shown in photograph 5 below. An unsigned storm discharge sampling point is also located on site as shown in photograph 6 below. At the time of the inspection, the site was found to be spilling to storm at the storm sampling point, possibly due to the regular showers experienced over the preceding 24 hours.

*Photograph 5: Final effluent sampling point*

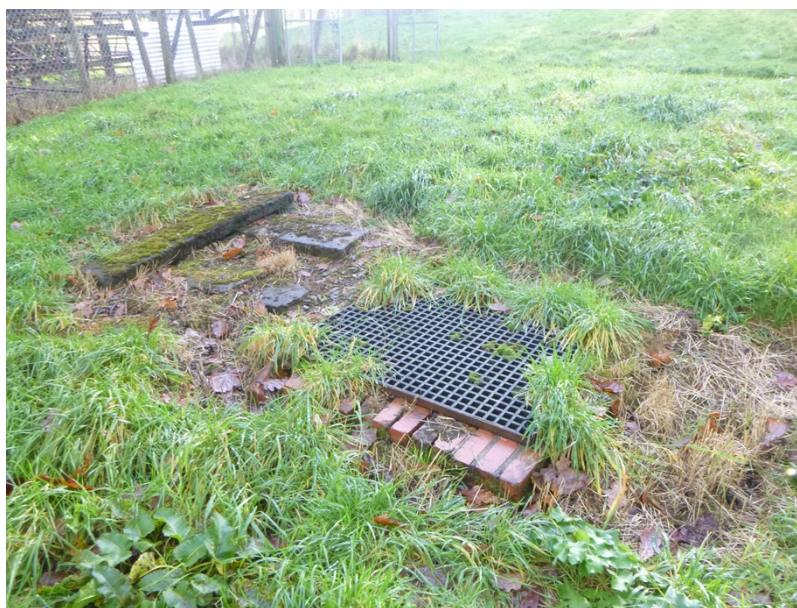
*Photograph 6: Storm discharge sampling point*

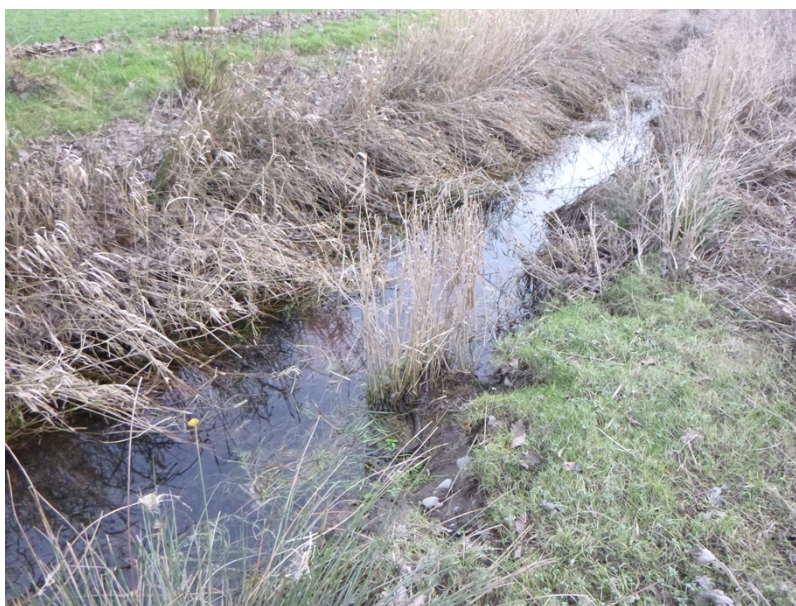
At the time of the above inspection, the NRW Officers were accompanied to the bank of the Afon Teifi at approximately SN 60126 49035 in search of the final effluent discharge point. The DCWW Operatives were unsure of the location of the discharge point and were unable to locate it at the time of the inspection. The site inspection therefore concluded at the final effluent and storm discharge sampling points. Due to the unpermitted storm overflow activity identified during the inspection however, the NRW Officers were keen to view the WwTW

discharge point(s) to determine what impact the WwTW may be having on the receiving watercourse(s). NRW Officer Bethan Lewis therefore visited the site again on the 01 February 2023, however was again unable to locate the discharge point(s) despite walking the entirety of the drain feeding into the Afon Teifi, passing the permitted final effluent discharge point at SN 60129 49105, as shown in schedule 7 of Cellan WwTW's permit. Despite being unable to locate the discharge point(s), the NRW Officer observed no signs of pollution affecting the drain feeding into the Afon Teifi or immediately upstream/downstream of its confluence with the Afon Teifi, both of which are shown in photographs 7 and 8 below. The NRW Officer also did not notice any odour. Therefore, whilst the location of the discharge point(s) remains unknown, NRW have no evidence to suggest that the WwTW is having a negative impact on the drain feeding into the Afon Teifi or the Afon Teifi itself. NRW do however ask DCWW to confirm the grid reference of the final effluent and storm discharge point(s) at Cellan WwTW by no later than the 13 March 2023.

*Photograph 7: Drain to the Afon Teifi*

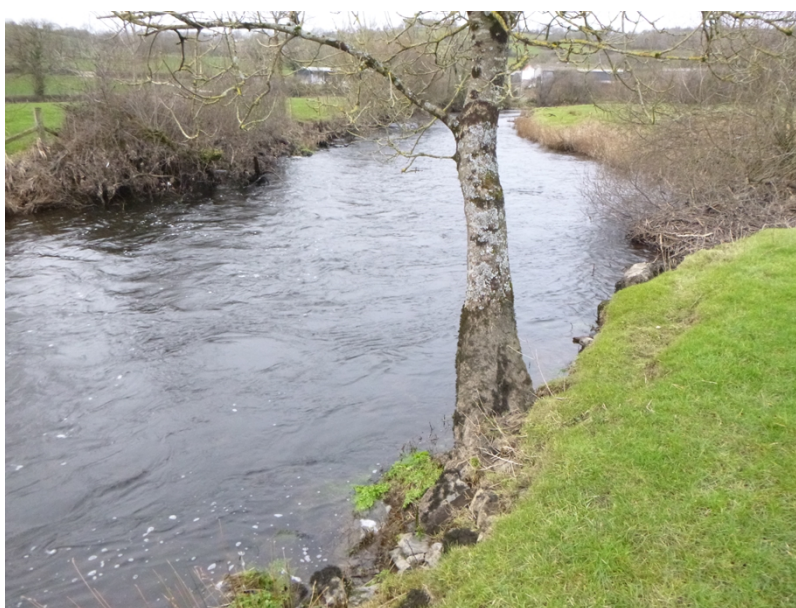
*Photograph 8: Afon Teifi downstream of drain confluence*
