Pantyffynnon, River Loughor Weir Removal

FRAP Reference: DFR/S/2021/0237

Site Information

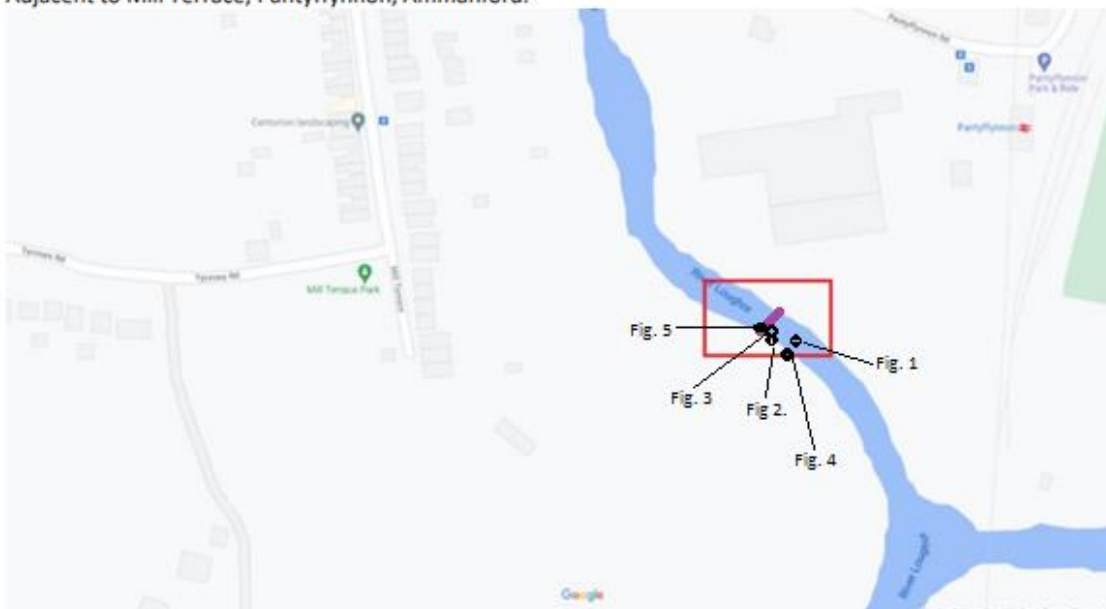
Figure 0. Location of weir (purple line) and locations of site photos (black points).

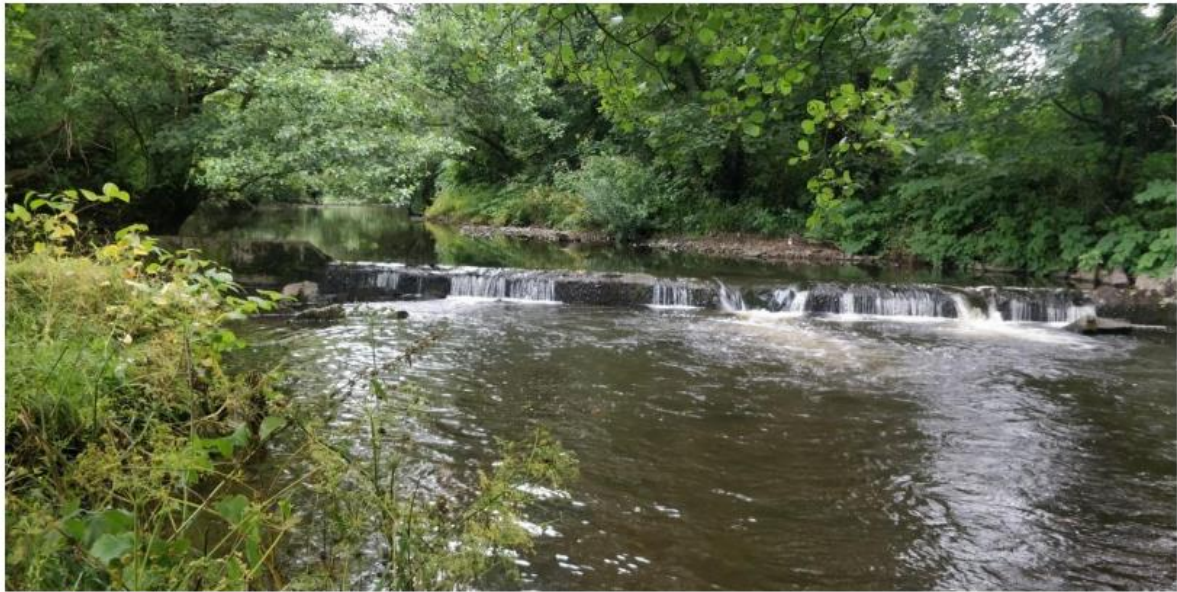
Figure 1. Pantyffynnon weir.

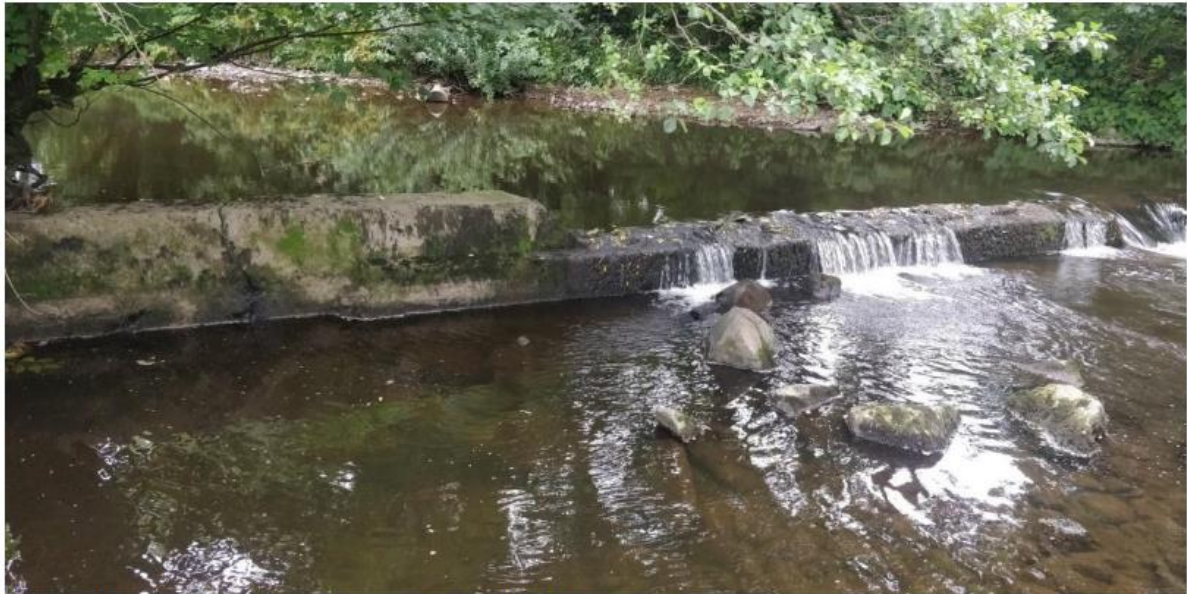
Figure 2. The wing wall on the left of the photo that is to be retained.

- Approximately two thirds of the weir structure will be removed (the centre of the structure), retaining the wing walls to aid with scouring the centre of the channel of silt (improving spawning conditions) as well as preventing bank erosion.
- Broken concrete will be used to fill in an existing area of bank erosion on the right-hand bank in front of the wing wall. It is anticipated that this, as with other similar projects, will accumulate silt, vegetate and form part of the natural bankside.

We can confirm that any remaining infrastructure (the wing walls) will not impound the watercourse, including during high flows:

- The retained wing walls will not raise the upstream water level outside the normal (non-flood conditions) wetted perimeter of the stream?
- The remaining structure will not modify the natural flow regime due to the small length retained compared to the over-widened channel width.

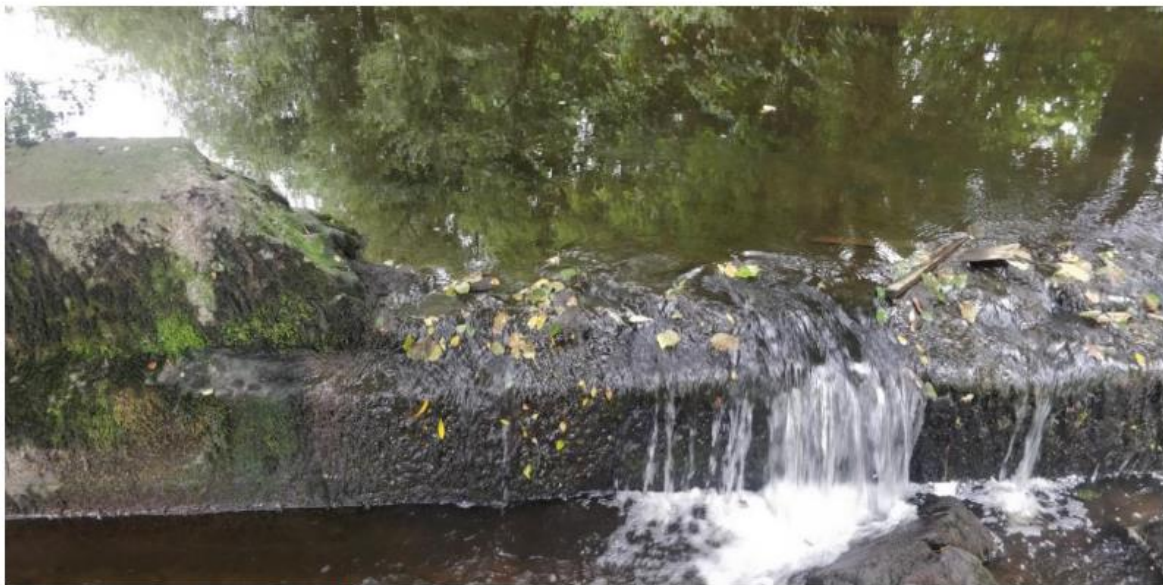
Figure 3. The weir is constructed from concrete.

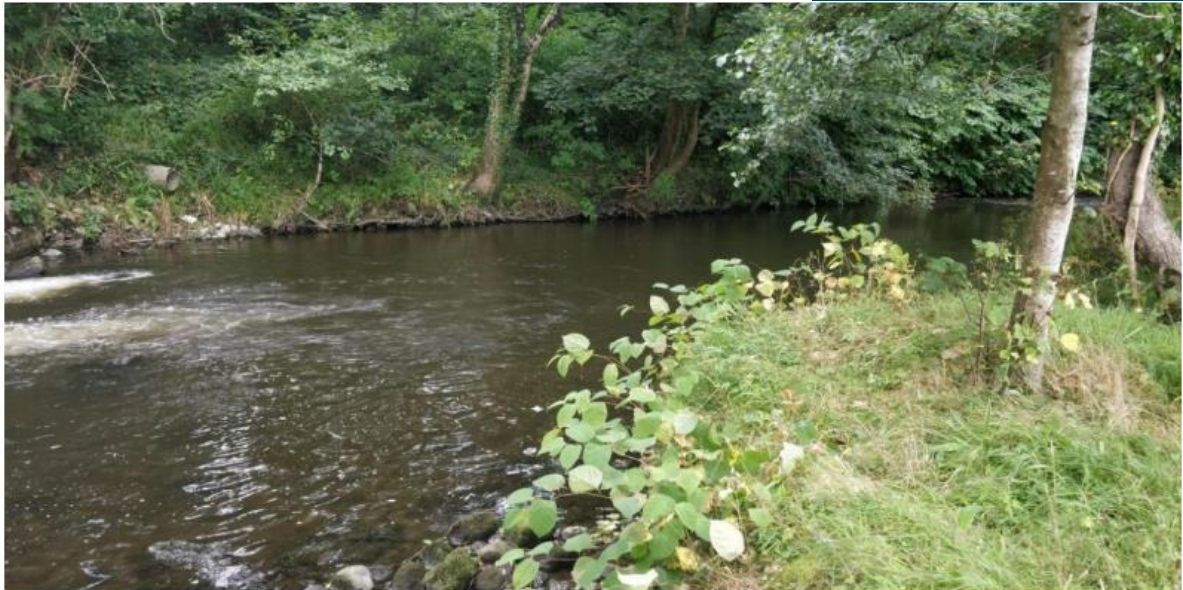
Figure 4. Habitat downstream of the weir.

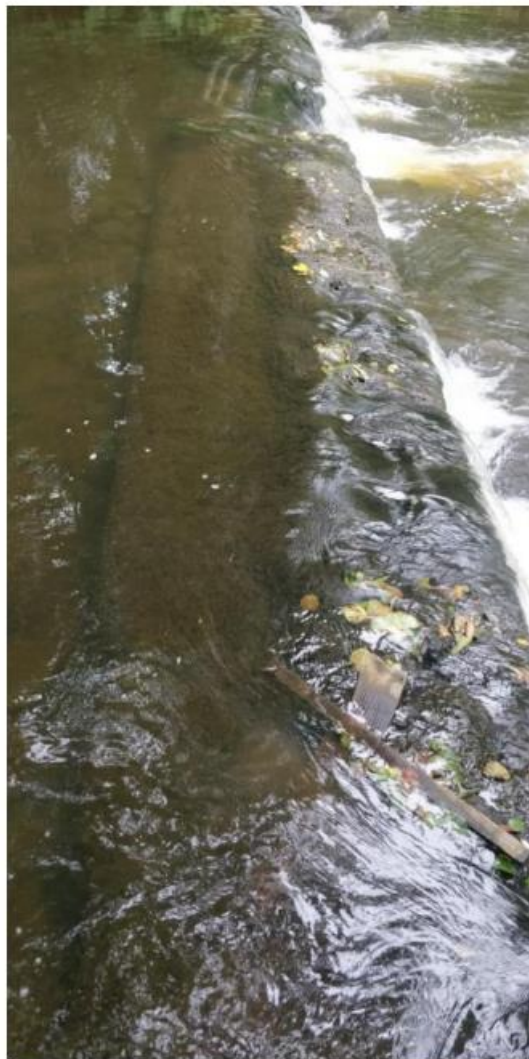
Figure 5. Photo to show the construction of the weir.

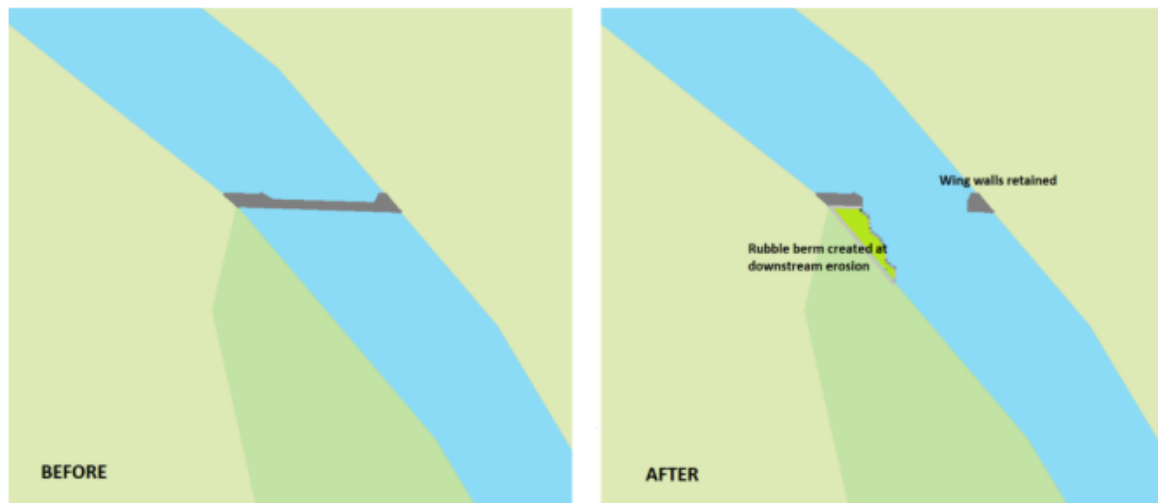
Figure 6. Visual impression of before and after works
