## Tir John (Phase 1) Landfill

**Annual Monitoring Review January-December 2022**

**Enovert South Limited**

**Report No. 14-K6065-ENV-R024**

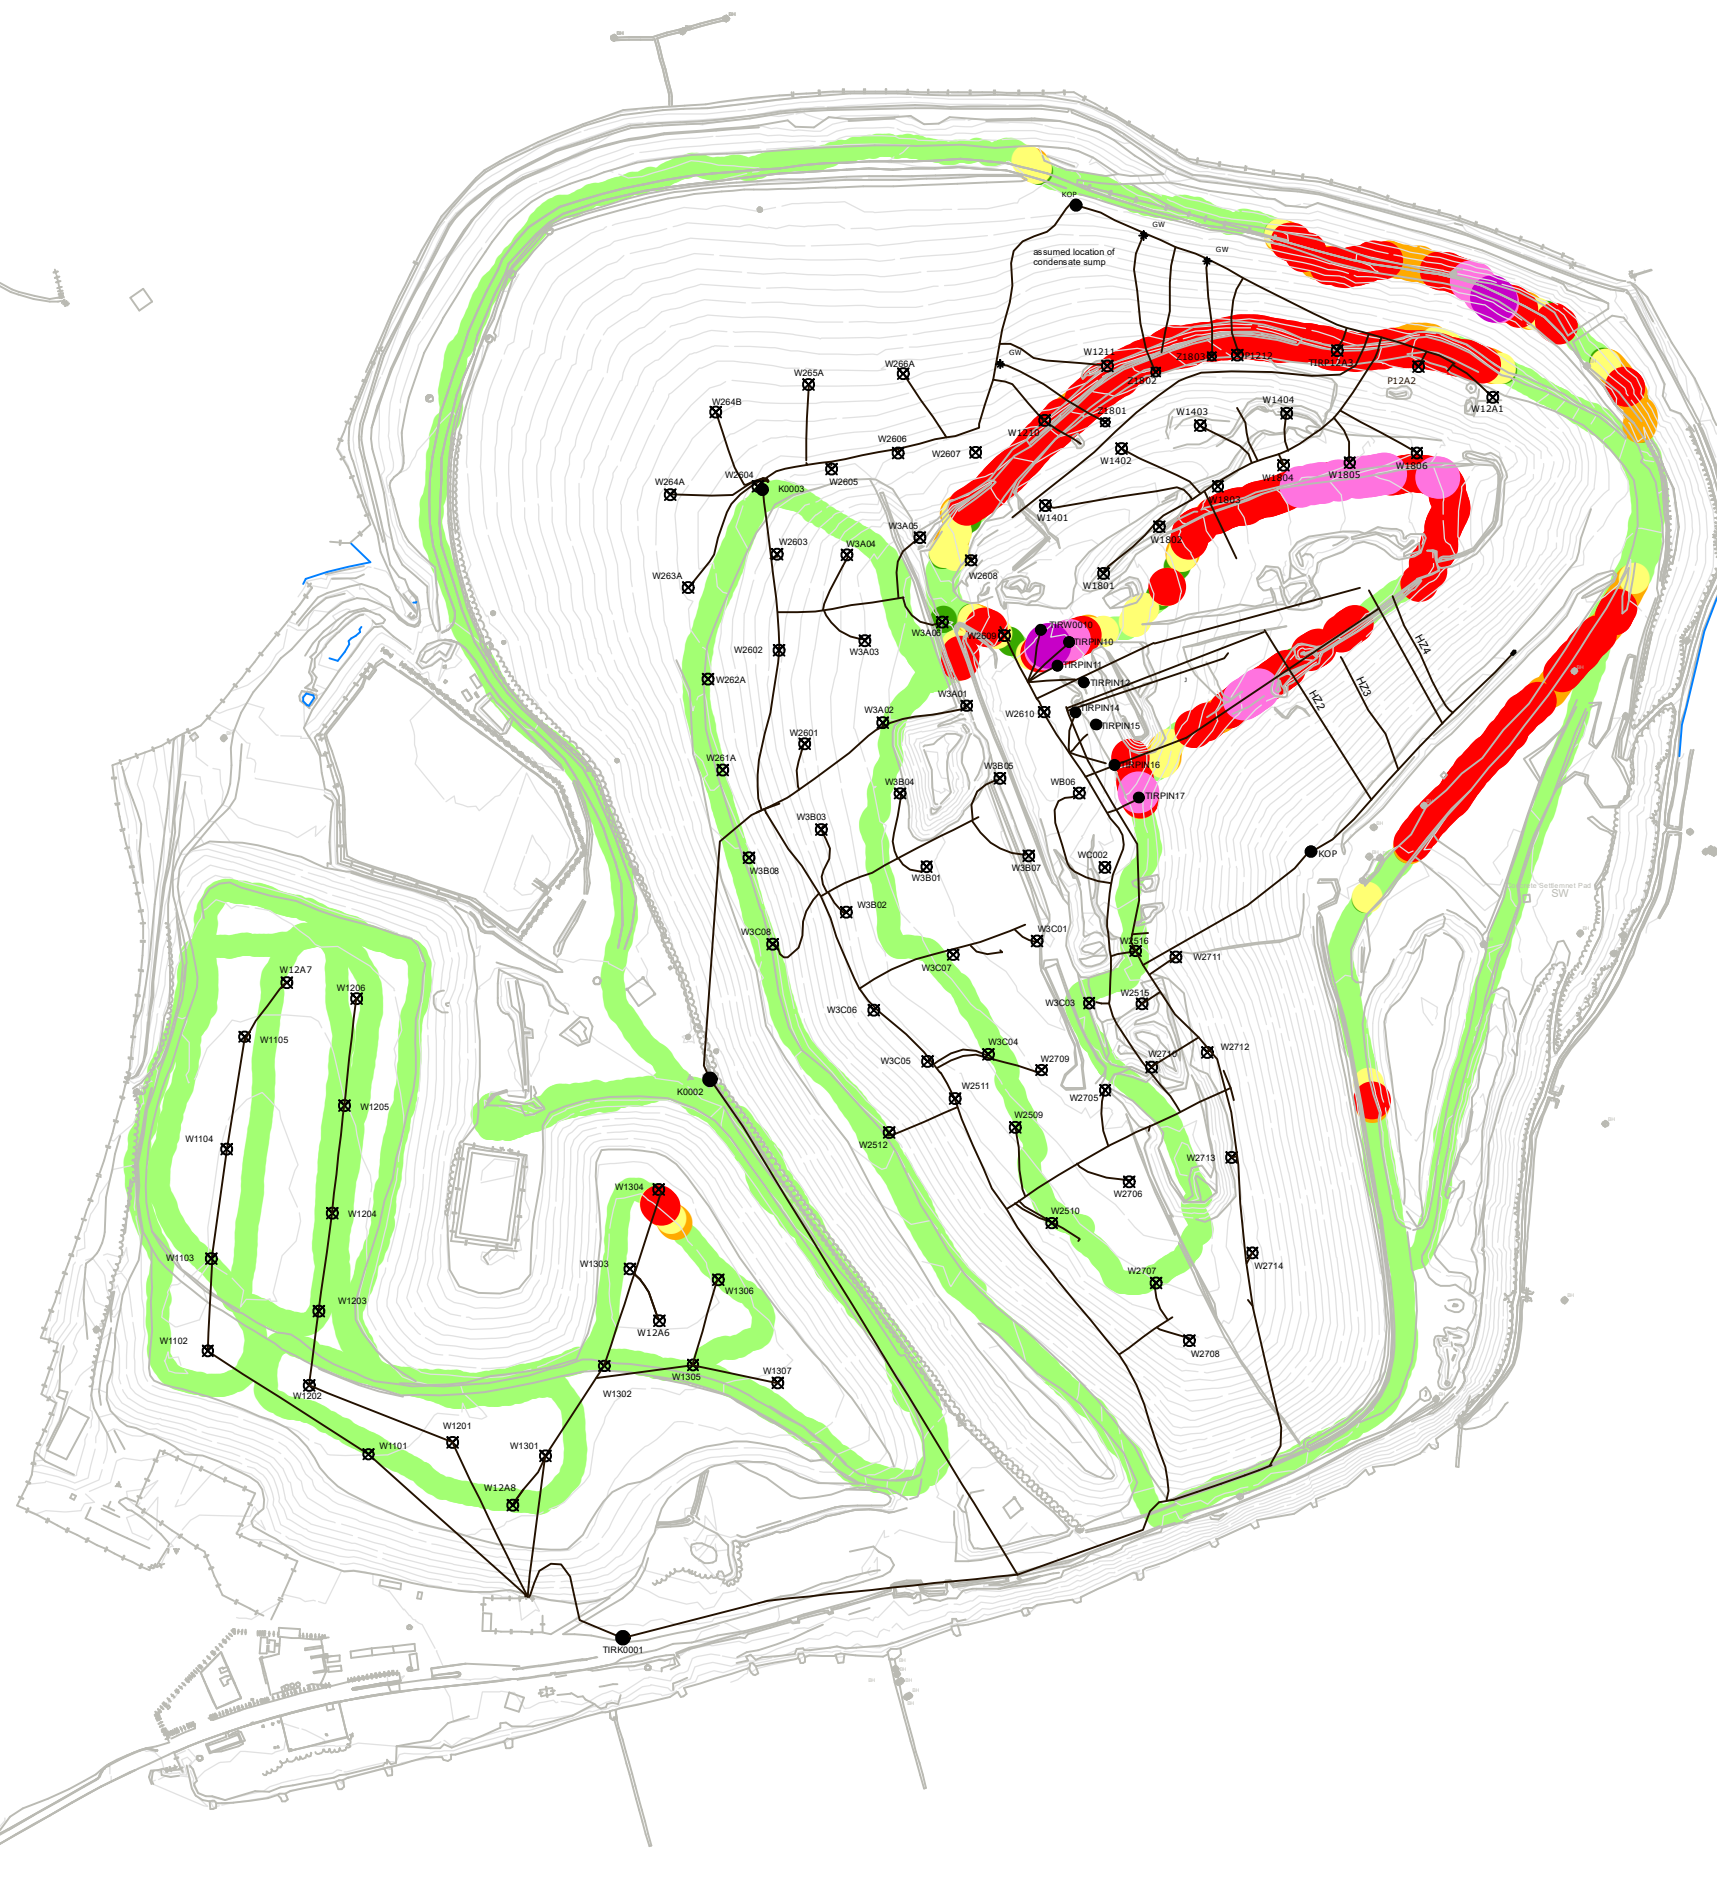
TIR JOHN  
FID Survey Dated 21-12-22

The survey demonstrates that there is generally good gas control at the site with low emissions (*i.e.* <10ppm) occurring across the majority of the Phase 1 area. Emissions in the range 100–499ppm were identified adjacent gas well W1304. Given that the higher readings observed occurred adjacent to a discrete feature they are not considered to be significant, and no further actions are required.
