## Tir John (Phase 2) Landfill

**Annual Monitoring Review January - December 2022**

**Enovert South Limited**

**Report No. 14-K6065-ENV-R025**

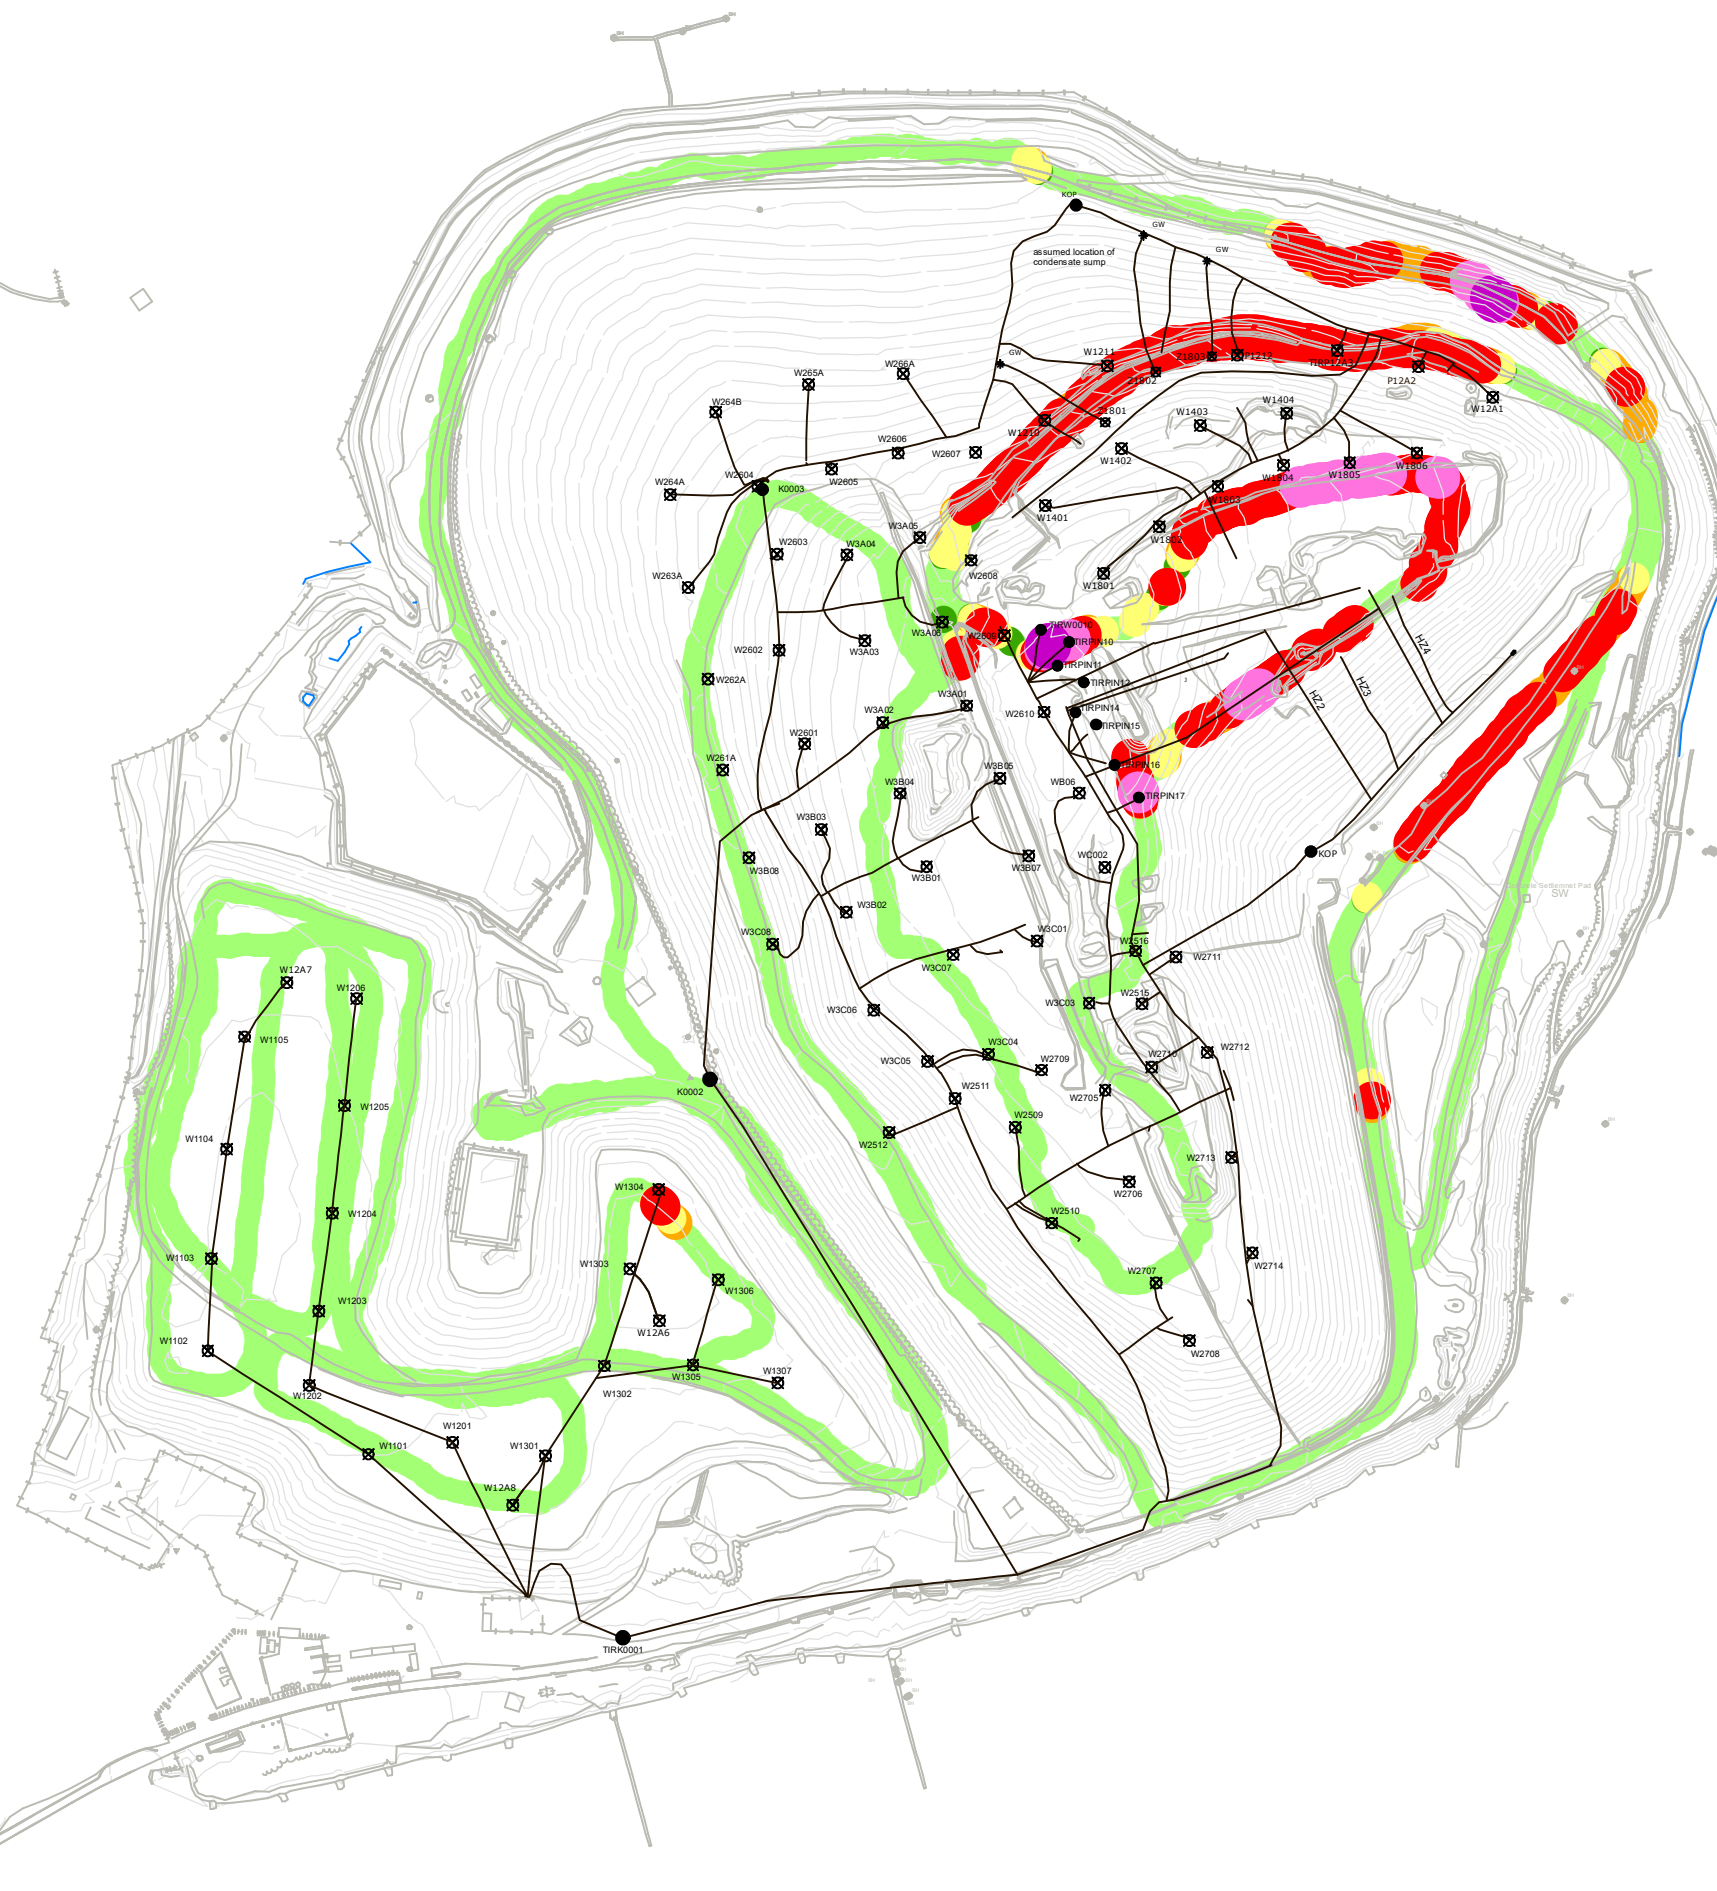
TIR JOHN  
FID Survey Dated 21-12-22

More significant emissions in the 100 to >1,000ppm were identified above the operational areas of the site which is consistent with these areas being uncapped. Increased emissions were also identified adjacent to the perimeter of the uncapped cells, and this may reflect the underlying ground conditions (pre-existing wastes). Similar levels of methane were not identified at the perimeter monitoring points indicating that the reported results may be attributed to an error during the survey.
