## Compliance Assessment Report CAR\_NRW0041530

**Permit being assessed:** CB3797CA.

For: Units 9 & 10, held by New Horizon Biofuel and Animal Bedding Co Ltd

**Type of assessment carried out:** Site Inspection, Reason: Incident Response (Incident number 2301520).

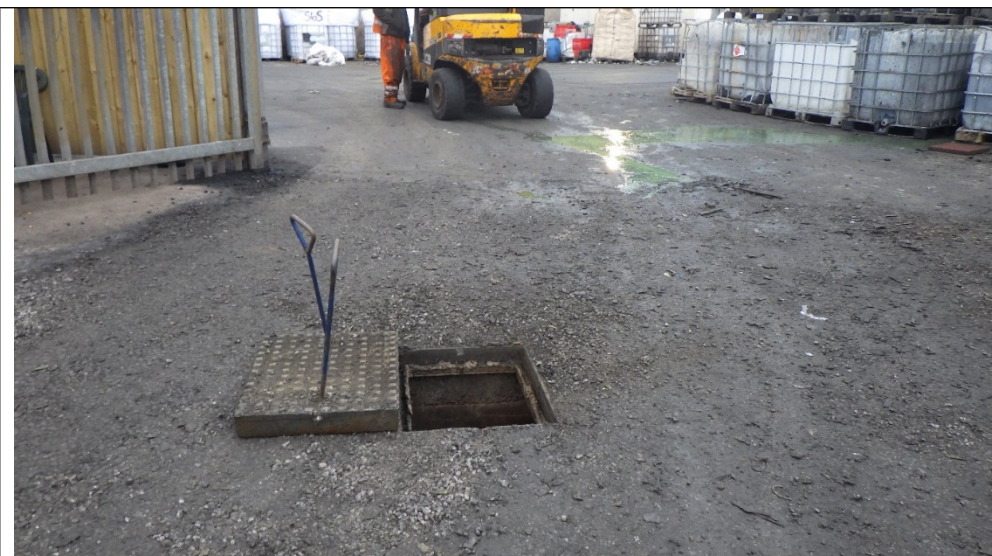
During the visit officers witnessed a significant amount of bright green liquid pooling at the gates to the site.

In front of this there was a surface water chamber which contained what appeared to be a similar green liquid that was visible on the ground. Please see the photo below.

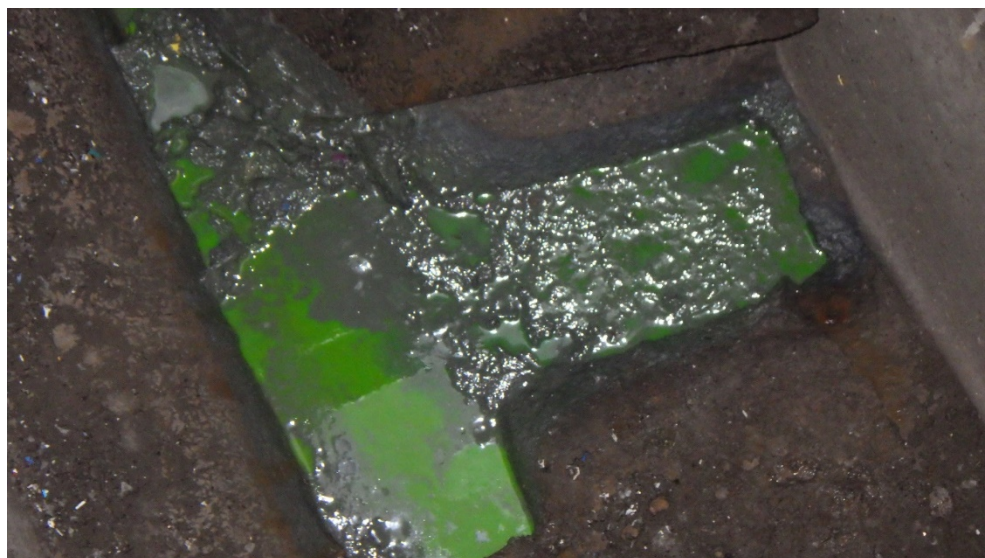
The drainage system was checked and officers observed the green liquid within. Please see the below photo

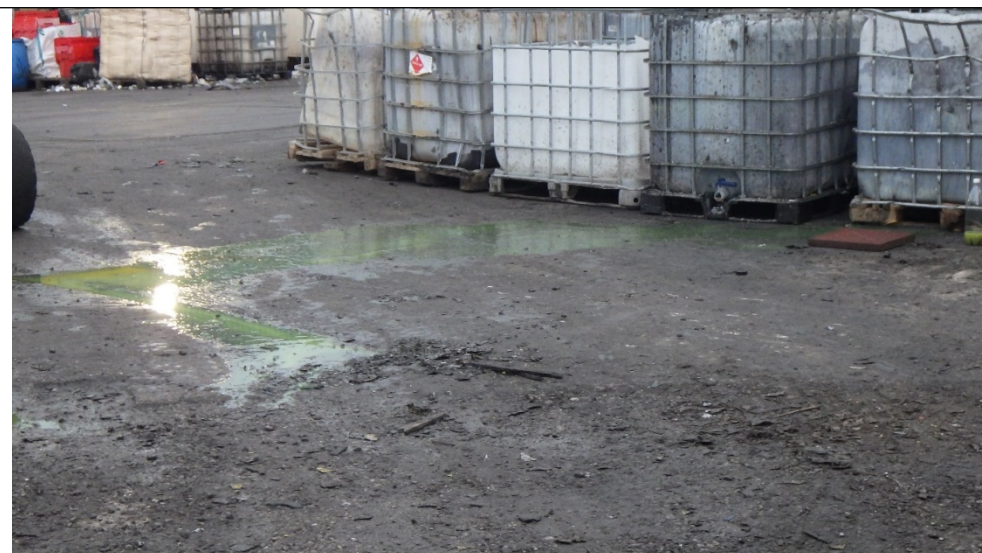
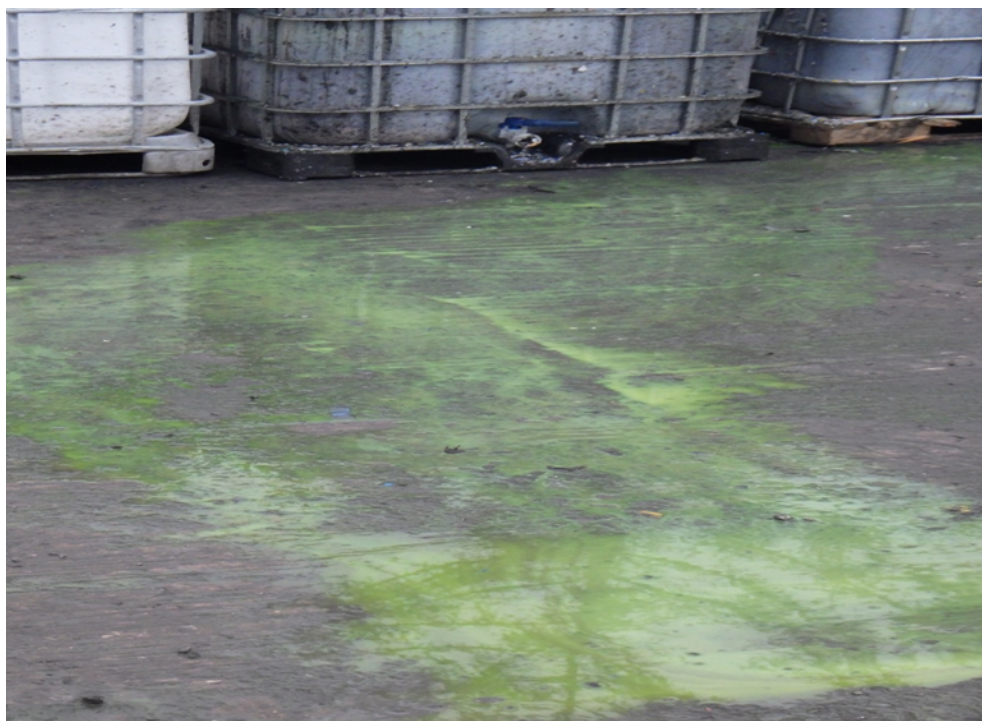
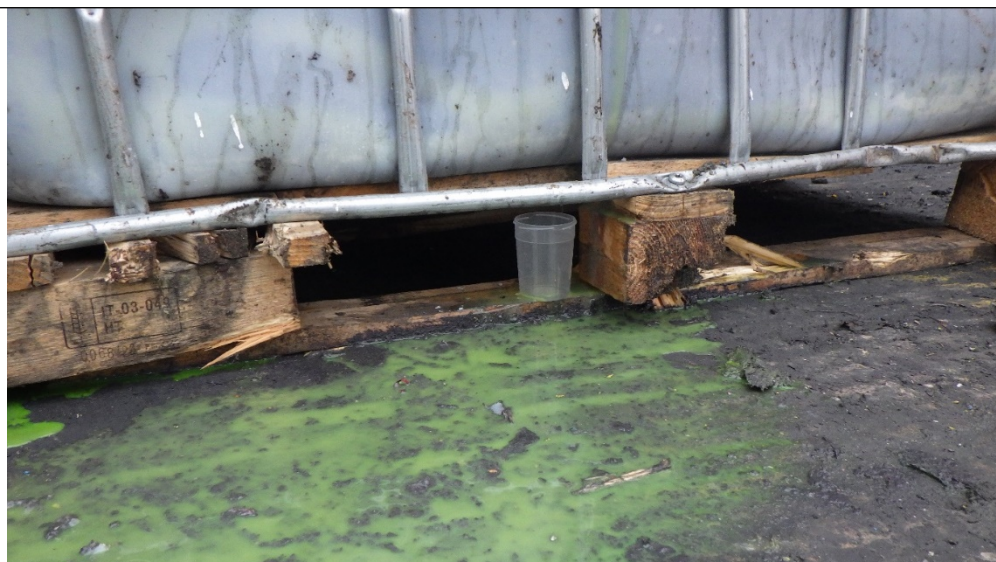
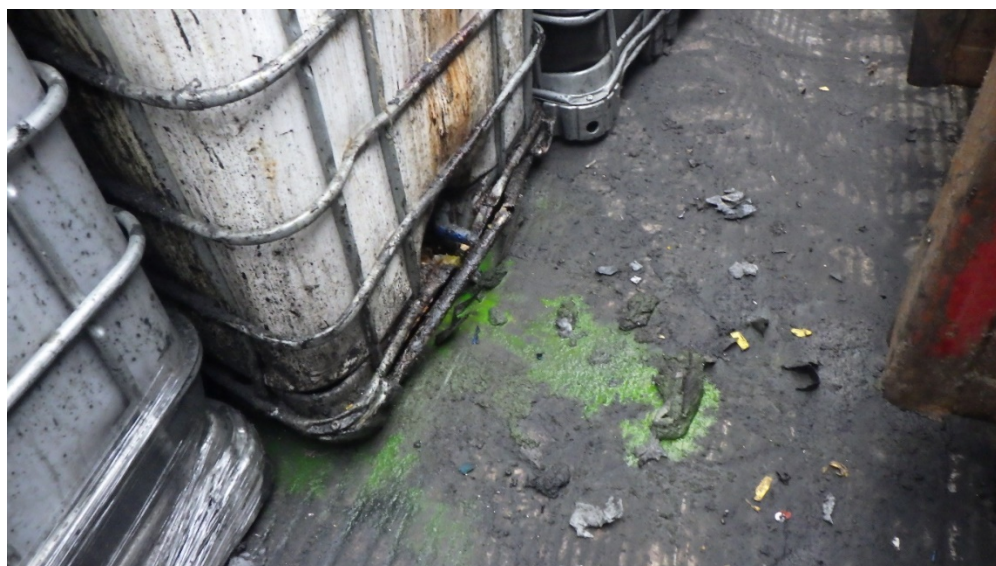
The source of the pollution was identified as IBCs stored in the yard. The site supervisor informed officers they contained waste shredded plastic. The containers were open-topped which would allow rain water to fill up the containers.

Officers identified two fractured IBCs which were leaking a bright green liquid. A large area of the yard was covered with it as shown of the below photos.

At the request of NRW officers the leaking IBCs were moved to a sealed skip. Officers asked that the area be cleaned using spill kits, and banded to stop any further liquid draining from the yard.

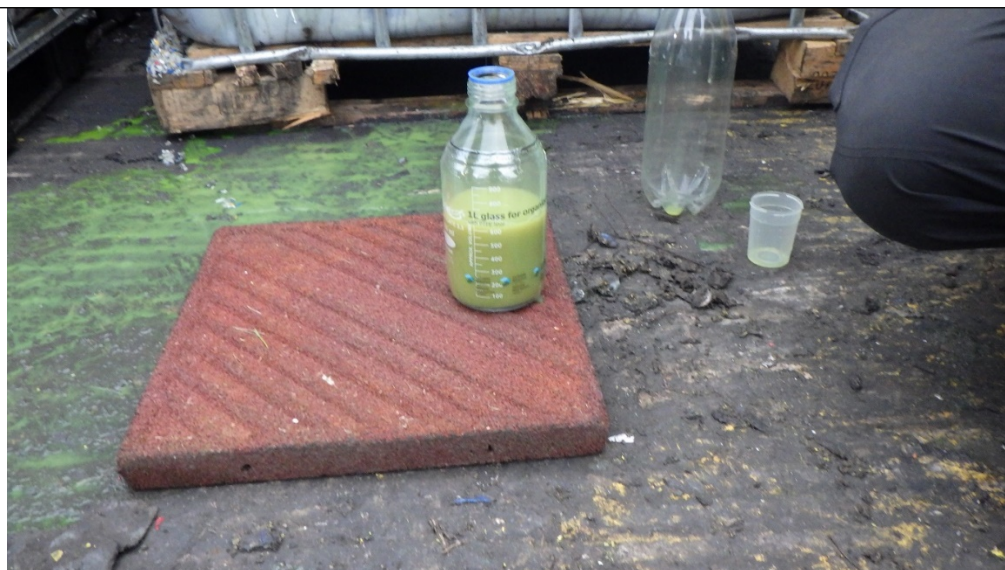
#### Leaking IBC containers

The site supervisor could not provide further details in relation to the containers or their contents.

The majority of the leaking had stopped at the time officers were on site. Officers obtained approximately 500ml of the liquid from the bottom of one of the leaking IBCs.

A formal sample was taken and served on the site manager.

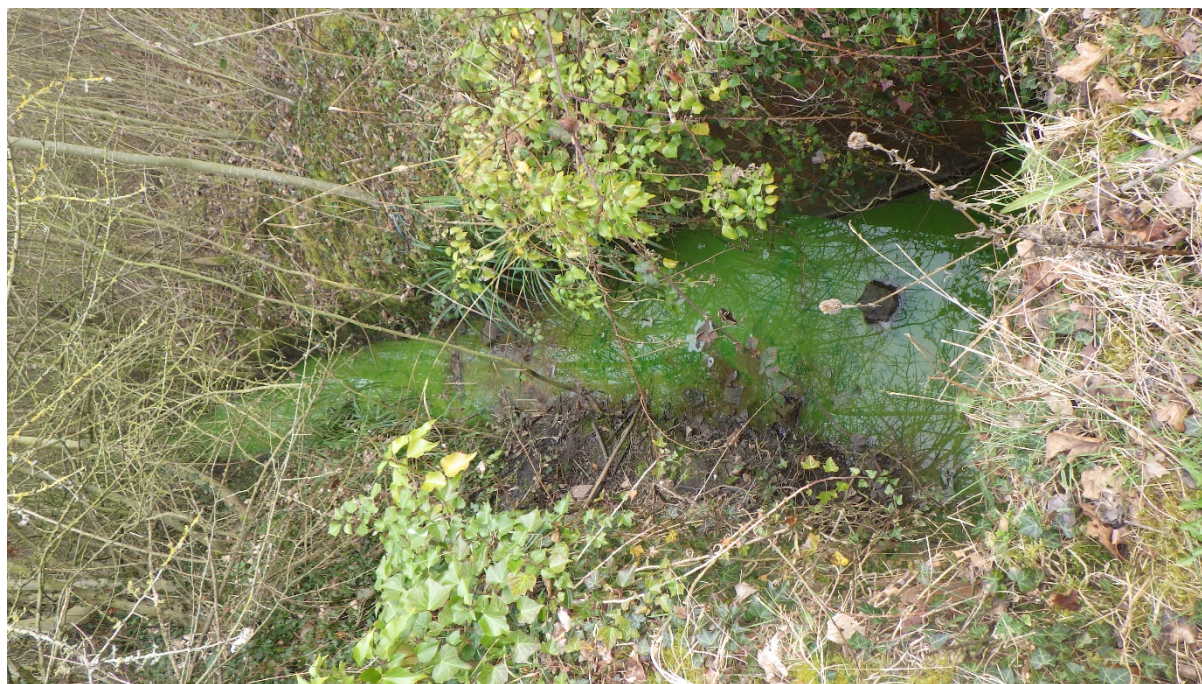
The pollution from the yard entered the surface water drainage system and polluted the nearby watercourse. Please see the photo below

Since the incident the owner has informed NRW that an ACO drain has been installed at unit 9 which ensures the drainage system is sealed.

**Action:** Please provide evidence of the afore mentioned works to NRW. Please comply by the 27<sup>th</sup> of March 2023

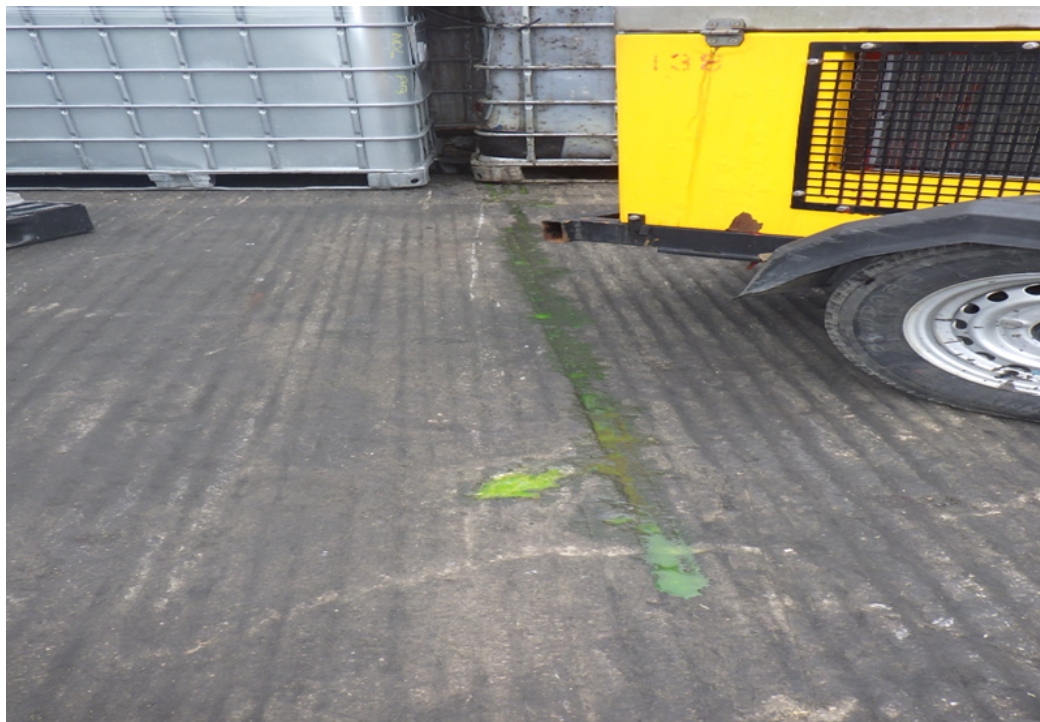
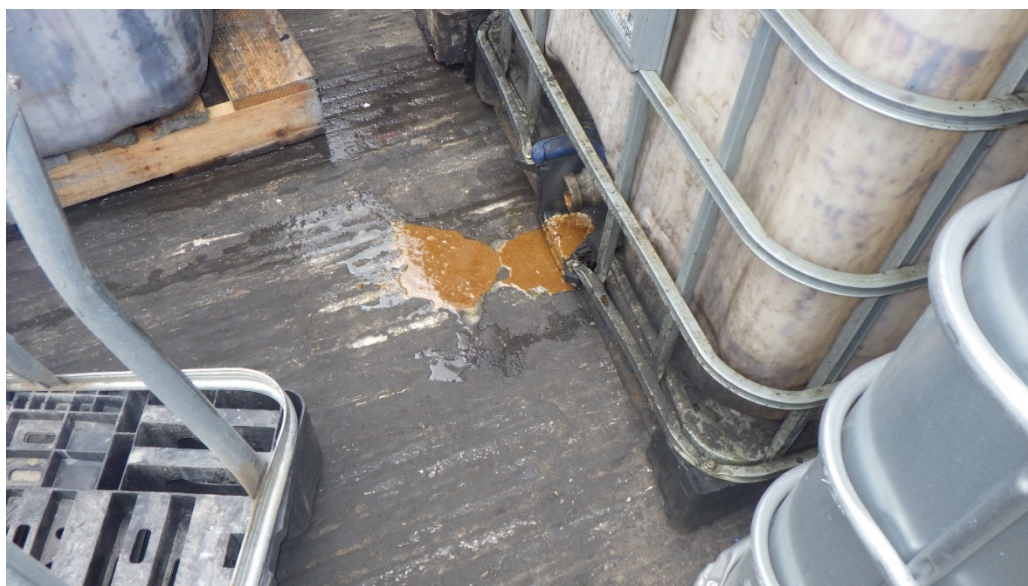
As officers checked the IBCs storage area, they noticed that some containers were still leaking onto the yard. Please see photos below.

The containers were open- topped and not double-bunded causing the leak to escape onto the yard.

Craig instructed one of the employees to deal with the leak. The employee started putting spill pads down which officers deemed insufficient. They requested the broken IBCs be placed in another container to ensure no further pollution occurred.

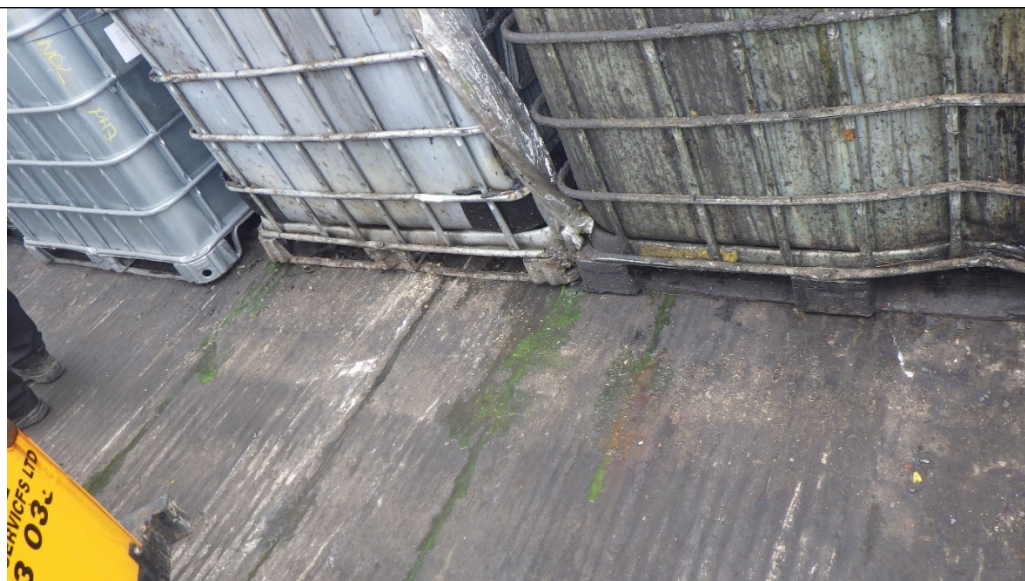
Officers also saw an IBC leaking a brown substance. The manager did not know what substance was stored in the IBCs.

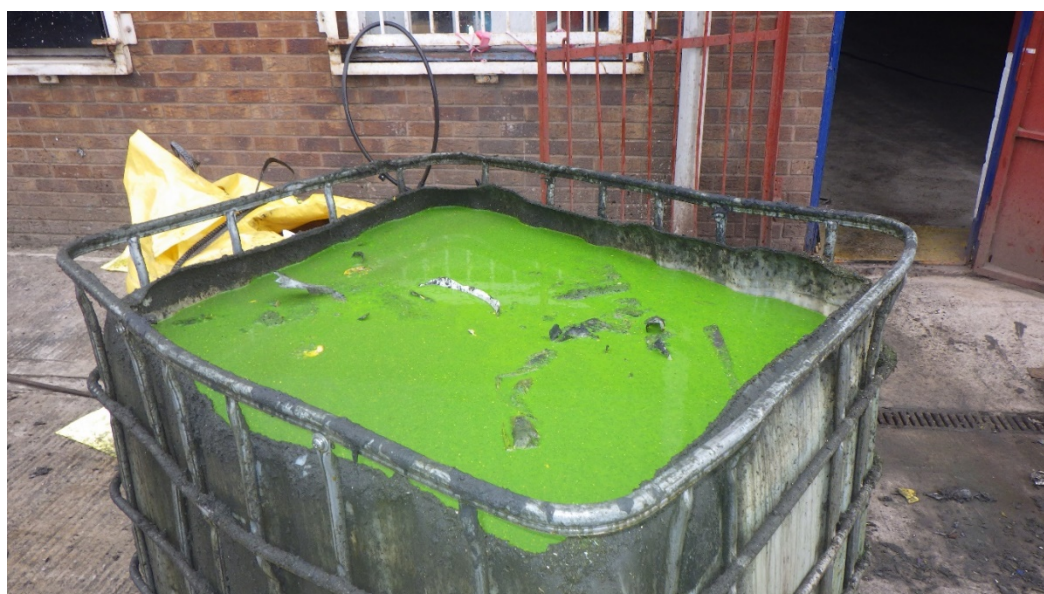
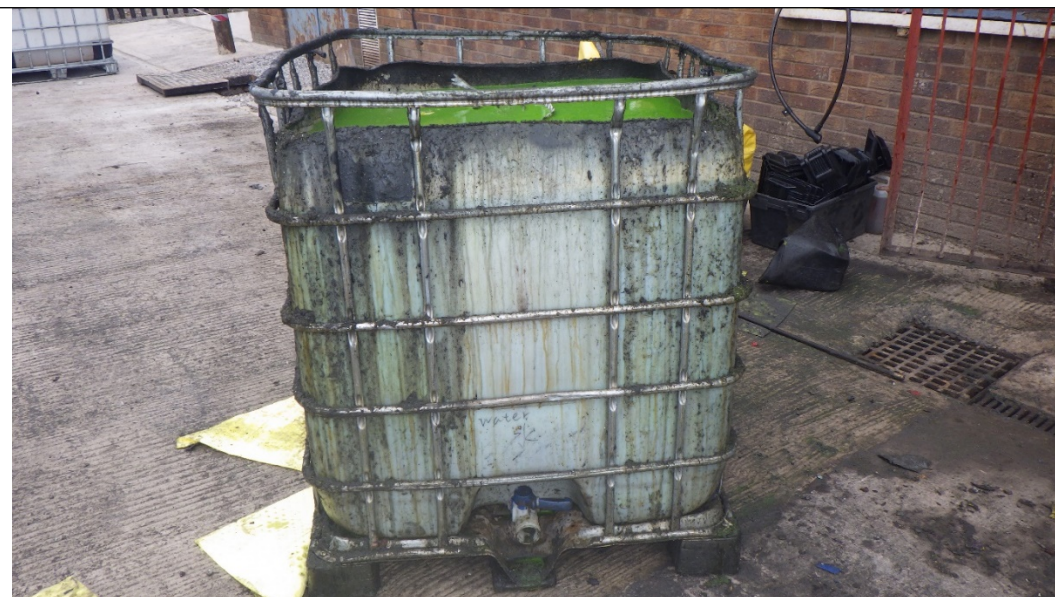
Officers also saw a container by the entrance to the treatment building. It was filled almost to the top with a green liquid which clearly posed a risk of further spill/pollution.

The manager was instructed to place the container inside the building to ensure the liquid is safely stored prior to imminent disposal by an authorised company.

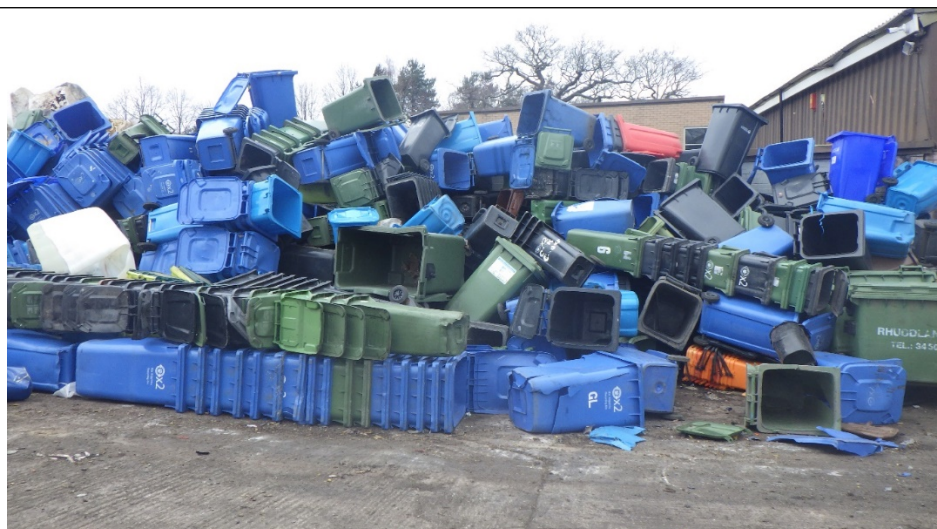
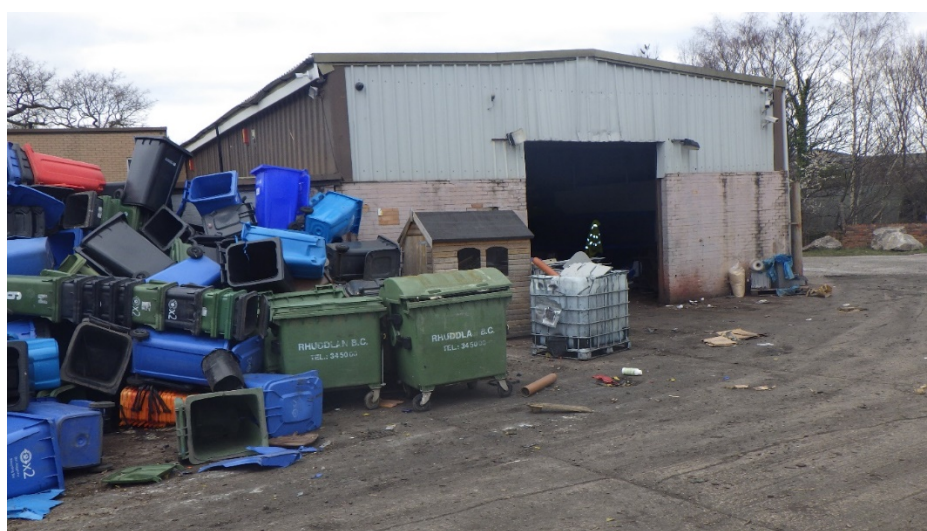
Officers then inspected Unit 10. They saw a number of waste plastic bins stacked next to the storage building. Please see photos below.

It was pointed out that current storage arrangements were also not in line with the Environment Management System (EMS).

This storage is not compliant with the EMS and is also a fire hazard.

**Action:** Unit 10 – As discussed with the site management, please re-arrange the storage of waste to ensure it's in line with your current EMS.

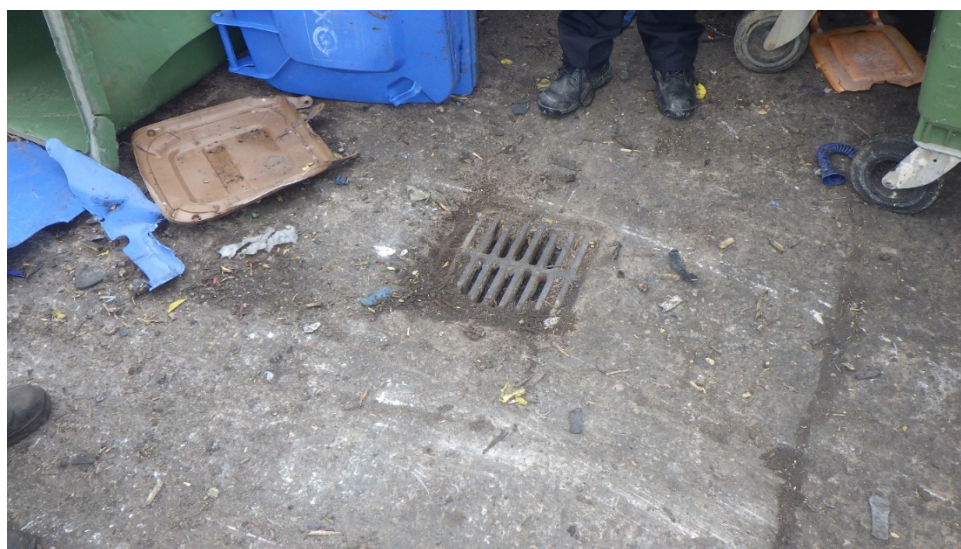
A surface water drain located close to the rubbish bins was checked and appeared blocked.

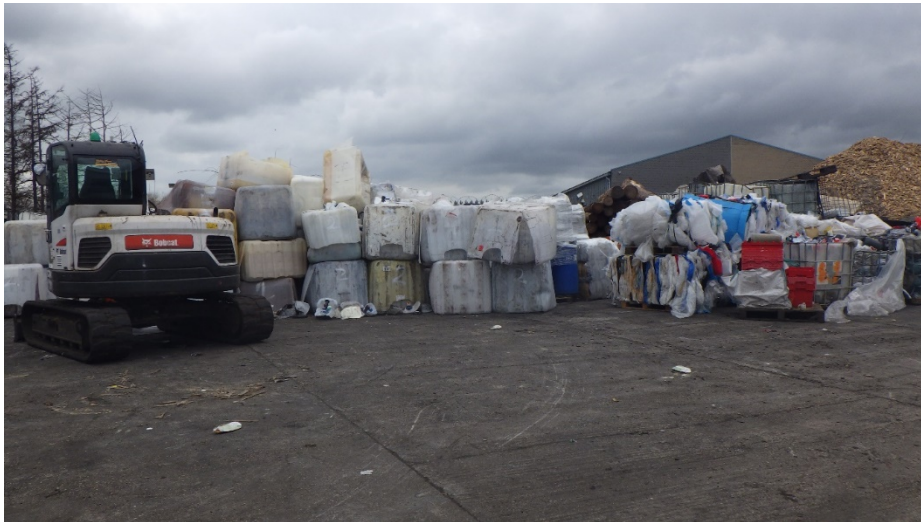
Further non-compliant storage was observed with waste streams stored in the quarantine area.

It was noted that shredded wood was being stored next to plastic waste which is a breach of the permit and a fire hazard.

**Action:** Please ensure all material is stored as detailed in your EMS. Please comply by the 27<sup>th</sup> of March
