ABERMULE BUSINESS PARK

Site Condition Report

December 2021

Abermule Business Park Development - Newtown Bulk Recycling Facility.

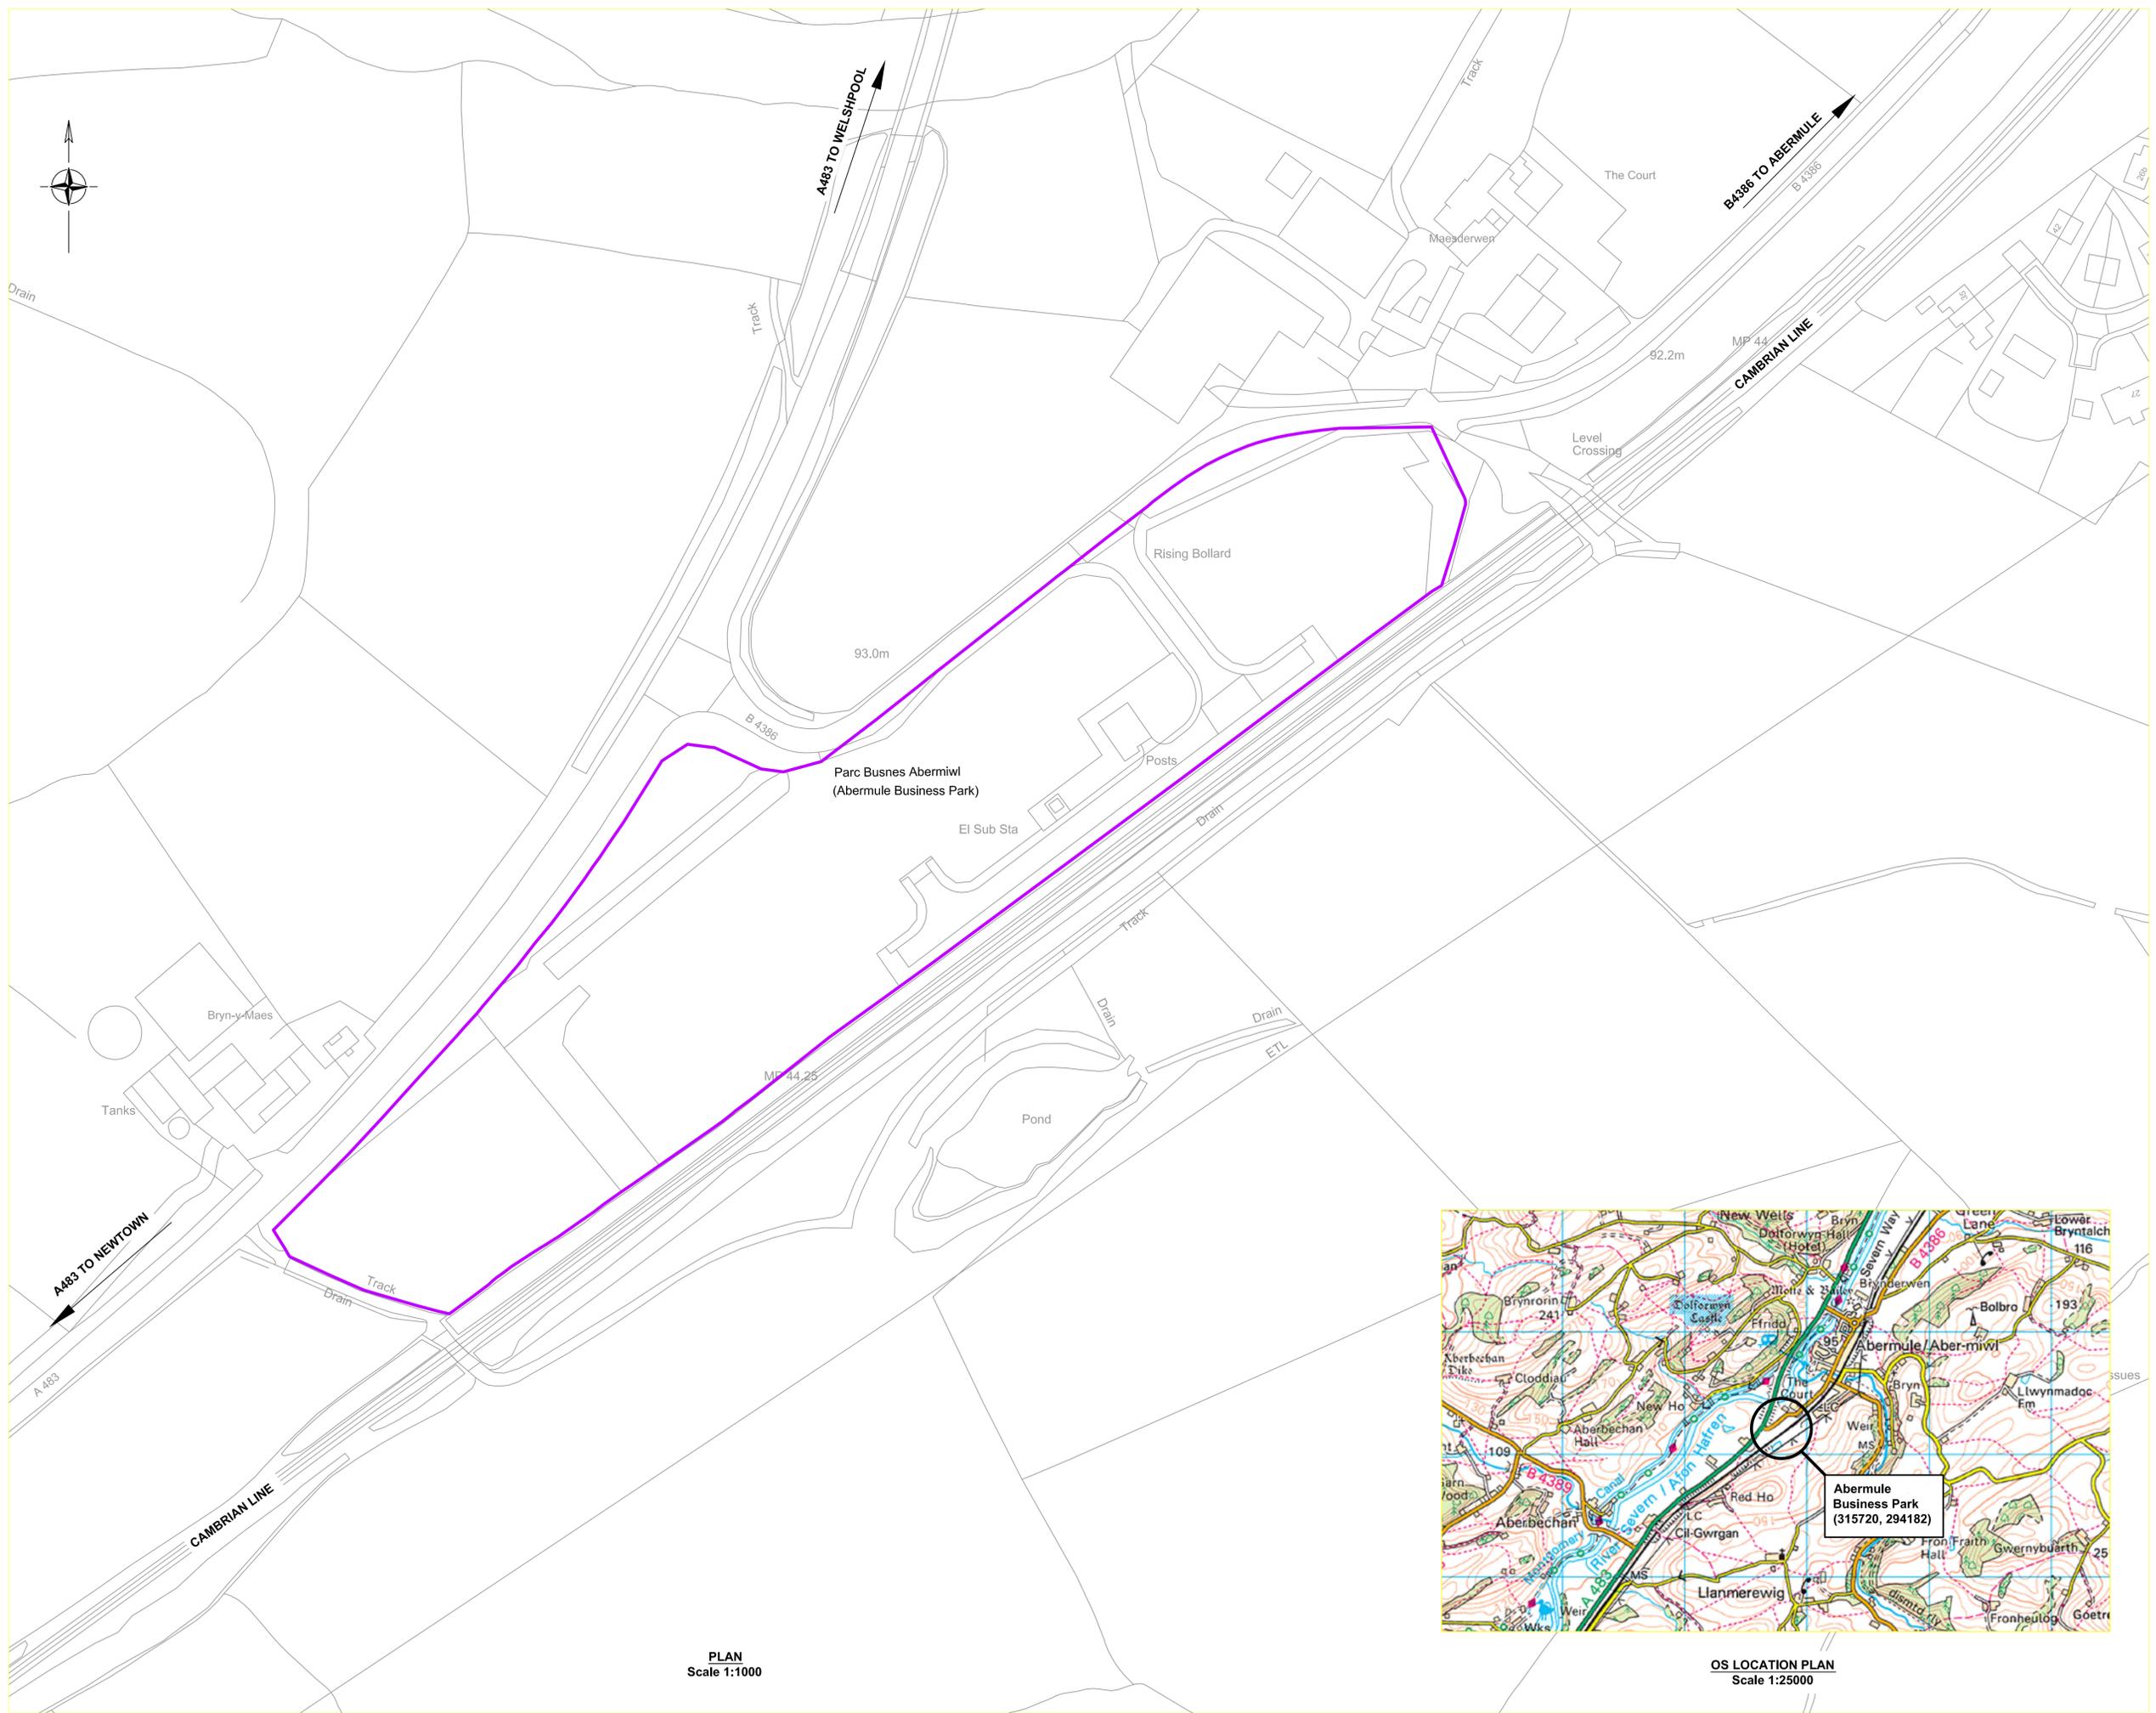
Drawing Title: **Survey Boundary and Location Plan.**

PLAN
Scale 1:1000

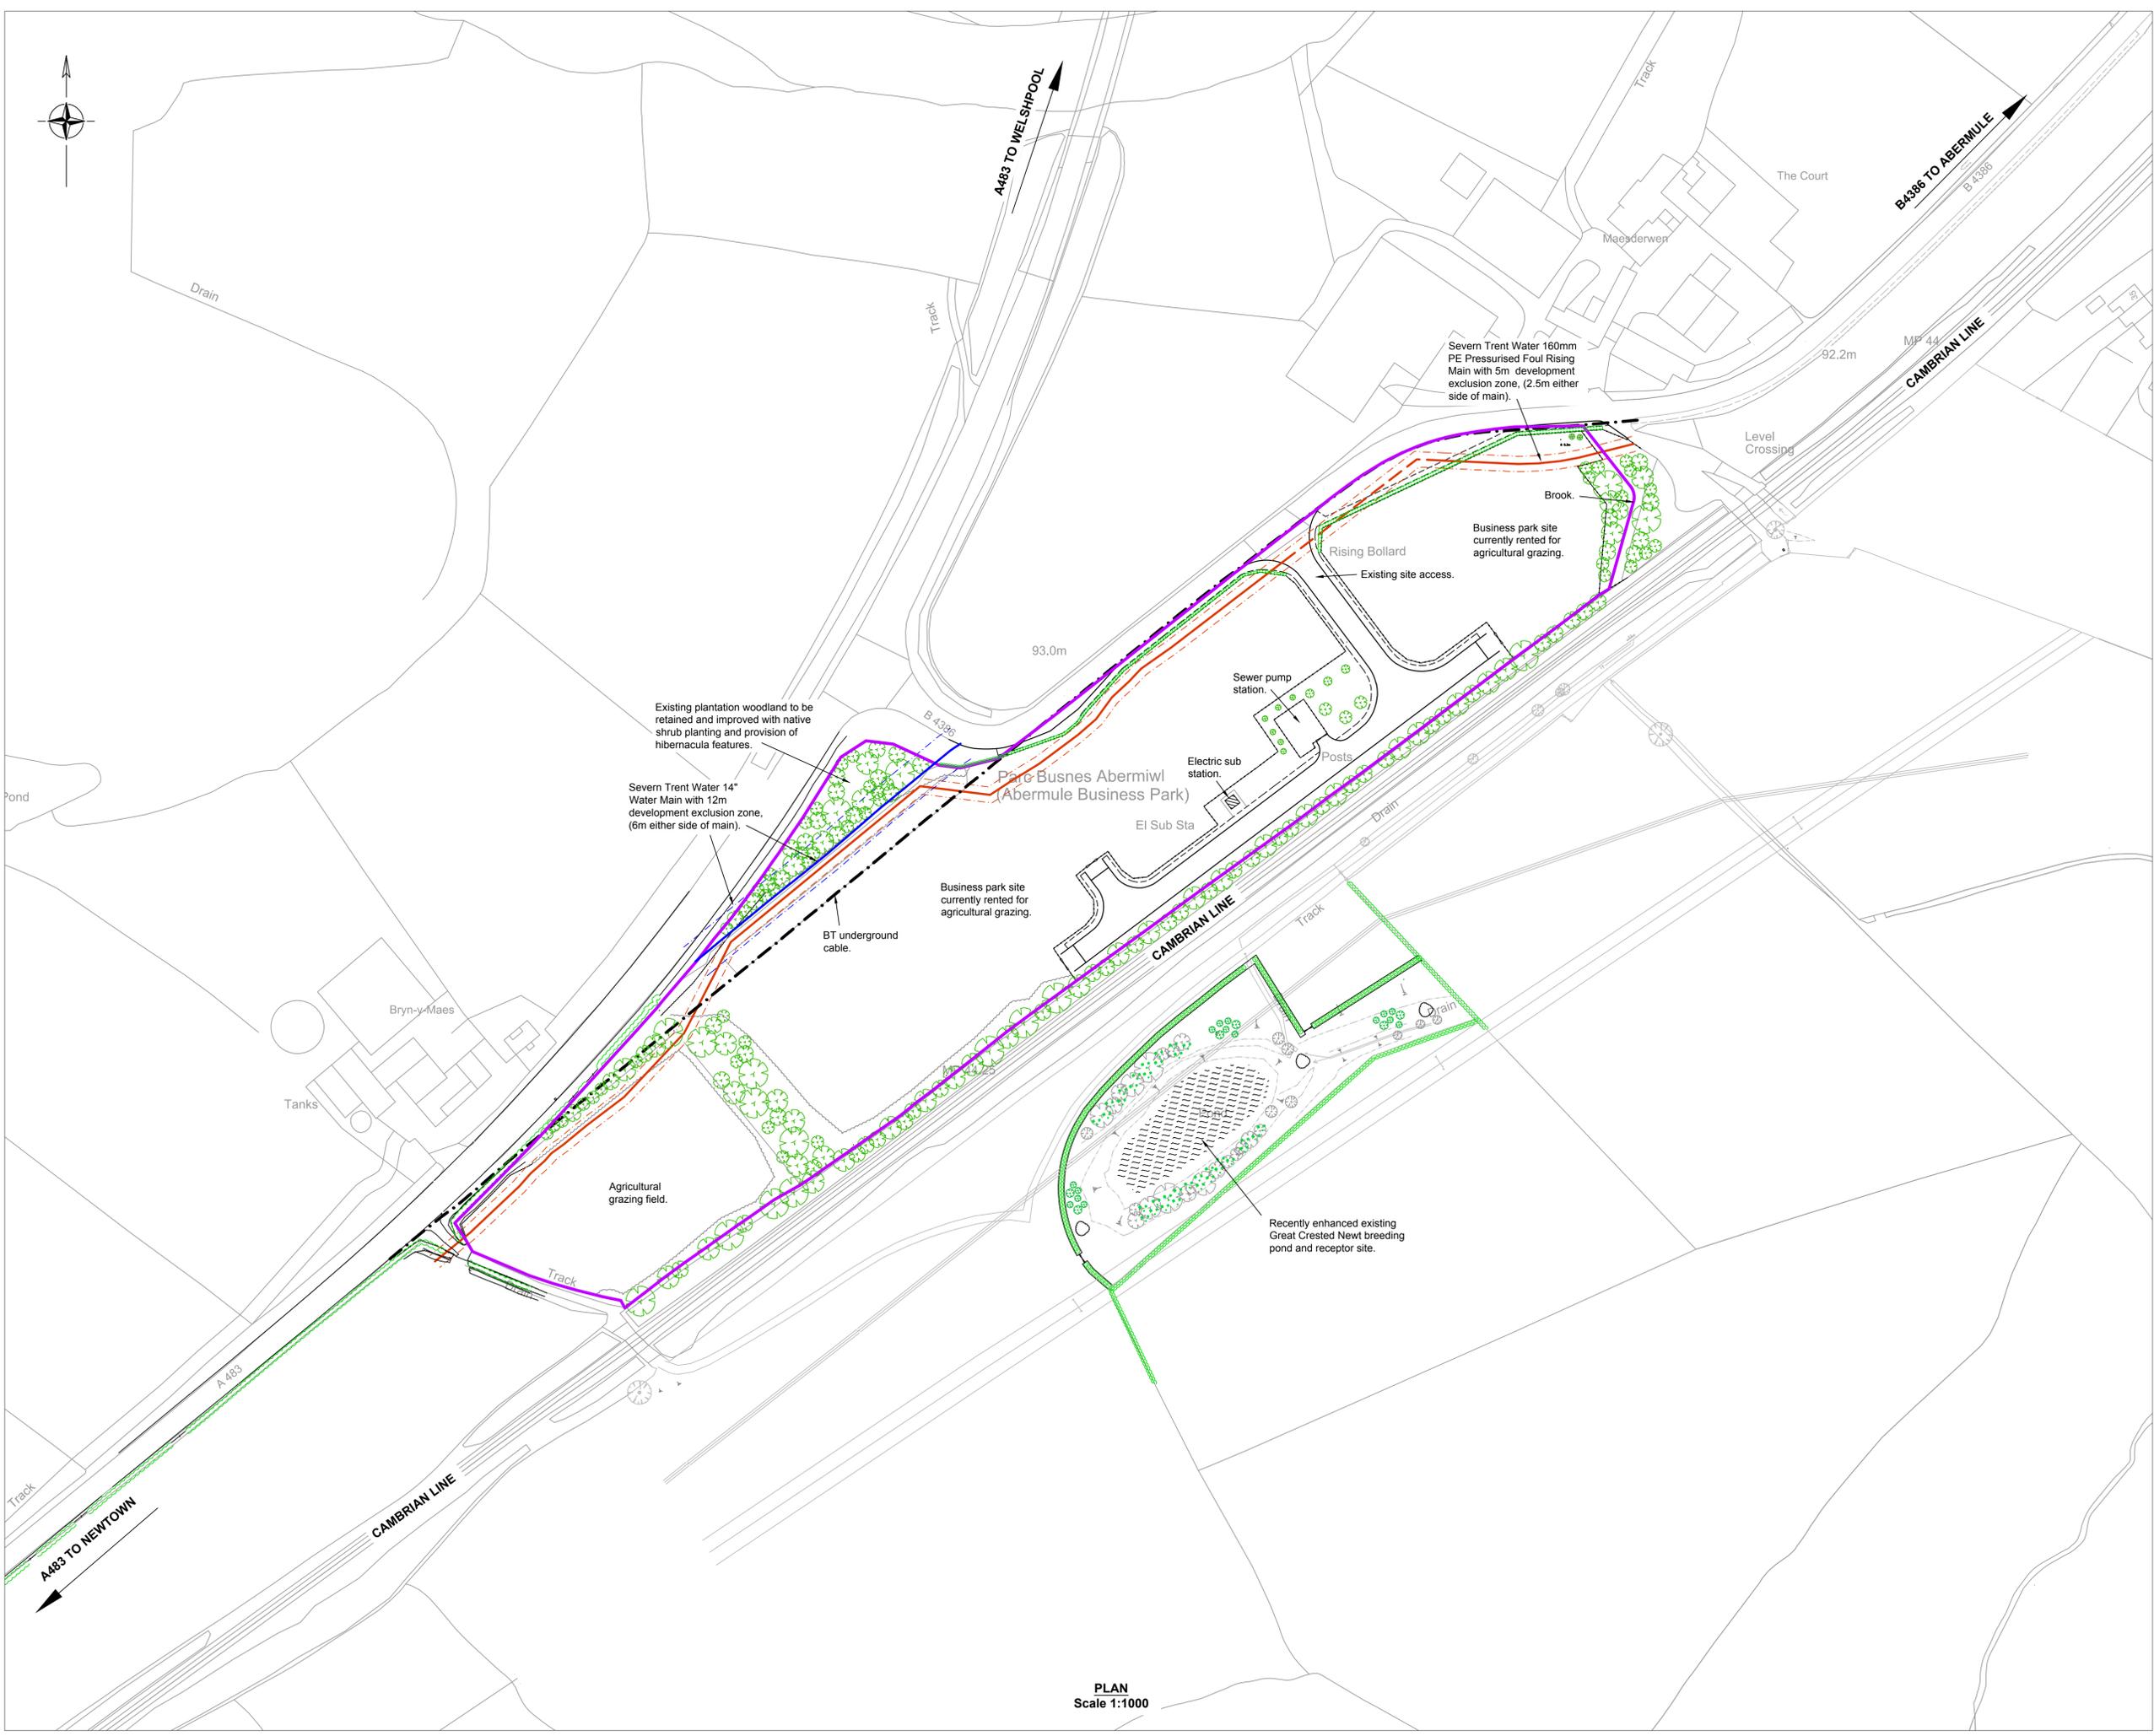
Drawing Title: **Existing Site Layout.**

PLAN
 Scale 1:1000

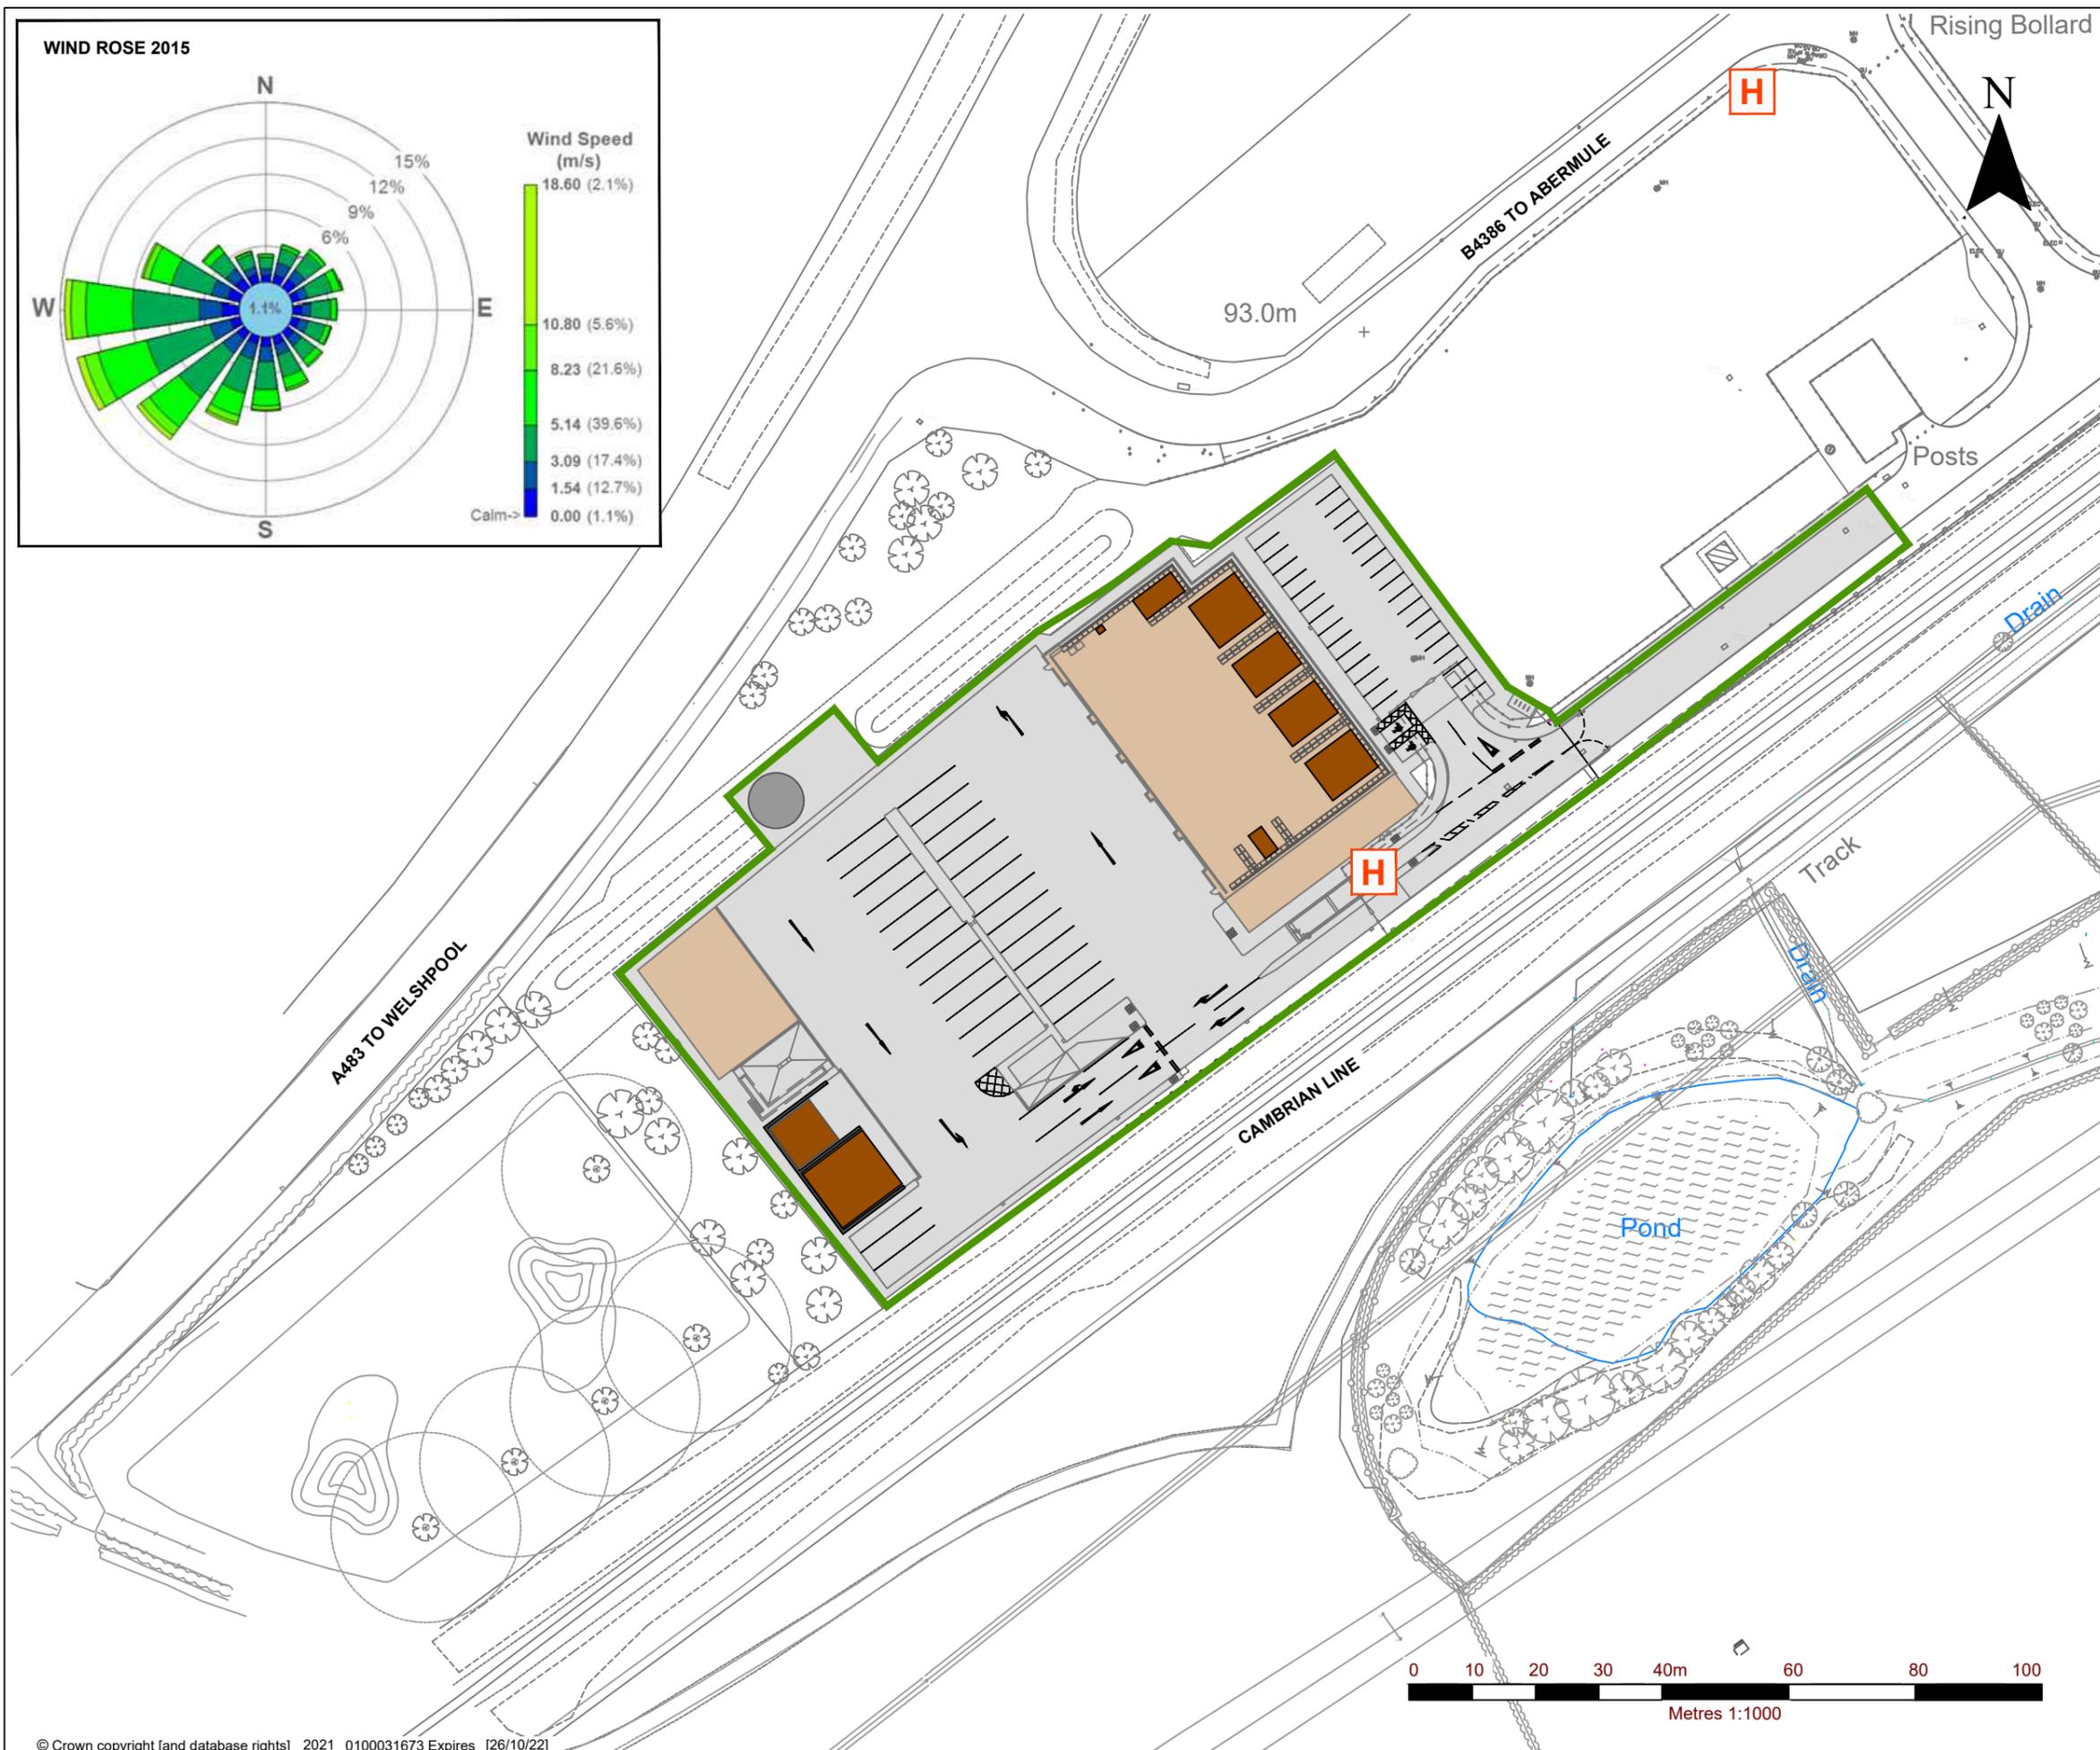
DRAWING 004

NORTH POWYS BULKING FACILITY
ENVIRONMENTAL PERMIT APPLICATION
ENVIRONMENTAL PERMIT BOUNDARY

Powys County Council has provided a 'Site Boundary Plan' which shows the boundary for permitted activities and is attached as drawing no. 004 in Appendix A.

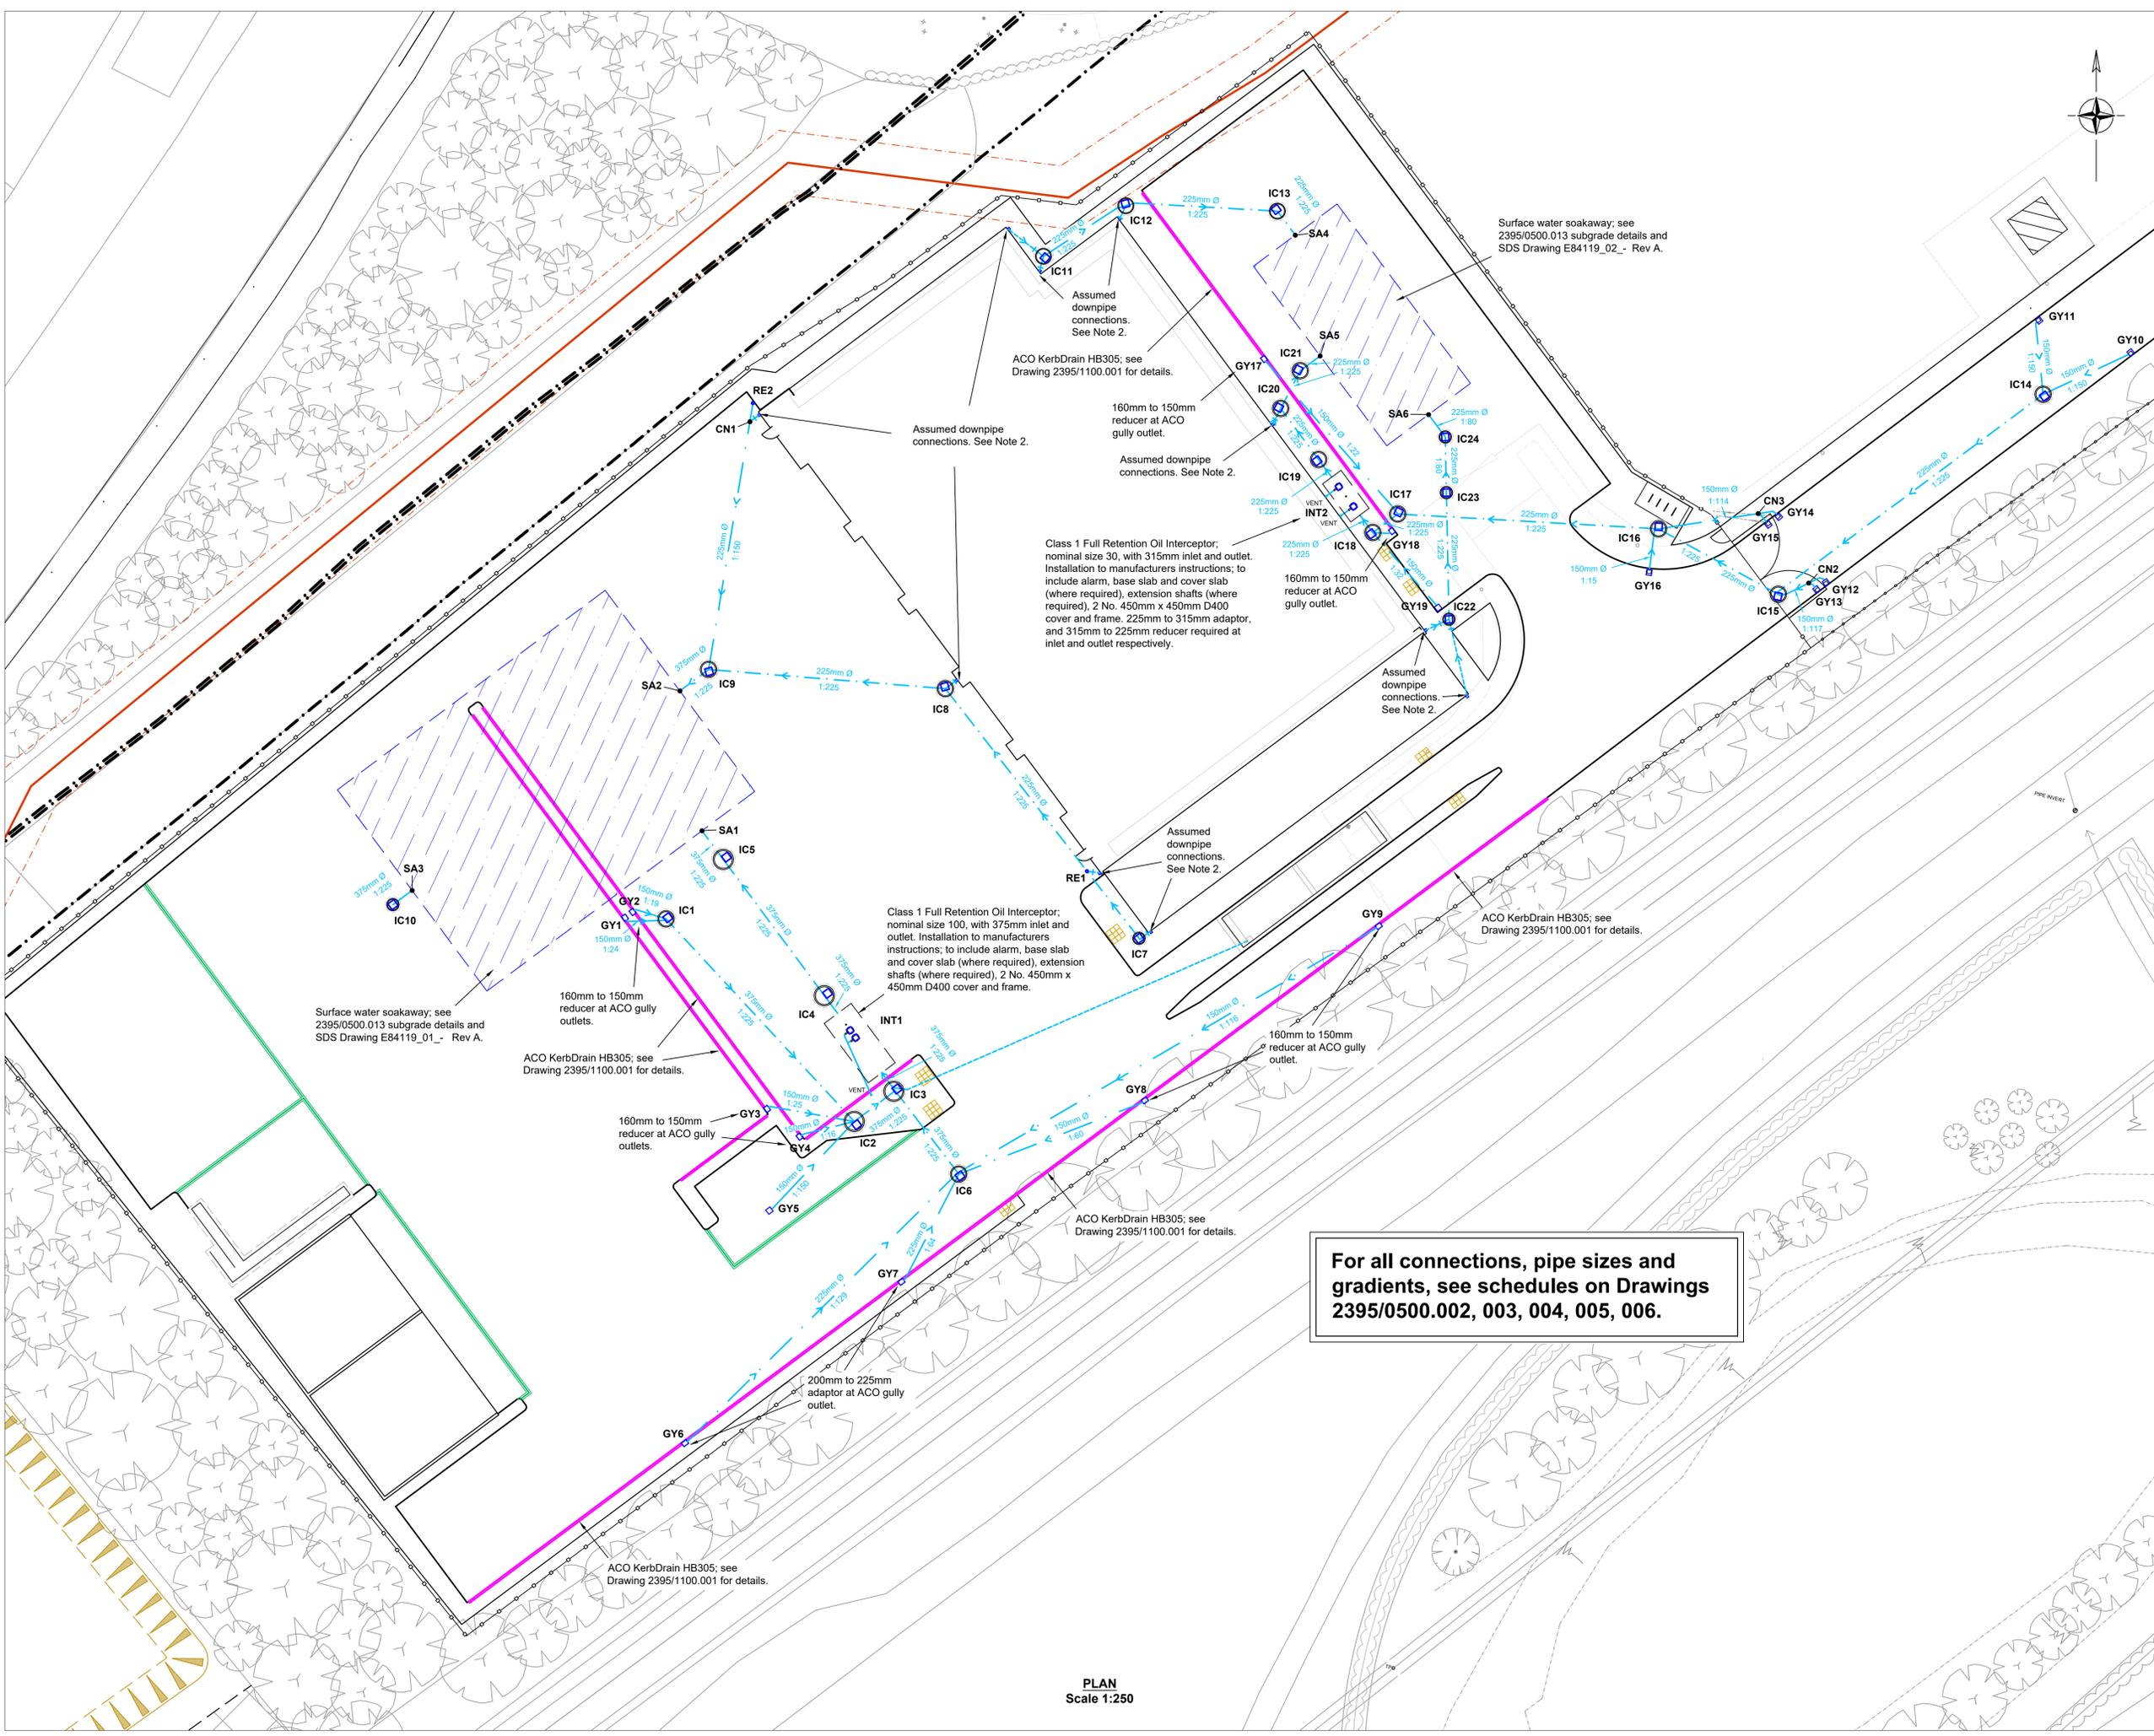
Proposed Surface Water Drainage Plan.

Surface water soakaway; see 2395/0500.013 subgrade details and SDS Drawing E84119_02_ - Rev A.

ACO KerbDrain HB305; see Drawing 2395/1100.001 for details.

160mm to 150mm reducer at ACO gully outlet.

Class 1 Full Retention Oil Interceptor; nominal size 30, with 315mm inlet and outlet. Installation to manufacturers instructions; to include alarm, base slab and cover slab (where required), extension shafts (where required), 2 No. 450mm x 450mm D400 cover and frame. 225mm to 315mm adaptor, and 315mm to 225mm reducer required at inlet and outlet respectively.

Class 1 Full Retention Oil Interceptor; nominal size 100, with 375mm inlet and outlet. Installation to manufacturers instructions; to include alarm, base slab and cover slab (where required), extension shafts (where required), 2 No. 450mm x 450mm D400 cover and frame.

Surface water soakaway; see 2395/0500.013 subgrade details and SDS Drawing E84119_01_ - Rev A.

PLAN
Scale 1:250
