Gold Mines of Wales (Operations) Ltd

Clogau St David's Mine Water Summary

5th April 2023

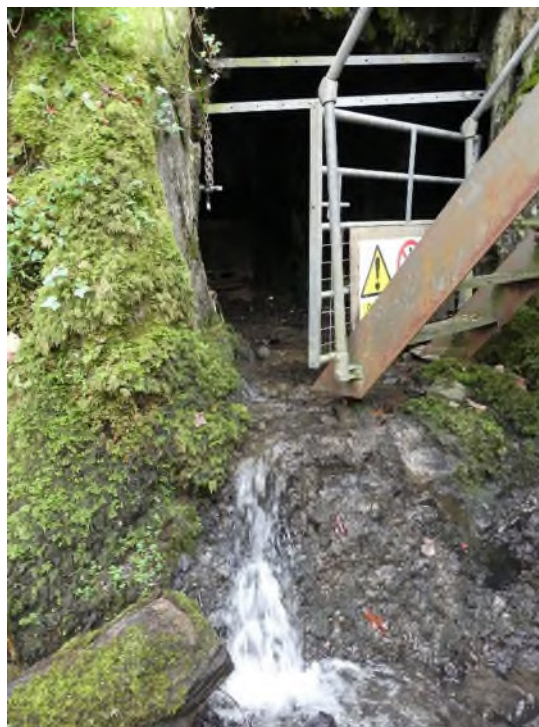
Figure 1 Existing mine water discharge from the Llechfraith Drainage Adit

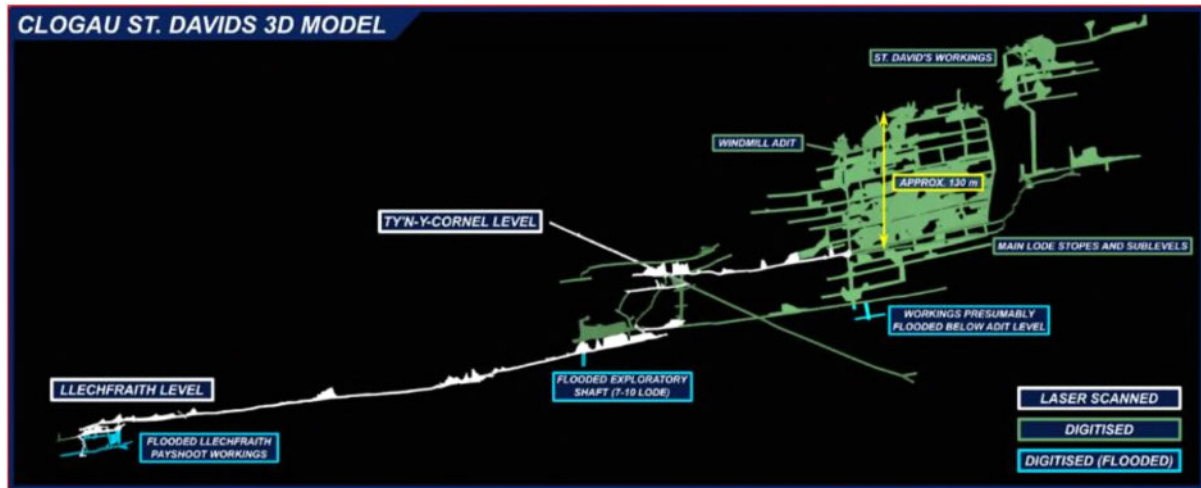
Figure 2 Extent of known mining network in the Clogau St David's mine. The Upper Workings form over 95% of the network, from the Llechfraith Level label on the left and right, the Lower Workings are in the bottom left corner, labelled Flooded Llechfraith Payshoot Workings.

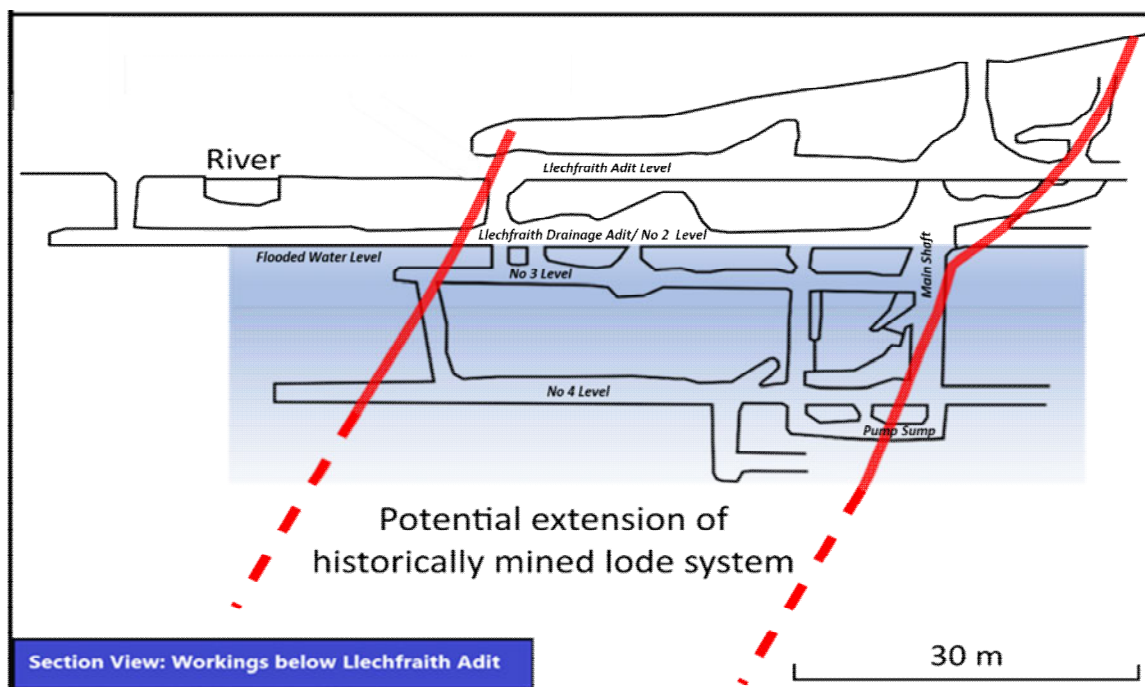
Figure 3 Cross section of the Lower Workings of the mine. Shaded blue area depicts level of flooded workings. Note: Level 2 discharges at river level but downstream of this cross section.

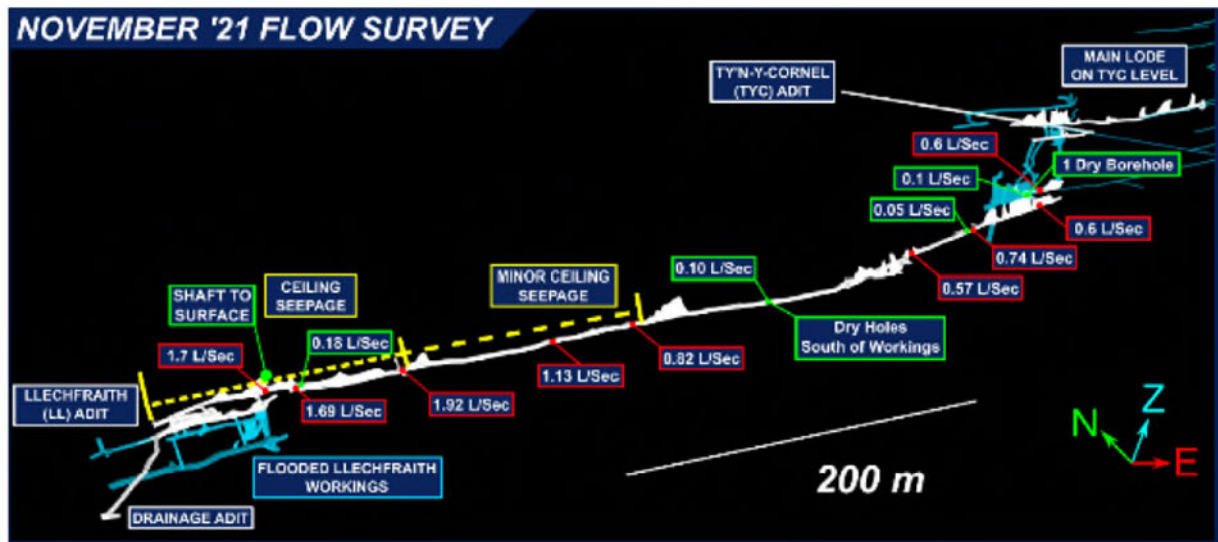
Figure 4 Llechfraith Adit water flow survey summary. Flow on floor (red), discrete borehole flows (green), ceiling seepage (yellow).

In November 2021, Groundwater Science Ltd undertook a walk-through survey of the water inflows into the Llechfraith Adit. They concluded that the majority of the observed inflow was intercepted surface waters travelling through to the groundwater.

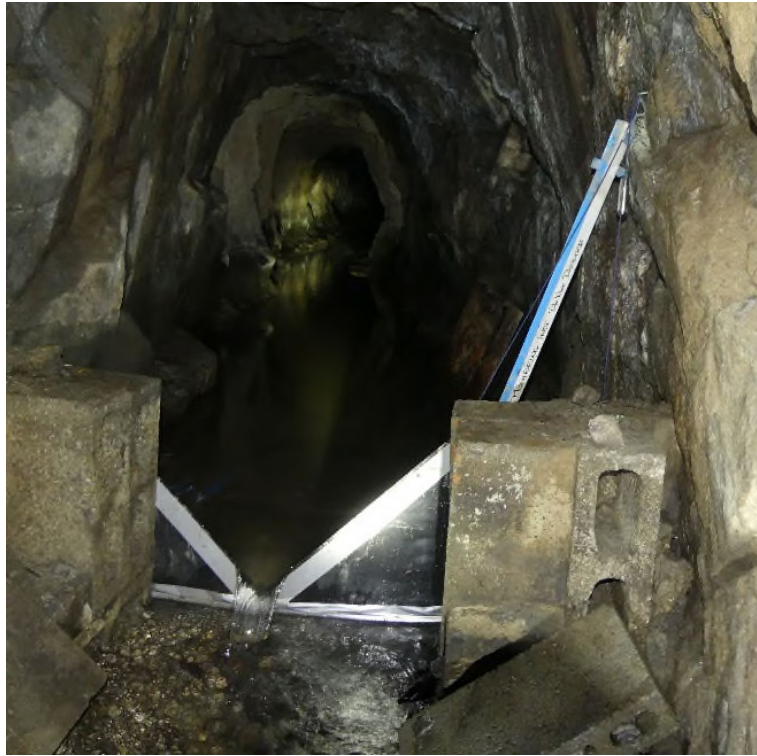
Figure 5 First internal v-notch weir, monitoring the net discharge flow from the mine.

In July 2020 a v-notched weir was installed 10m into the Llechfraith Drainage Adit to measure discharging water flow from the adit. A Van Essen CTD diver measuring conductivity, temperature and depth was also deployed here to record water quality, EC, and any change in water depth. This is the methodology employed to measure the discharge flow from the Llechfraith adit (via the drainage adit).

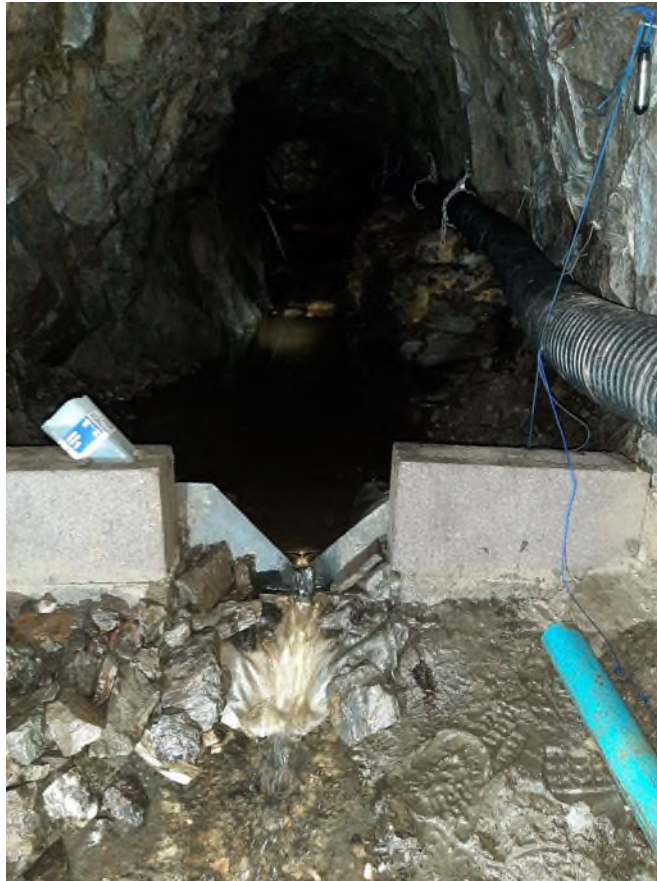
Figure 6 Second weir installed up-gradient of first weir. Note the black pipe on the right of picture carrying the diverted waters from the Upper Workings.

In July 2021 the Lower Workings were isolated from the normal water flow from the Upper Workings, by a simple internal diversion pipe. A second v-notched weir was installed in the drainage adit, about 30m upstream of the original weir, and this weir was used to determine the flow from the now isolated Lower Workings.

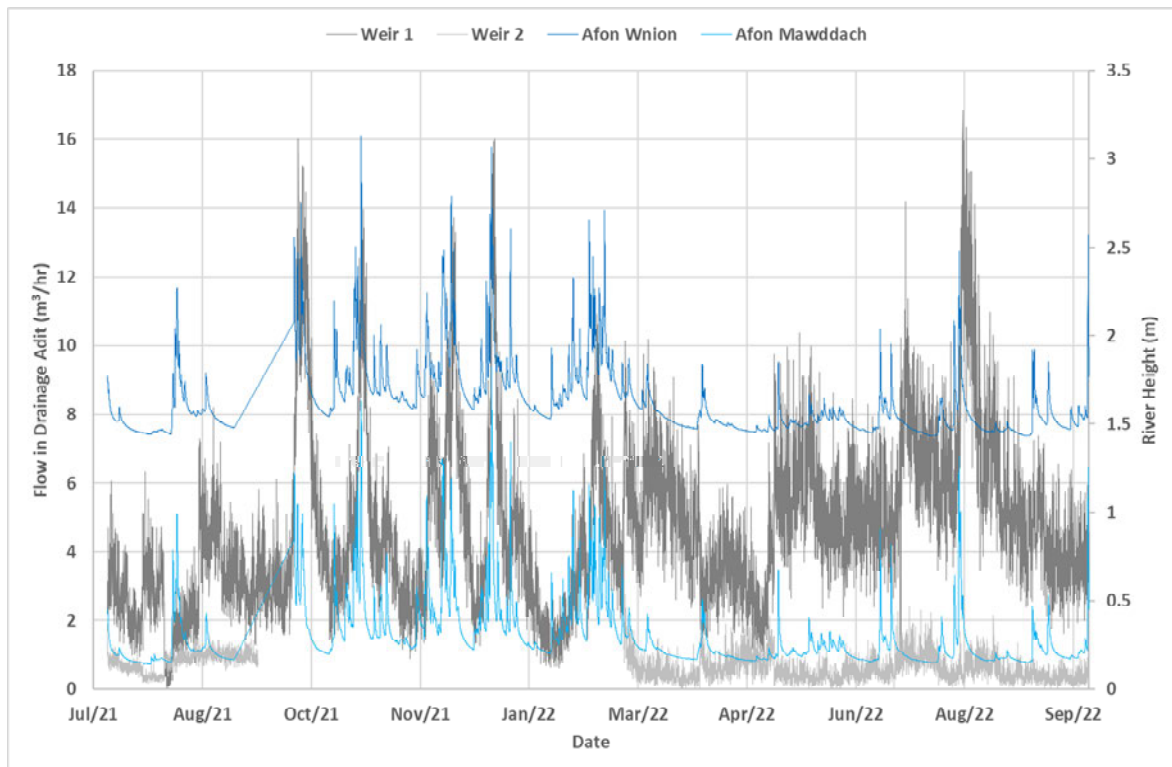
Figure 7 Variation of discharge rates from the Llechfraith drainage adit, Weir1, the flow from the flooded mining voids, Weir 2, and NRW monitored local river levels.

It is noted that both the rivers and the net discharge from the mine exhibit similar characteristics in response to flow from precipitation. This reinforces the findings of the Groudwater Science Ltd Llechfraith Adit survey that the bulk of the flow in the adit is from intercepted surface waters travelling to the groundwater.

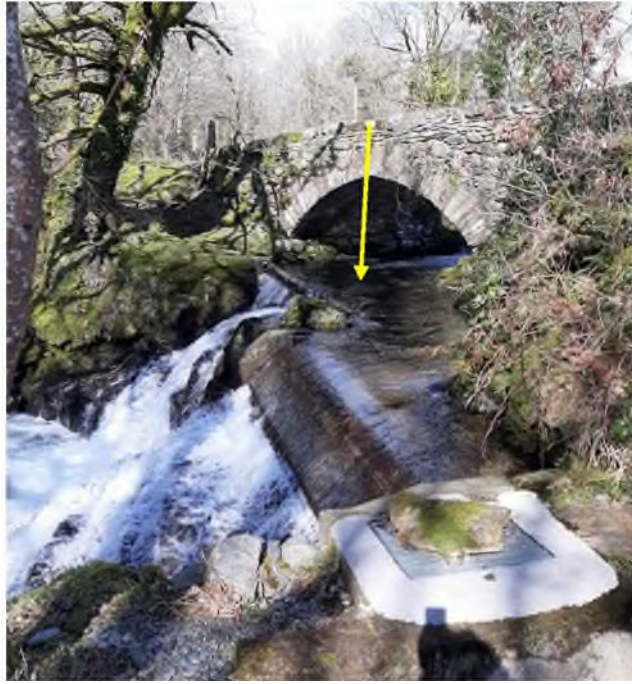
Figure 8 Sampling point UB, arrow indicates point of sampling.

Note Hydro take off weir, in foreground, is independent of GMOW activities.

- Upstream Sampling Point: from road bridge, approximately 300m upstream of Llechfraith mine site crossing the Afon Cwm Llechen. Sample ID: UB

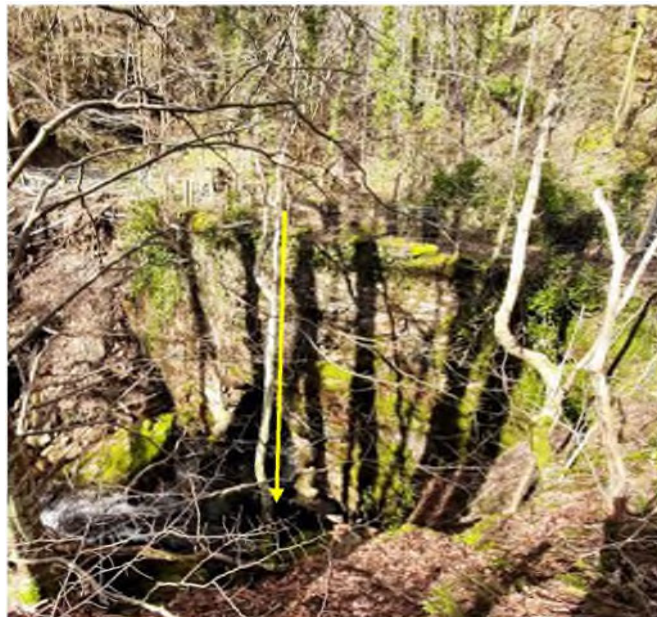
Figure 9 Sampling point LB, Ffynnon bridge, arrow indicates point of sampling.

- Downstream Sampling Point: from Ffynnon bridge, approximately 400m downstream of Llechfraith mine site, again crossing the Afon Cwm Llechen. Sample ID:

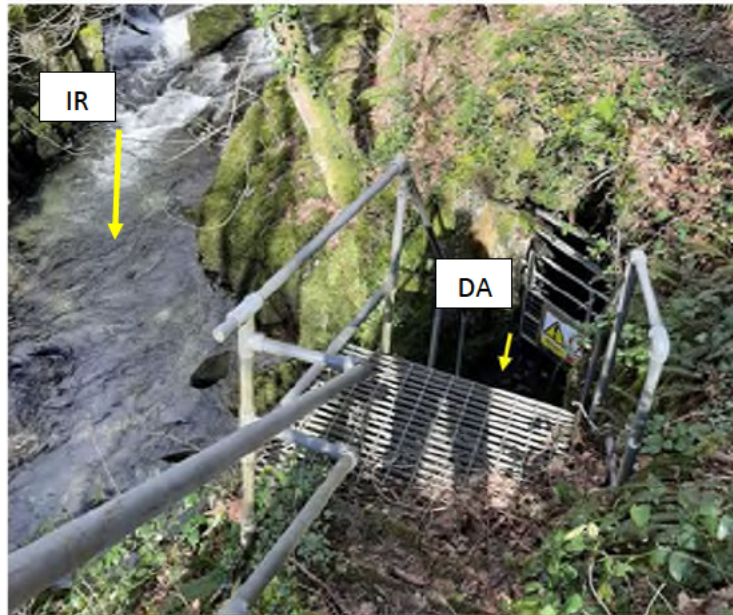
Figure 10 Sampling point DA and additional sampling point IR, arrows indicate the points of sampling.

- Llechfraith Mine Discharge Point: from the Llechfraith mine drainage adit, discharging directly to the Afon Cwm Llechen. Sample ID: DA

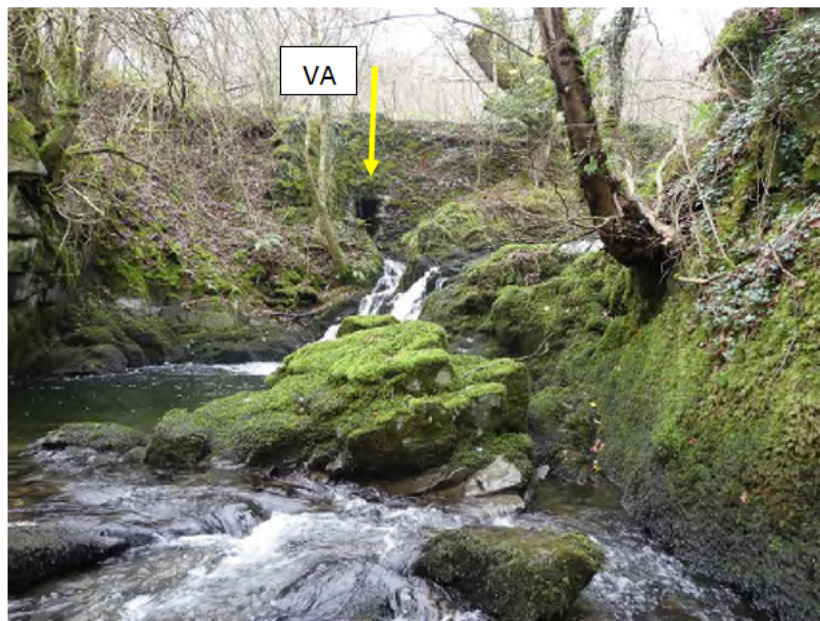
Figure 11 Sampling point VA, arrow indicates point of sampling. IR and DA sampling points are 30 to 40m downstream, and the mine yard is on top of the opposite, eastern bank.

- **Vigra Drainage Adit Sampling Point:** from the discharging stream from the adit on the western bank of the Afon Cwm Llechen. Sample ID: VA. *Note: although labelled as a drainage adit this turned out to be a culvert for a stream that passes through made ground.*

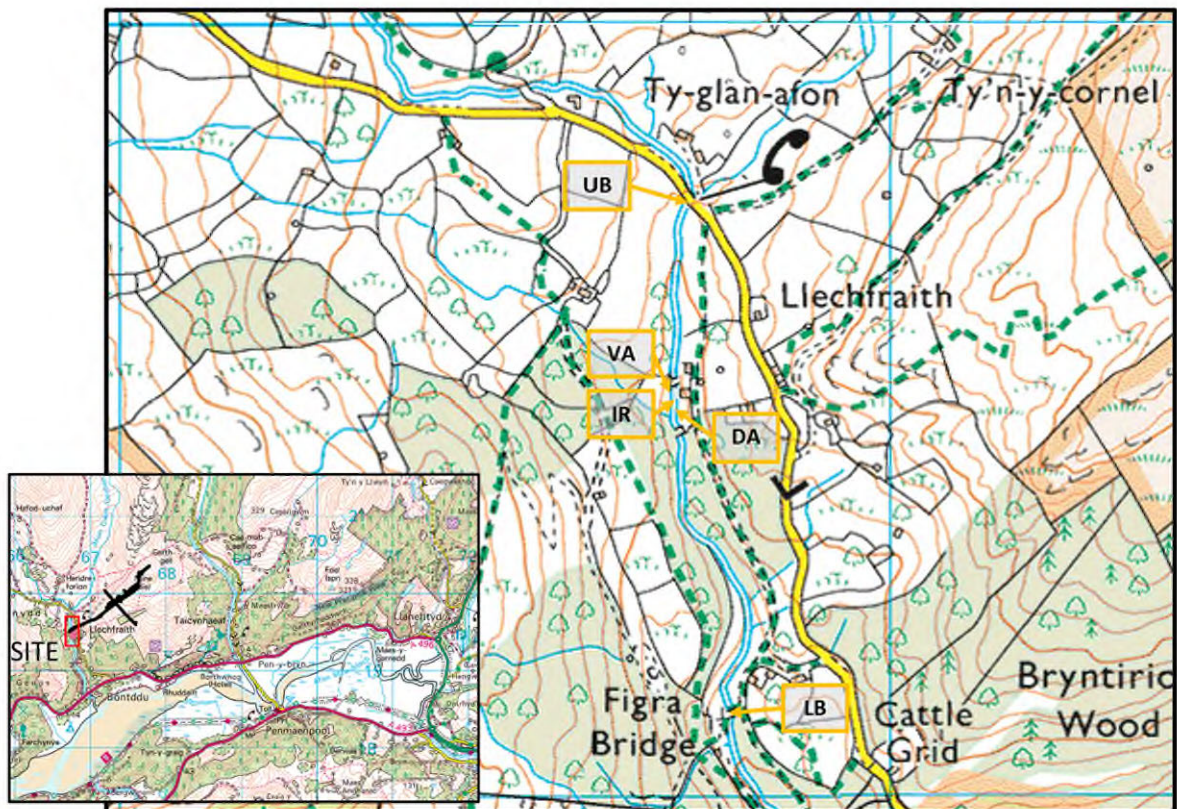
Figure 12 Location of water sampling points, inset illustrates extent of underground workings.

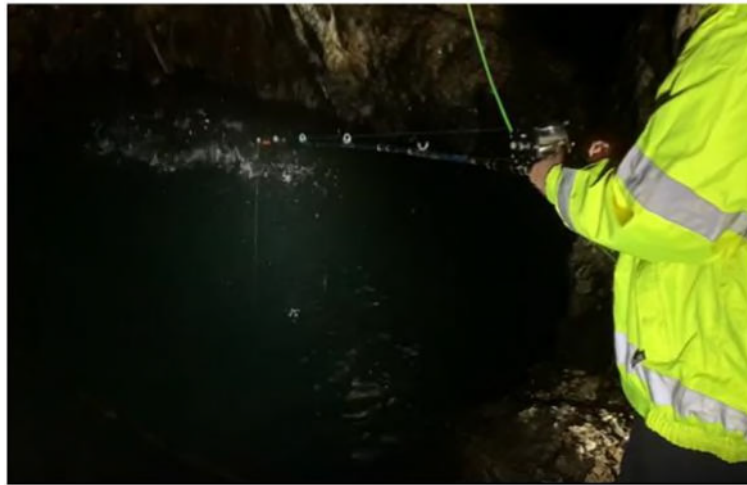
Figure 14 Lowering the Van Essen CTD diver with a fish rod in the flooded Main Shaft from the Llechfraith Drainage Adit, No 2 Level

The water column was profiled by lowering a Van Essen CTD diver, that was set to record water depth, temperature, and electro-conductivity every second. A fishing rod and line were utilized to centre the diver within the water column. The line was kept taut with the weight of the diver during lowering, and the diver was raised once an obstacle was encountered.

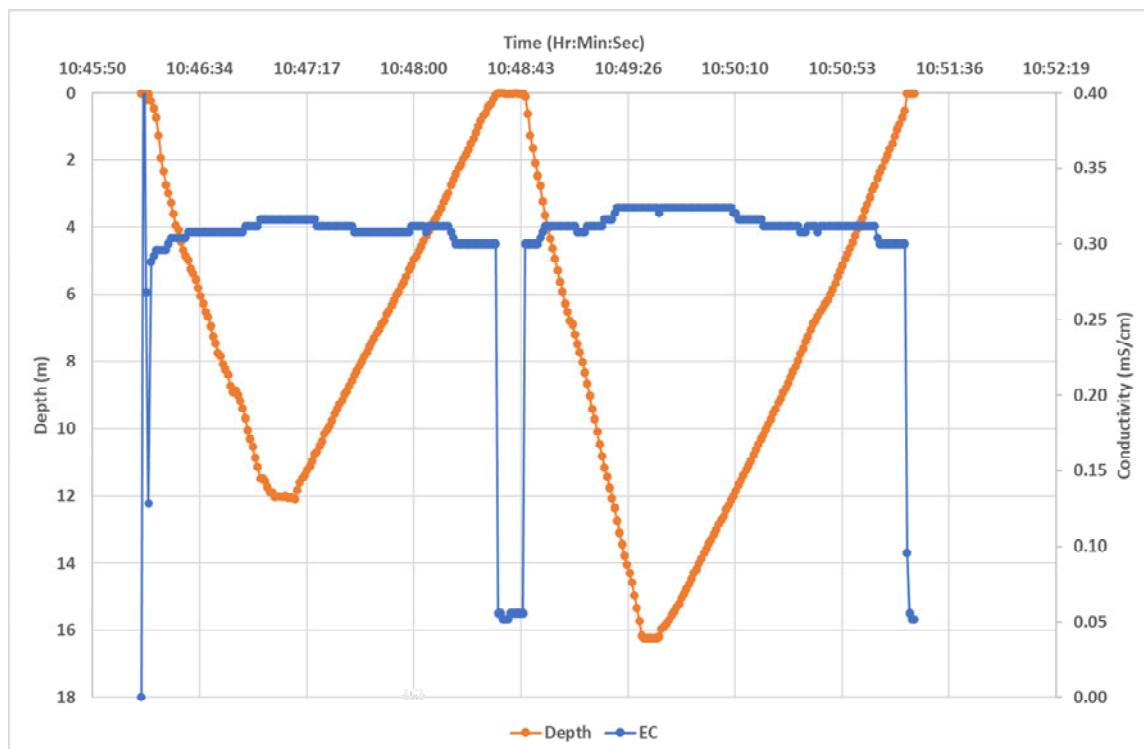
Figure 15 Flooded Main Shaft water profile 1st July 2020, an initial obstacle was encountered at 12m but on lowering again a depth of 16m was attained, very near the depth of the shaft from the floor of No 2 Level.

As can be seen in Figure 15 there is no discernable change in the water quality encountered in the water column profile, indicating there is little to no stratification of the water.

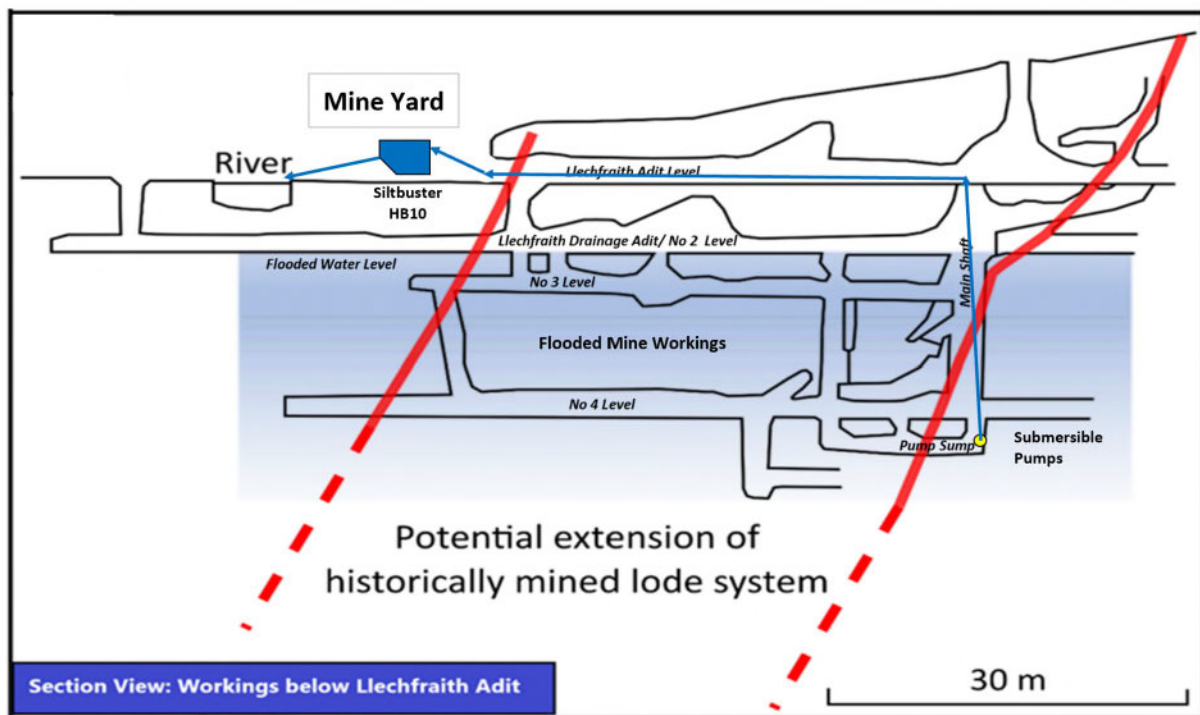
Figure 16 Schematic of proposed dewatering scheme

The proposed dewatering scheme would be to lower 1 to 2 submersible water pumps into Main Shaft from the Llechfraith Adit level and pump the water back through the Llechfraith adit to the mine yard. The pumps would be run off a 3-phase electric supply, from within the site workshop, and would have a float switch operation, such that they would switch on and off automatically, and do not run the pumps dry.

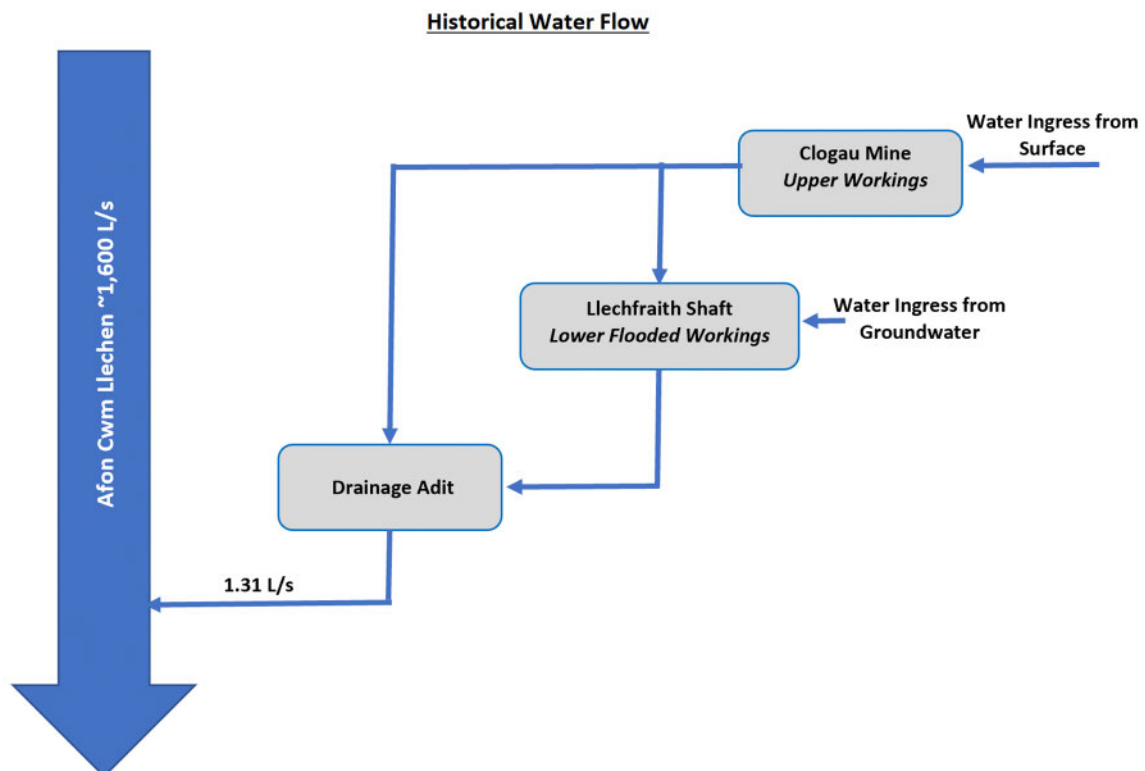
Figure 17 Historical flow of water through and from the Clogau Mine workings.

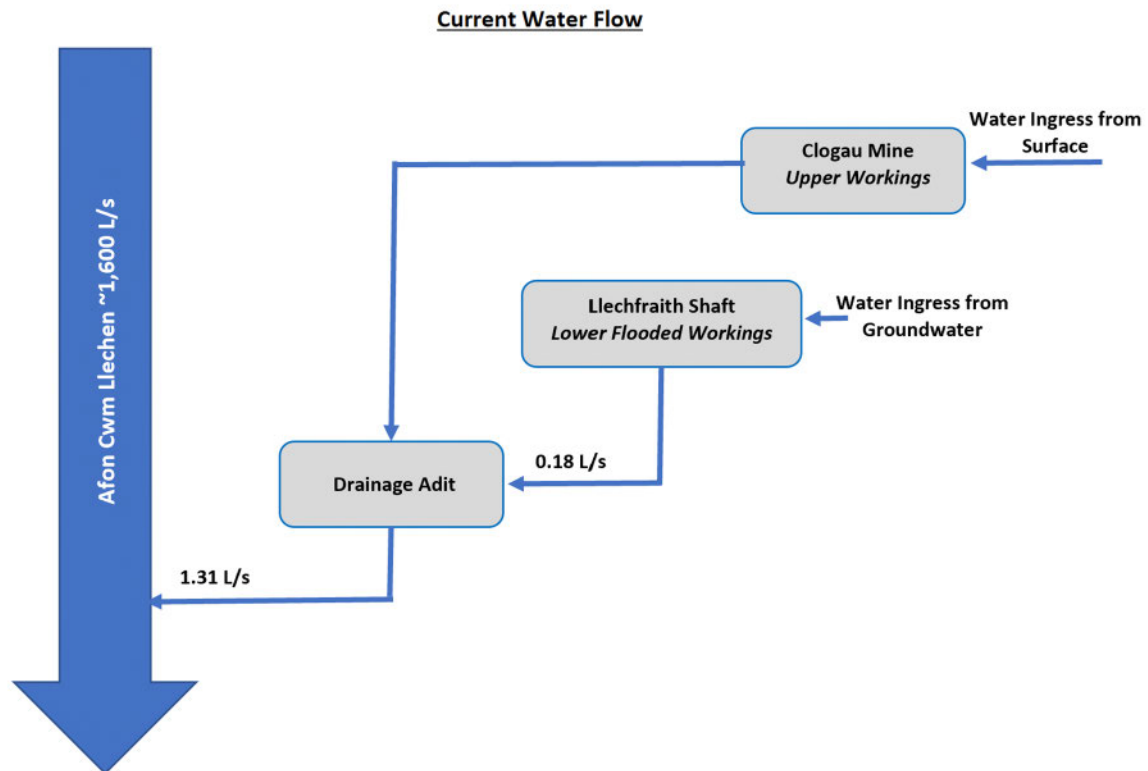
Figure 18 Current flow of water through and from the Clogau Mine workings. The Lower Flooded Workings are now isolated from the flows from the Upper Workings

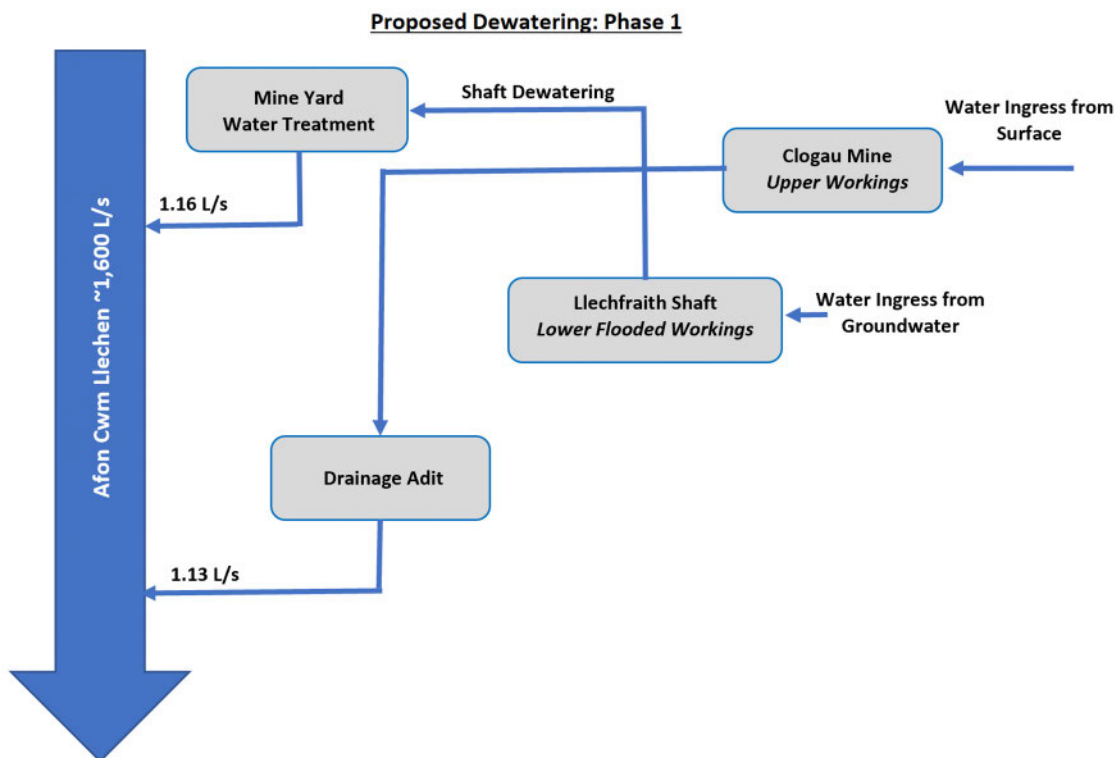
Figure 19 Proposed dewatering of the Lower Flooded Workings. Only the pumped waters will be treated.

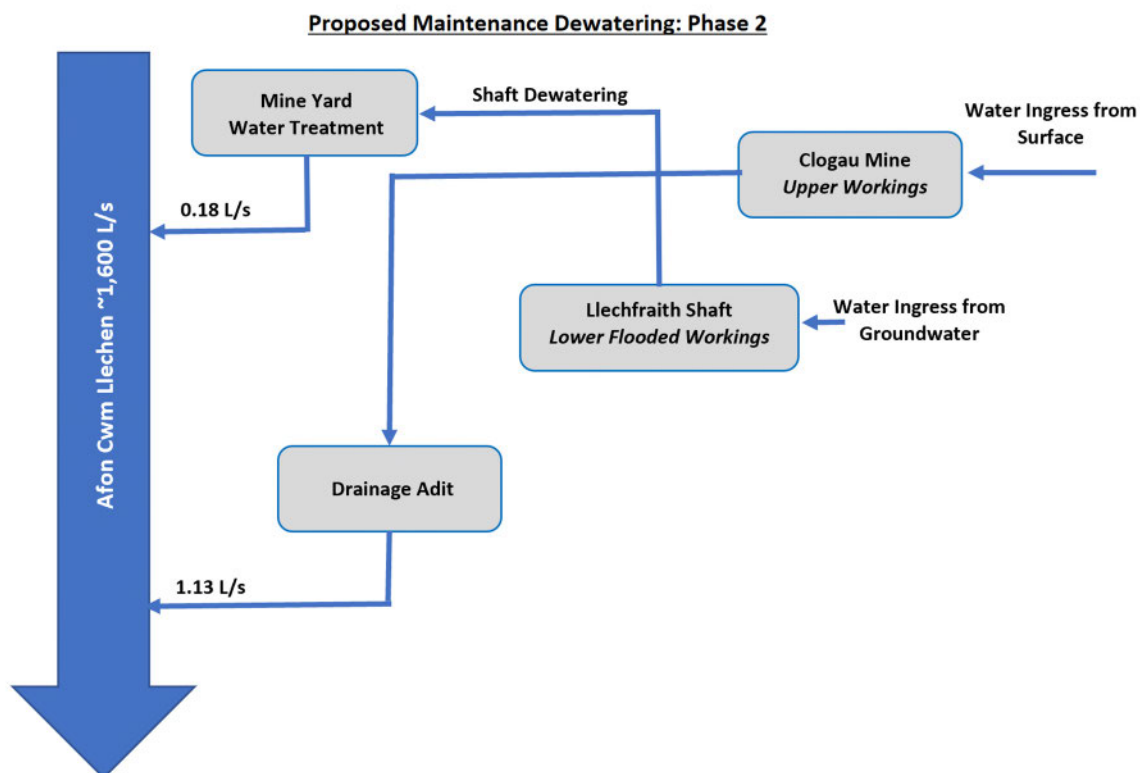
Figure 20 Proposed 'ongoing' maintenance pumping. Only the pumped waters will be treated.

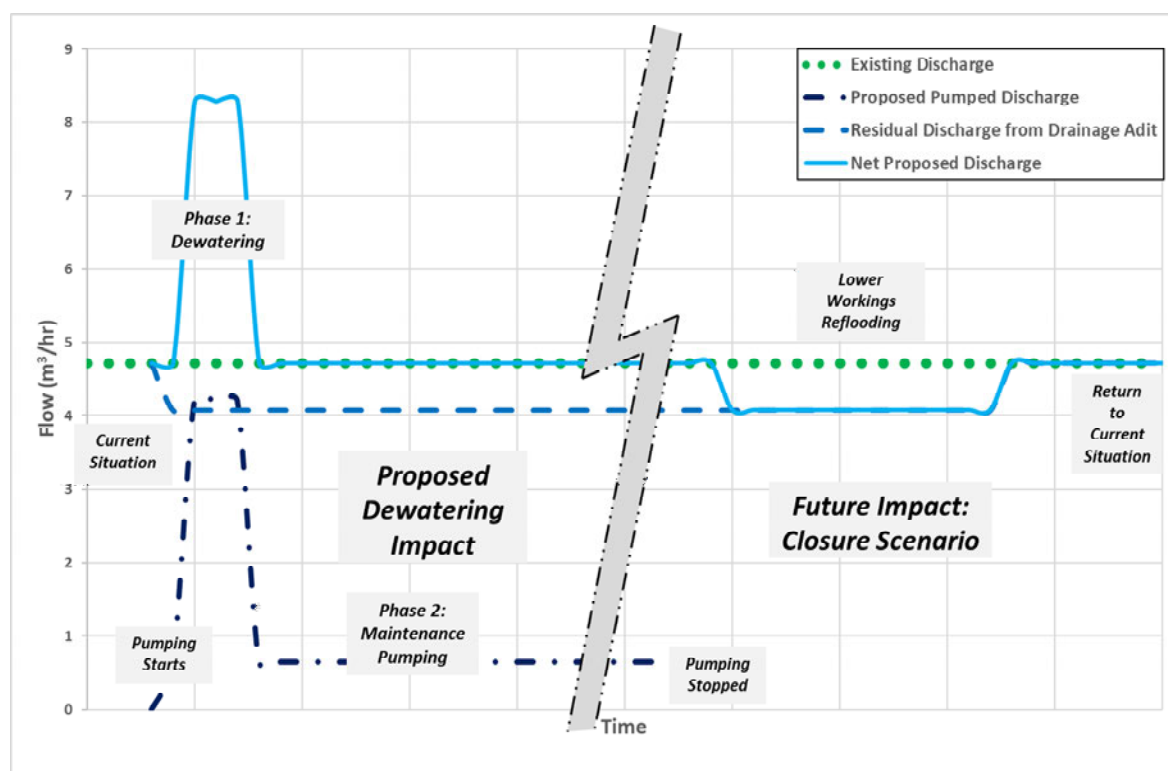
Figure 21 Depiction of Net and Individual Flows from mine during the various phases.

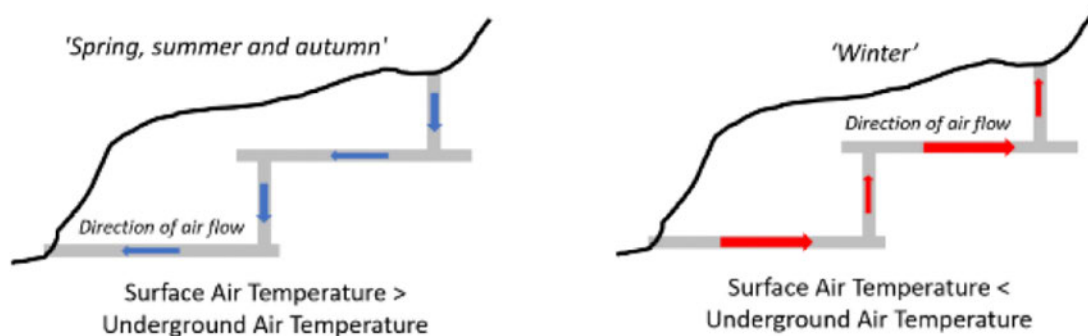
Figure 22 Schematic of the Natural Ventilation Mechanism within the mine.

Ventilation of the mine utilises a 'natural ventilation mechanism'. Air is generally drawn into the mine through the open stopes at the highest point in the mine, as well as through the Ty'n-y-Cornel Adit, during the warmer Summer months. Air may also, under extreme weather conditions and for periods of time during the winter, enter through the Llechfraith Adit.

In the sustained colder winter months, it is possible that the system can reverse, i.e., air entering the mine warms, decreases in density, and therefore rises through the workings. However, this has not been measured, due to restricted access during these months. Also, a change in the direction of flow would be expected to take some time, due to the momentum of the air within the mine requiring a sustained period of either cold or warming.

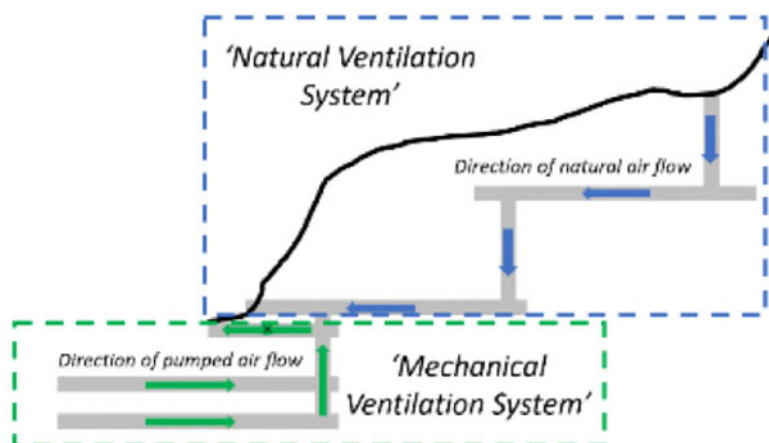
Figure 23 Schematic of proposed Mechanical Ventilation system for dewatered Lower Workings.

In contrast, the flooded Lower Workings are effectively a 'blind' working zone, i.e., the ingress and egress air routes are the same, and as a result when these levels are accessed a natural ventilation system will not function. Therefore, a mechanical ventilation system will be required. This system will operate independent of the natural system on the Llechfraith Level above and will be exhausted directly through the Llechfraith Drainage Adit. This isolation of the systems means that there will be no mixing of the two ventilation circuits and all heat/fumes generated during the exploration phase of works will be removed from the mine environment through this independent ventilation system.

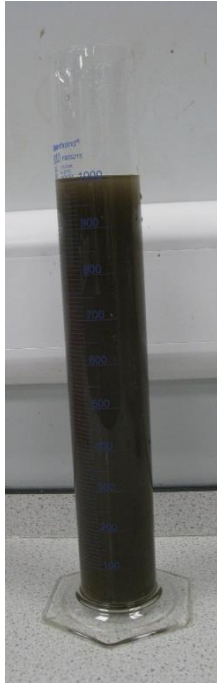
Plate 1: Adit Sample as received

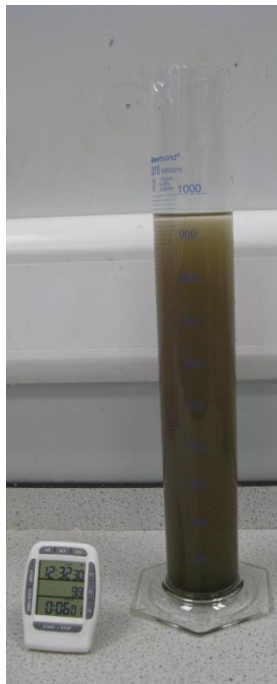
Plate 2: Adit Settling only 6mins

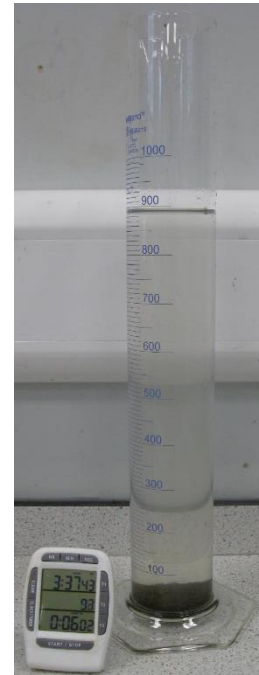
Plate 3: Adit Polymer & Settling 6mins

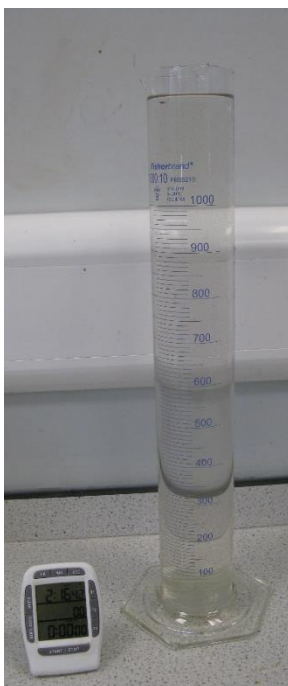
Plate 4: Shaft Sample as received

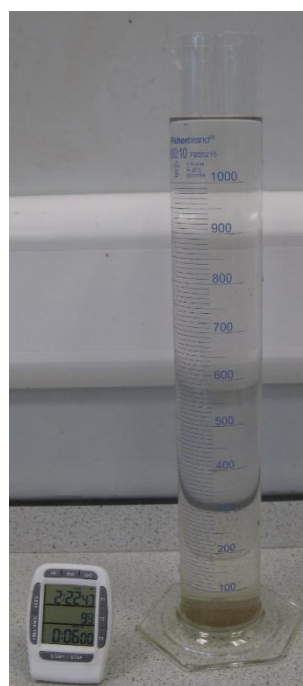
Plate 5: Shaft Settling only 6mins

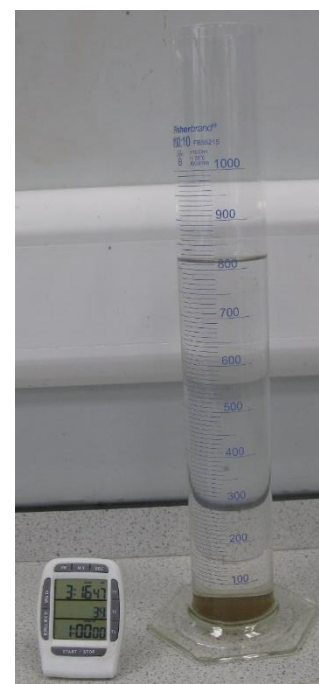
Plate 6: Shaft Settling only 60mins

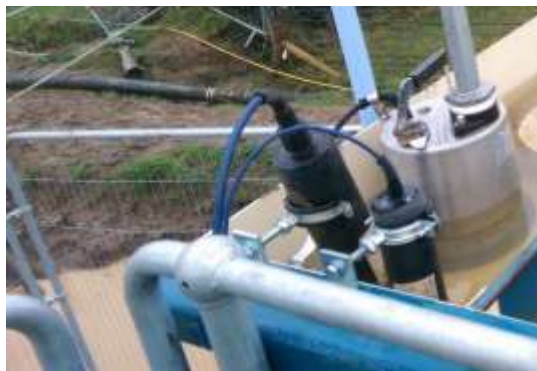
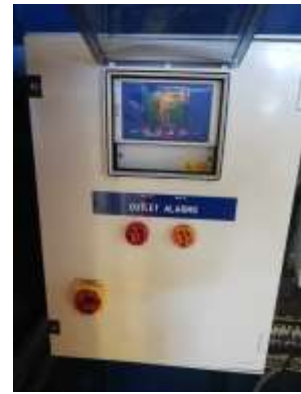
The Clarity sensors are fitted at the end of the Siltbuster process train, prior to discharger. An example of the arrangement is shown below which shows monitoring of turbidity (reported as total suspended solids) and pH probe. The signal from the Siltbuster flow meter can also be linked to Clarity.
