Report No: AC2019/ENV/01  
January 2019

REVIEW OF ENVIRONMENTAL MONITORING  
UNDERTAKEN AT THE  
BRYN PICA LANDFILL SITE DURING THE PERIOD  
JAN 18 – DEC 18

Amgen Cymru  
Bryn Pica Landfill Site  
Llwydcoed  
Aberdare  
CF44 0BX

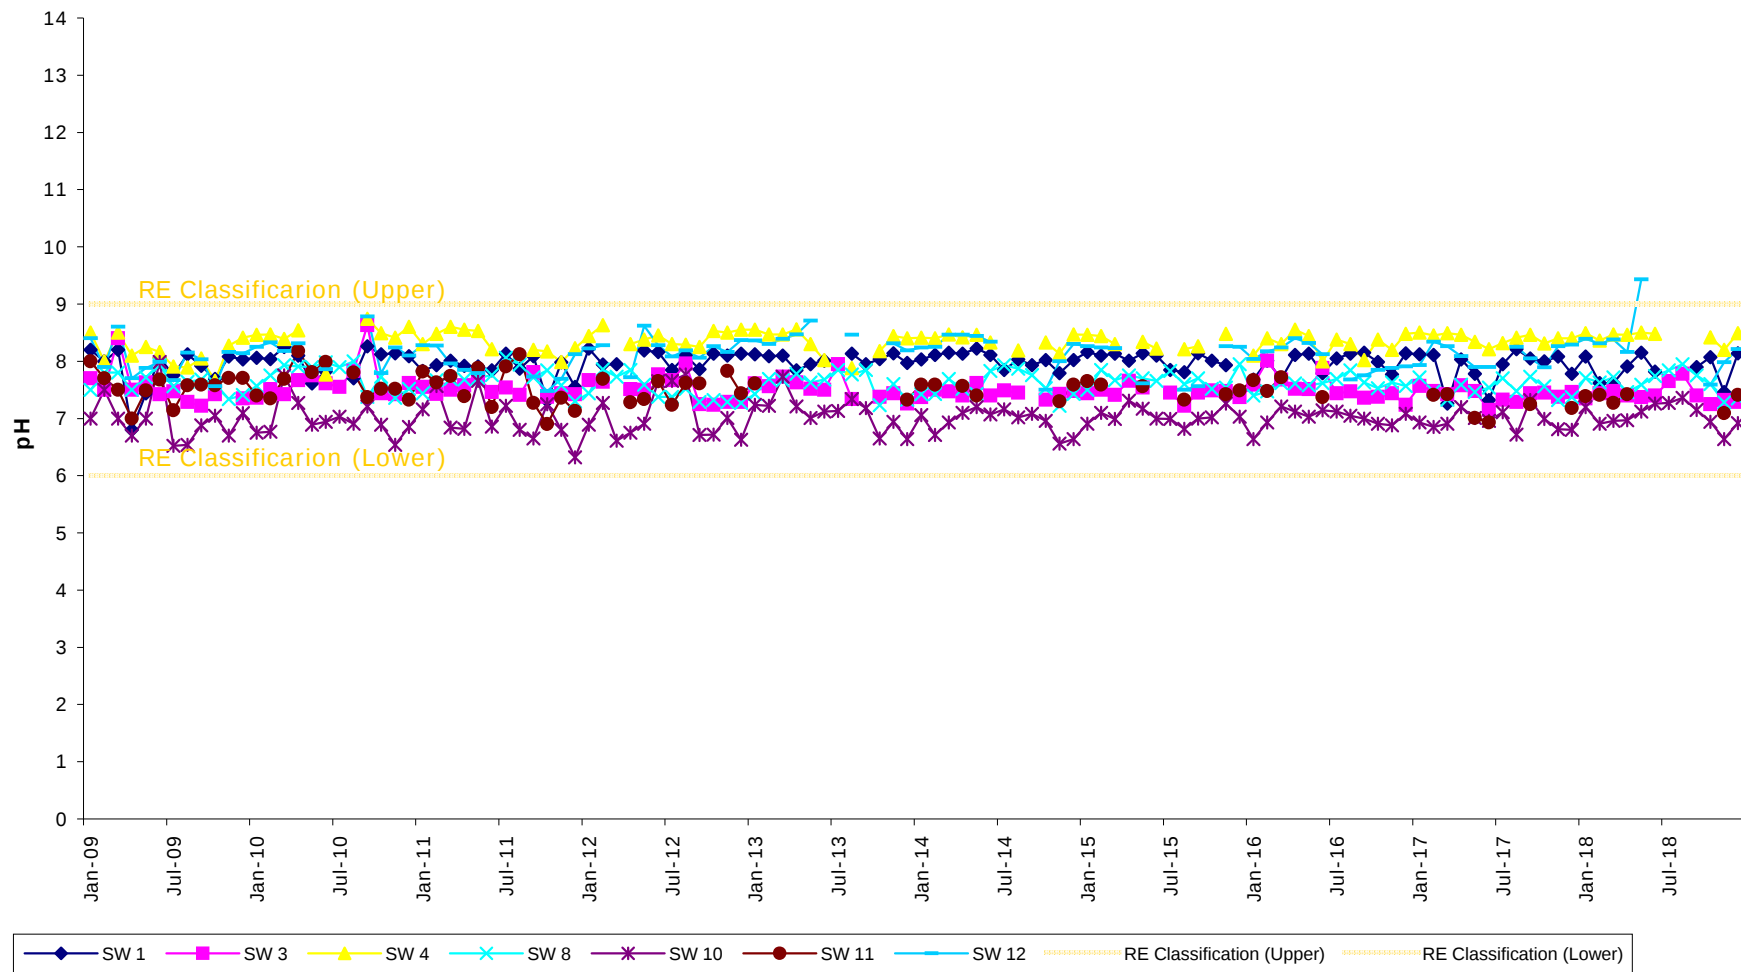
**Lab analysis of pH in surface water sampled by Amgen Cymru at the Bryn Pica Landfill Site during the period Jan 2009 - Dec 2018.**
