Our Ref: P19866/AP-L-01

Re: Notification of Works - Cerrigllwydion Hall, B5429 Gables Farm Junction to Llandyrnog Roundabout, Llandyrnog, Denbigh, Clwyd, LL16 4LE

1.0 Background

6.0 Groundwater Treatment System

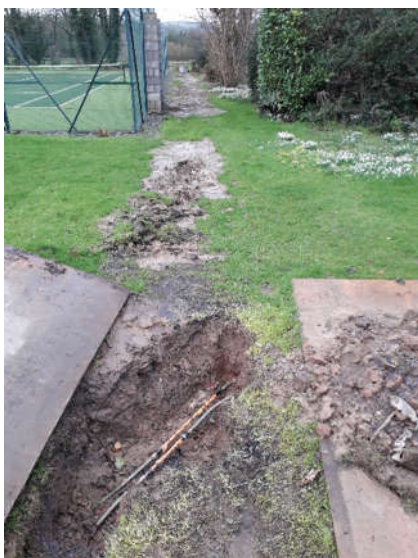
4.2.3 On 9 January 2020, the 2 no. kerosene fuel transfer lines (FTLs) were exposed for inspection. It was evident that one of the FTLs had failed and this was confirmed by a pressure test. OFL made a temporary repair to the failed FTL and replaced the isolation valve on the 1,200 L tank to allow for the pressure testing of the second FTL which passed.

- 4.2.5 Based on the available information provided to OEE, it appears that the spill was caused by damage to the FTL between the 2 no. larger OSTs and the Hall during works on the foul drainage system at the site. It is estimated that potentially in excess of 2000 litres of kerosene may have been lost to ground as a result of the spill incident.

Photo 3: Spill origin excavation exposing damaged feedline.

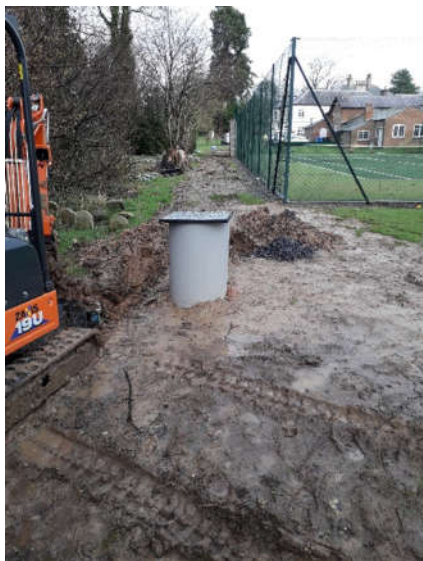
Photo 6: Septic tank is located near the tennis court in the south west corner.

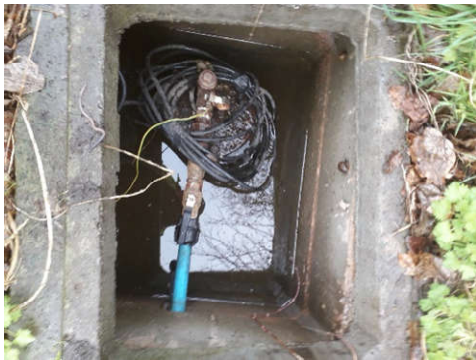
- 5.2 The superficial geology is classified as a Secondary aquifer and the solid geology is classified as a Principal aquifer. The site is not located within 1 km of a mapped groundwater source protection zone for a public water supply. There is a borehole located approximately 50 m to the south west of the spill origin and it is understood the borehole is solely used to supply water to the nearby pond.

Photo 8: Borehole chamber on site.

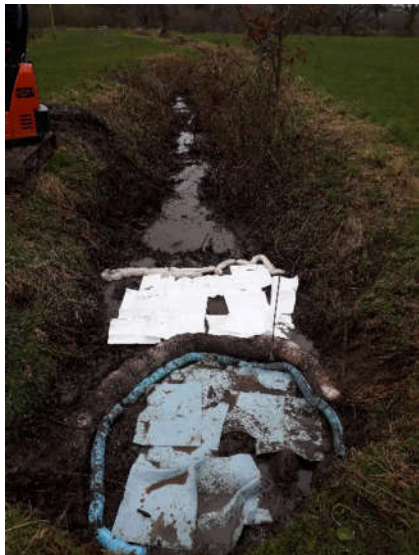
- 4.3.3 Due to the close proximity of the brook to the spill origin and the identified areas of impact, absorbent booms and pads were deployed in the brook to minimise migration downstream in the brook. A considerable sheen was present approximately 300 m downstream when vegetation was disturbed. OFL have set up several boomed areas to prevent further migration in the brook and these are being regularly inspected and maintained.

Photo 9: Absorbent booms and mats were deployed next to the brook opening.

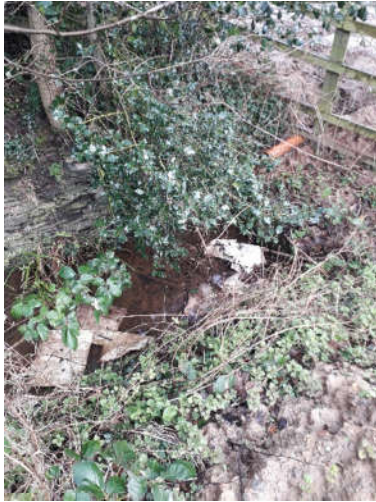
Photo 10: Drainage ditch which feeds the brook. An overflow pipe from the pond can be seen.

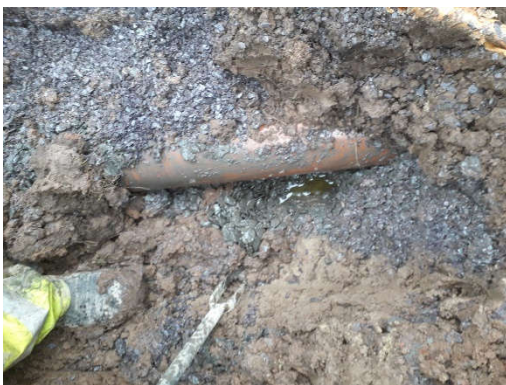
- 4.3.2 Kerosene contamination was identified in soils beneath the spill origin to the maximum extent of the investigation at 2 m depth. Kerosene contamination was also identified along the entire route of the foul drainage system and around the septic tank serving the property. Recommendations have been provided to OFL to excavate kerosene contaminated soils at the spill origin, along the route of the foul drainage and around the septic tank. Shallow groundwater was encountered around the septic tank at depths of 1.5 to 2 m bgl.

Photo 12: The foul pipe was exposed in TP-1 and neat product was identified. Gravels around the pipe were significantly contaminated.

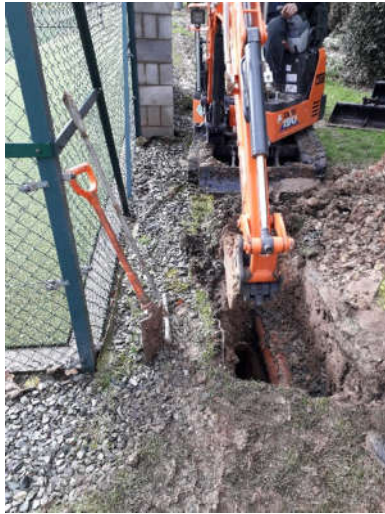
Photo 13: TP-2 was advanced next to the tennis court.

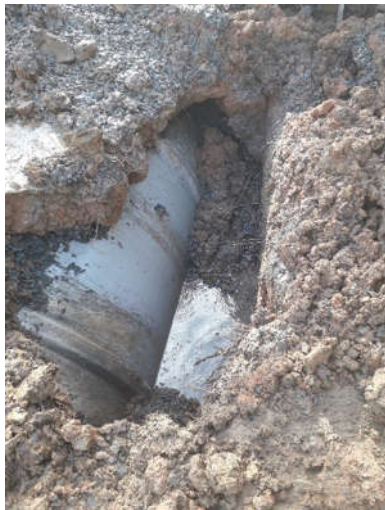
Photo 14: TP-3 and TP-4 were advanced next to the septic tank. Groundwater entered the excavations between 1.5 – 2.0 m.

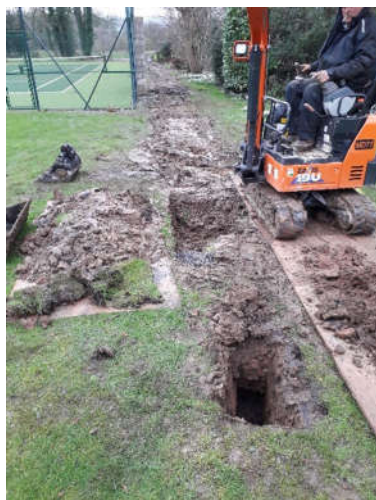
Photo 15: TP-5 was advanced 1 .0 m from the spill origin excavation towards the car park.

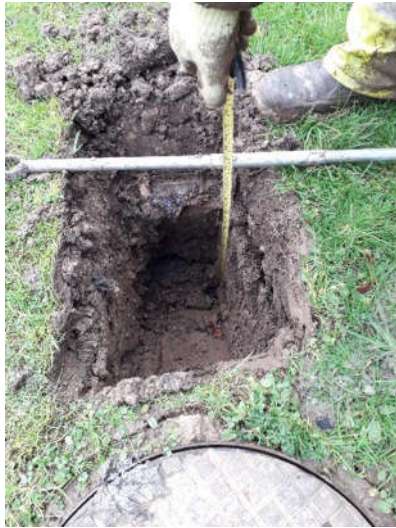
Photo 16: TP-6 was advanced next to the extent of the grass area and manhole.

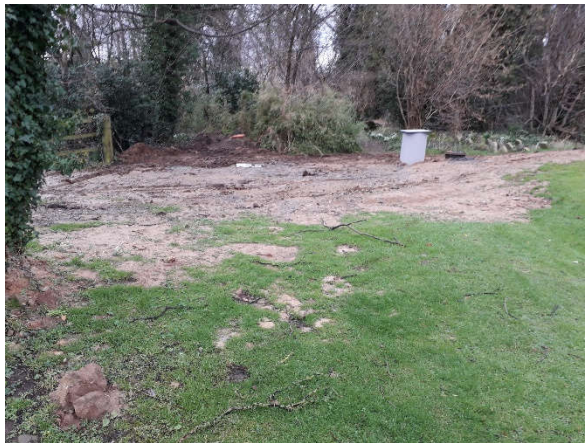
Photo 17: Ideal location for a groundwater treatment system would be behind the tennis court near to the septic tank providing power can be sourced.
