**HIGHWAYS DEVELOPMENT: ASSET AND DESIGN SERVICES**

**ED3816 – Glan Y Mor PRow Bridge Erosion Control PEA & EcIA**

Report Prepared by: George HT Rley, Highway's Ecologist. For: Daniel Davies, Design Technician, and Rhodri James, Senior Engineer.

**DATE: 07/08/2023**

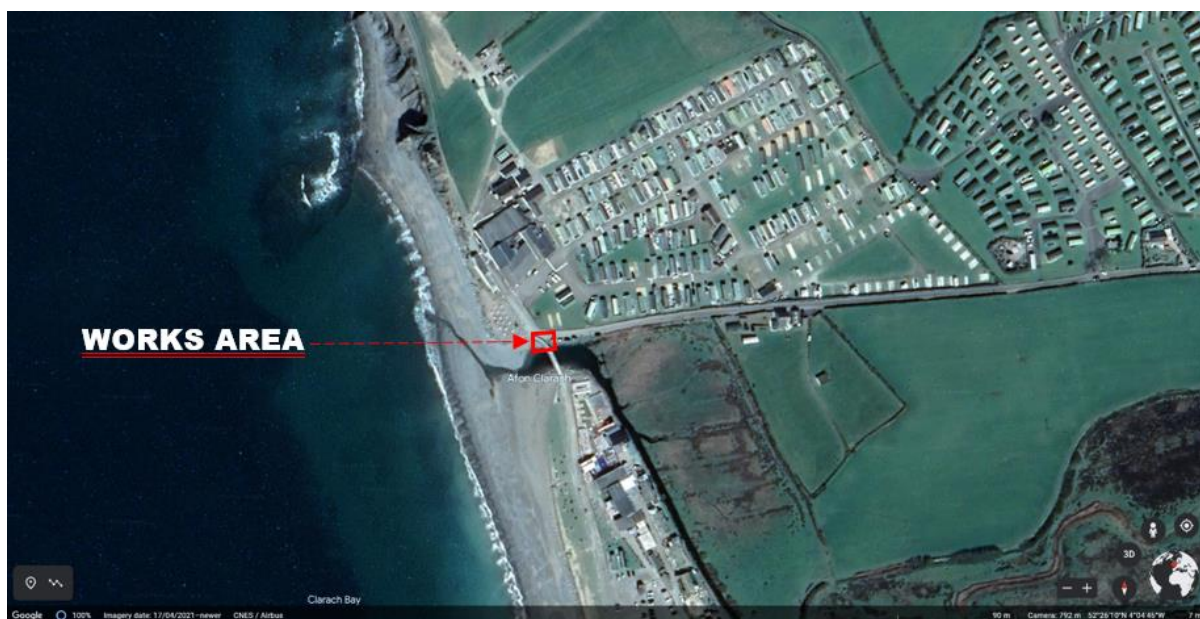
A view of the scheme area and surroundings can be viewed in figure 2 below. To the west of the bridge is Clarach Beach (mostly shingle and cobbles, but some areas of sand/fine sediment) and the dynamic mouth of the river Clarach. To the north sits the Aber Bay Holiday Park and a few caravan parks. The land then rises above this point, leading to some nice soft-rock cliffs and coastal grassland. The beach continues south of the works area, with some poor-quality grassland, shops, car parks, and further caravan parks.

East and southeast of the works area is marshy grassland fringed with reeds near the river and along intersecting ditches. This area is of large ecological significance. Beyond this are agricultural fields used for grazing by sheep.

**Figure 2:** Aerial photography of the general scheme area and surrounding countryside.

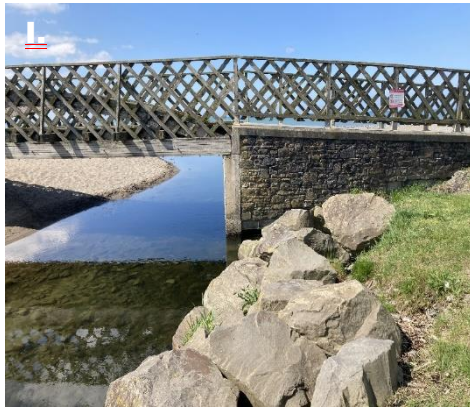
**I.** View of east/upstream parapet with the upstream line of scour protection boulders. **II.** As I, but from the southern embankment, showing the small gap between existing scour protection boulders and the east parapet. **III.** View of scour on west/downstream parapet. **IV.** As III, but from southern embankment – scour protection boulders of former carpark also visible.

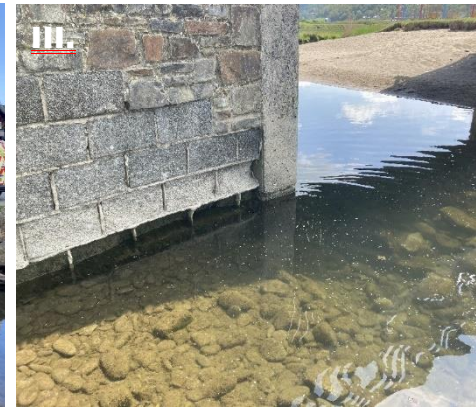
The bridge abutment is subject to continuous erosion forces from the standard flow of the river, with some whirlpooling evident on both sides. During stormy conditions, high spring tides, or any other period of elevated river levels, these forces are likely amplified. This has had a scouring effect on the exposed concrete blocks that make up the abutment face at that height of the structure. Without remediation, the bridges structural integrity will come into question and the safety of the structure for public use.

**Bridge Maintenance:** An area of up to two metres in front of the east and west parapets of the northern abutment will be shuttered off using sandbags and/or ton bags, or equivalents, and the water pumped out through sediment filter bags. Once the working areas are dry, marine-grade concrete will be used to fill the voids and the scoured areas. This will be left to dry before the shuttering is removed.

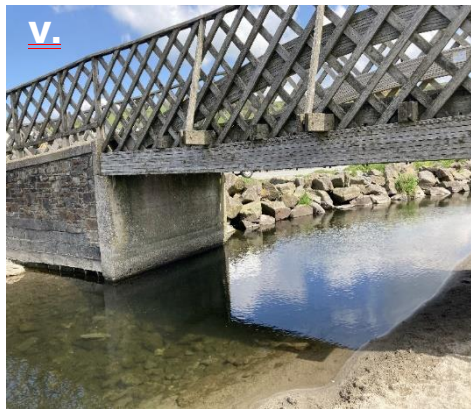
**V.** View of river channel underneath bridge, highlighting the interaction with the northern abutment. **VI.** End view of existing upstream scour protection, as well as the bend in the river, marginal reeds, and marshy grassland behind. **VII.** View of eastern parapet from beach. **VIII.** View of scour protection boulders for former carpark.
