## Compliance Assessment Report CAR\_NRW0042125

**Permit being assessed:** WB3993HE.

For: Gellia'r-gwellt Uchaf Transfer & Composting Station, held by Bryn Recycling Limited  
At: Gellia'r-gwellt Uchaf Transfer & Composting Station, Hengoed, Caerphilly, CF82 8FY.

**Type of assessment carried out:** Site Inspection, Reason: Routine.

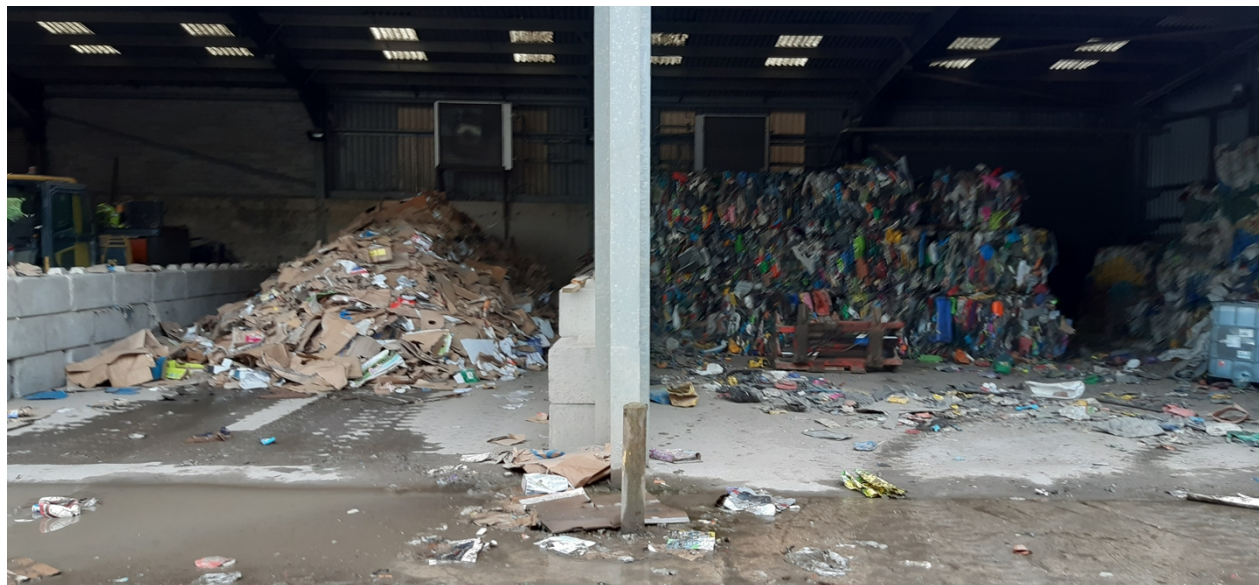
Waste(s) stored within the buildings were separated, not overlapping bays and not in exceedance of the sites Fire Prevention and Mitigation Plan (FPMP) - see photo 1. As a reminder to the operator, please ensure you remain within waste stockpile height / width limits as identified in your site FPMP. No offensive waste odours or excessive noises were noted by NRW personnel in this part of the site during the site inspection.

**Photo 1** - View inside waste transfer station building

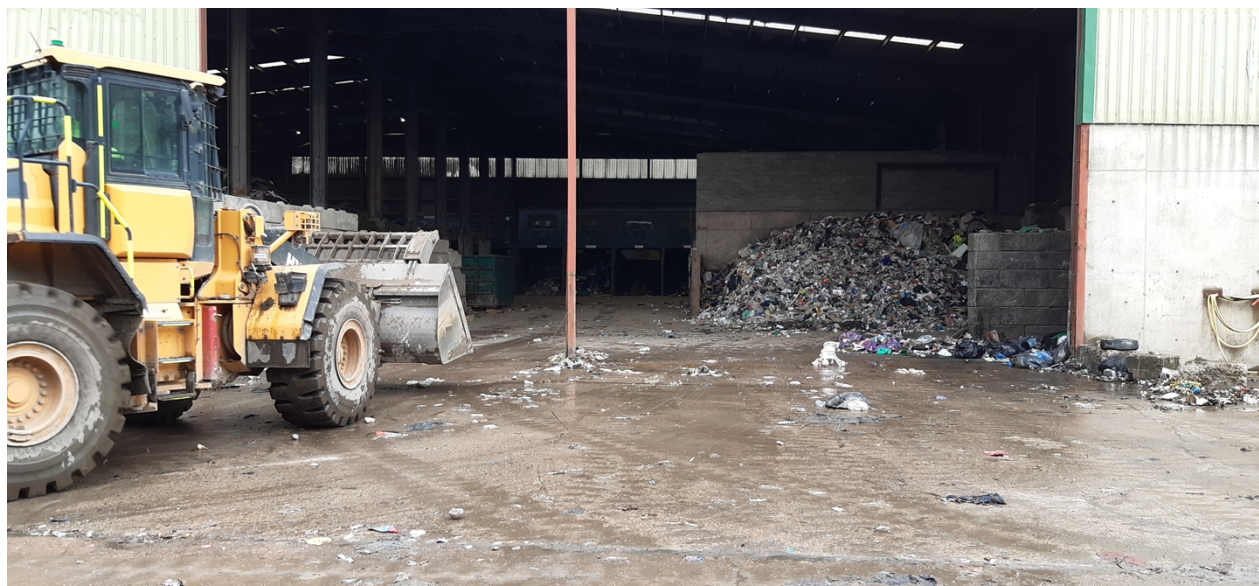
3. The waste transfer station area was operational at the time of the site inspection with stockpiles of various waste streams being processed. Housekeeping in the area was in good condition with no excess loose debris present twinned with the flooring infrastructure within the operational areas in good condition with no visible damage present.

**Photo 2** - View inside waste transfer station building

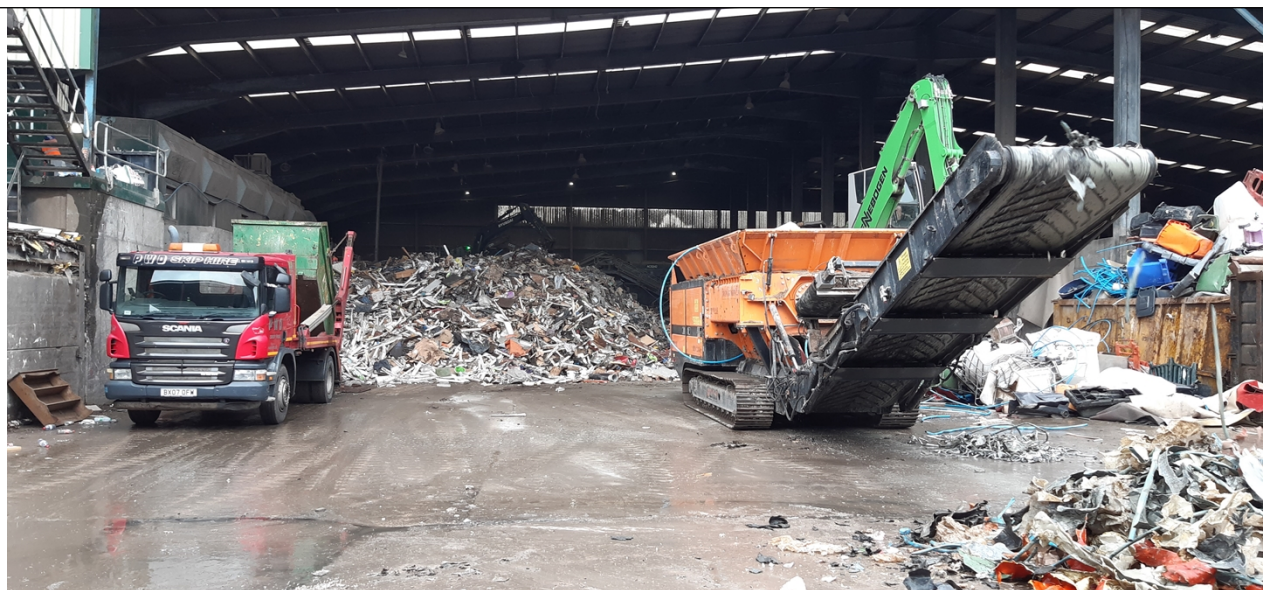
**Photo 3** - View inside waste transfer station building

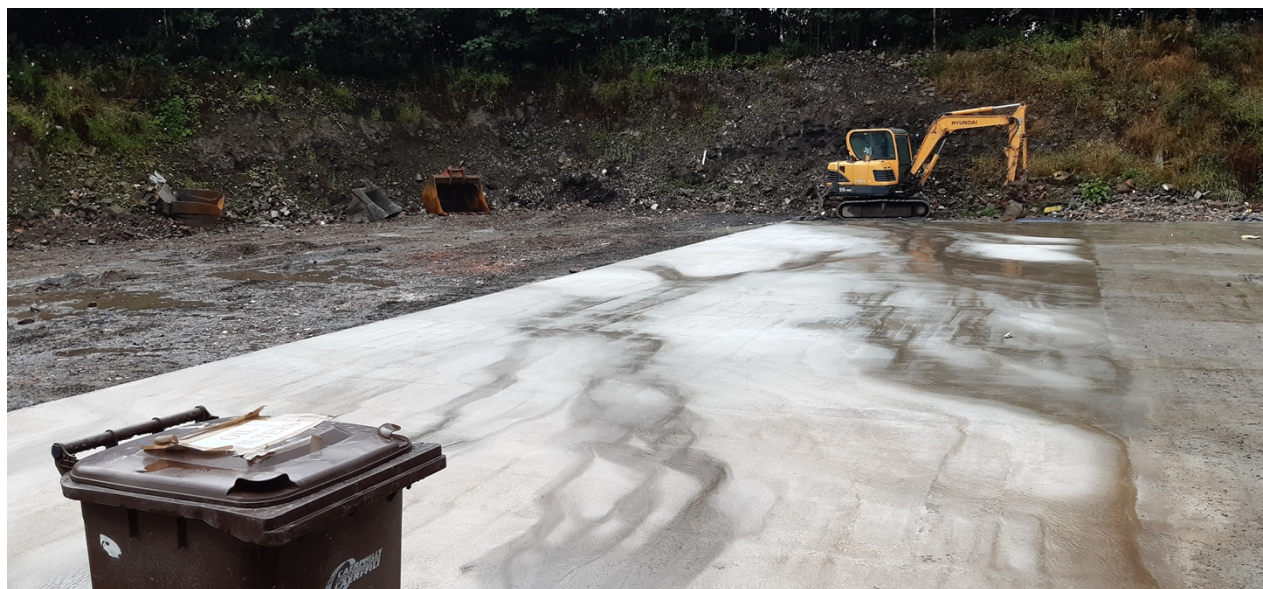
As identified during a previous site inspection conducted by NRW Officers on 26/01/22 (CAR\_NRW0039228), a section of the impermeable surface where construction and demolition (C&D) waste is stored was in poor condition. During this site inspection, the area in question has undertaken surface infrastructure improvements with further works continuing into the coming weeks. NRW Officers were satisfied that no waste(s) were being stored on damaged / non-impermeable surface areas and content that the site has taken proactive steps to improve infrastructure conditions to minimise environmental impact should a loss of containment occur. See photo 4.

**Photo 4** - Flooring infrastructure improvements at Bryn Recycling Ltd

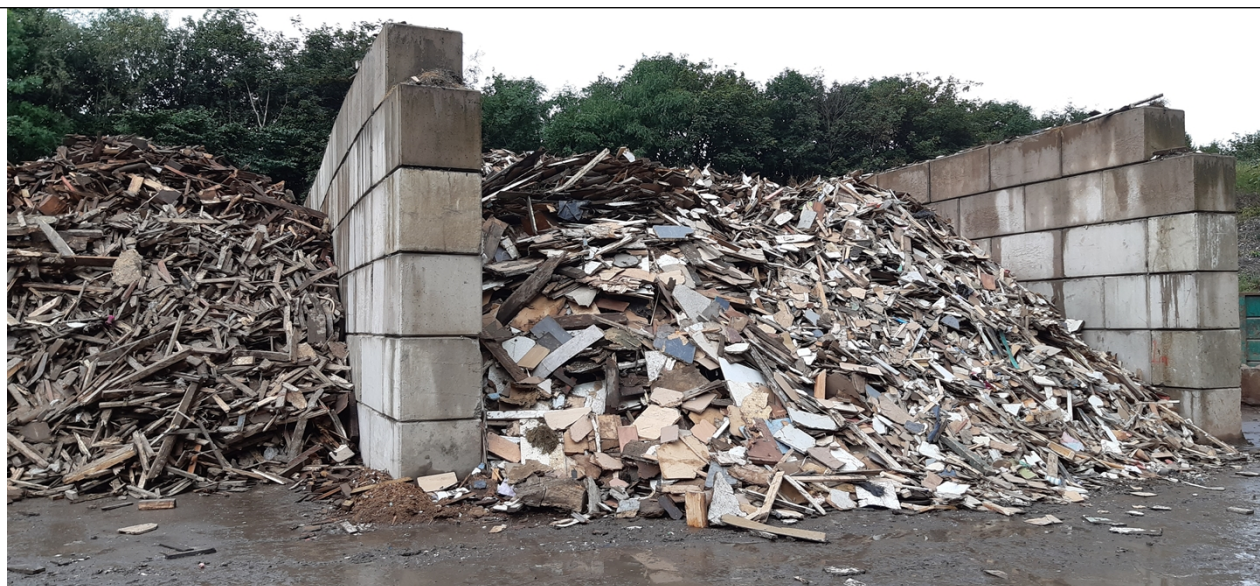
During this site inspection, it was assessed that the stockpile(s) of waste(s) and waste fines in the outside designated bays were within compliance of the FPMP guidance and the current site FPMP document. - see photo 5 and 6.

**Photo 5** - Stockpile of waste(s) at south west area of waste transfer station

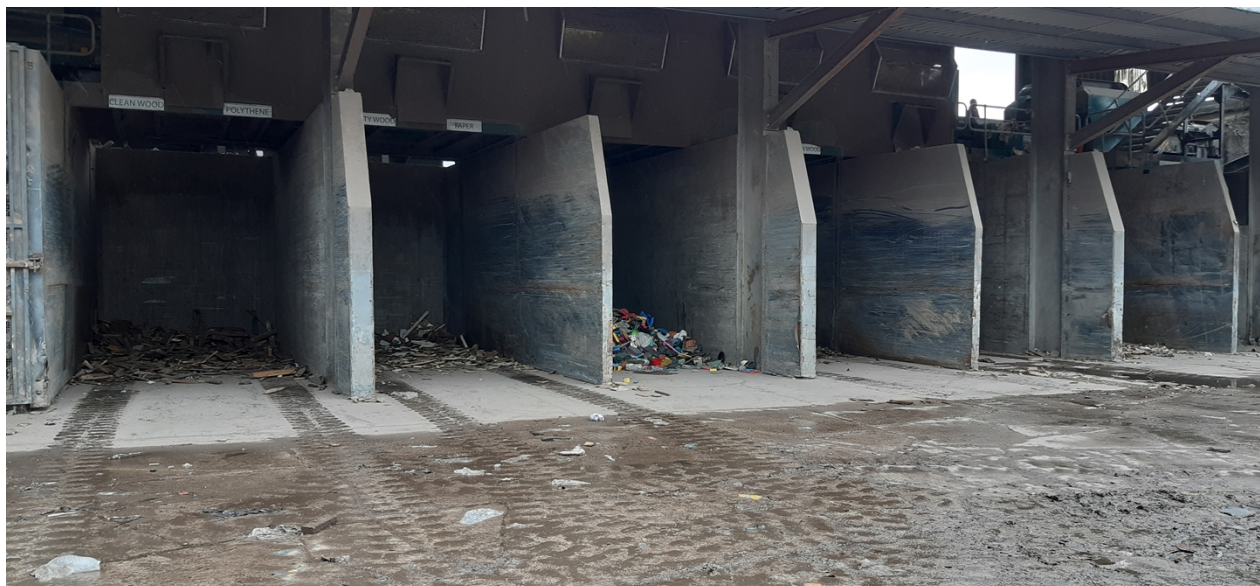
**Photo 6** - Stockpile of waste(s) at south west area of waste transfer station

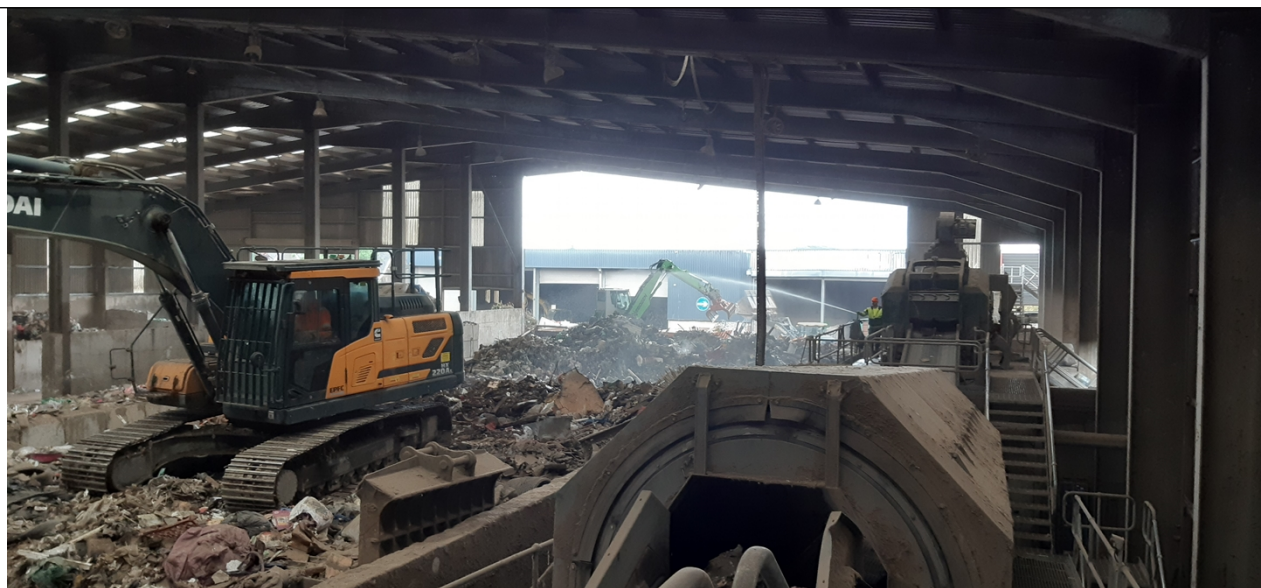
NRW personnel were then escorted to within the waste transfer station building which was undertaking waste processing activities. Stockpiles of waste(s) were within compliance of the FPMP guidance and the current site FPMP document. No offensive waste odours or excessive noises were noted by NRW personnel in this part of the site during the site inspection. Dust suppression techniques (dampening down of waste(s)) were witnessed by NRW Officers whilst within the transfer station building. See photo 7

**Photo 7** - Stockpile of waste(s) within waste transfer station building and dust suppression techniques being undertaken (background off centre (right))

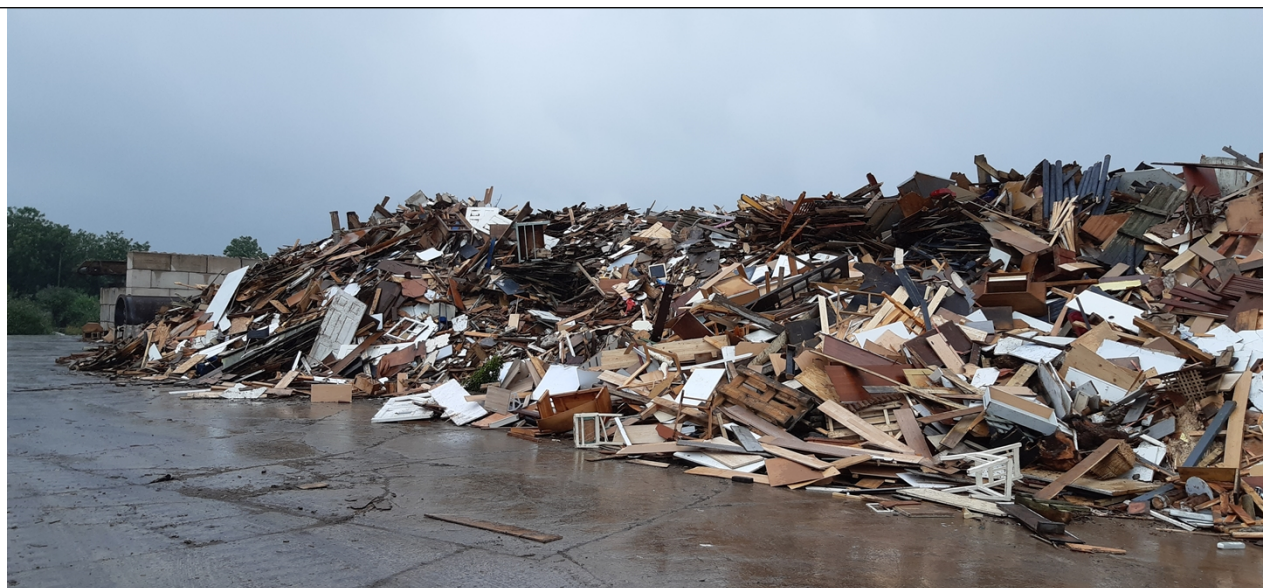
- Stockpile of unprocessed wood waste not being stored in compliance with FPMP guidance and sites FPMP document.

There was a stockpile of unprocessed wood material that required being brought back into compliance with the FPMP guidance and sites current FPMP document - see photo 8. During discussions with the operator at the time of the inspection it was ascertained that the reason for the larger stockpile size of unprocessed wood was due to issues with planned maintenance and unforeseen breakdowns at the destination site. Within the sites current FPMP document, it provides the maximum dimensions for the stockpile of unprocessed wood (see screenshot 1 below). NRW Officers concluded that whilst the maximum individual stack dimensions, as identified within the sites current FPMP document were within compliance, the maximum stack height of 4 metres was not.

**Photo 8** - Stockpile of unprocessed waste wood located on the 'top yard'

| Criteria | Action needed | Complete by |
|---|---|---|
| C4 | Reduce height and size of stockpile of unprocessed waste wood on the 'top yard' to ensure compliance with your site FPMP, EMS and official FPMP guidance | 07/08/2023 |

**CATEGORY 3 BREACH:** Reduce height and size of stockpile of unprocessed waste wood on the 'top yard' to ensure compliance with your FPMP (and EMS) and FPMP guidance.

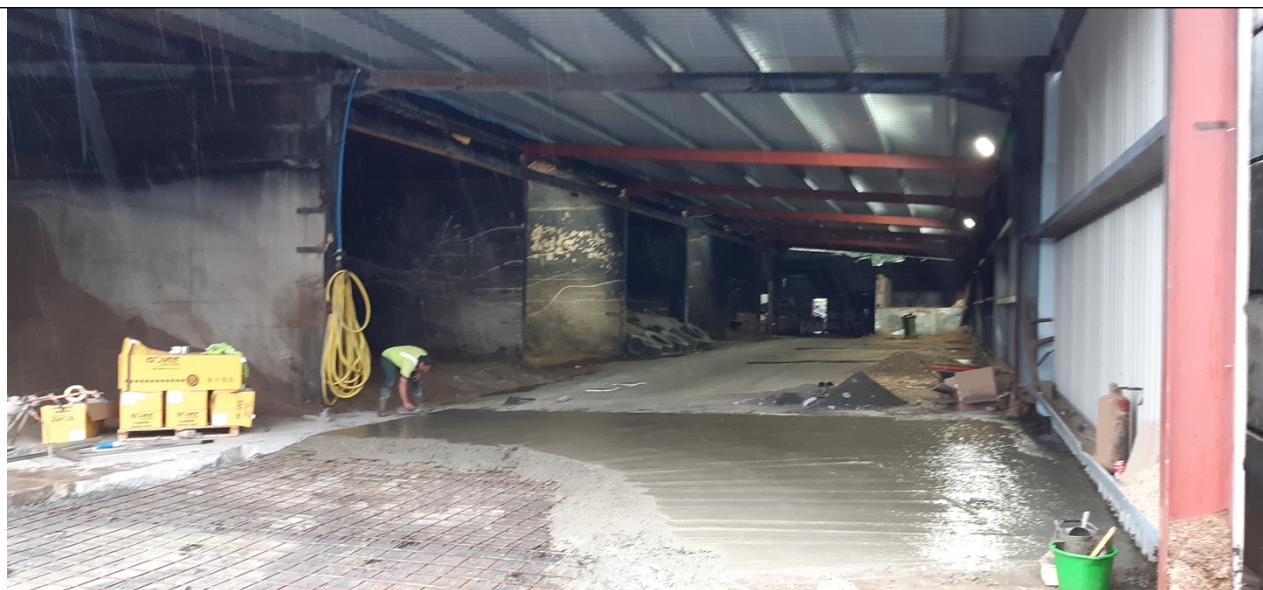
The drying sheds area were inspected with further infrastructure improvement works having taken place which again, was proactive from the operator to further improve infrastructure conditions to minimise environmental impact should a loss of containment occur - see photo 9.

**Photo 9** - Drying sheds area with infrastructure improvements taking place

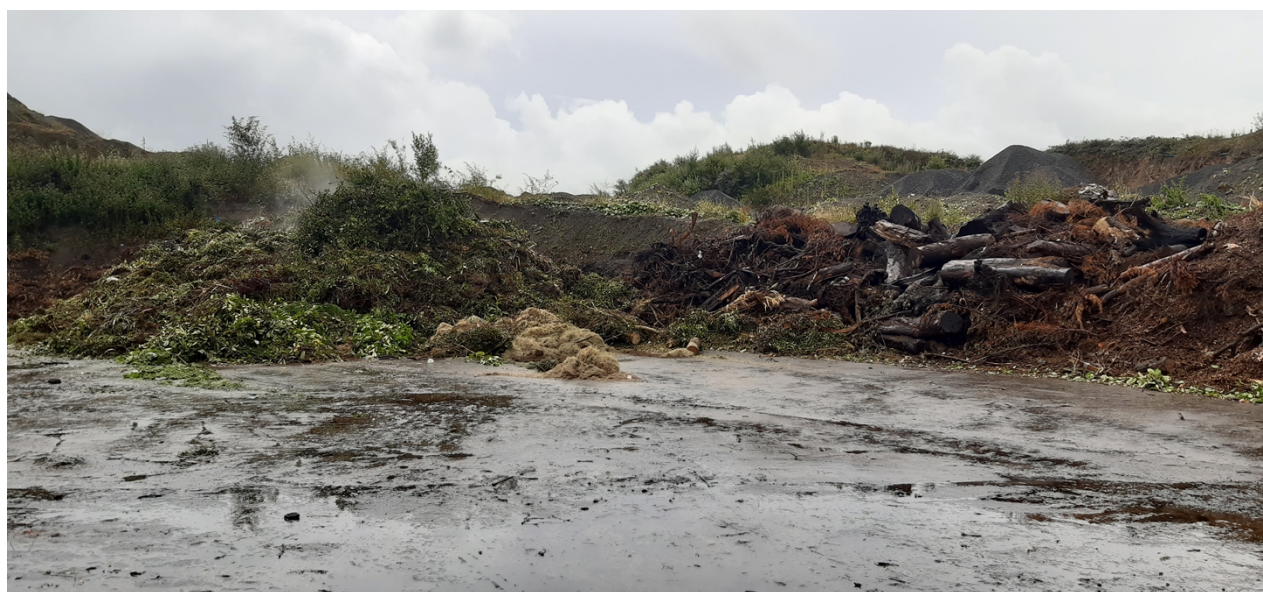
NRW personnel were then escorted to the composting station area. There was no treatment of green waste taking place at the time of the site inspection - see photos 10-12. During this site inspection all composting stockpiles / windrows were within the compliance of the sites FPMP document.. As previously mentioned, please continue to ensure you remain within waste stockpile height / width limits as identified in your site FPMP.

**Photo 10** - Unprocessed green waste in composting area

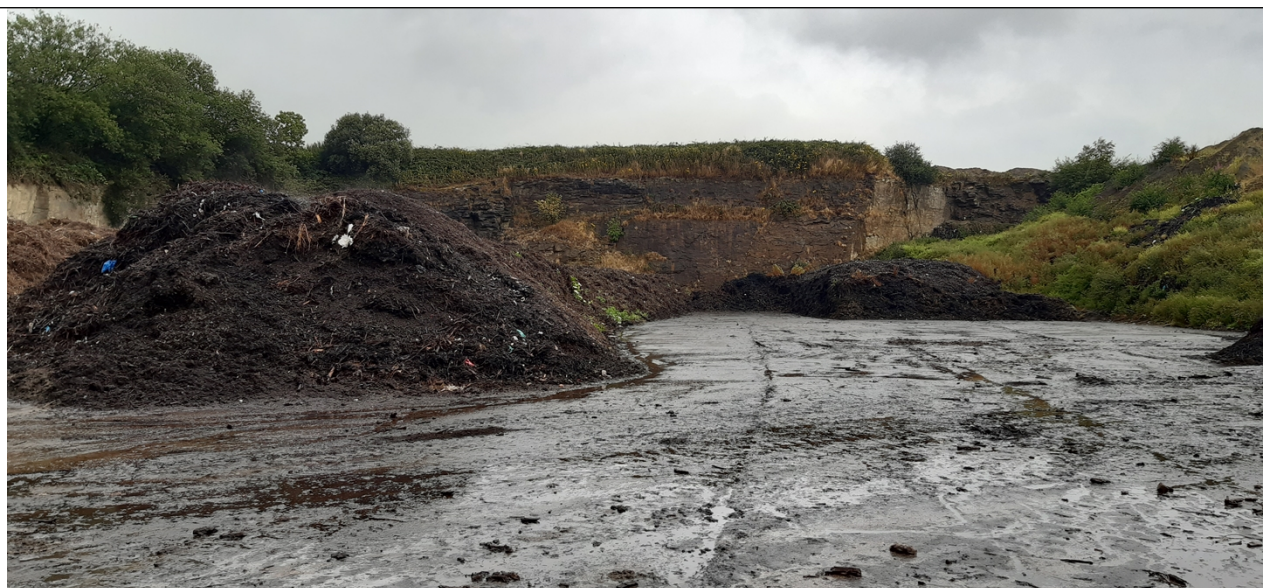
During the inspection of the composting area it was noted that the flooring infrastructure was in good working order with no excess loose debris present. There was also no offensive composting odours or excessive noises witnessed by NRW personnel in this part of the site during the site inspection.

**Photo 11** - View of the composting station area

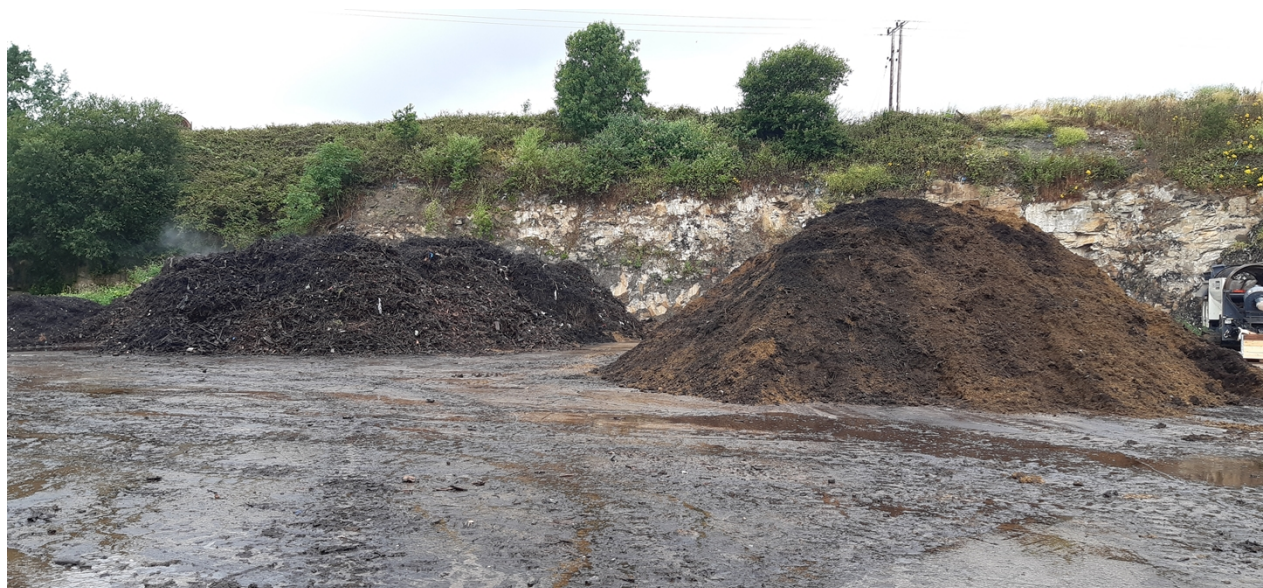
**Photo 12** - Stockpiles of unprocessed green waste in composting station area
