**MORFA NON HAZARDOUS  
LANDFILL PERMIT  
BV7311Ie**

**BIOCELL RESTORATION**

Construction Quality  
Assurance Validation Report  
*Report Number 2035r3v1d0822*

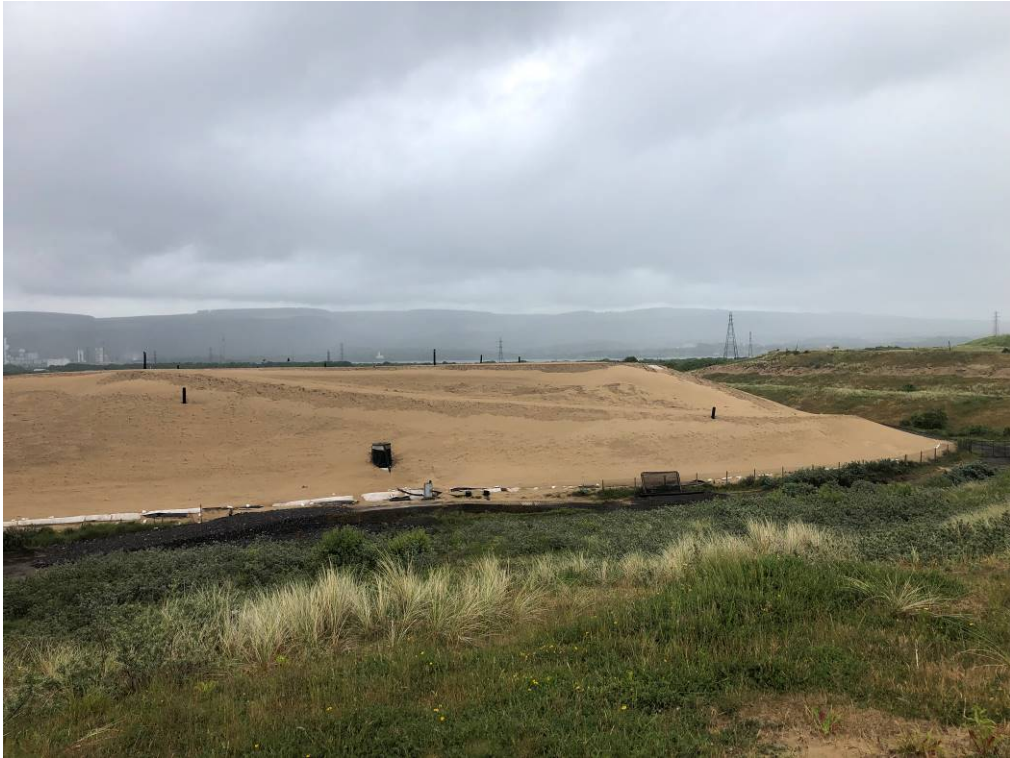
Biocell covered in restoration soil (sand)

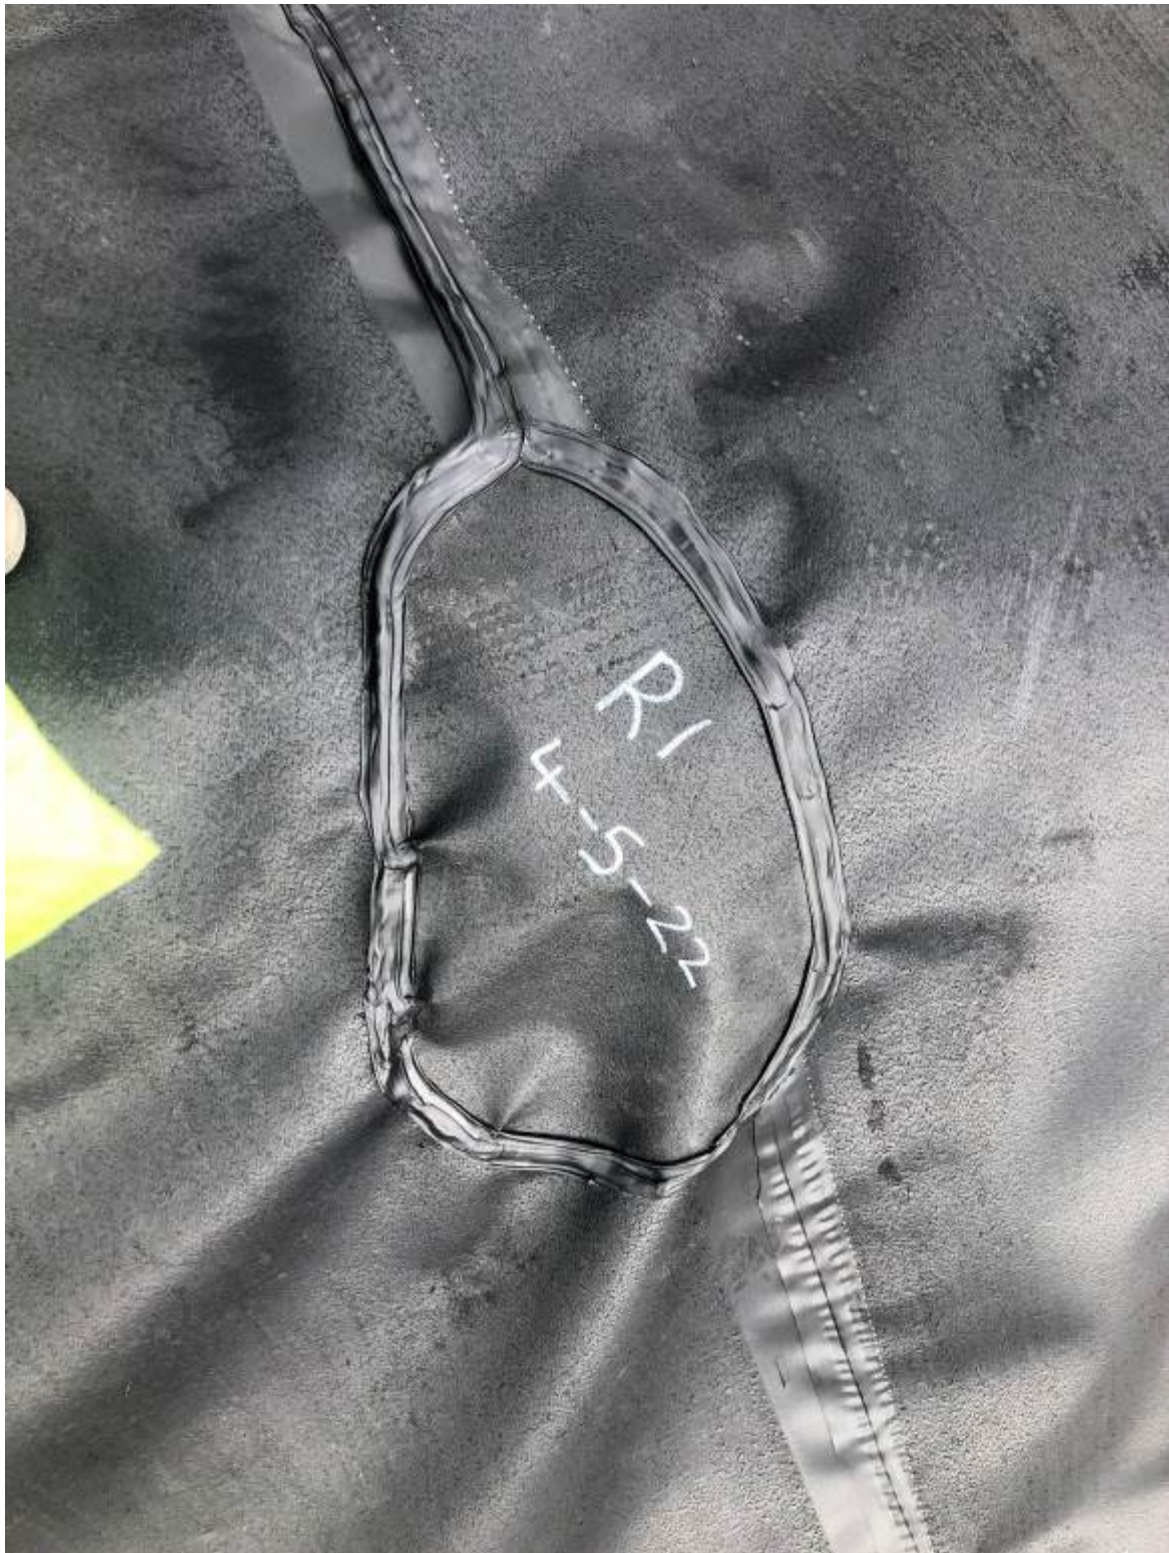
**Repair 1**

| Date | Repair No | Location | Defect Type | Repair Type | Machine | Operator | NDT | Test Time | Pass/Fail | Approved |
|---|---|---|---|---|---|---|---|---|---|---|
| 04/05/2022 | 1 | P3/P4 | Weld Burn | Patch | 7118 | EJ | Vacc | | Pass | Y |

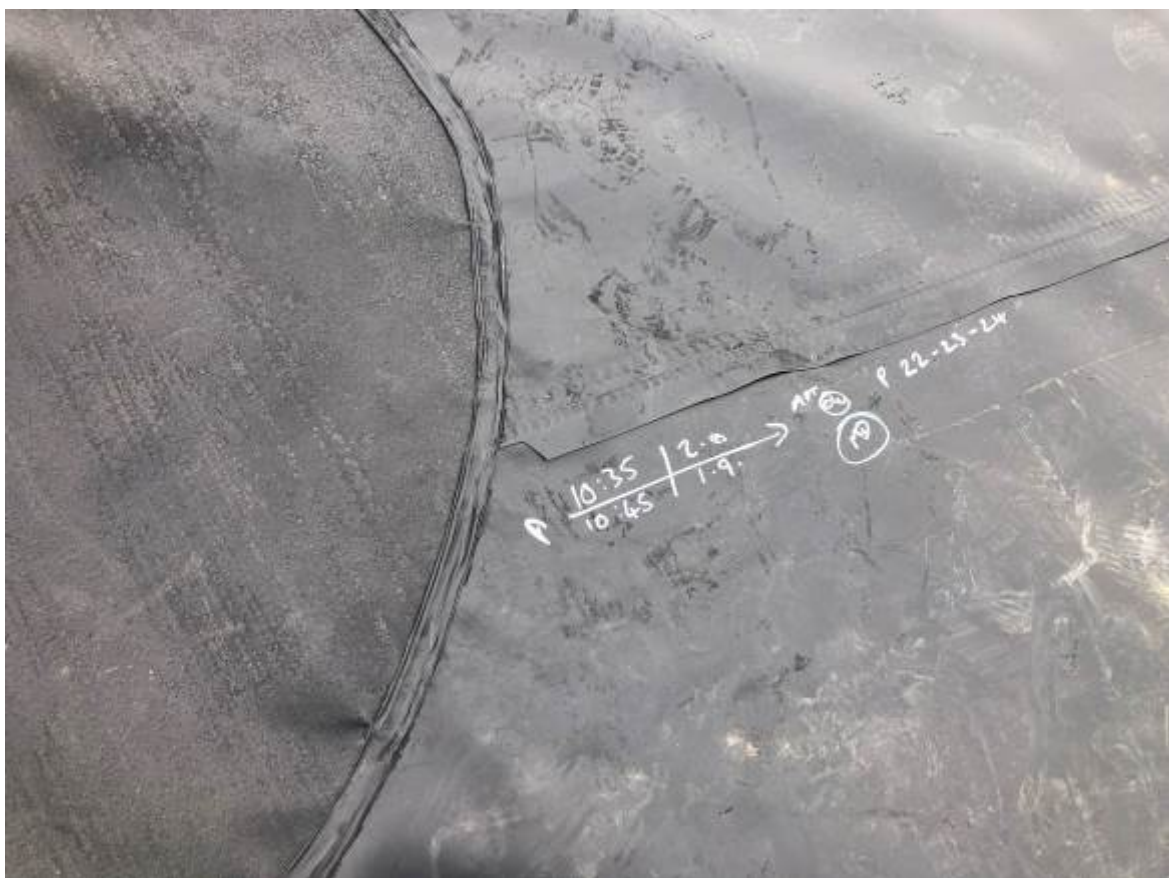
**Repair 11**

| Date | Repair No | Location | Defect Type | Repair Type | Machine | Operator | NDT | Test Time | Pass/Fail | Approved |
|---|---|---|---|---|---|---|---|---|---|---|
| 06/05/2022 | 11 | P23/P33/P28 | Weld Burn | Patch | 7118 | GE | Vacc | | Pass | Y |

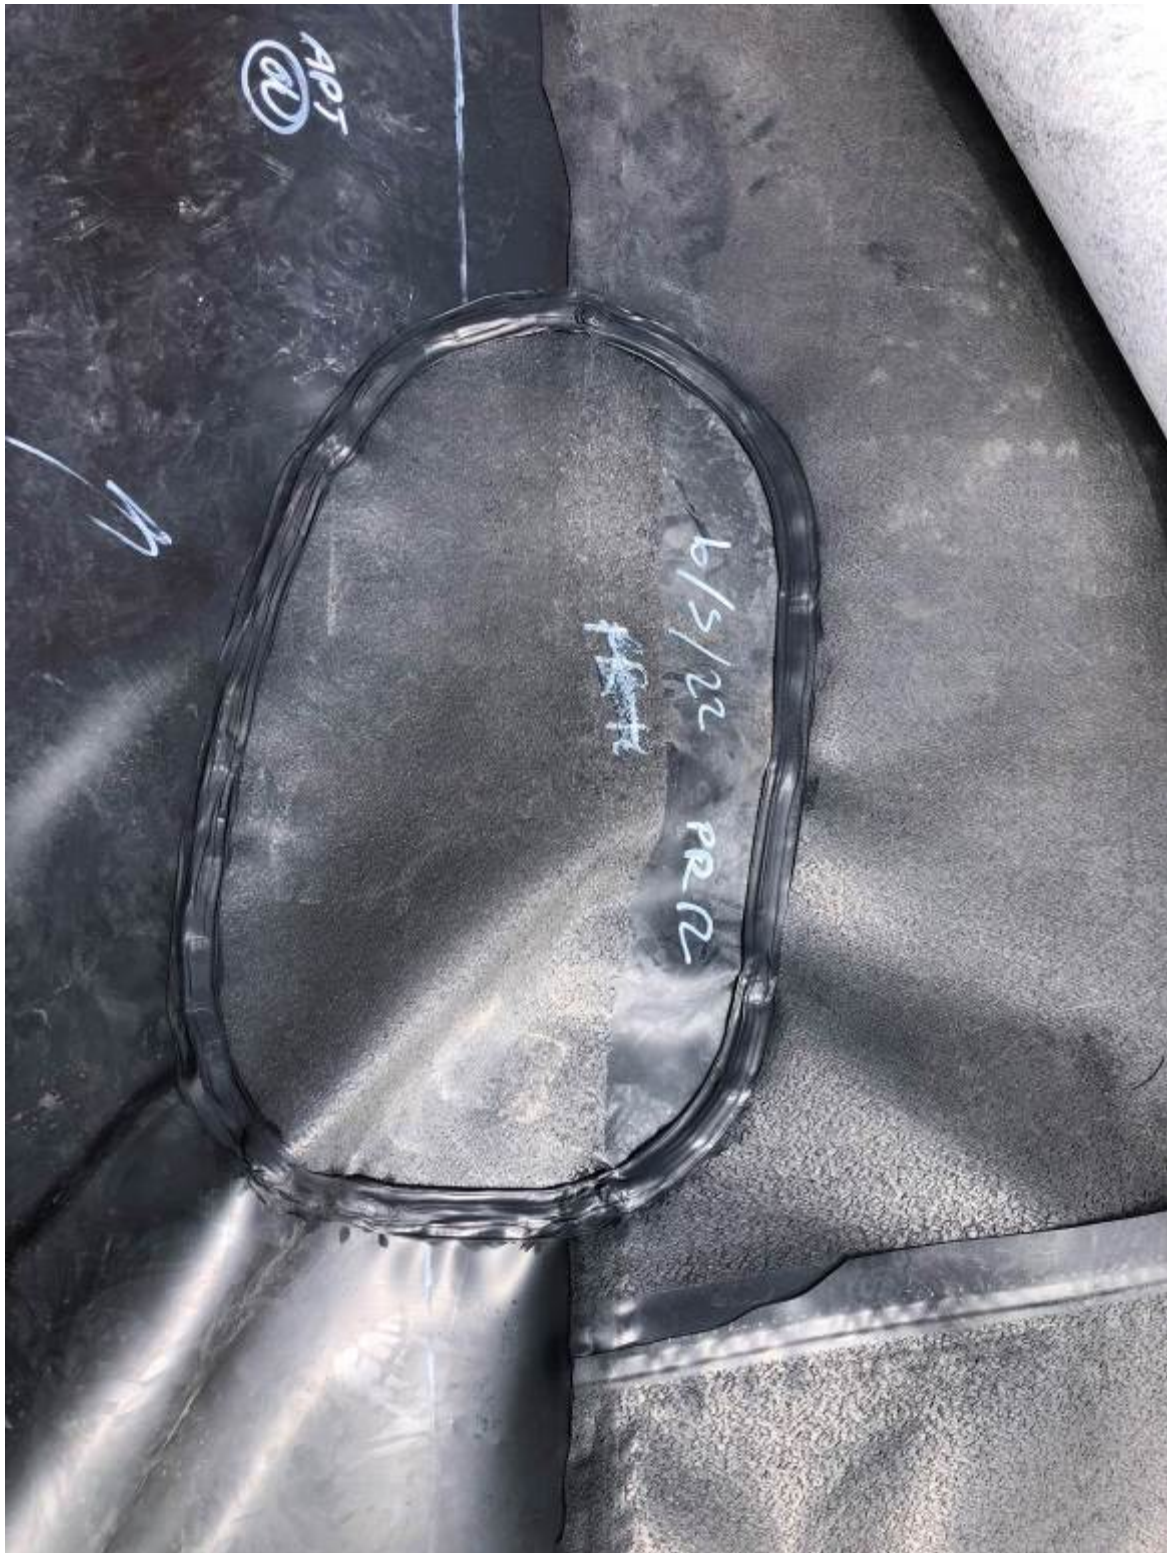
**Repair 12**

| Date | Repair No | Location | Defect Type | Repair Type | Machine | Operator | NDT | Test Time | Pass/Fail | Approved |
|---|---|---|---|---|---|---|---|---|---|---|
| 06/05/2022 | 12 | P34/P26 | Weld Burn | Patch | 7118 | GE | Vacc | | Pass | Y |

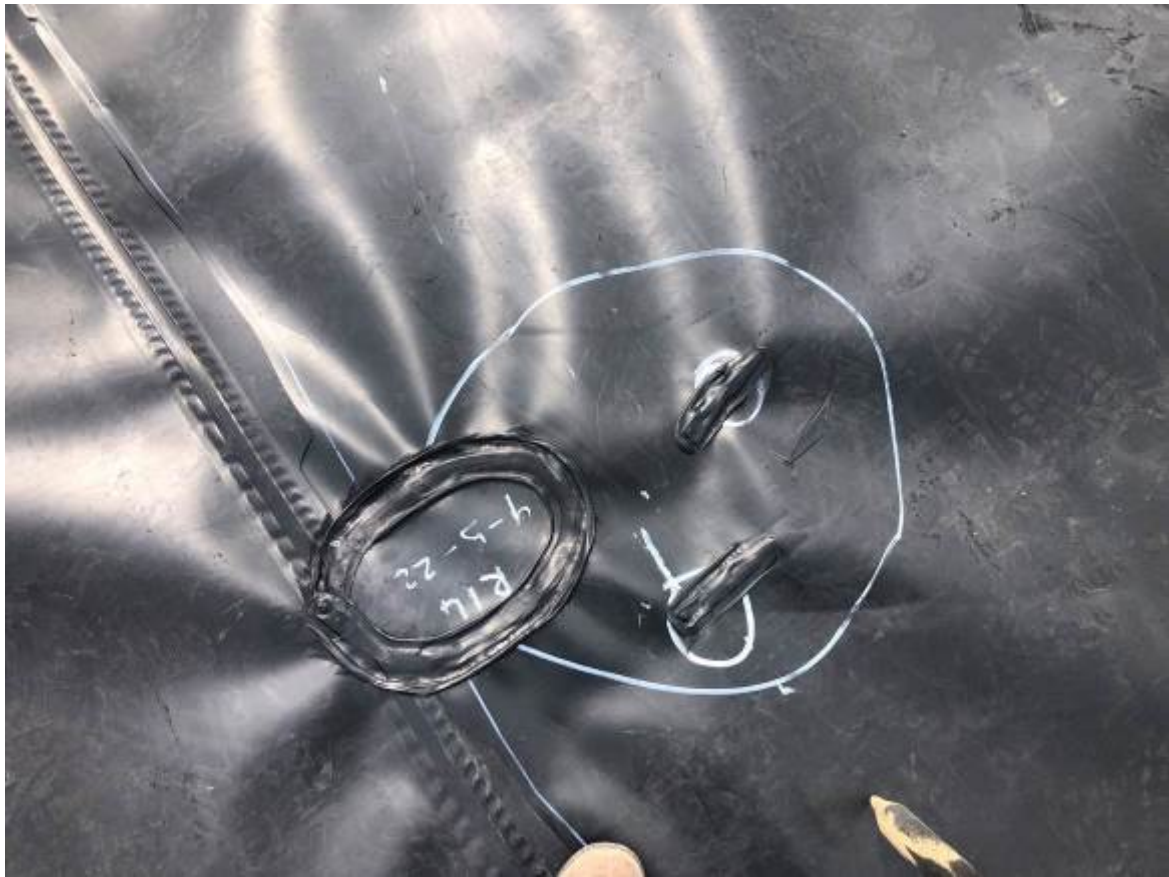
**Repair 14**

| 09/05/2022 | 14 | P39/P40 | Damaged Liner | Patch | 7118 | DJ | Vacc | | Pass | Y |

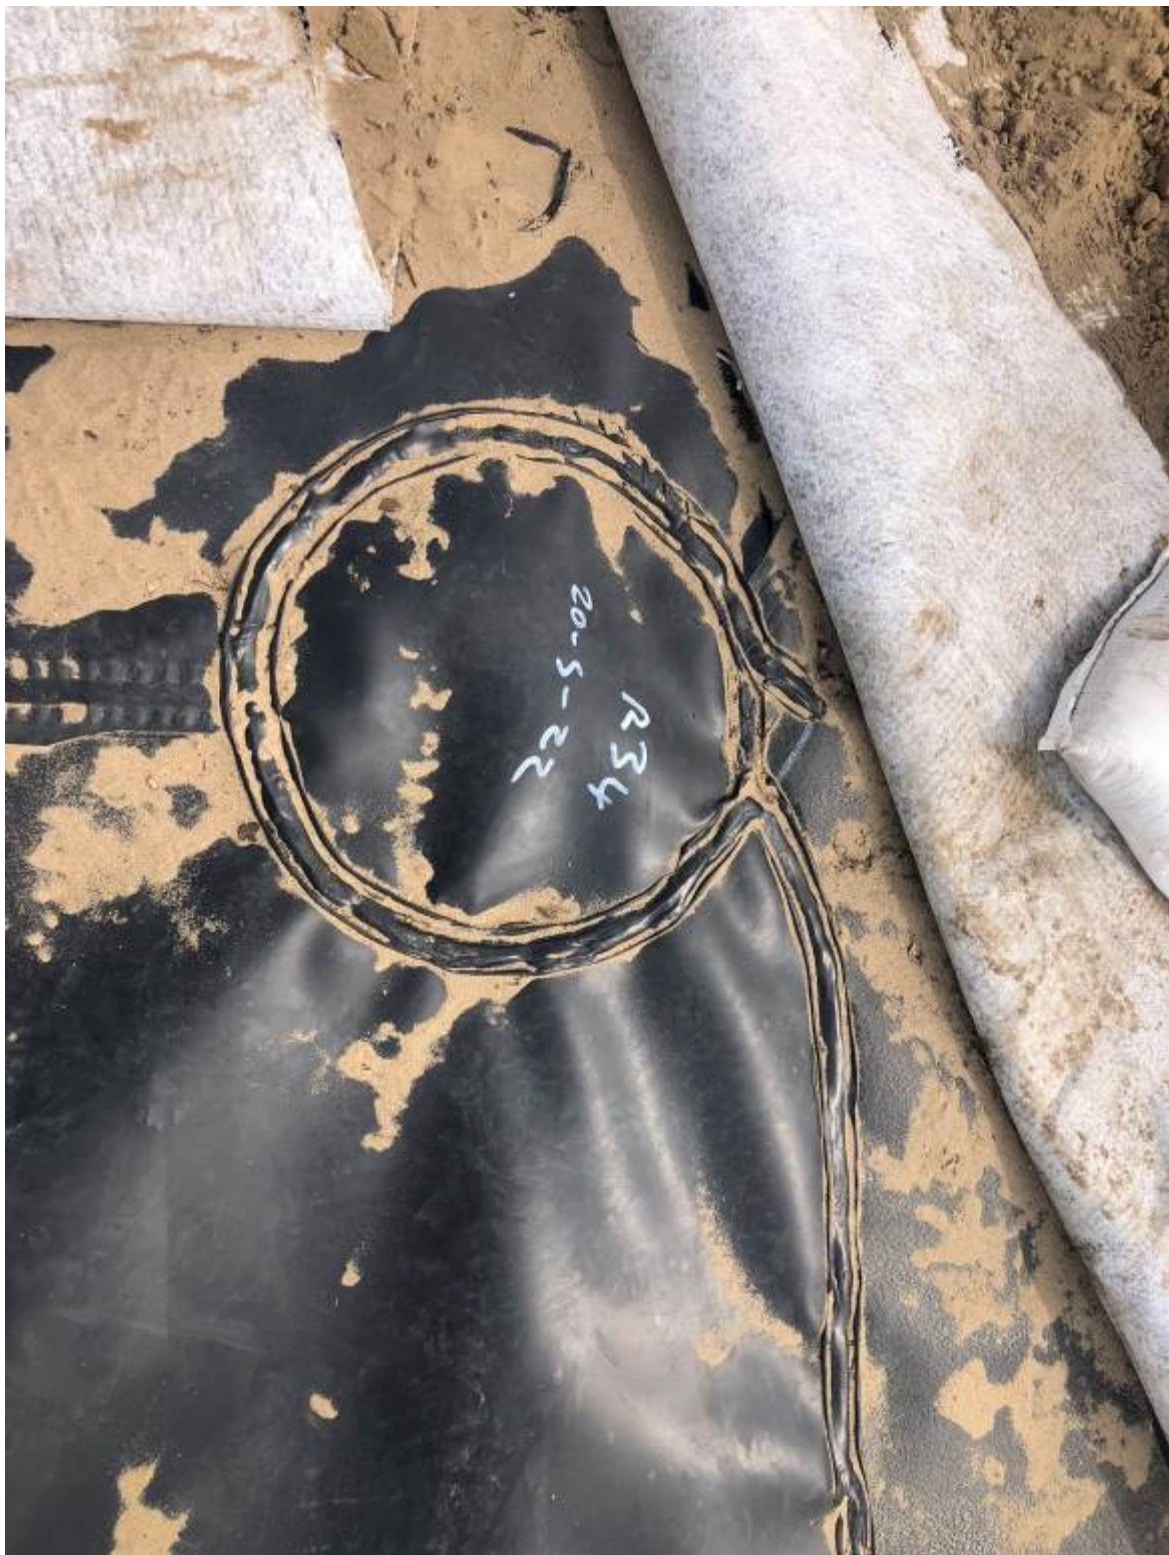
**Repair 33**

| 19/05/2022 | 33 | P67 | Damaged Liner | Patch | 7118 | DJ | Vacc | | Pass | Y |

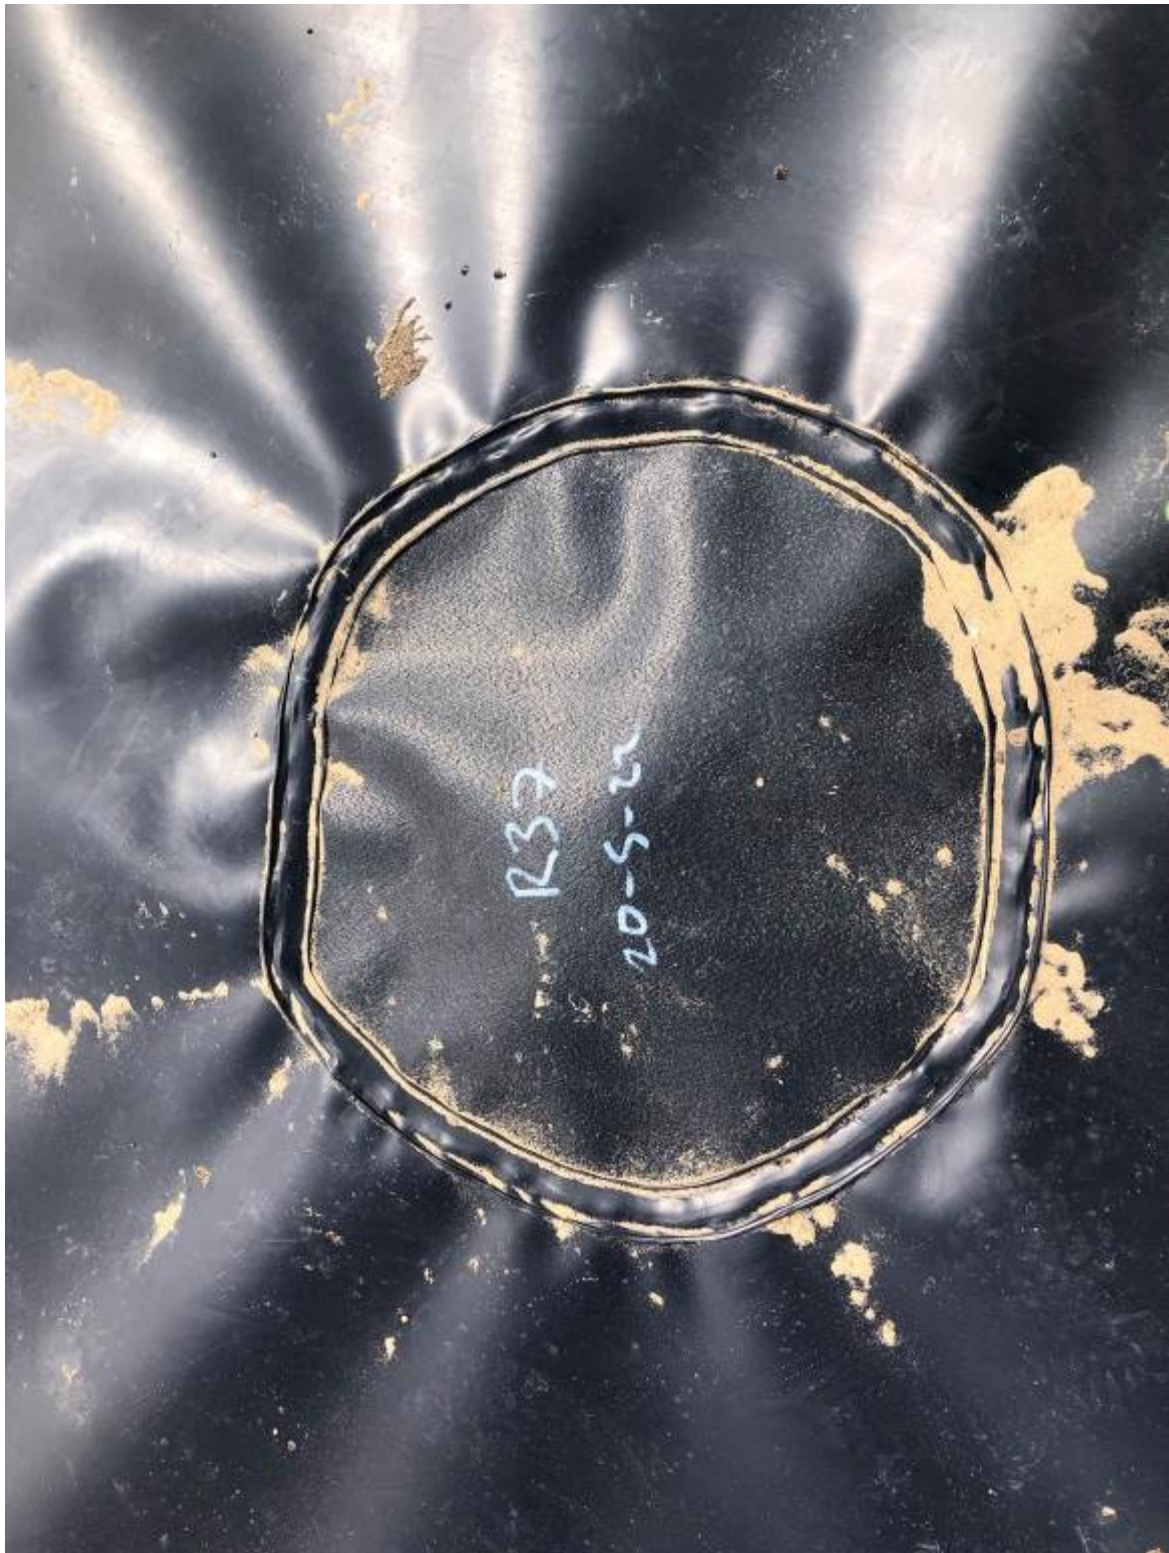
**Repair 36**

| 20/05/2022 | 37 | P76 | Damaged Liner | Patch | 7118 | EJ | Vacc | | Pass | Y |
