Colomendy Industrial Estate Depot
Geotechnical Report
Cyngor Sir Ddinbych

Report Date – March 2019
Report Revision – V. 01

Denbighshire County Council / Cyngor Sir Ddinbych (DCC) propose to construct a new depot on undeveloped land adjacent to the Colomendy Industrial Estate in Denbigh.

Daeare GeoConsulting (Daeare) has been appointed to carry out a preliminary geotechnical ground investigation and interpretative report for the proposed development.

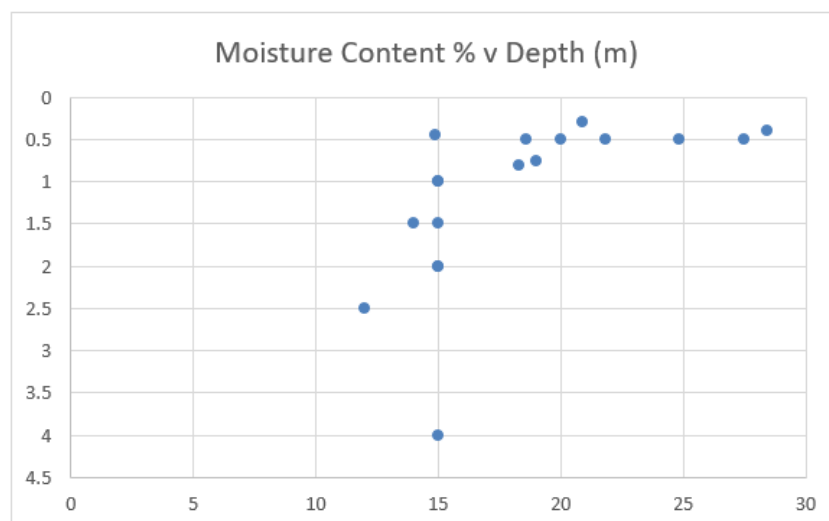
Eighteen (18No.) moisture content tests were carried out on the cohesive soils. The results varied between 12% and 28.4%, and are presented on the chart below, which shows that there was significant variation in the moisture content in the upper 800mm or so, with consistent readings below 1m.

There was significant variation of the moisture content in the upper 0.5-0.75m of the cohesive glacial till at the site, which ranged between 15 and 28%. This will result in variable drying times and compaction performance of the near surface soils. It is likely that this variability will reduce during drier months.

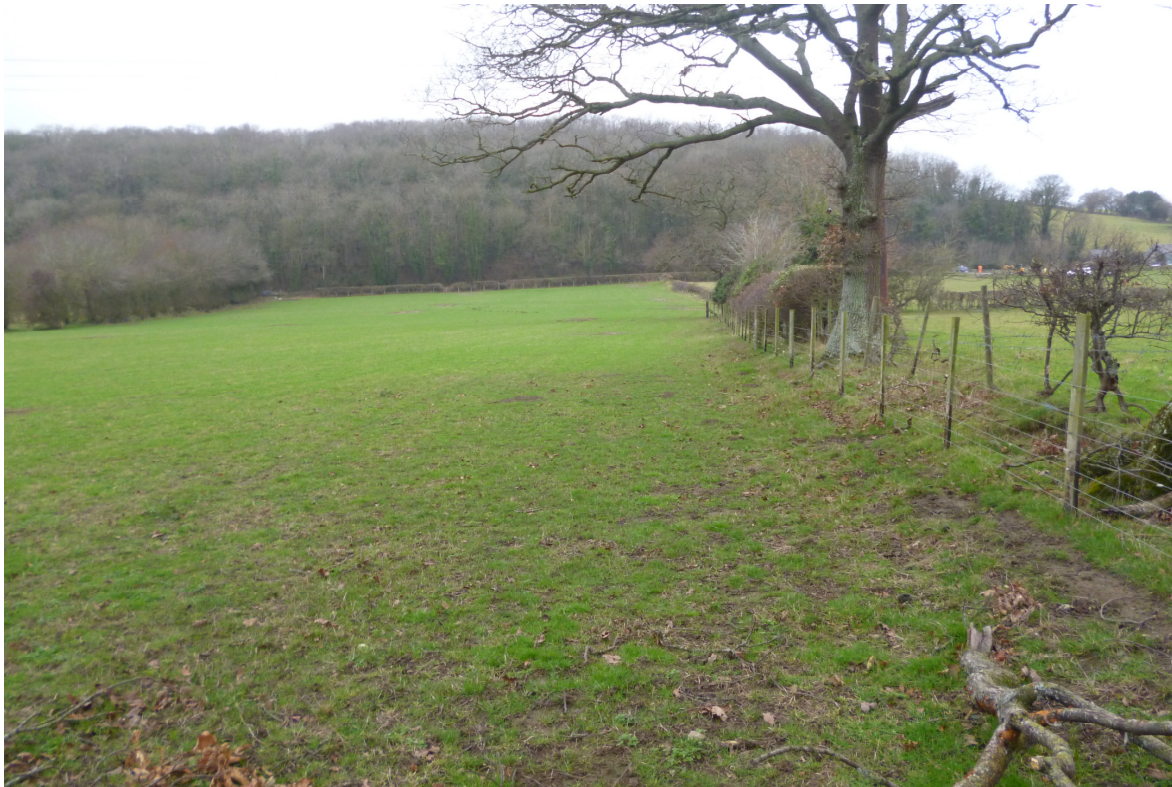
Photo A – General View from NE corner

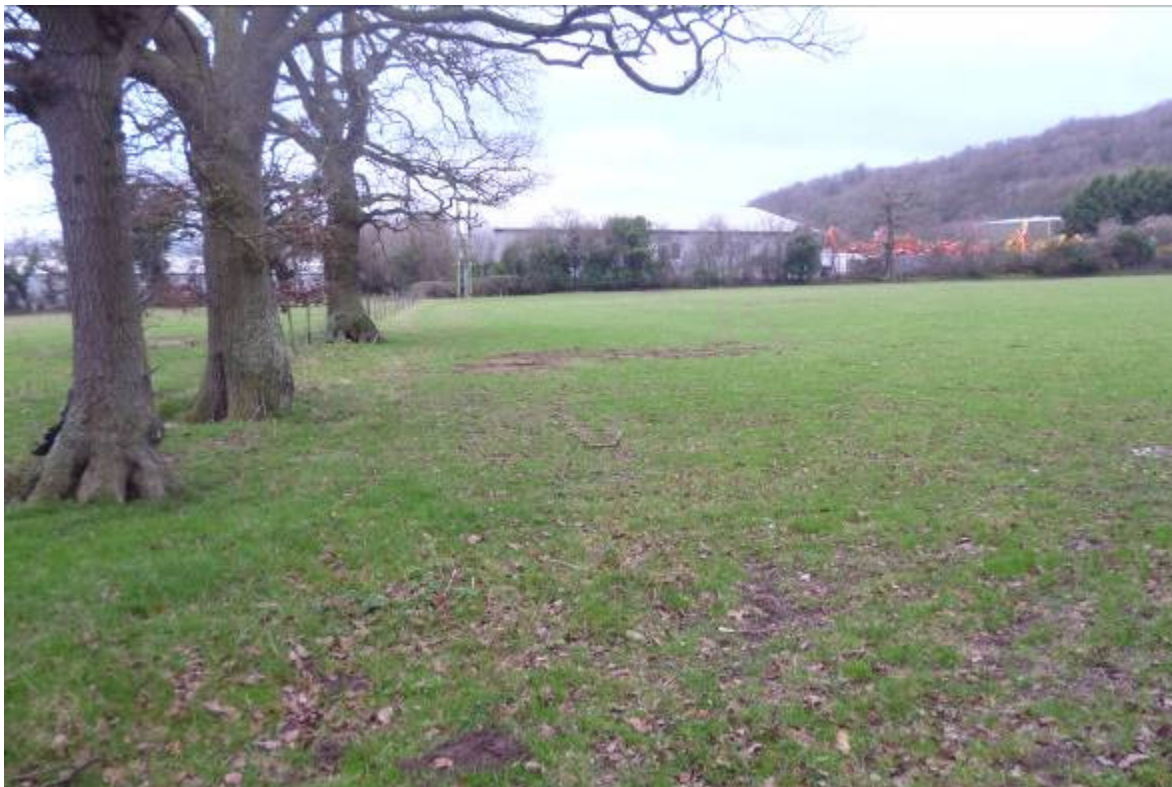
Photo B – General View along Eastern Boundary from NE corner

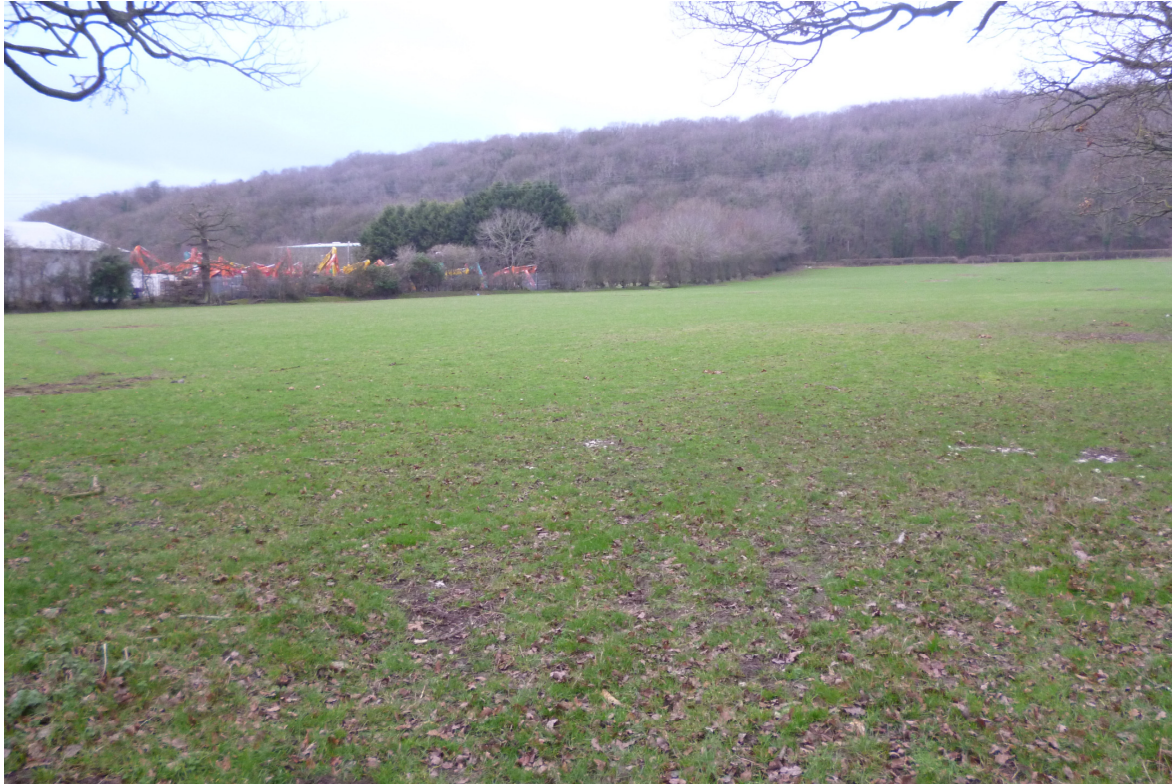
Photo C – General View along of southern site area from NW corner

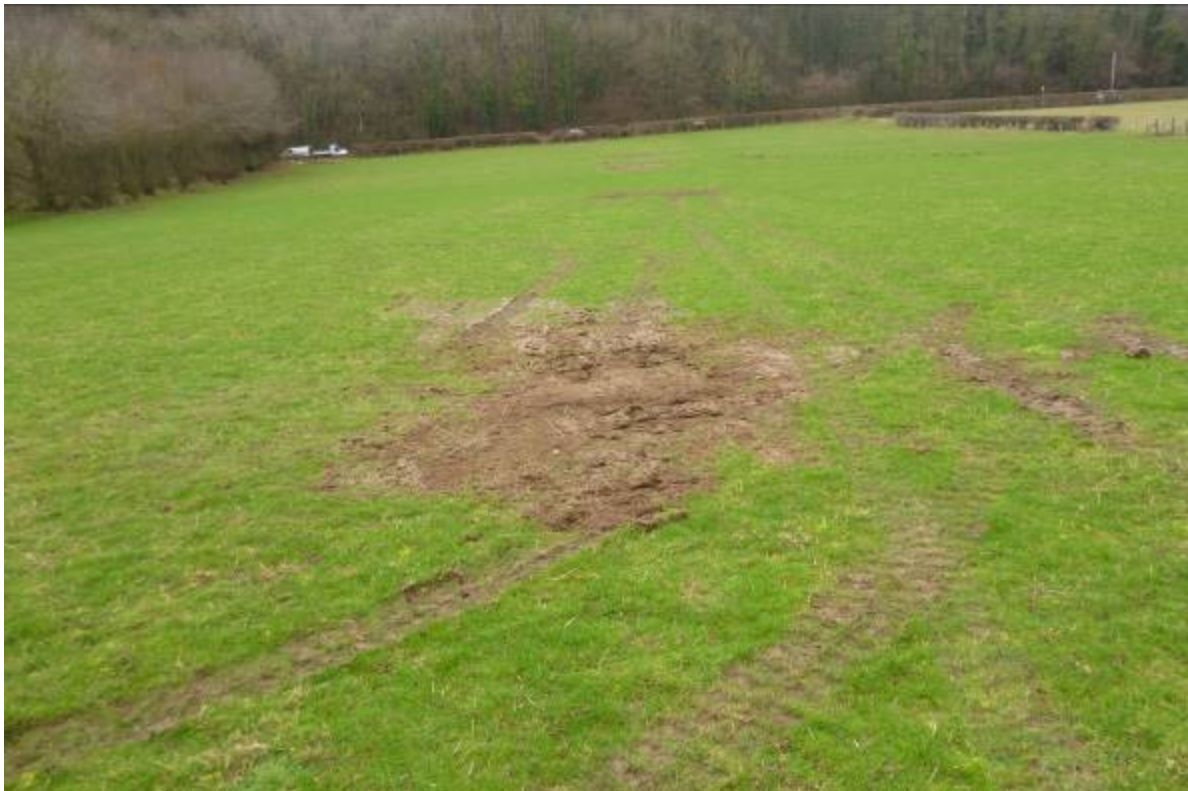
Photo D – General View of western site from centre of site

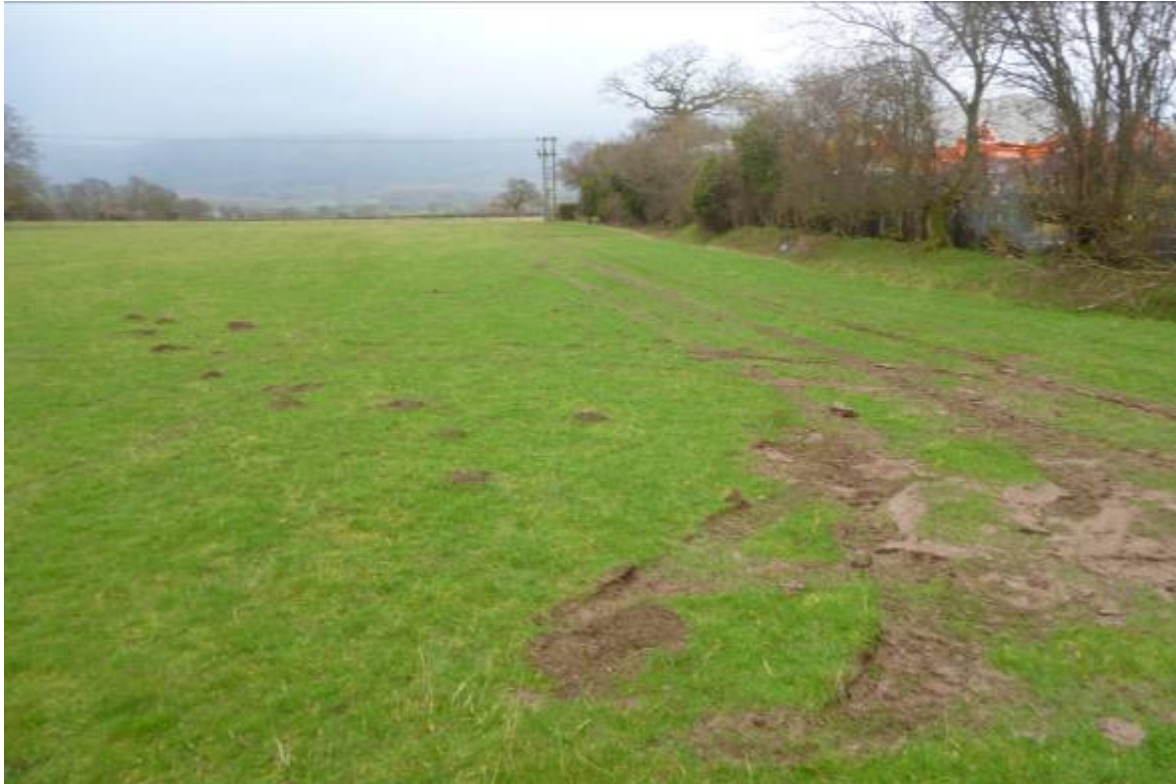
Photo E – General view of SE site, towards SE corner

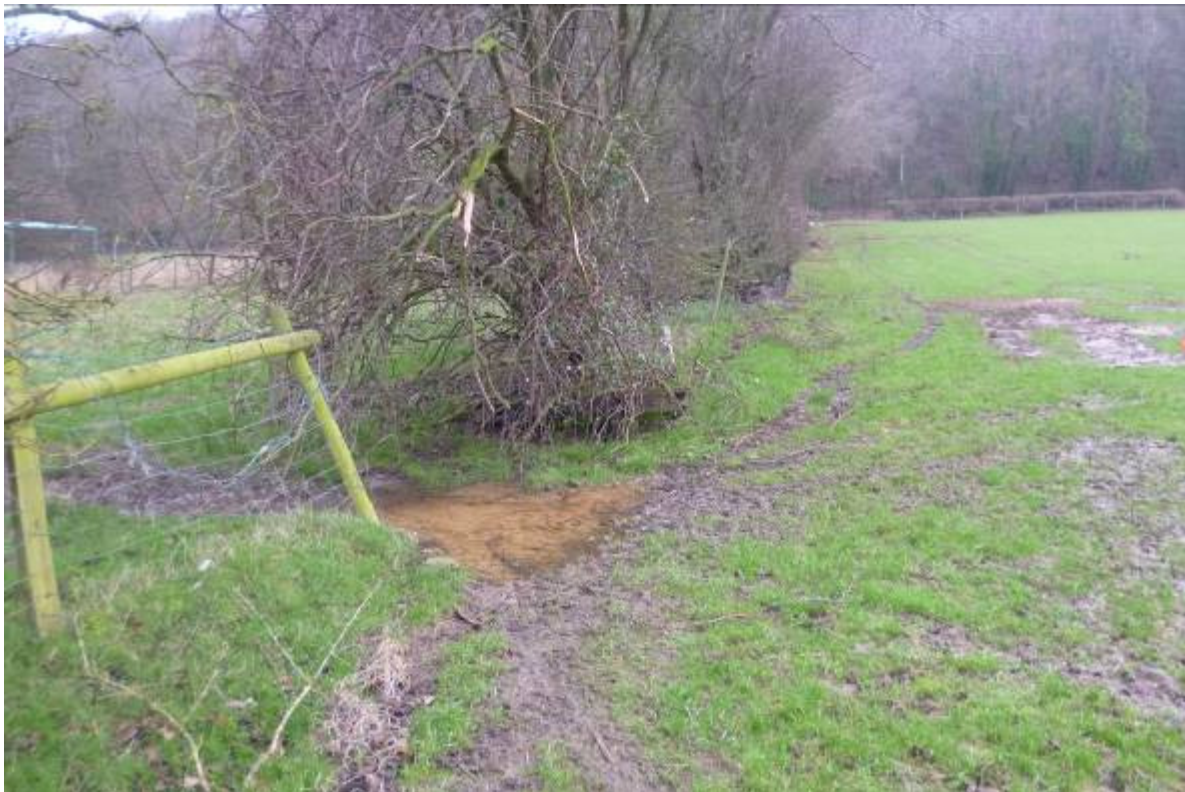
Photo F – Surface water collecting along southern boundary

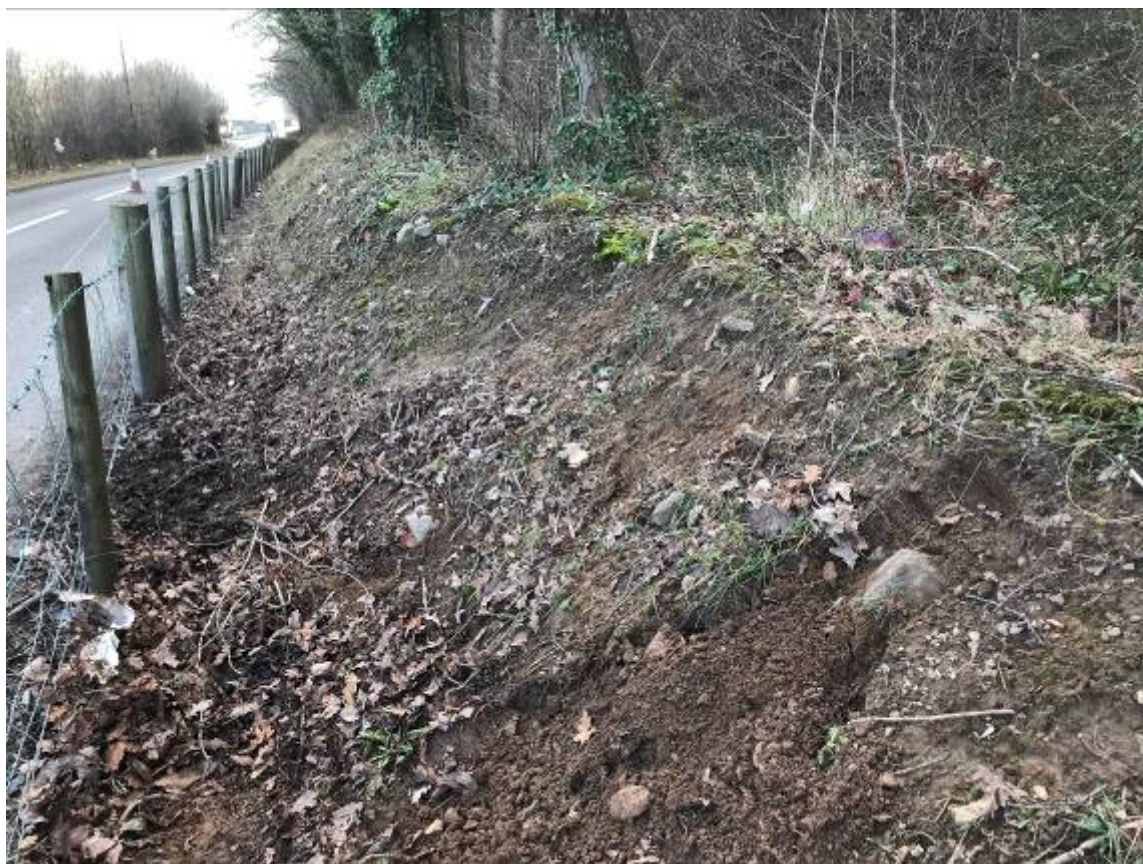
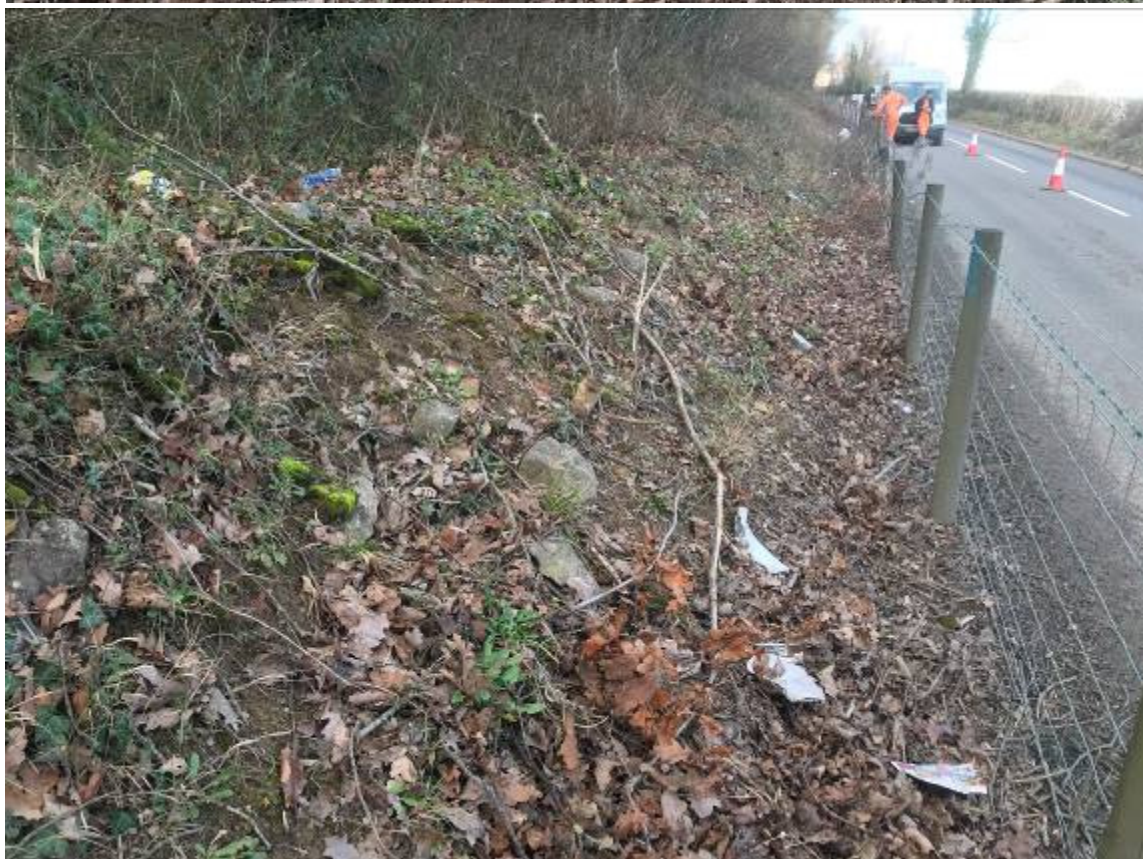
Photo G – General view of cutting on western boundary of Craig Road

HP02 and HP05 were excavated as a wedge into the cut slopes. Ground conditions from the crest of the cut (approx. 1.1m above road level) comprised interbedded granular and cohesive glacial till. CBR Testing was carried out from slightly above road level, from the base of the hand pit, and recorded CBR values above 10%.

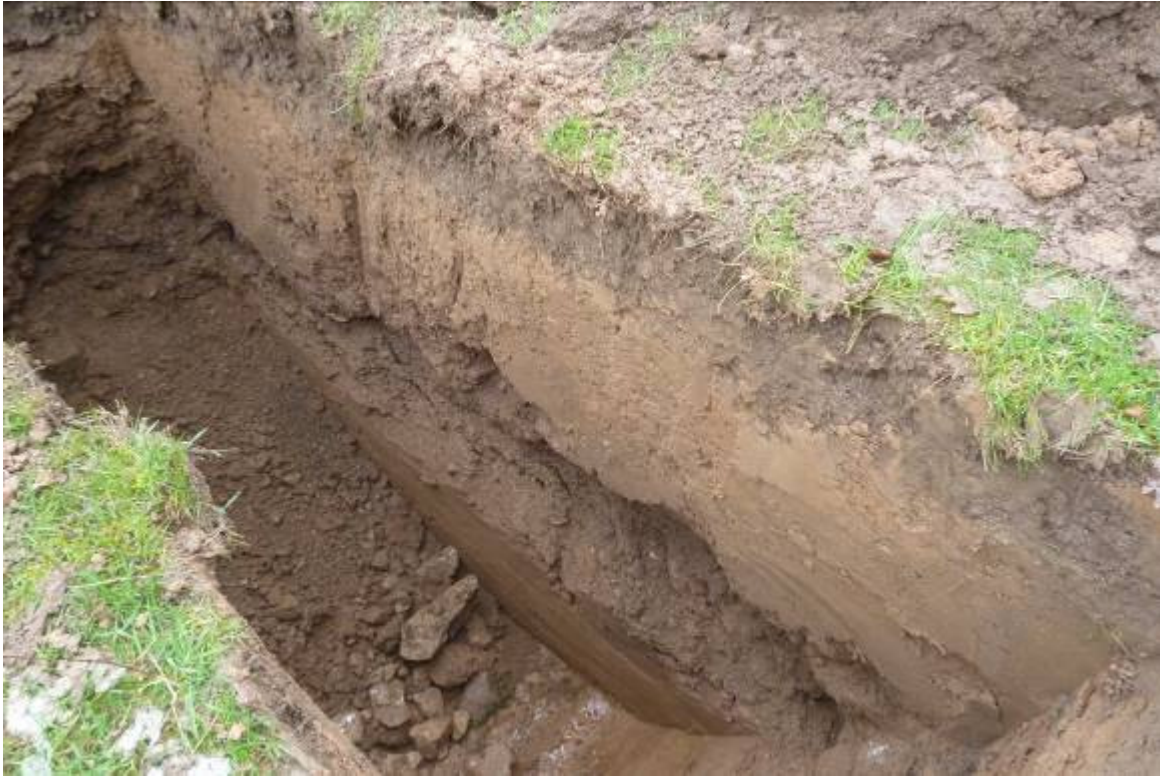
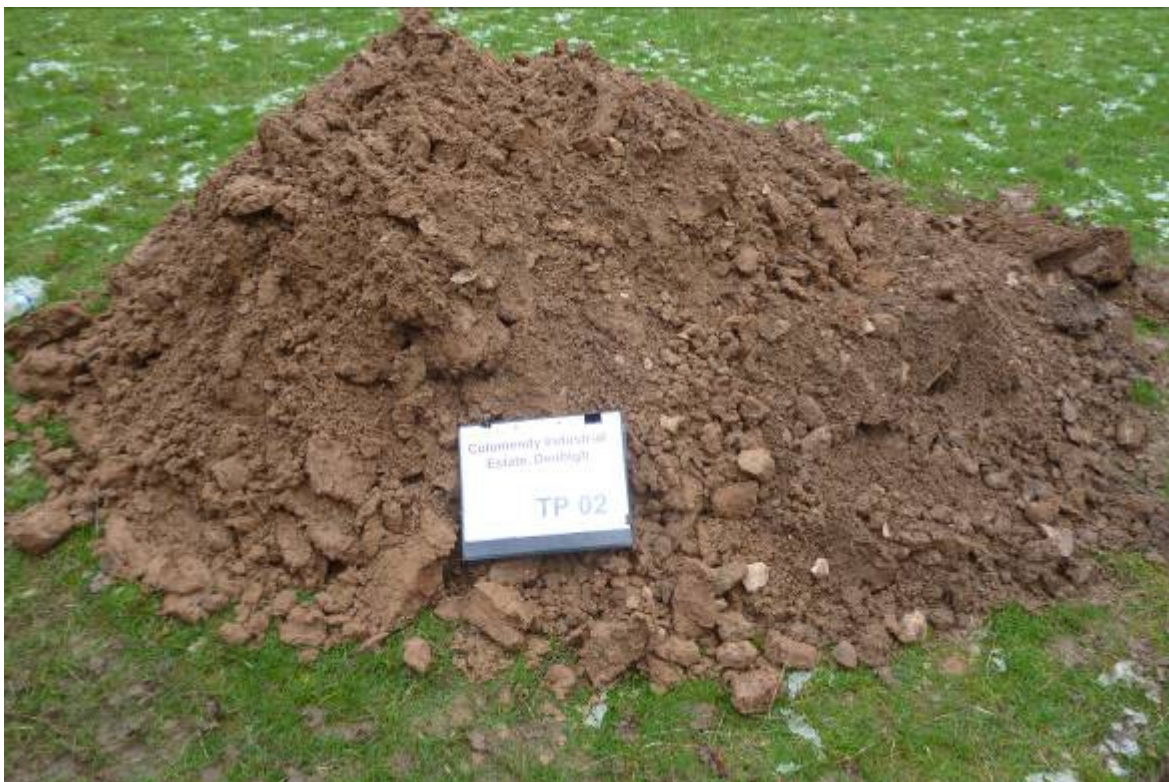
Project: Colomendy Industrial Estate Depot, Denbigh	Trial Pit: TP02
Excavation date: 24 th & 25 th Jan 2019	Logged by: APJ	Client: Cyngor Sir Ddinbych	Project ID: 1639
Strata:			
Depth (m)		Description	Samples
From	To		
0	0.25	Turf over topsoil	
0.25	0.8	Loose to medium dense, clayey, silty gravelly SAND, grading into sandy gravelly CLAY	0.3-0.6m – Bulk
0.8	1.3	Medium Dense, silty, very gravelly SAND with localised cobbles and rare boulder of limestone	0.9-1.2m - Bulk
1.3	1.9	Firm, becoming stiff, below 1.5m, slightly sandy, grading to sandy locally, slightly gravelly CLAY	
Excavated by – 3 ton tracked Excavator; 0.6m wide toothless digging bucket Plan dimensions – 0.6m x 3.0m Groundwater – Dry / localised seepage from one corner @1.6m Stability – slight collapse/overbreak of granular horizon Contamination – No visual or olfactory evidence of contamination HSV – Hand Shear Vane

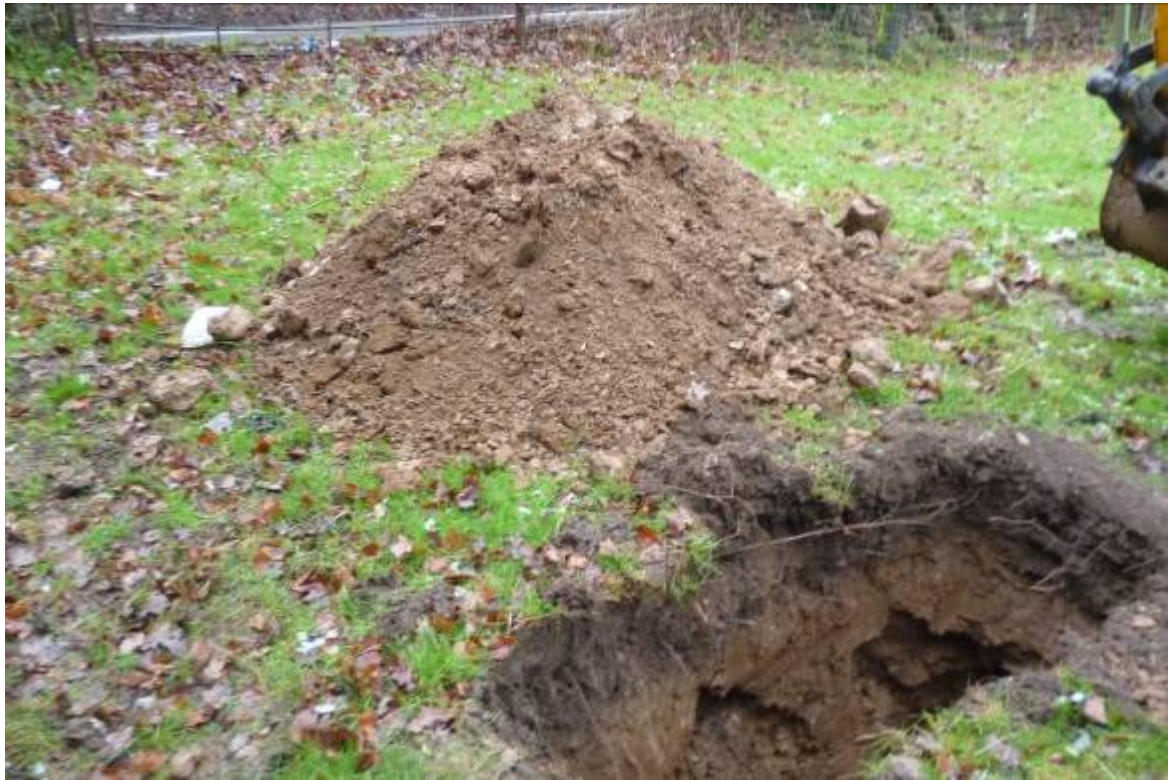
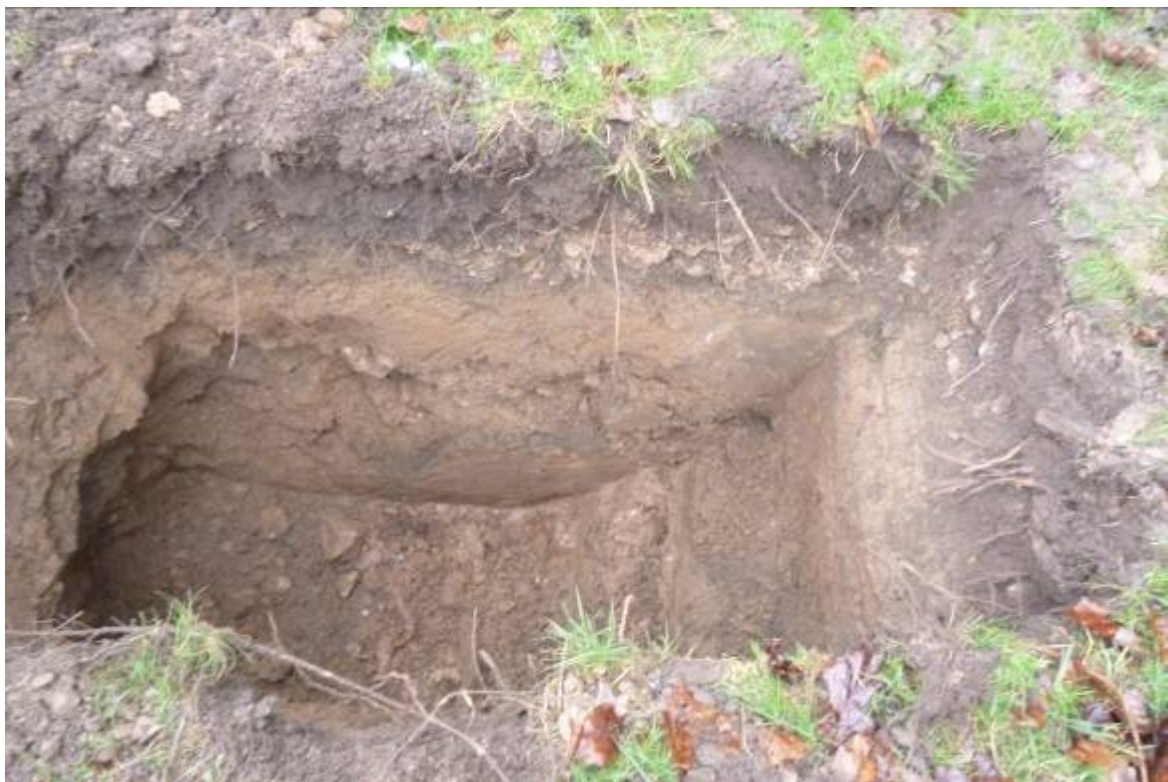
Project: Colomendy Industrial Estate Depot, Denbigh	Trial Pit: TP03
Excavation date: 24 th & 25 th Jan 2019	Logged by: APJ	Client: Cyngor Sir Ddinbych	Project ID: 1639
Strata:			
Depth (m)		Description	Samples / Tests
From	To		
0	0.25	Turf over topsoil	0.5m, HSV – av. 147kPa

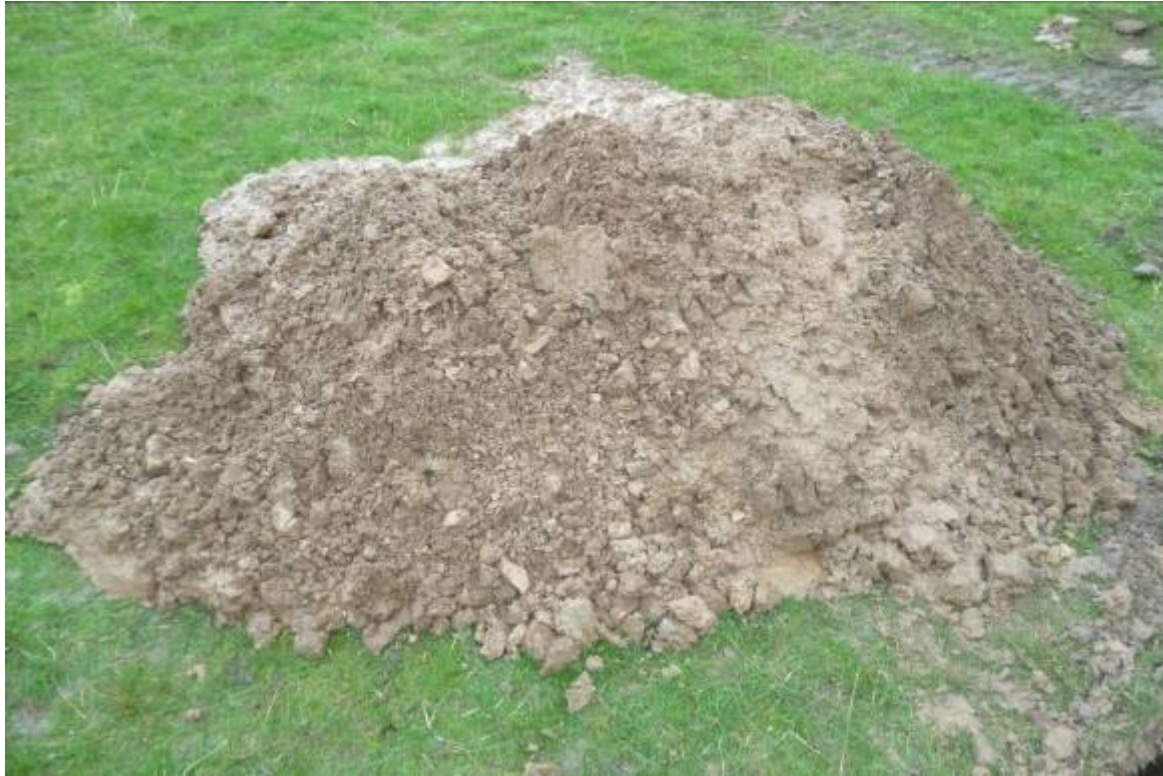
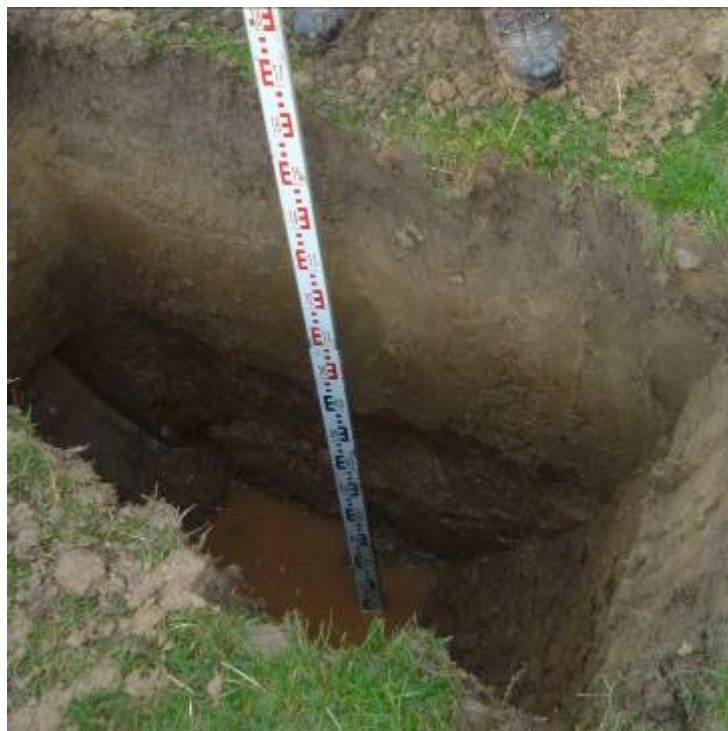
<div>daear</div> <div>Geo Consulting</div>		Project: Colomendy Industrial Estate Depot, Denbigh		Trial Pit: TP04	
Excavation date: 24 th & 25 th Jan 2019		Logged by: APJ		Client: Cyngor Sir Ddinbych	
				Project ID: 1639	
Strata:					
Depth (m)		Description		Samples / Tests	
From	To				
0	0.22	Turf over topsoil		HSV: 0.5m; 96-110kPa Samples 0.5-0.6m – Tub 1.0-1.3m - Bulk	
0.22	0.9	Firm stiff below 0.5m, slightly gravelly sandy, CLAY			
0.9	1.4	Medium Dense, silty, clayey, gravelly to very gravelly SAND			
Excavated by – 3 ton tracked Excavator; 0.6m wide toothless digging bucket Plan dimensions – 0.6m x 3.0m Groundwater –Seepage from granular horizon, standing at 0.9m after 3 hrs Stability – slight collapse/overbreak of granular horizon Contamination – No visual or olfactory evidence of contamination HSV – Hand Shear Vane

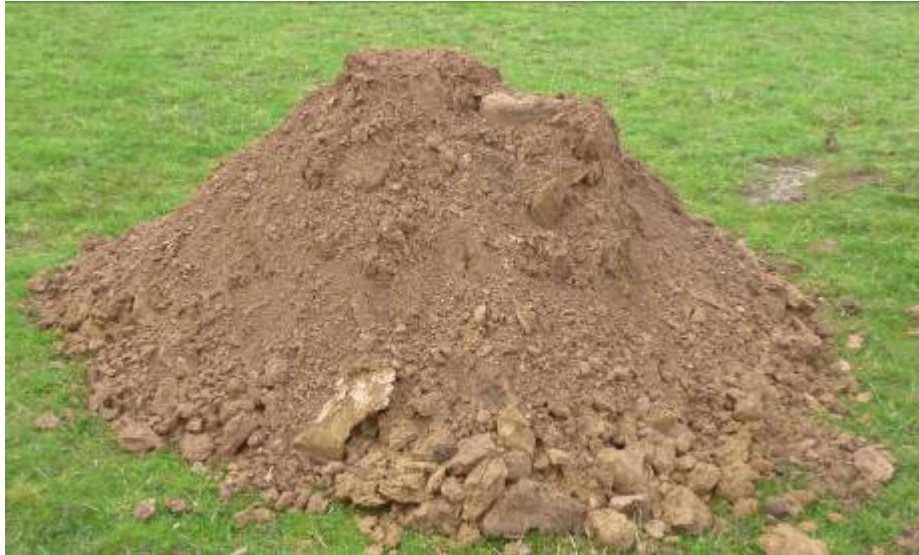
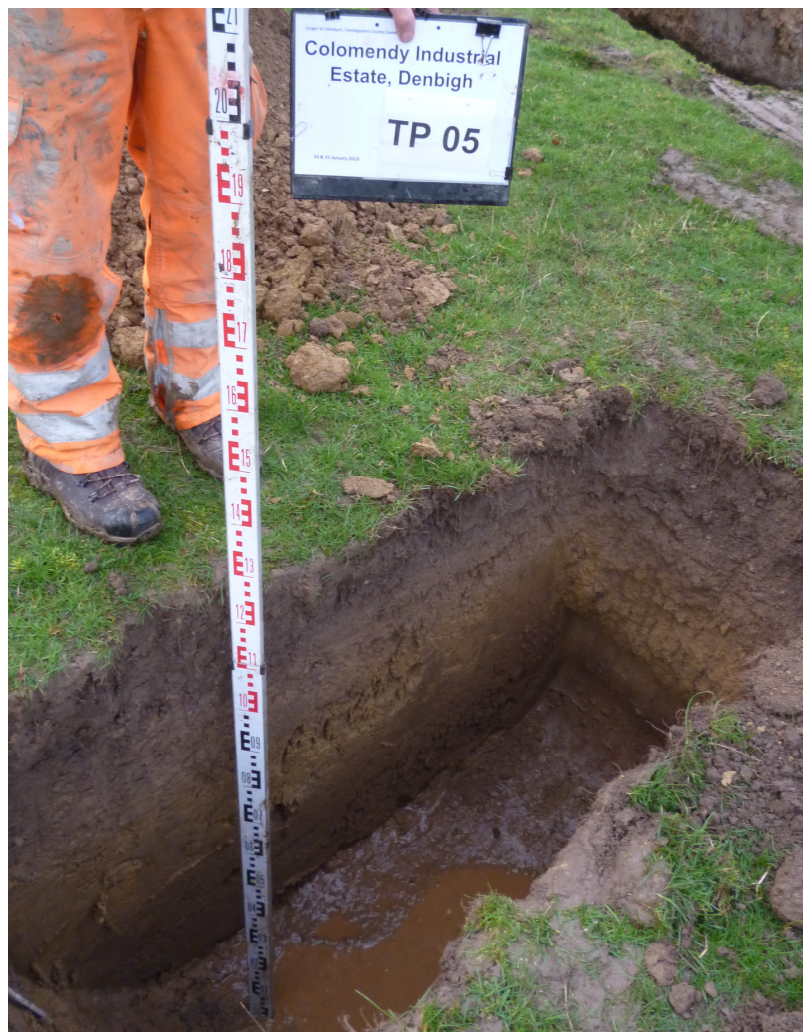
<div>daear</div> <div>Geo Consulting</div>		Project: Colomendy Industrial Estate Depot, Denbigh	Trial Pit: TP05
Excavation date: 24 th & 25 th Jan 2019	Logged by: APJ	Client: Cyngor Sir Ddinbych	Project ID: 1639
Strata:			
Depth (m)		Description	Samples/Tests
From	To		
0	0.25	Turf over topsoil	HSV: 0.5m; 85-99kPa 0.7m; 105-170kPa
0.25	1.3	Firm, becoming stiff to very stiff below 0.5m, slightly sandy, slightly gravelly silty CLAY	
Excavated by – 3 ton tracked Excavator; 0.6m wide toothless digging bucket Plan dimensions – 0.6m x 3.0m Groundwater – Dry no standing water after 2.5hrs Stability – No sidewall instability recorded in short term Contamination – No visual or olfactory evidence of contamination HSV – Hand Shear Vane

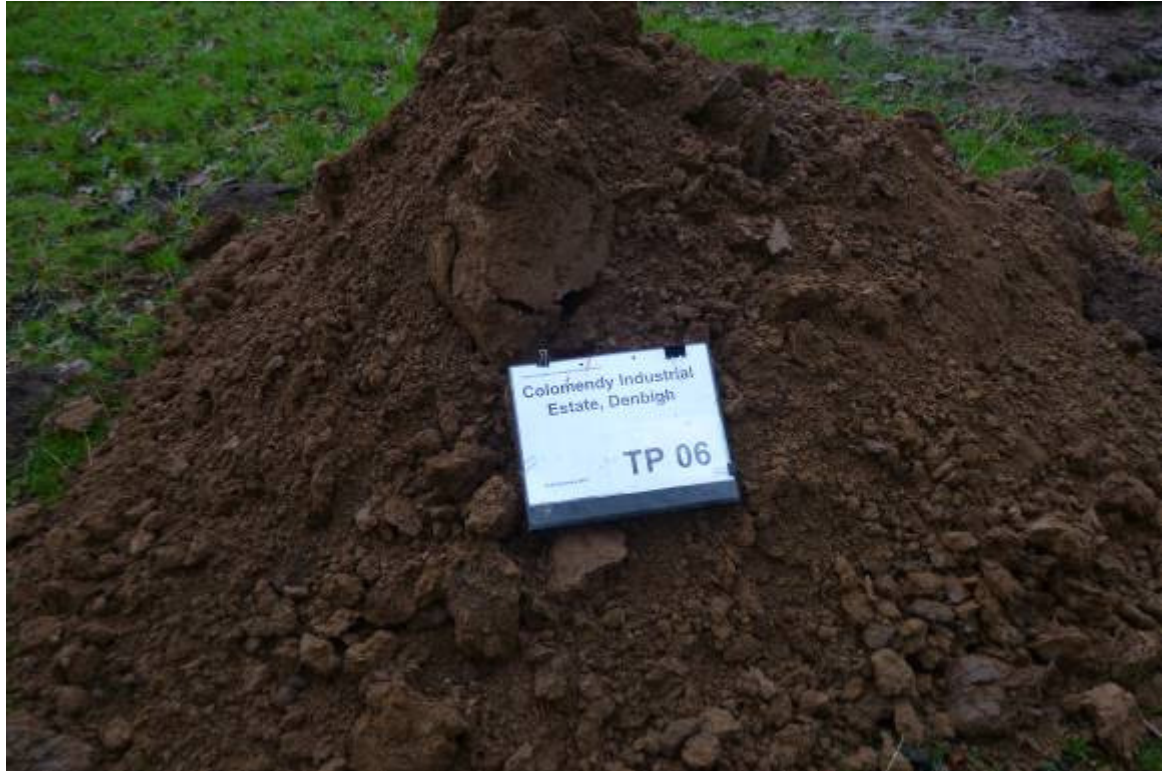
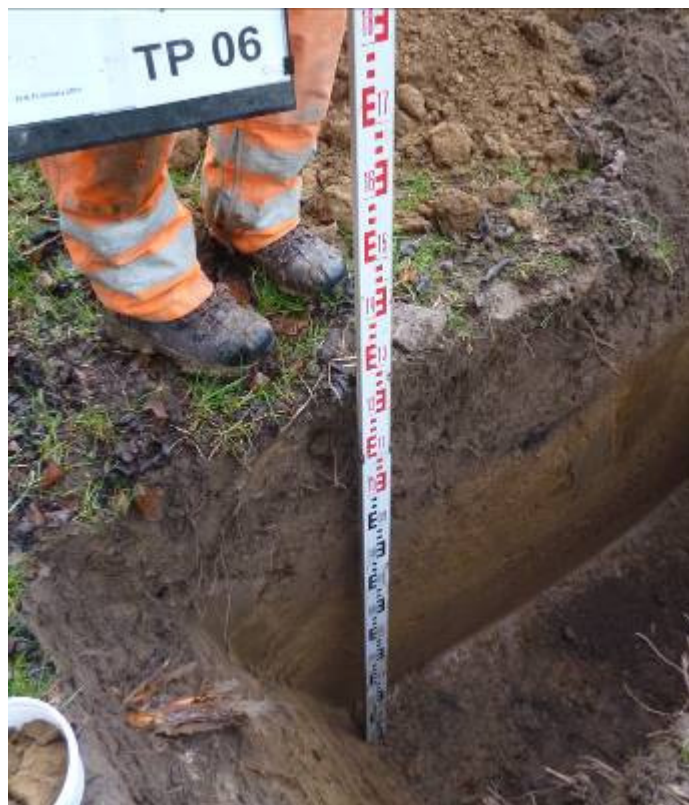
Project: Colomendy Industrial Estate Depot, Denbigh	Trial Pit: TP06
Excavation date: 24 th & 25 th Jan 2019	Logged by: APJ	Client: Cyngor Sir Ddinbych	Project ID: 1639
Strata:			
Depth (m)		Description	Samples
From	To		
0	0.32	Turf over topsoil	
0.32	1.4	Stiff, becoming very stiff below 1.2m, slightly sandy silty CLAY with rare individual gravel fragments Hand Shear Vane Records: 0.5m – 109kPa 0.7m - 112kPa 0.9m - 133kPa 1.1m – 91/112/123kPa 1.3m – 147/160kPa	
Excavated by – 3 ton tracked Excavator; 0.6m wide toothless digging bucket Plan dimensions – 0.6m x 3.0m Groundwater – Dry Stability – No sidewall instability recorded in short term Contamination – No visual or olfactory evidence of contamination HSV – Hand Shear Vane

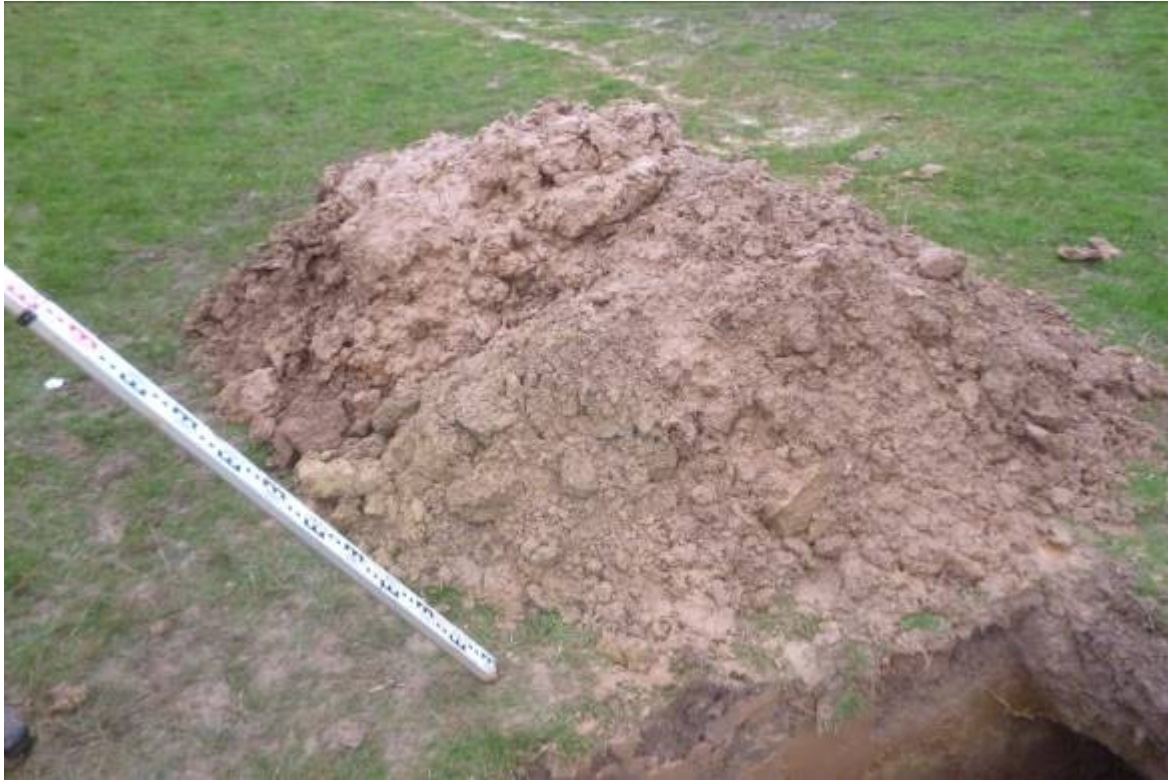
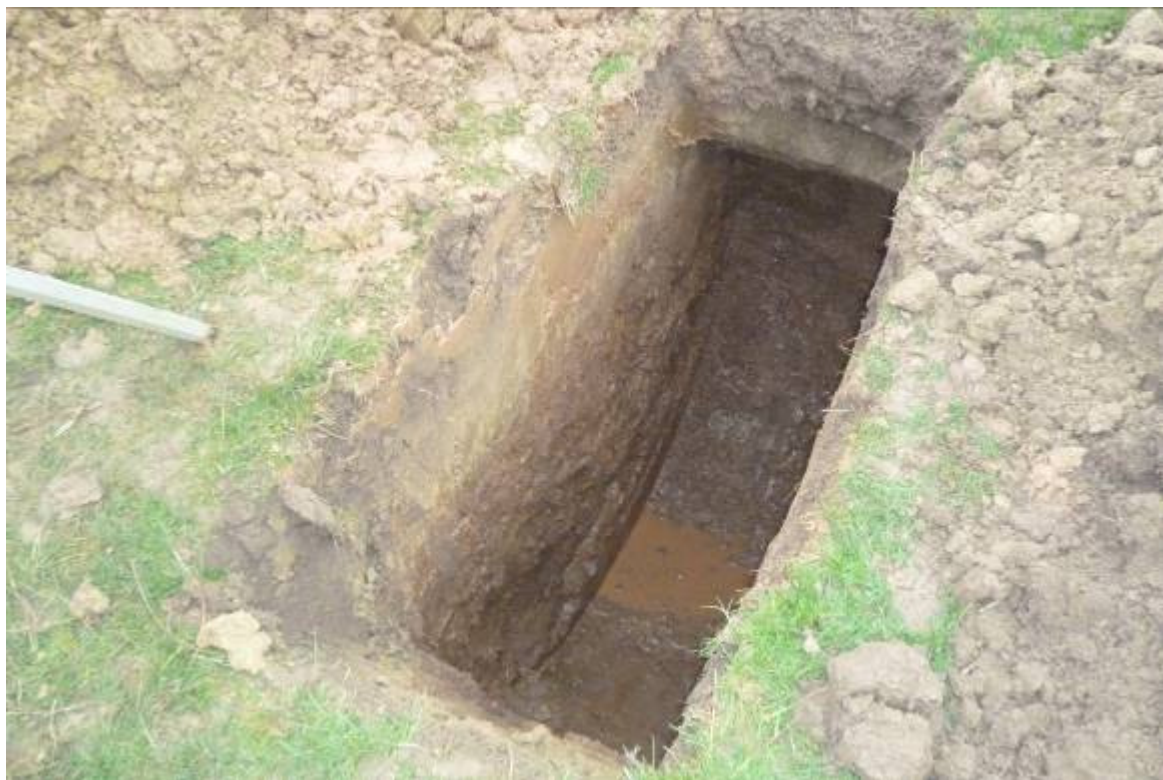
A groundwater infiltration test was carried out in TP07. The test was abandoned due to rising water levels. The results are presented on the Exploratory hole log in Appendix C.

<div><div>daear</div><div>Geo Consulting</div></div>		Project: Colomendy Industrial Estate Depot, Denbigh		Trial Pit: TP07																
Excavation date: 24 th & 25 th Jan 2019		Logged by: APJ		Client: Cyngor Sir Ddinbych																
				Project ID: 1639																
Strata:																				
Depth (m)		Description			Samples															
From	To																			
0	0.25	Turf over topsoil			HSV: 0.5m; 67kPa															
0.25	0.9	Firm, slightly sandy, slightly silty CLAY with localised discreet fine to medium sub rounded gravel																		
0.9	1.7	Medium Dense, silty, clayey to very clayey, gravelly to very gravelly SAND. Gravel is fine to coarse, sub rounded to sub angular of mudstone and limestone																		
1.7	2.0	Stiff, becoming very stiff below 1.9m, reddish brown, slightly sandy, silty, CLAY with localised discreet fine to medium sub rounded gravel Soakaway Test Carried out when pit at 1.5m, see below for results. Pit extended to 2.0m after test

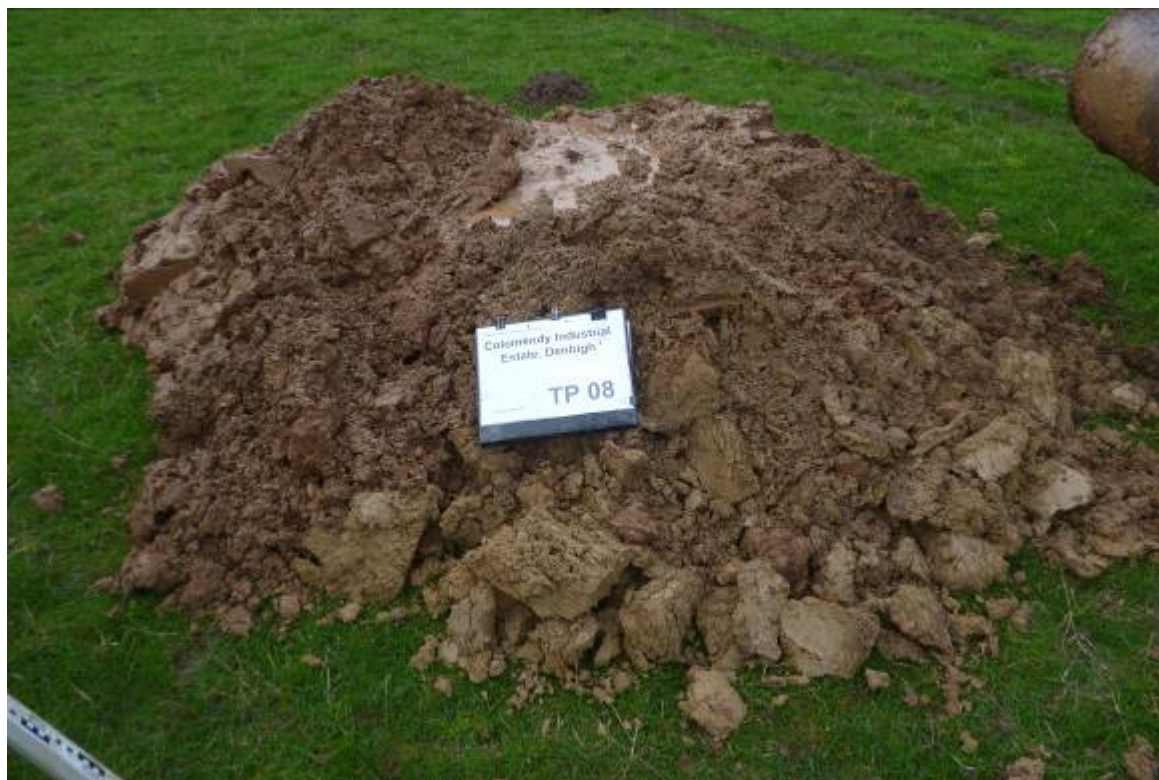
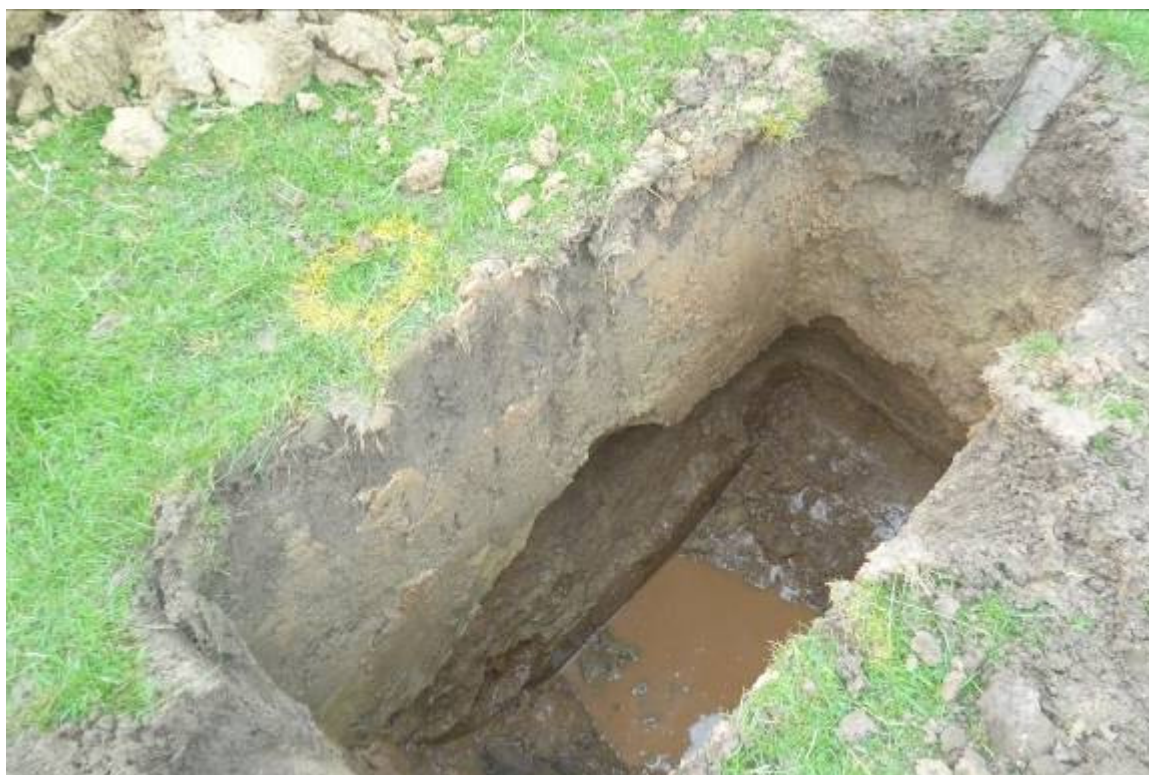
Project: Colomendy Industrial Estate Depot, Denbigh	Trial Pit: TP08
Excavation date: 24 th & 25 th Jan 2019	Logged by: APJ	Client: Cyngor Sir Ddinbych	Project ID: 1639
Strata:			
Depth (m)		Description	Samples
From	To		
0	0.25	Turf over topsoil	HSV: 0.5m; 53-59kPa 0.7m; >180kPa 1.2m; >180kPa

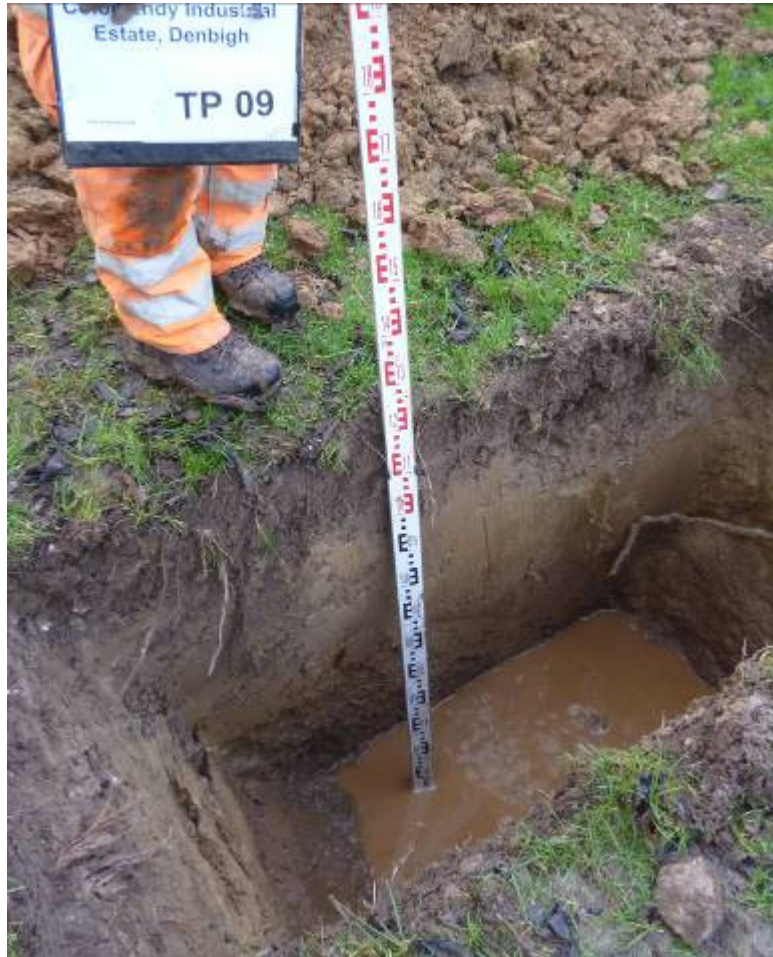
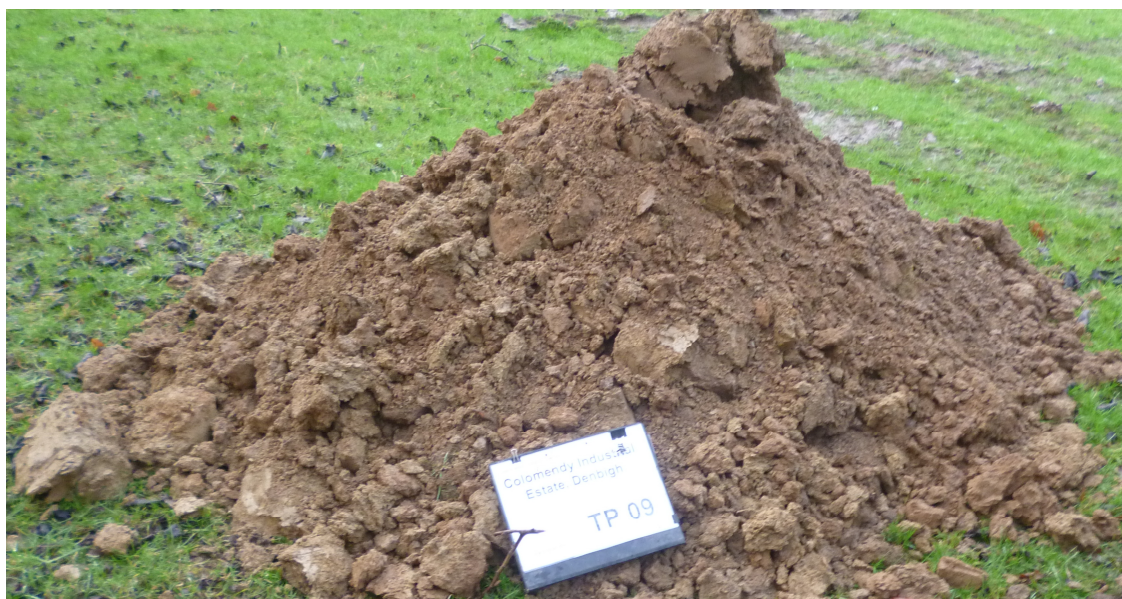
Project: Colomendy Industrial Estate Depot, Denbigh	Trial Pit: TP09
Excavation date: 24 th & 25 th Jan 2019	Logged by: APJ	Client: Cyngor Sir Ddinbych	Project ID: 1639
Strata:			
Depth (m)		Description	Samples / Tests
From	To		
0	0.2	Turf over topsoil	0.5m, HSV –. 85/109/125kPa
0.2	1.1	Firm to Stiff, light brown slightly sandy, slightly silty CLAY with localised discreet gravel	
1.1	1.3	Medium Dense, slightly silty, clayey, gravelly to very gravelly SAND with localised cobbles and rare boulder of limestone	
Excavated by – 3 ton tracked Excavator; 0.6m wide toothless digging bucket Plan dimensions – 0.6m x 3.0m Groundwater – Water inflow from 1.1m, equalised at 0.75m after 2hrs Stability – no sidewall instability recorded in short term Contamination – No visual or olfactory evidence of contamination HSV – Hand Shear Vane
