Colomendy Industrial Estate Depot
Geotechnical Report
Cyngor Sir Ddinbych

Report Date – March 2019
Report Revision – V. 01

Denbighshire County Council / Cyngor Sir Ddinbych (DCC) propose to construct a new depot on undeveloped land adjacent to the Colomendy Industrial Estate in Denbigh.

Daeare GeoConsulting (Daeare) has been appointed to carry out a preliminary geotechnical ground investigation and interpretative report for the proposed development.

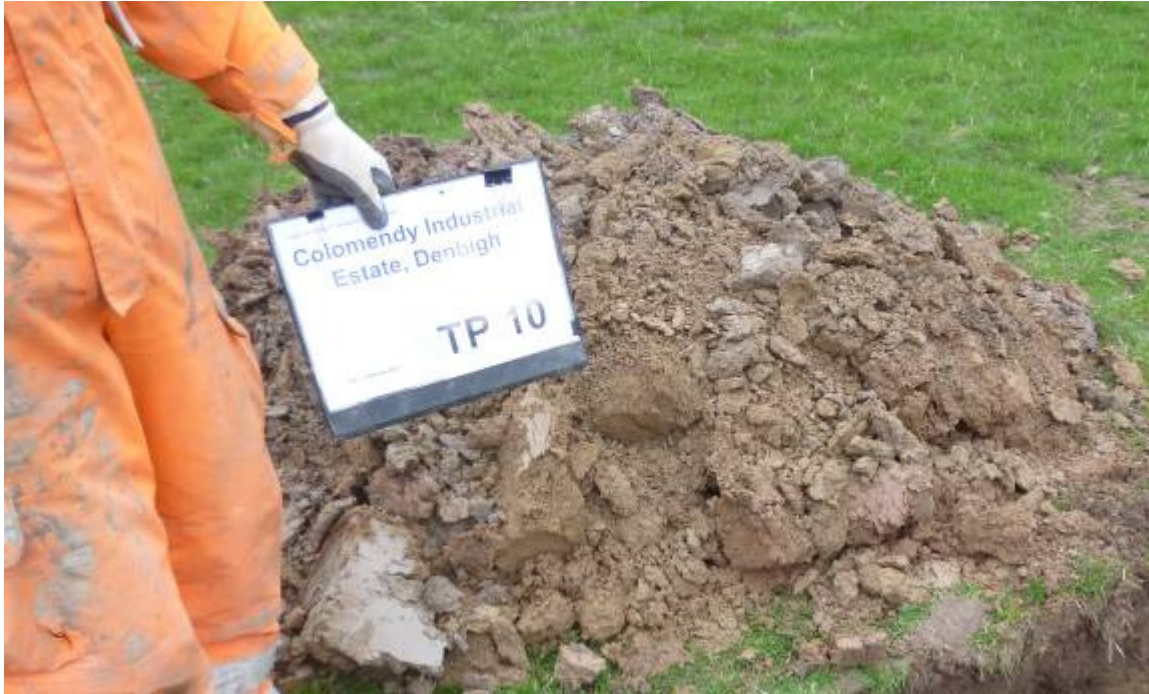
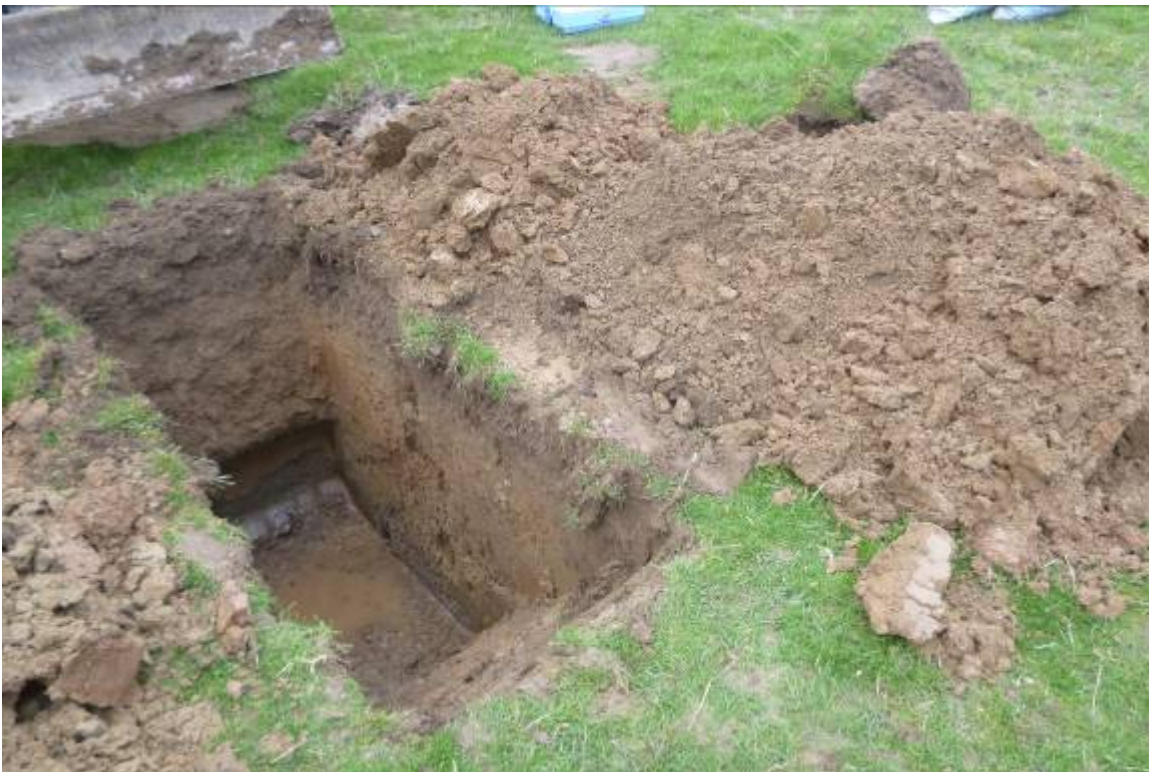
Project: Colomendy Industrial Estate Depot, Denbigh	Trial Pit: TP10
Excavation date: 24 th & 25 th Jan 2019	Logged by: APJ	Client: Cyngor Sir Ddinbych	Project ID: 1639
Strata:			
Depth (m)		Description	Samples
From	To		
0	0.25	Turf over topsoil	Tub – 0.3-0.5 HSV: 0.3m; 75-80kPa 0.6m; 104-110kPa 0.9m; 77-83kPa 1.2m; 104-123kPa 1.4m; >180kPa

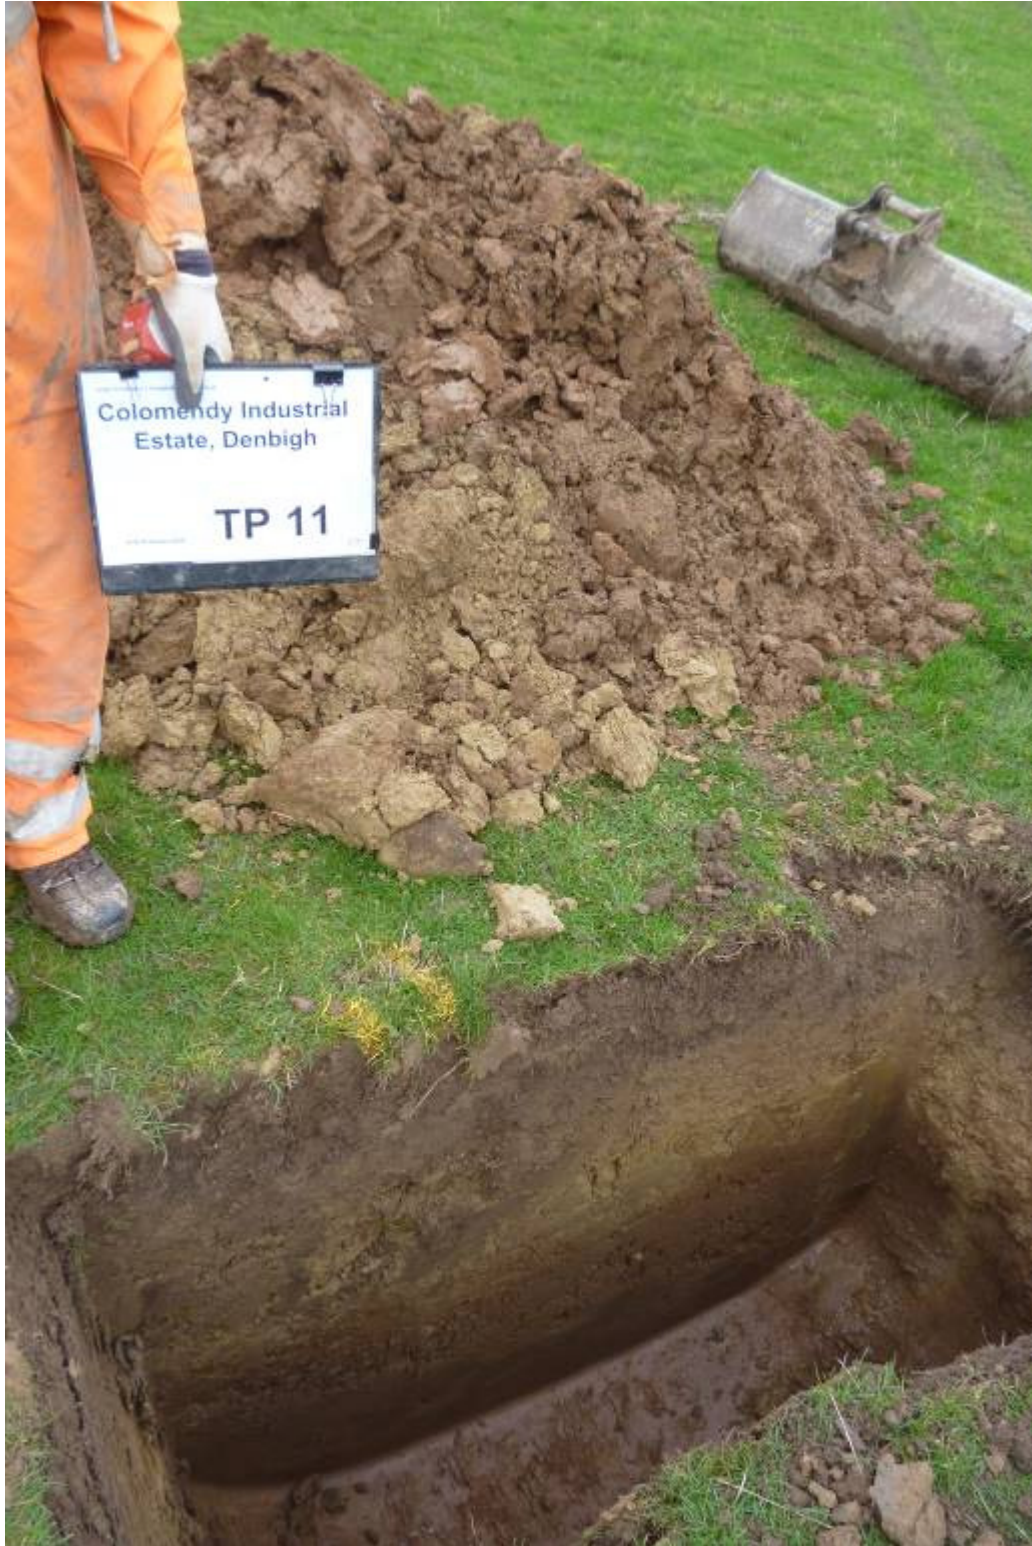
Project: Colomendy Industrial Estate Depot, Denbigh	Trial Pit: TP11
Excavation date: 24 th & 25 th Jan 2019	Logged by: APJ	Client: Cyngor Sir Ddinbych	Project ID: 1639
Strata:			
Depth (m)		Description	Samples/Tests
From	To		
0	0.23	Turf over topsoil	HSV: 0.5m; 72-85kPa 0.7m; 93-99kPa

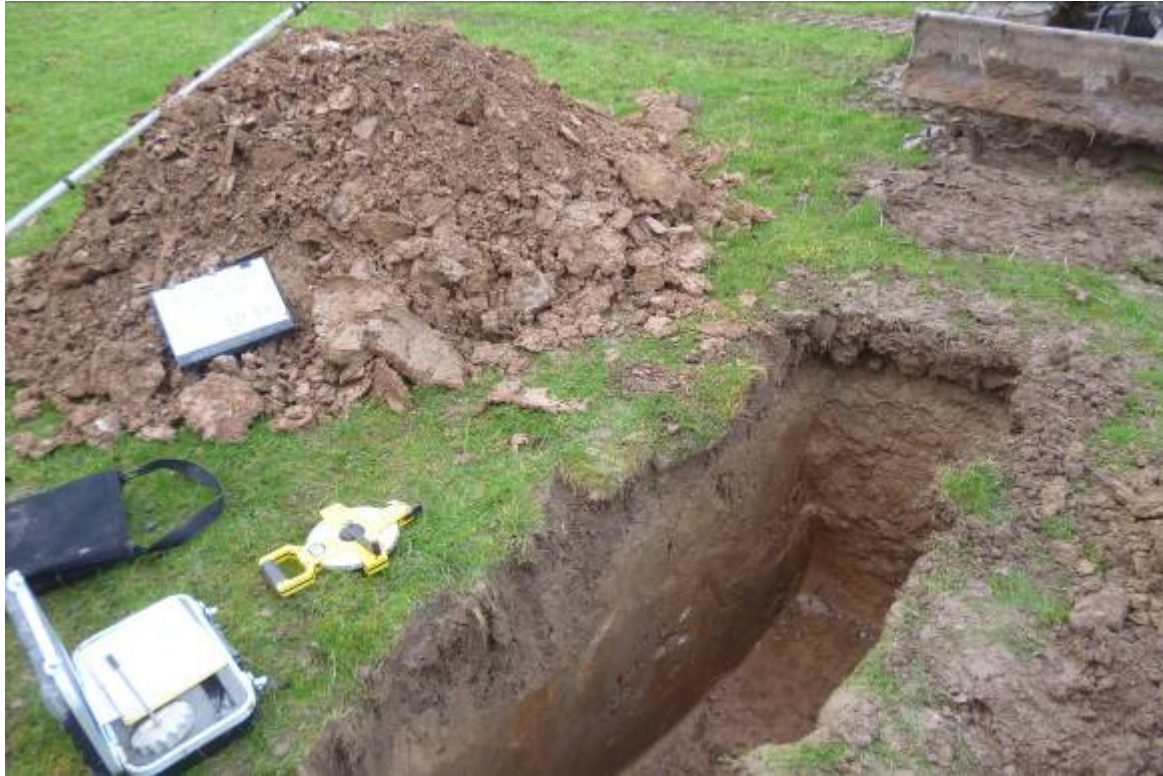
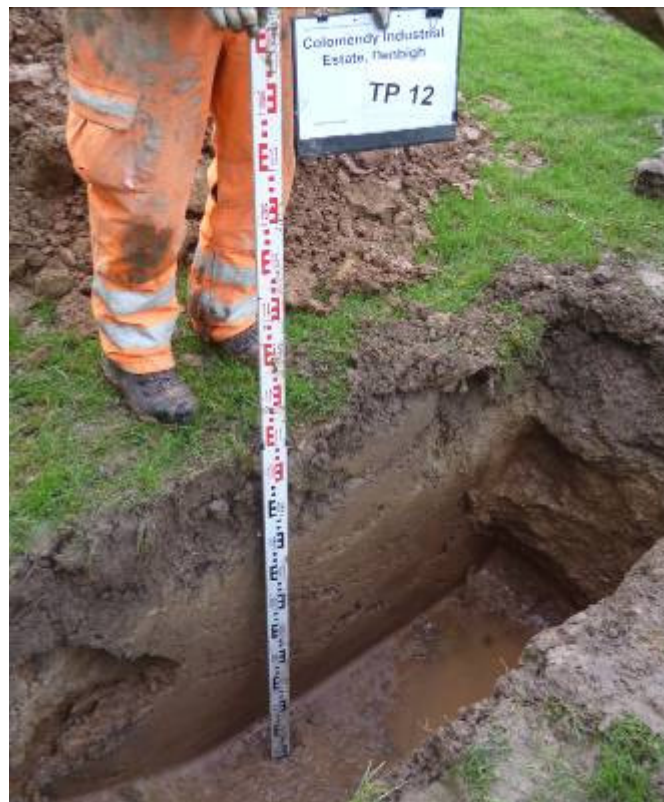
<div>daear</div> <div>Geo Consulting</div>		Project: Colomendy Industrial Estate Depot, Denbigh		Trial Pit: TP12	
Excavation date: 24 th & 25 th Jan 2019		Logged by: APJ		Client: Cyngor Sir Ddinbych	
				Project ID: 1639	
Strata:					
Depth (m)		Description			Samples
From	To				
0	0.25	Turf over topsoil			HSV: 0.5m; 53-59kPa 0.7m; >180kPa 1.2m; >180kPa

0.25	1.2	Firm, becoming stiff and very stiff below 0.6m, reddish brown, slightly sandy, silty, CLAY with localised discreet fine to medium sub rounded gravel.			
0		Localised, relatively small pockets (<300mm) of gravelly sand			
Excavated by – 3 ton tracked Excavator; 0.6m wide toothless digging bucket Plan dimensions – 0.6m x 3.0m Groundwater – Surface water seepage from Topsoil, standing at 0.8m after 1hr. Localised seepage from granular pockets Stability – No sidewall instability recorded in short term Contamination – No visual or olfactory evidence of contamination HSV – Hand Shear Vane

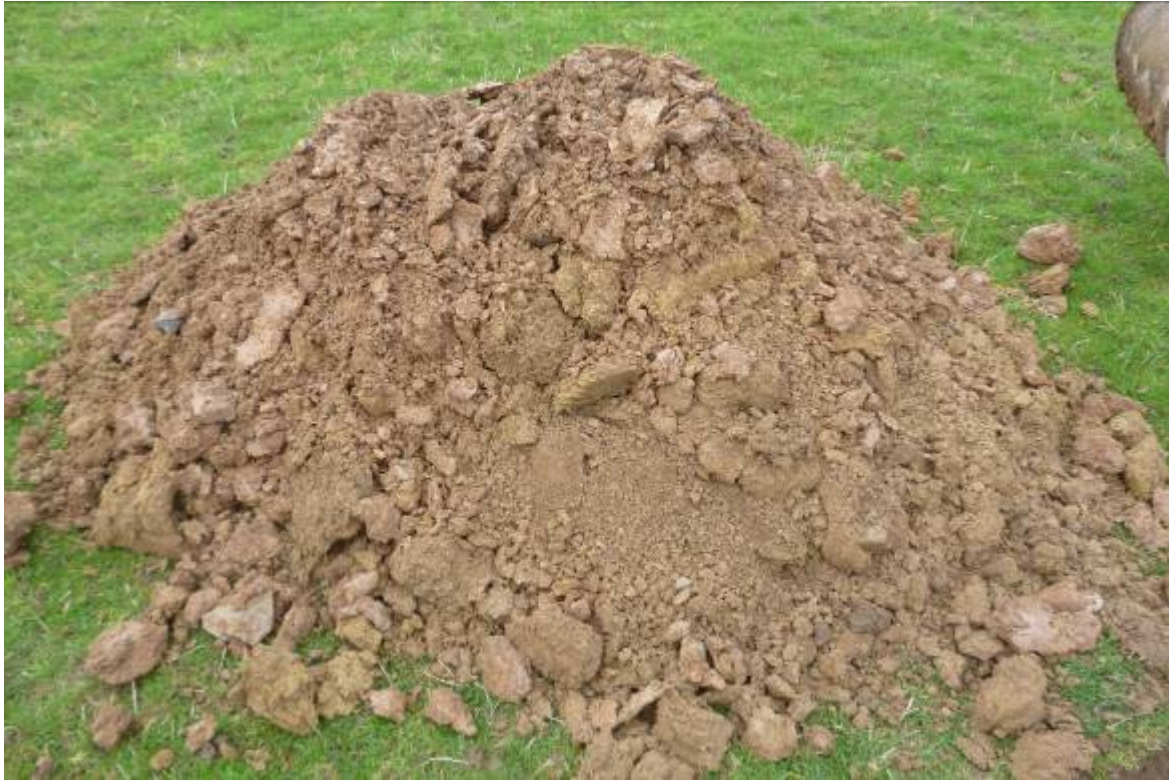
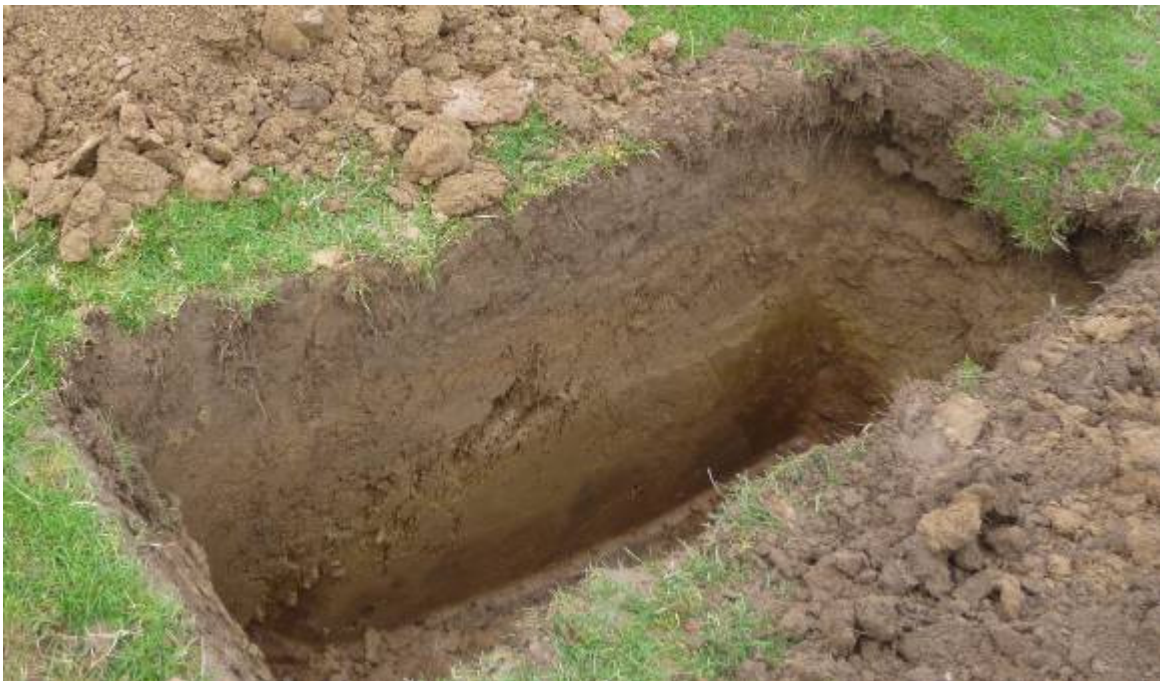
<div>daear</div> <div>Geo Consulting</div>		Project: Colomendy Industrial Estate Depot, Denbigh		Trial Pit: TP13	
Excavation date: 24 th & 25 th Jan 2019		Logged by: APJ		Client: Cyngor Sir Ddinbych	
				Project ID: 1639	
Strata:					
Depth (m)		Description			Samples
From	To				
0	0.22	Turf over topsoil			HSV: 0.3m; 80-99kPa 0.5m; 77-91kPa Bulk; 0.4-0.6m HSV: 0.7m; 120-130kPa 1.1m; >187kPa Bulk; 0.7-0.9

0.22	0.65	Stiff, light brown, slightly sandy, CLAY with discreet individual gravel fragments			
0.65	1.2	Stiff, becoming very stiff below 0.9m, reddish brown, slightly sandy, silty, CLAY with localised discreet fine to medium sub rounded gravel and sub angular cobbles			
Excavated by – 3 ton tracked Excavator; 0.6m wide toothless digging bucket Plan dimensions – 0.6m x 3.0m Groundwater –Groundwater upwelling locally from base of pit below 1.1m depth Stability – No sidewall instability recorded in short term Contamination – No visual or olfactory evidence of contamination HSV – Hand Shear Vane

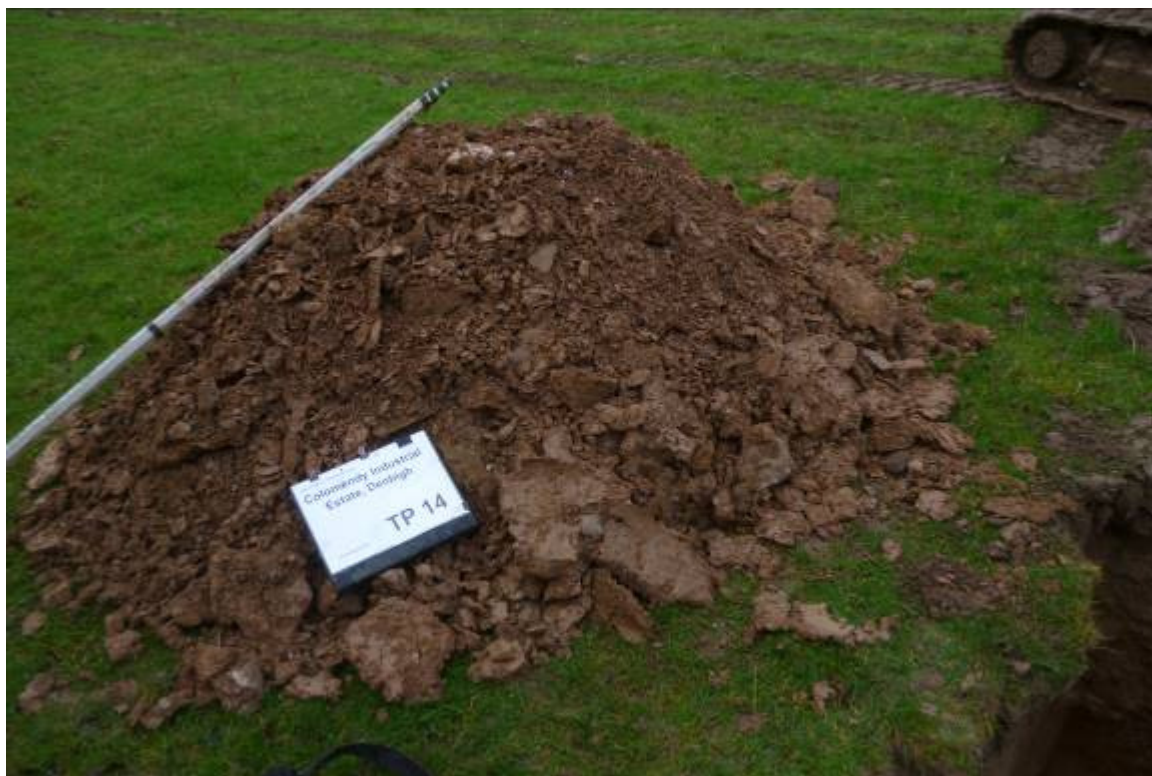
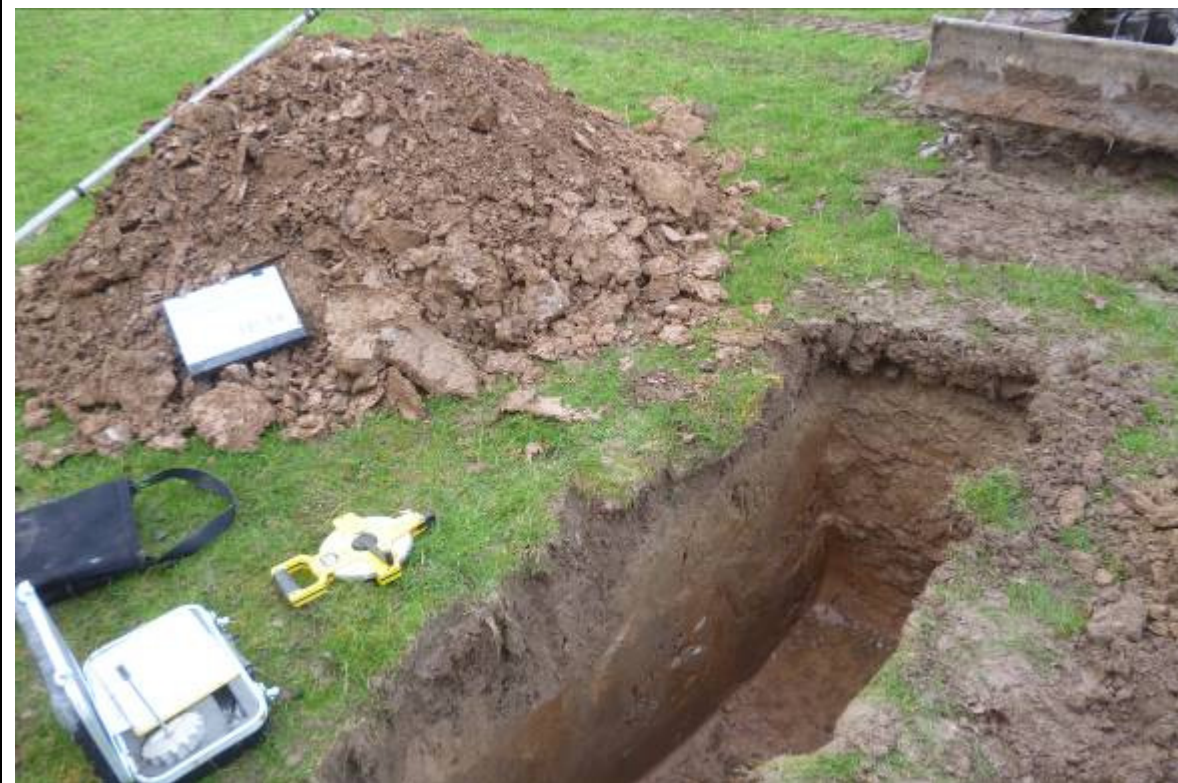
<div>daear</div> <div>Geo Consulting</div>		Project: Colomendy Industrial Estate Depot, Denbigh		Trial Pit: TP14			
Excavation date: 24 th & 25 th Jan 2019		Logged by: APJ		Client: Cyngor Sir Ddinbych		Project ID: 1639	
Strata:							
Depth (m)		Description				Samples/Tests	
From	To						
0	0.22	Turf over topsoil				HSV: 0.4m; 85-107kPa 0.6m; >180kPa 1.0m; >180kPa	
0.22	1.2	Firm to stiff, becoming very stiff below 0.6m, reddish brown, slightly sandy, silty CLAY with localised discreet fine to medium sub rounded gravel and cobbles.					
0							
Excavated by – 3 ton tracked Excavator; 0.6m wide toothless digging bucket Plan dimensions – 0.6m x 3.0m Groundwater – Dry Stability – No sidewall instability recorded in short term Contamination – No visual or olfactory evidence of contamination HSV – Hand Shear Vane

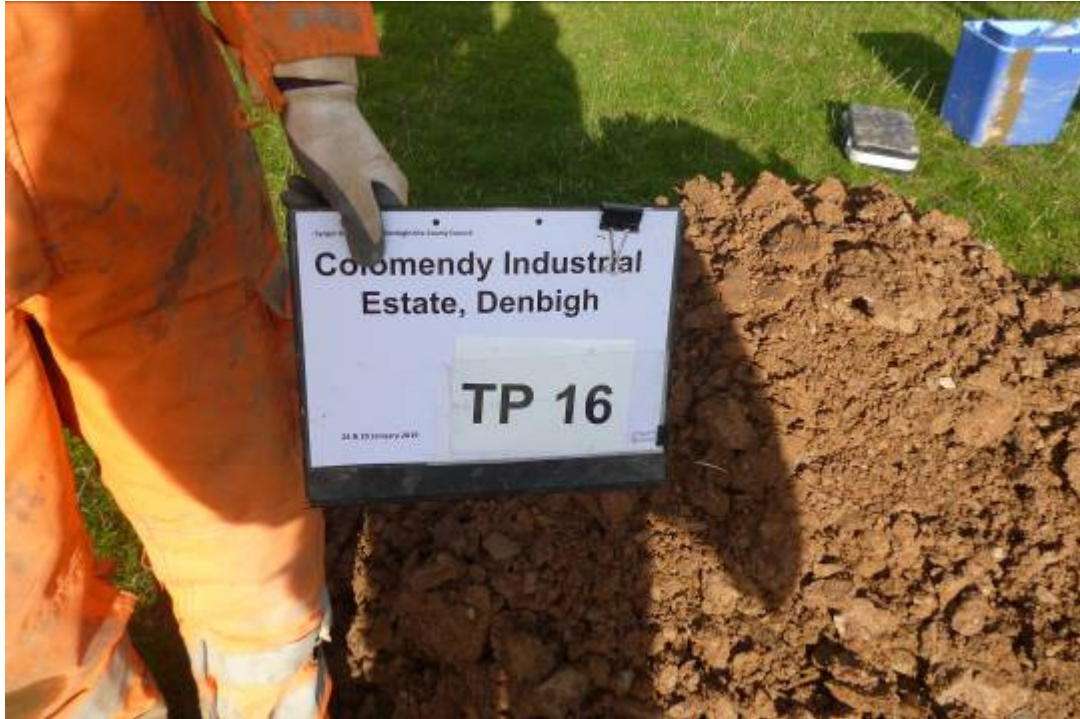
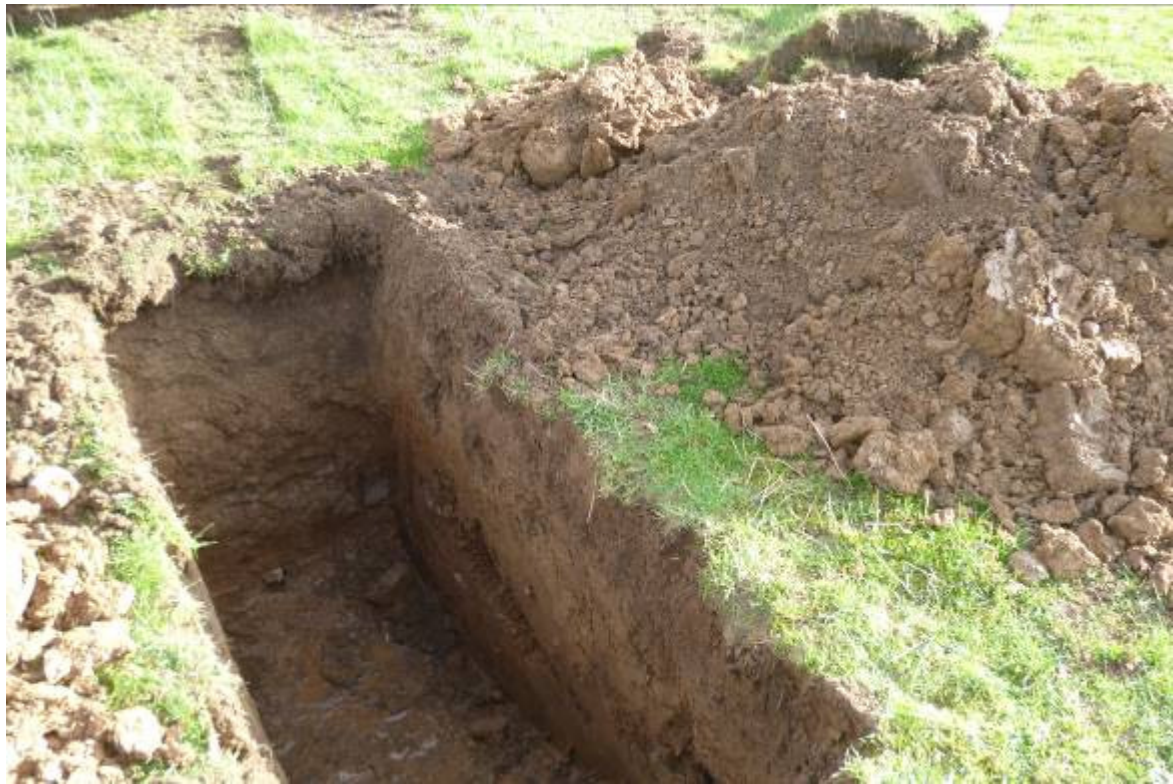
Project: Colomendy Industrial Estate Depot, Denbigh	Trial Pit: TP16
Excavation date: 24 th & 25 th Jan 2019	Logged by: APJ	Client: Cyngor Sir Ddinbych	Project ID: 1639
Strata:			
Depth (m)		Description	Samples
From	To		
0	0.2	Turf over topsoil	HSV: 0.3m; 72-104kPa 0.5m; 112-140kPa 0.8m; >180kPa

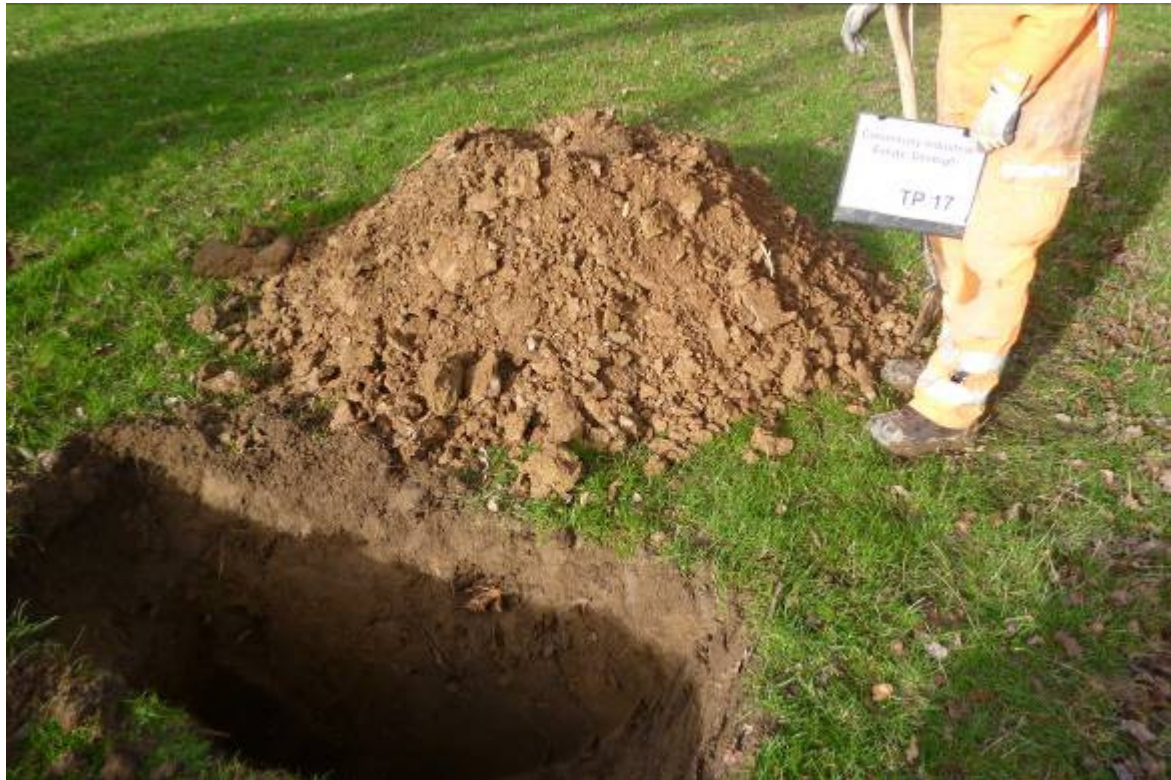
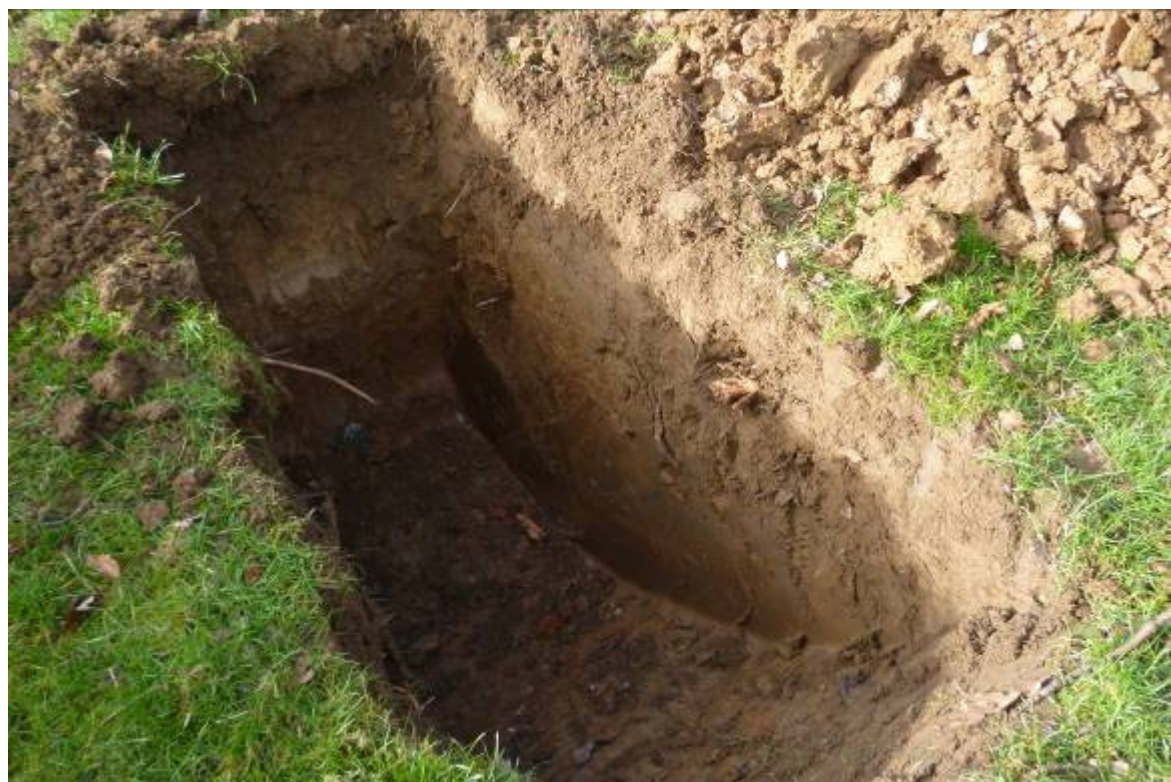
Project: Colomendy Industrial Estate Depot, Denbigh	Trial Pit: TP17
Excavation date: 24 th & 25 th Jan 2019	Logged by: APJ	Client: Cyngor Sir Ddinbych	Project ID: 1639
Strata:			
Depth (m)		Description	Samples
From	To		
0	0.18	Turf over topsoil	HSV: 0.4m; 104-110kPa 0.5m; 160-170kPa 0.8m; >180kPa

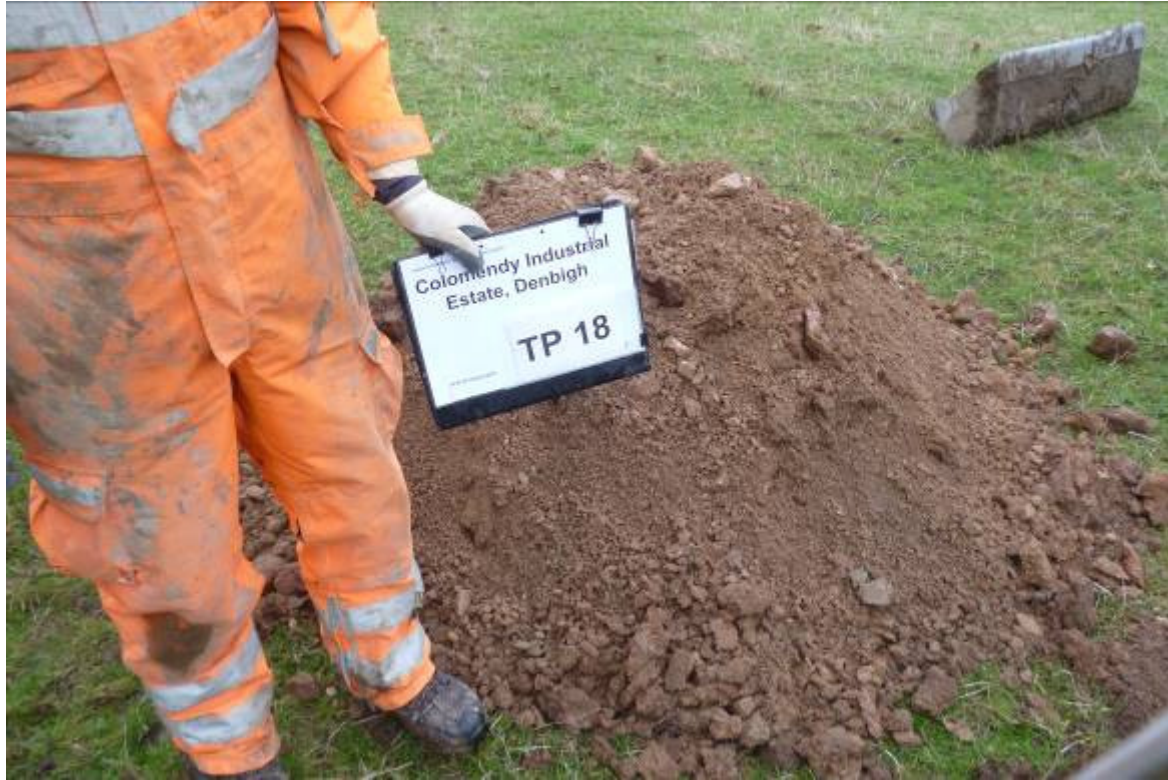
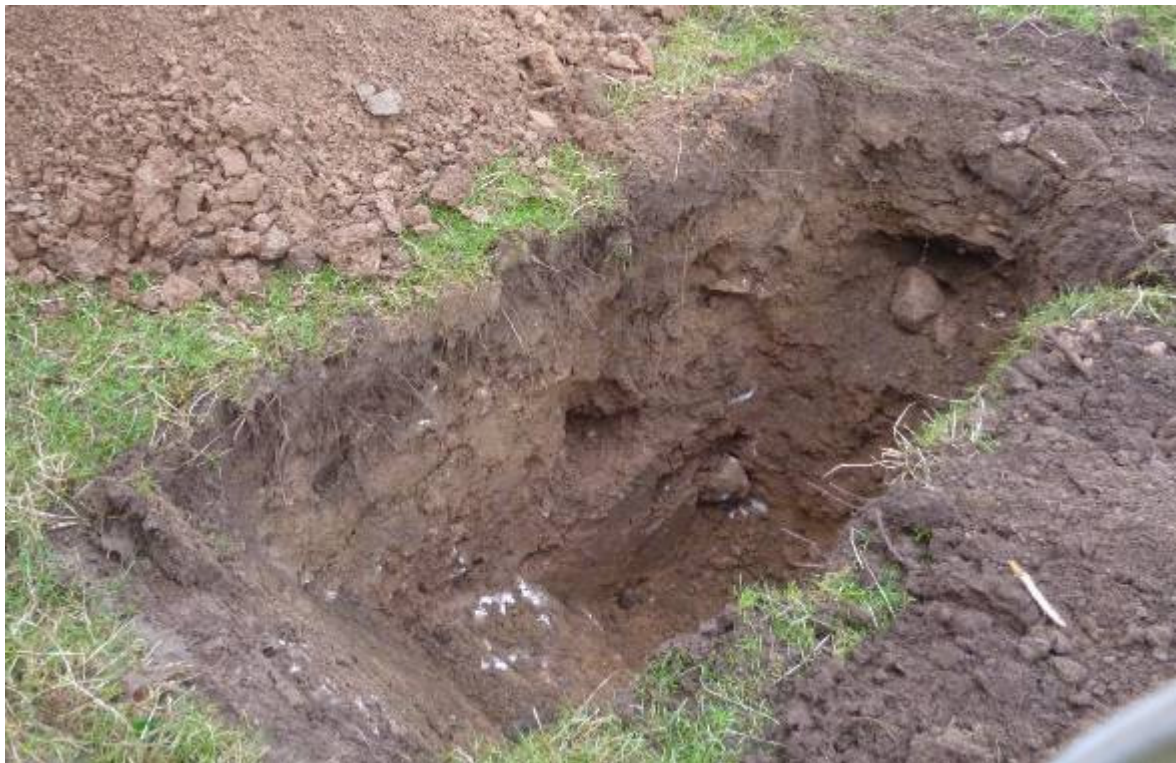
Project: Colomendy Industrial Estate Depot, Denbigh	Trial Pit: TP18
Excavation date: 24 th & 25 th Jan 2019	Logged by: APJ	Client: Cyngor Sir Ddinbych	Project ID: 1639
Strata:			
Depth (m)		Description	Samples
From	To		
0	0.05	Turf over topsoil	Tub – 0.05-0.1

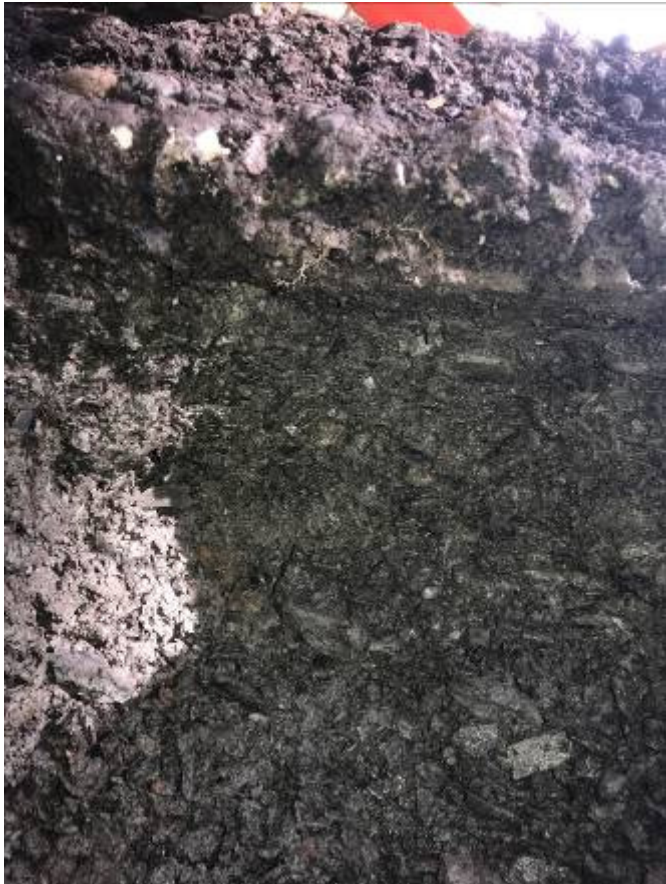
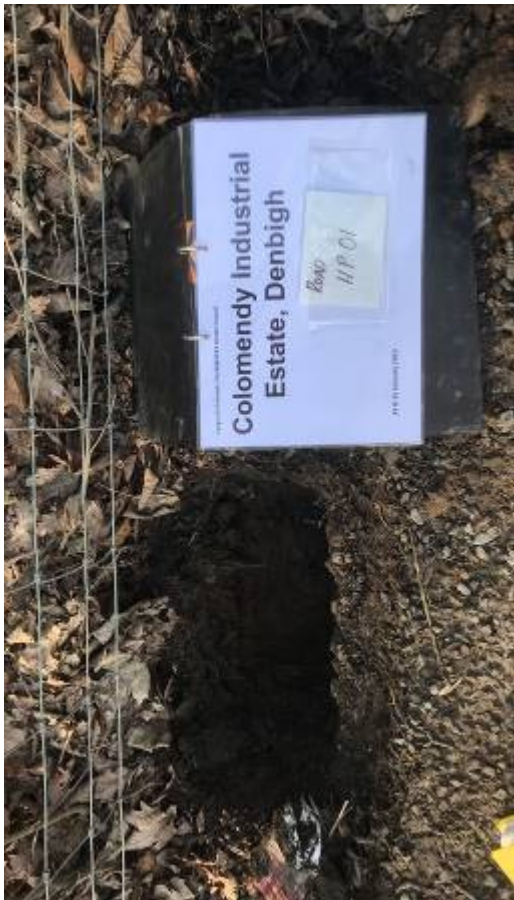
Project: Colomendy Industrial Estate Depot, Denbigh	Hand Pit: HP01
Excavation date: 21 st Feb 2019	Logged by: APJ	Client: Cyngor Sir Ddinbych	Project ID: 1639
Strata:			
Depth (m)		Description	Samples/Tests
From	To		
		Excavated adjacent to edge of carriageway	
0	0.15	Tarmac, upper layer c.80mm	
0.15	0.38	Slightly silty sandy GRAVEL of slate (Sub-base/capping)	
0.38	0.46	Reddish brown sandy CLAY	
		CBR Probe HP01 carried out from 0.46m	CBR >11%
Photographs			
<div style="display: flex; justify-content: space-around;">

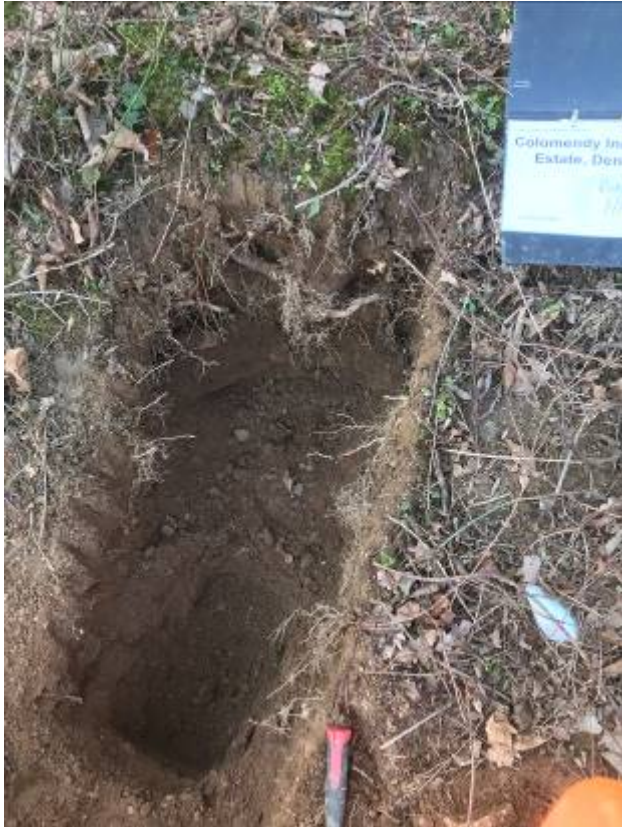
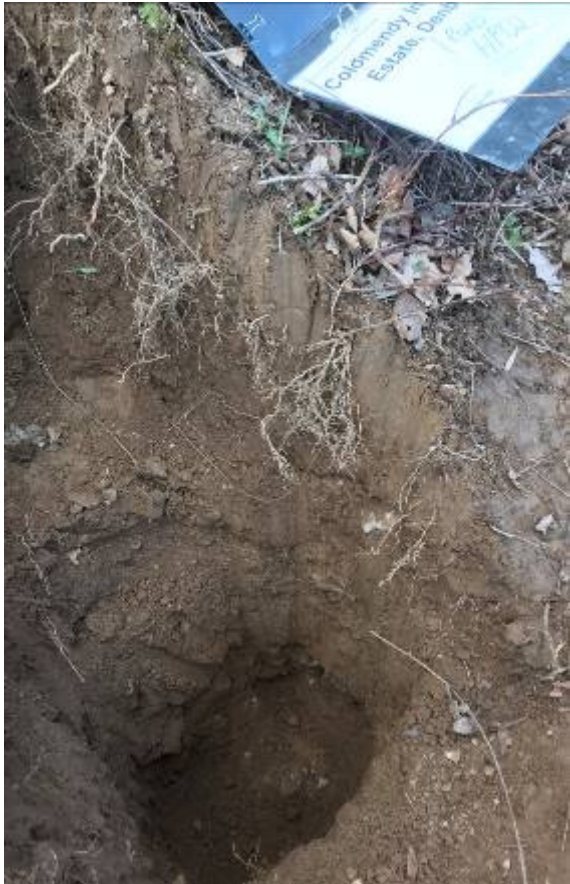
Project: Colomendy Industrial Estate Depot, Denbigh	Hand Pit: HP02
Excavation date: 21 st Feb 2019	Logged by: APJ	Client: Cyngor Sir Ddinbych	Project ID: 1639
Strata:			
Depth (m)		Description	Samples
From	To		
0	0.7	Excavated into 1.1m high, 35° cut slope adjacent to road. All Dims measured from top of cut slope Moss and sparse grass cover on surface Loose to medium dense, slightly gravelly, clayey/silty SAND	Bulk; 0.7-0.9m
0.7	1.2	Medium dense, slightly silty gravelly SAND	
1.2	1.55	Very clayey silty SAND grading into firm to stiff sandy silty CLAY Terminated on boulder CBR Probe HP02 carried out from 0.8m	
Photographs			
<div style="display: flex; justify-content: space-around;">

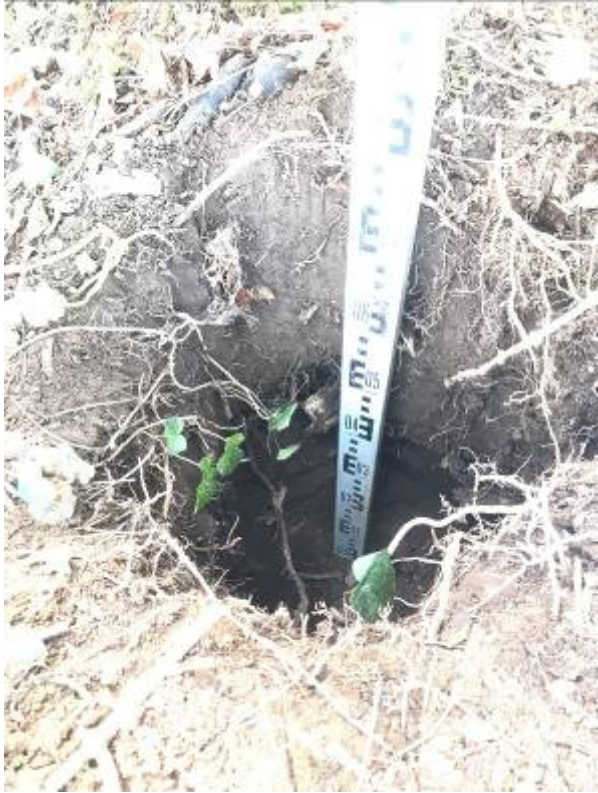
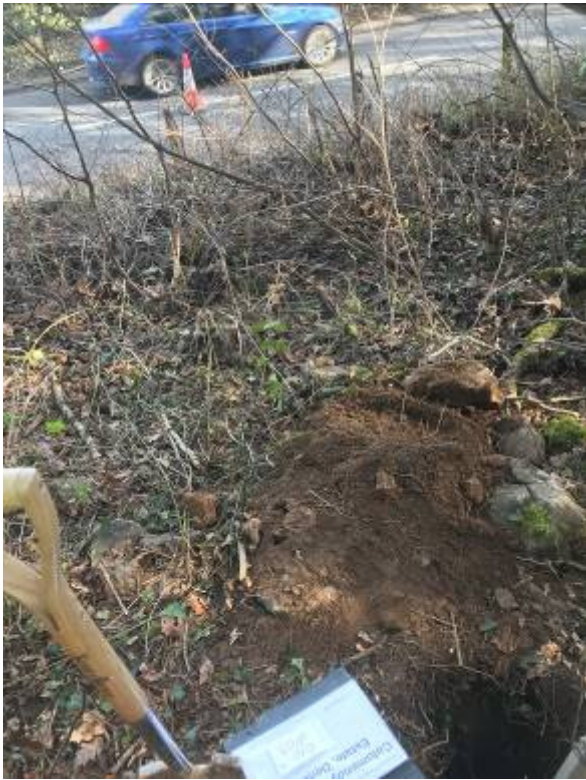
Project: Colomendy Industrial Estate Depot, Denbigh	Hand Pit: HP03
Excavation date: 21 st Feb 2019	Logged by: APJ	Client: Cyngor Sir Ddinbych	Project ID: 1639
Strata:			
Depth (m)		Description	Samples
From	To		
0 0.45	0.45 0.85	Positioned 6m from edge of road. Dark Brown Topsoil with numerous roots Loose to medium dense, light brown clayey, silty, gravelly to very gravelly SAND Terminated on boulder of limestone CBR Probe carried out from ground level CBR HP3A -3D positioned around pit and confirmed obstruction as boulder not bedrock	Bulk; 0.5-0.8m
Photographs			
<div style="display: flex; justify-content: space-around;">

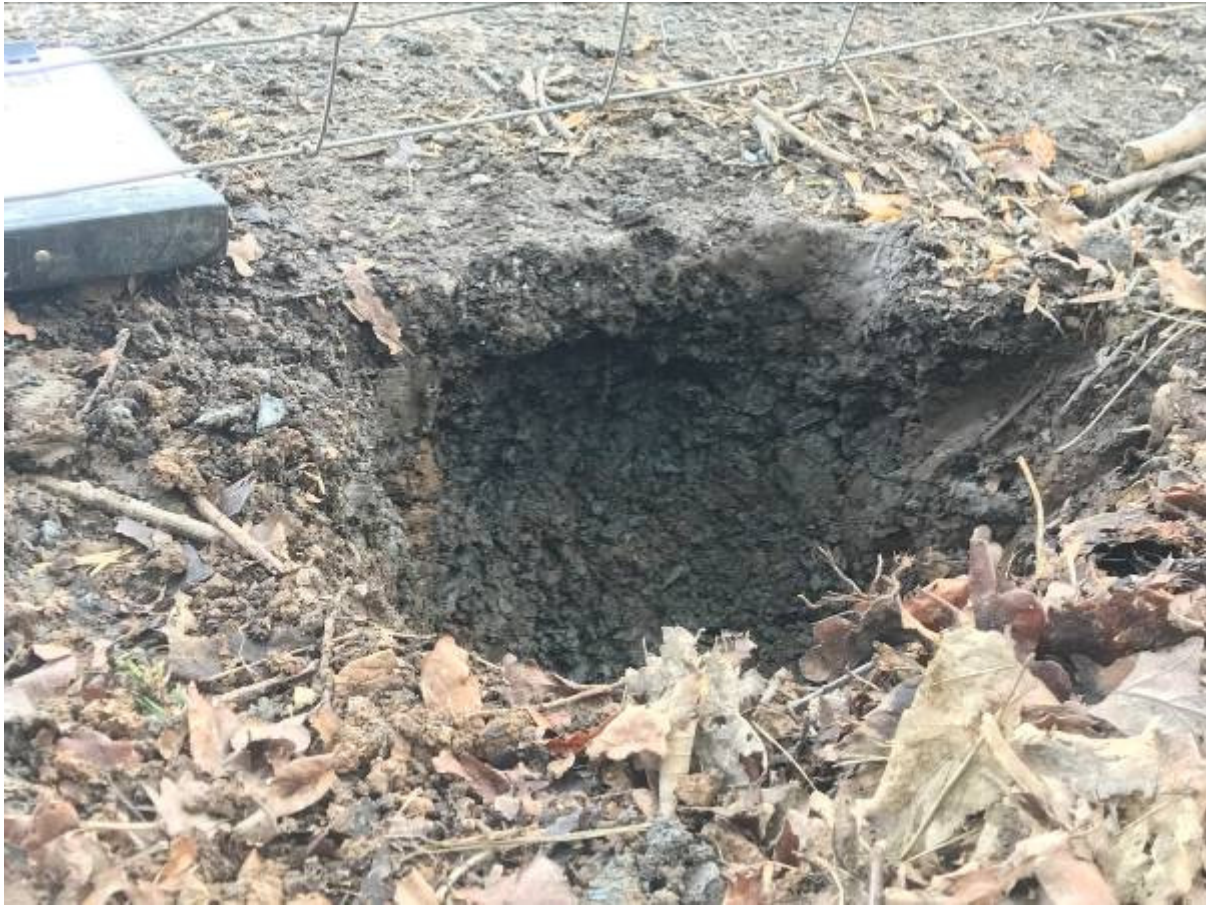
Project: Colomendy Industrial Estate Depot, Denbigh	Hand Pit: HP04
Excavation date: 21 st Feb 2019	Logged by: APJ	Client: Cyngor Sir Ddinbych	Project ID: 1639
Strata:			
Depth (m)		Description	Samples/Tests
From	To		
		Excavated adjacent to edge of carriageway	
0	0.08	Tarmac	
0.08	0.26	Slightly silty sandy GRAVEL of slate (Sub-base / capping)	
0.26	0.35	Reddish brown clayey, very sandy GRAVEL	
		CBR Probe HP04 carried out from 0.35	CBR 3% to 0.85m >15% below 0.85m
Photographs

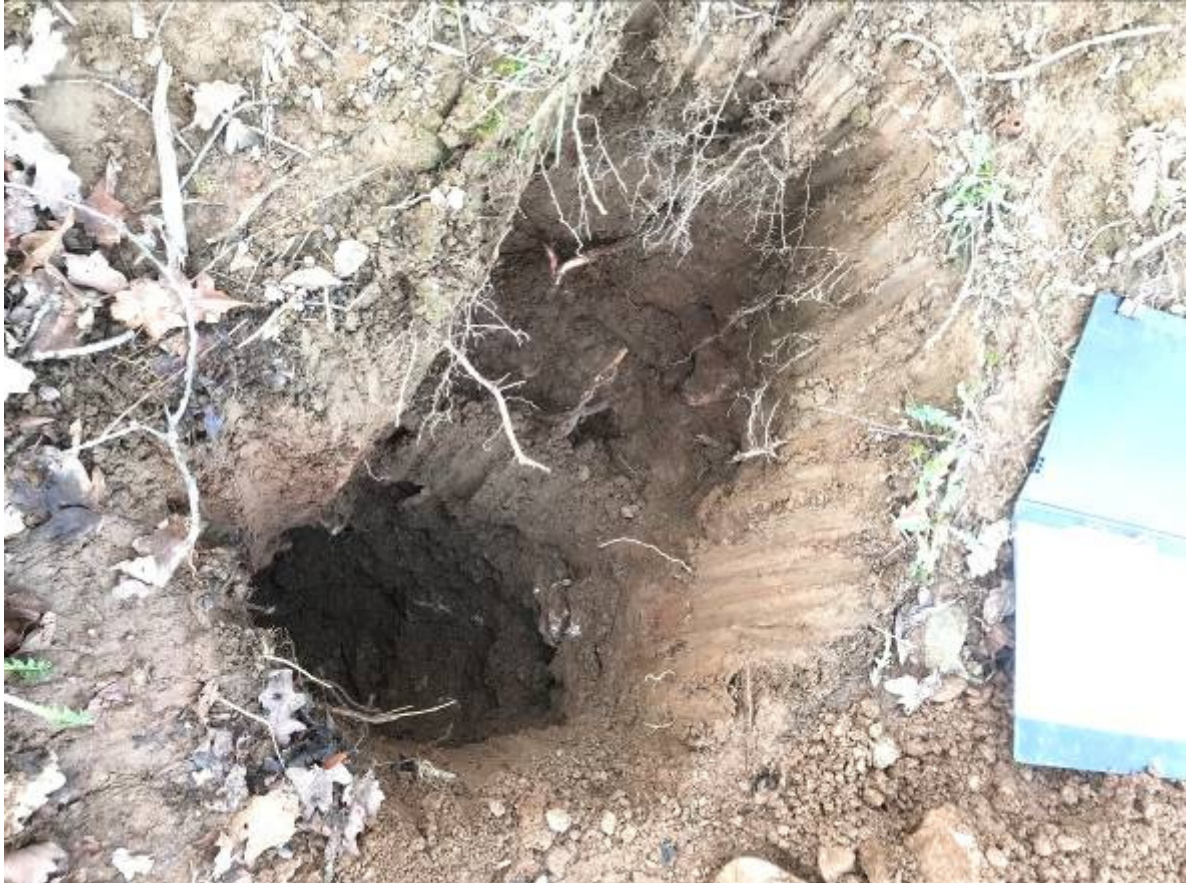
Project: Colomendy Industrial Estate Depot, Denbigh	Hand Pit: HP05
Excavation date: 21 st Feb 2019	Logged by: APJ	Client: Cyngor Sir Ddinbych	Project ID: 1639
Strata:			
Depth (m)		Description	Samples/tests
From	To		
0	1.2	Excavated into 1.1m high, 36-38° cut slope adjacent to road. All Dims from top of cut slope Moss and sparse grass cover on surface Loose to medium dense, light brown clayey, silty slightly gravelly SAND, grading into sandy CLAY	
1.2	1.6	Slightly silty very gravelly SAND	
1.6	1.8	Grey mottled orange slightly sandy CLAY (possible completely weathered limestone). CBR Probe (CBRHP05) carried out from 1.1m	CBR >10%
Photographs

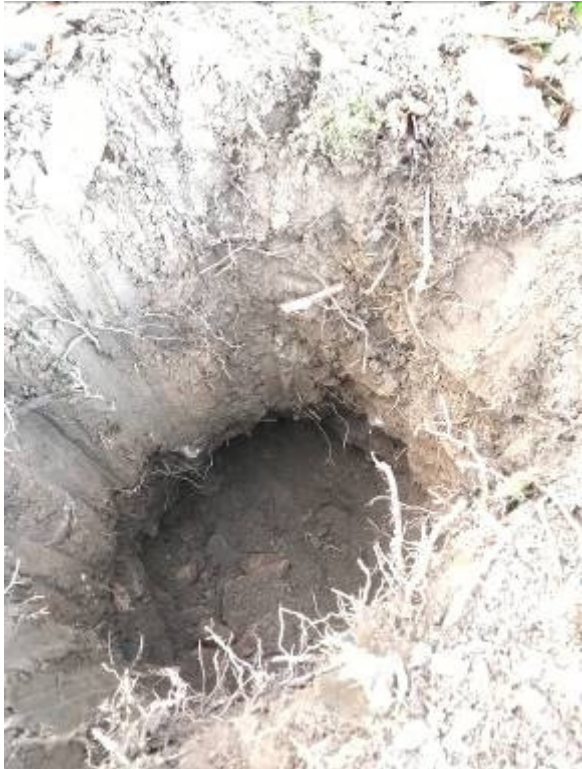
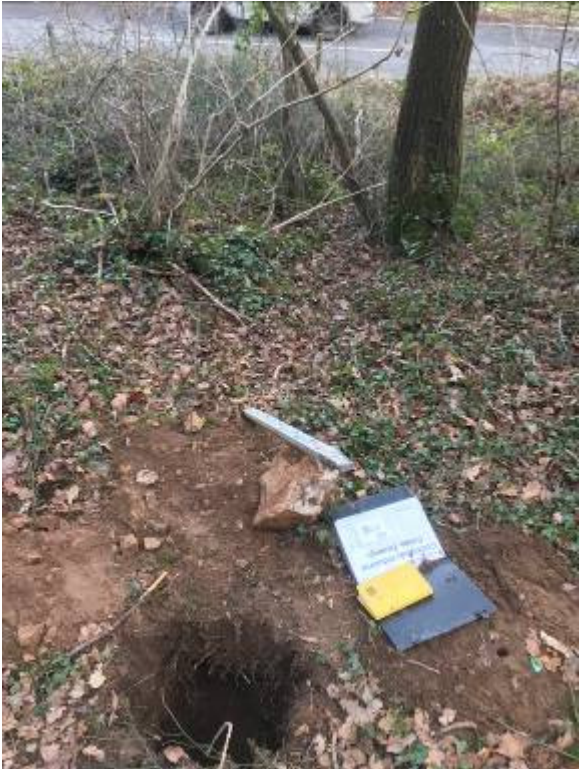
Project: Colomendy Industrial Estate Depot, Denbigh	Hand Pit: HP06
Excavation date: 21 st Feb 2019	Logged by: APJ	Client: Cyngor Sir Ddinbych	Project ID: 1639
Strata:			
Depth (m)		Description	Samples
From	To		
0 0.3 0.5	0.3 0.5 0.9	Positioned 10.5m from edge of road. Dark Brown Topsoil with numerous roots Loose to medium dense, light brown slightly clayey/silty SAND & GRAVEL with occasional sub rounded to sub-angular cobbles and boulders (<300mm) of mixed lithologies. Terminated on boulder/possible bedrock, CBR probe could not be driven past 0.9m CBR Probe HP06a – 6c carried out from ground level adjacent to pit	CBR 0-0.6m – 2-10% >0.6m - >10%
Photographs:			
<div style="display: flex; justify-content: space-around;">

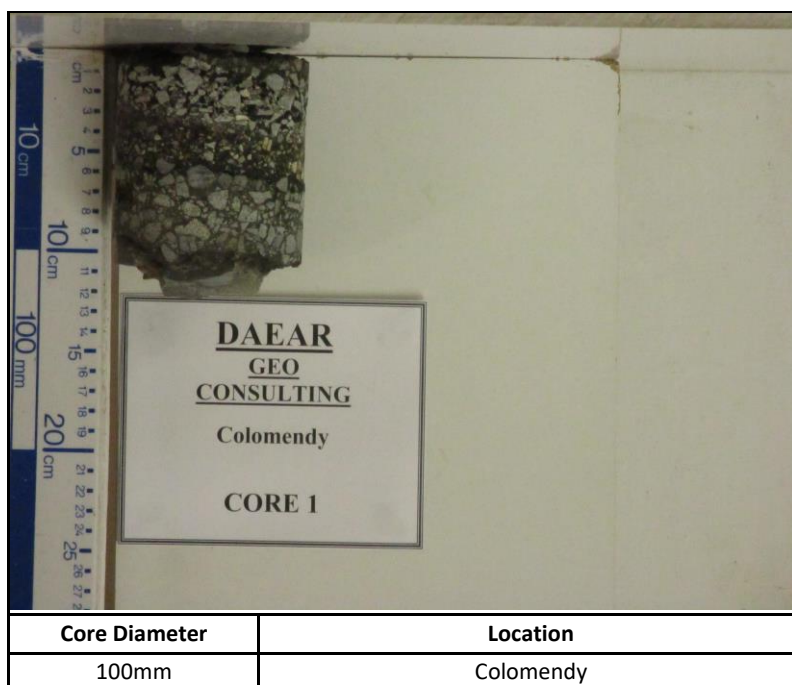
3.1 Core No.1

Core Depth (mm)	Layer Thickness (mm)	Assumed Material	Nominal Size	Comments	Category	Tar Level
0-7	7	Thin Surface Course	6		Category 3	Category B
7-40	33	Regulating or Surface Course	10		Category 4	Category D
40-60	20	Regulating or Surface Course	6		Category 3	Category D
60-101	41	Regulating or Surface Course	10		Category 3	Category E
101-111	10	Base Course	32		Category 5	Category E

The cores recovered from Ffordd y Graig Road were sprayed with PAK marked and observed under UV light. The results are not conclusive in relation to Coal Tar content; the near surface layers had faint markings suggesting bituminous based binder, however deeper layers had increased indicators suggesting higher concentrations of Coal Tar.
