Colomendy Industrial Estate Depot
Geotechnical Report
Cyngor Sir Ddinbych

Report Date – March 2019
Report Revision – V. 01

Denbighshire County Council / Cyngor Sir Ddinbych (DCC) propose to construct a new depot on undeveloped land adjacent to the Colomendy Industrial Estate in Denbigh.

Daeare GeoConsulting (Daeare) has been appointed to carry out a preliminary geotechnical ground investigation and interpretative report for the proposed development.

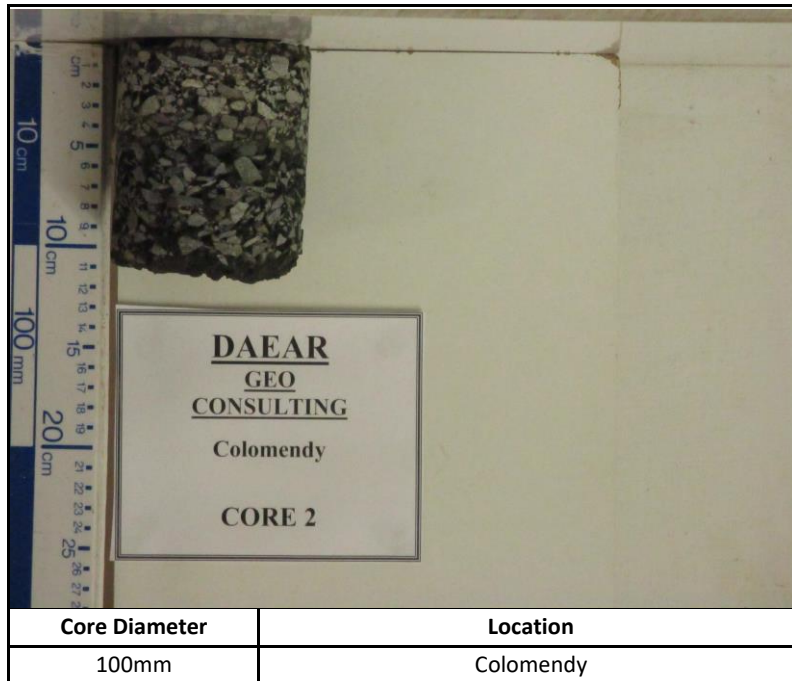
3.2 Core No.2

Core Depth (mm)	Layer Thickness (mm)	Assumed Material	Nominal Size	Comments	Category	Tar Level
0-9	9	Thin Surface Course	6		Category 3	Category B
9-43	34	Regulating or Surface Course	10		Category 4	Category B
43-106	63	Regulating or Surface Course	10		Category 4	Category C

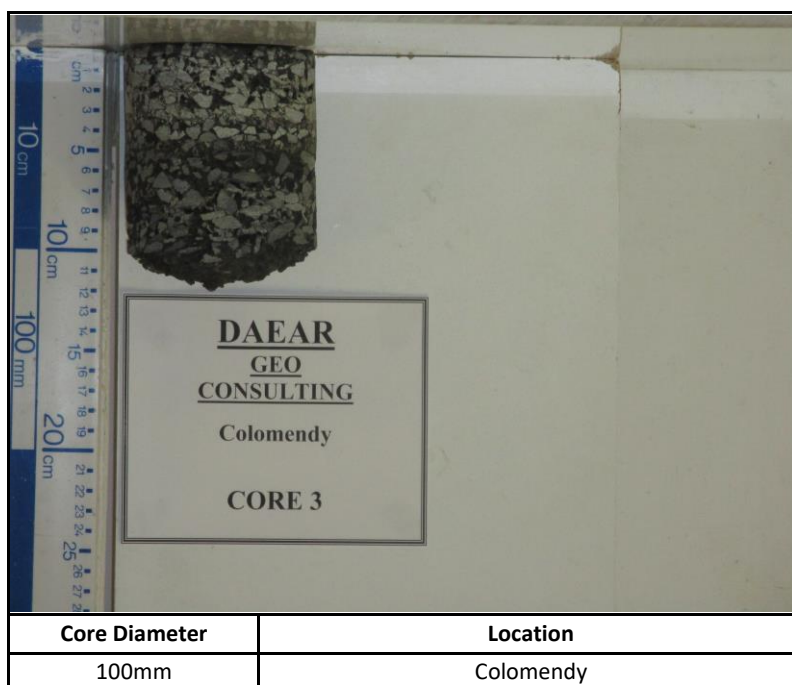
3.3 Core No.3

Core Depth (mm)	Layer Thickness (mm)	Assumed Material	Nominal Size	Comments	Category	Tar Level
0-5	5	Thin Surface Course	6		Category 3	Category B
5-42	37	Regulating or Surface Course	10		Category 4	Category C
42-53	11	Regulating or Surface Course	10		Category 3	Category C
53-100	47	Regulating or Surface Course	10		Category 4	Category C

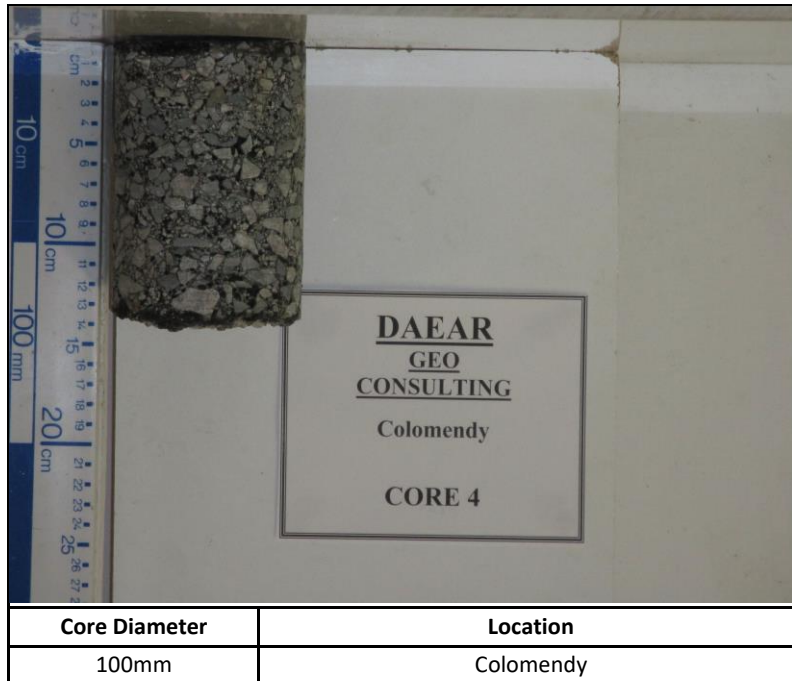
3.4 Core No.4

Core Depth (mm)	Layer Thickness (mm)	Assumed Material	Nominal Size	Comments	Category	Tar Level
0-6	6	Thin Surface Course	6		Category 3	Category C
6-53	47	Regulating or Surface Course	10		Category 3	Category C
53-136	83	Binder Course	20		Category 3	Category C

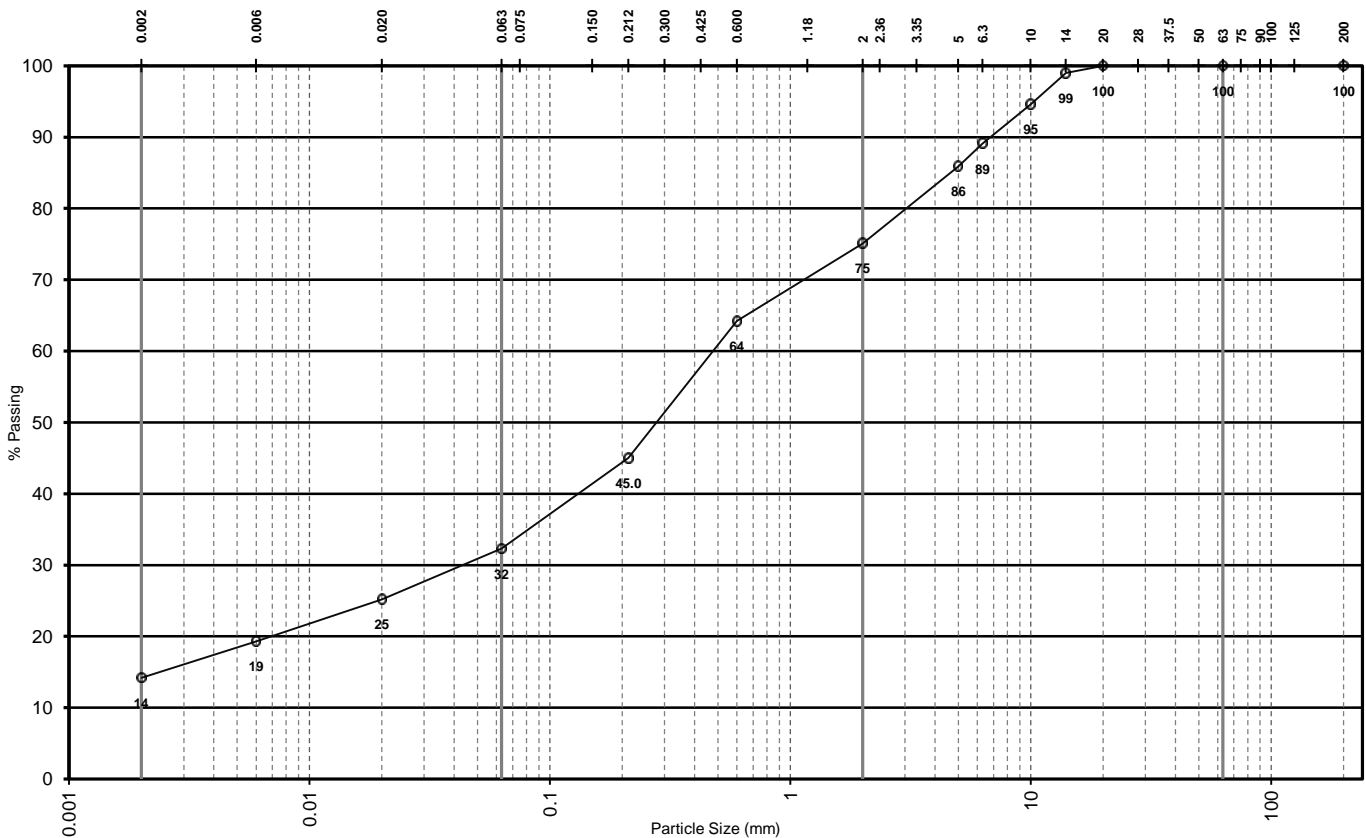
Method of pre-treatment:		N/A			
Sieve Size mm	% Passing	Sieve Size mm	% Passing	Cobbles	0.0
				Gravel	24.9
				Sand	42.8
200	100	3.35		Silt	18.1
125		2.36		Clay	14.2
100		2.0	75		
90		1.18			
75		0.600	64		
63	100	0.425			
50		0.300			
37.5		0.212	45		
28		0.150			
20	100	0.075			
14	99	0.063	32.3		
10	95	0.020	25.2		
6.3	89	0.006	19.3		
5.0	86	0.002	14.2

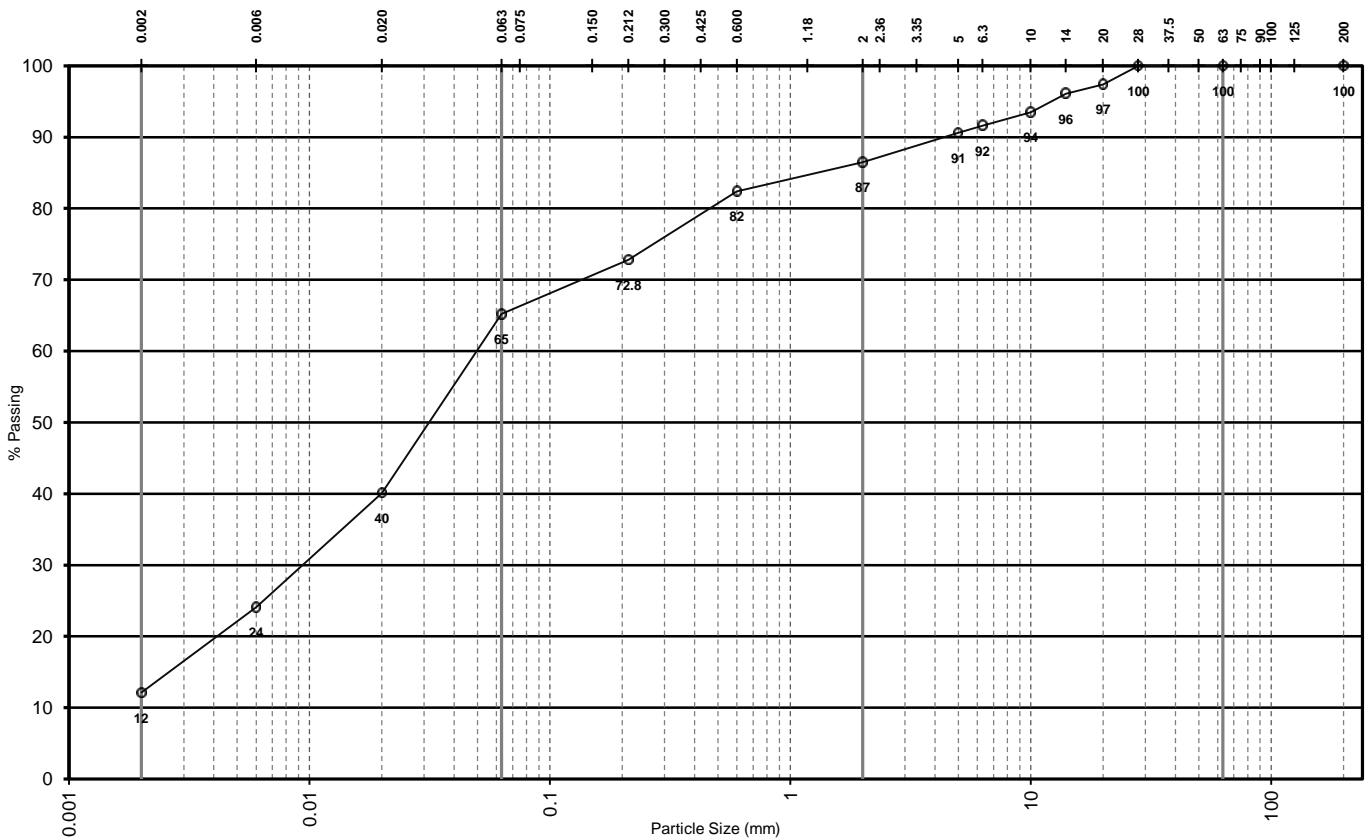
Method of pre-treatment:		N/A			
Sieve Size mm	% Passing	Sieve Size mm	% Passing	Cobbles	0.0
				Gravel	13.5
				Sand	21.3
200	100	3.35		Silt	53.1
125		2.36		Clay	12.1
100		2.0	87		
90		1.18			
75		0.600	82		
63	100	0.425			
50		0.300			
37.5		0.212	73		
28	100	0.150			
20	97	0.075			
14	96	0.063	65.2		
10	94	0.020	40.1		
6.3	92	0.006	24.1		
5.0	91	0.002	12.1

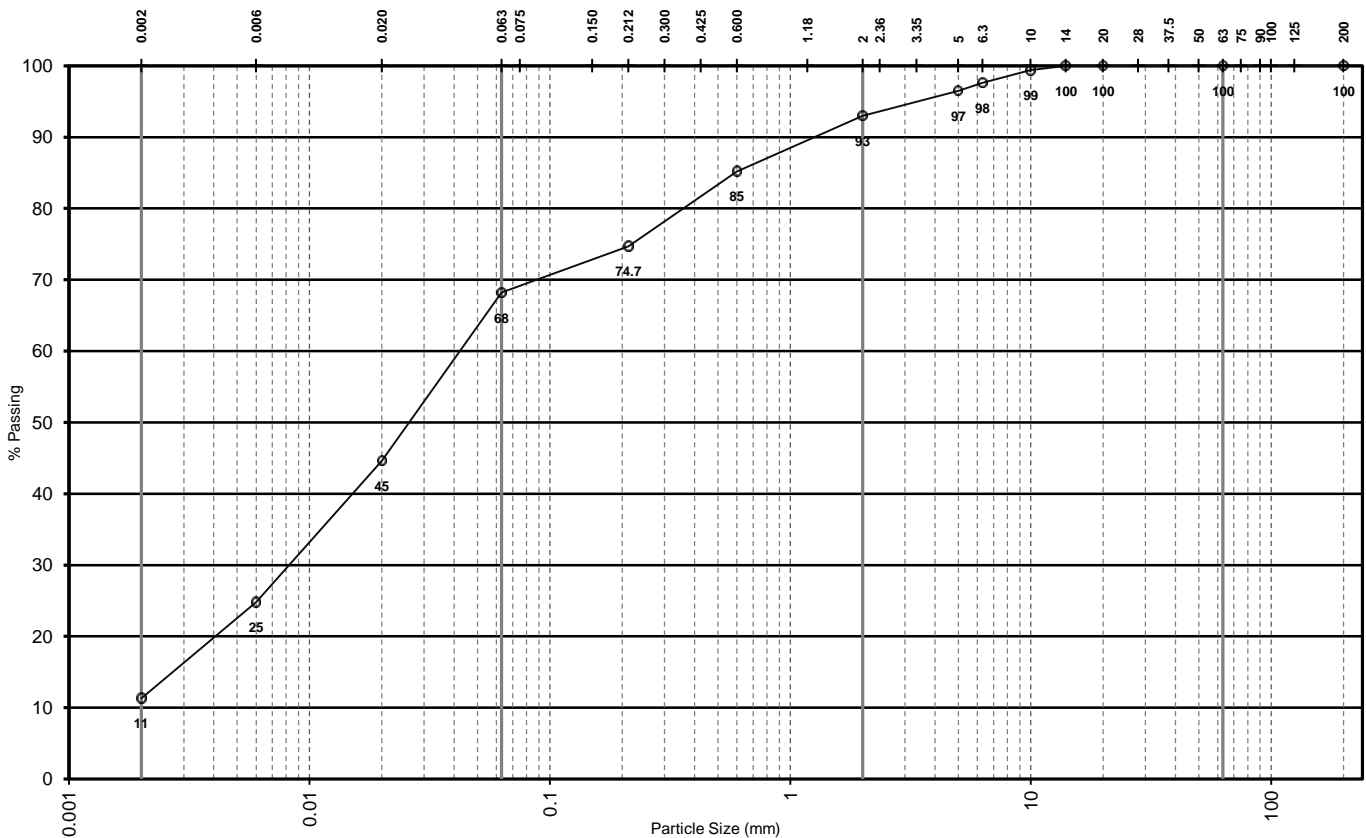
Method of pre-treatment:		N/A			
Sieve Size mm	% Passing	Sieve Size mm	% Passing	Cobbles	0.0
				Gravel	7.0
				Sand	24.8
				Silt	56.9
				Clay	11.3
200	100	3.35			
125		2.36			
100		2.0	93		
90		1.18			
75		0.600	85		
63	100	0.425			
50		0.300			
37.5		0.212	75		
28		0.150			
20	100	0.075			
14	100	0.063	68.2		
10	99	0.020	44.6		
6.3	98	0.006	24.8		
5.0	97	0.002	11.3

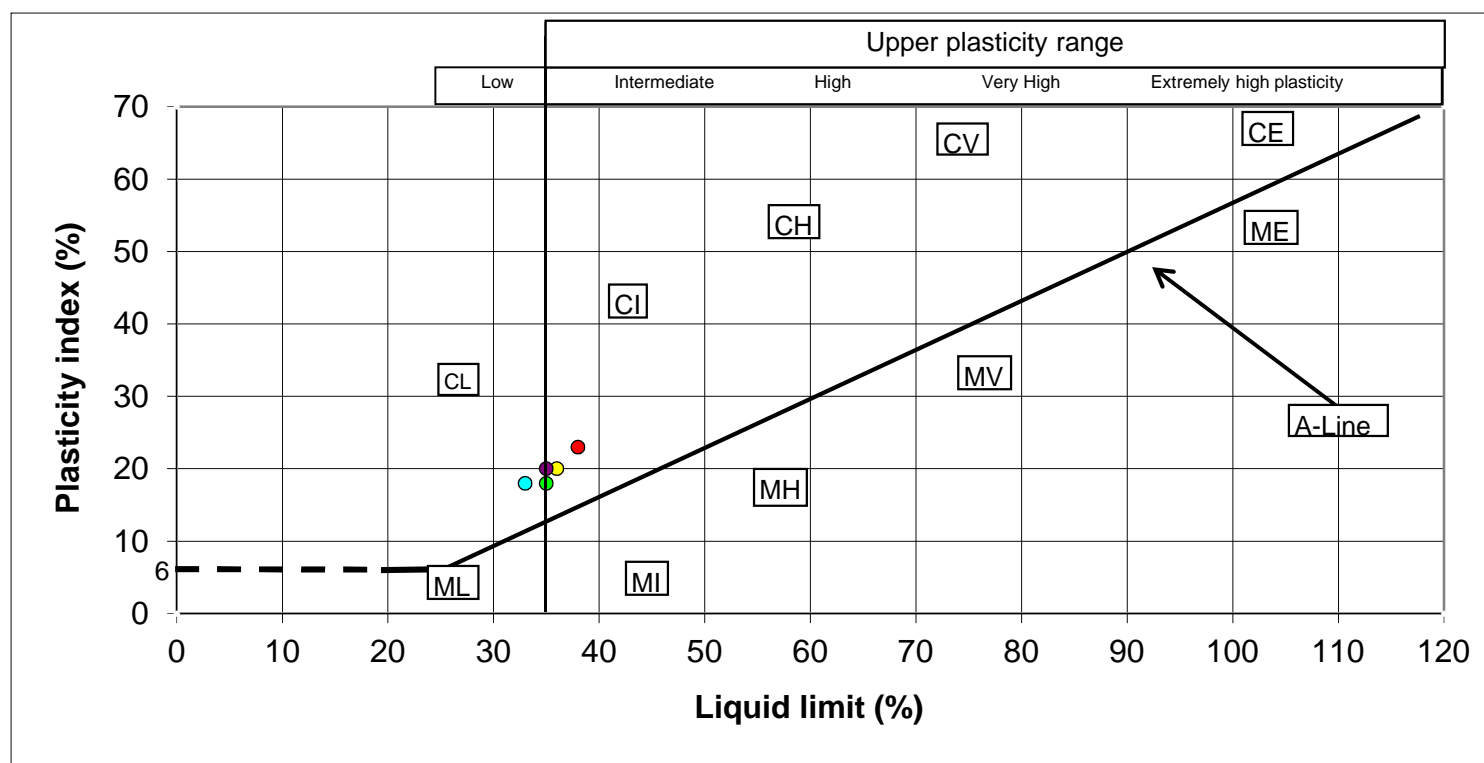
SILT (M-SOIL), M plots below A-Line , CLAY,C, plots above A-Line, M and C may be combined as FINE SOIL, F.

BH	Sample Depth	Liquid limit	Plasticity index
WS1	1.00	35.0	18.0
WS1	2.00	36.0	20.0
WS2	4.00	33.0	18.0
WS3	0.75	38.0	23.0
WS5	1.00	35.0	20.0

The Plastic Limit results are relatively consistent across the site, ranging between 15% and 22%, with the Liquid Limit ranging between 27% and 38%, resulting in Plasticity Index values of between 10% and 23%. The moisture content is generally above the Plastic Limit in the near surface soils (<1m or so) and at or slightly below the plastic limit below 1m depth, reflecting the increased variation in near surface soils compared to the deeper soils.

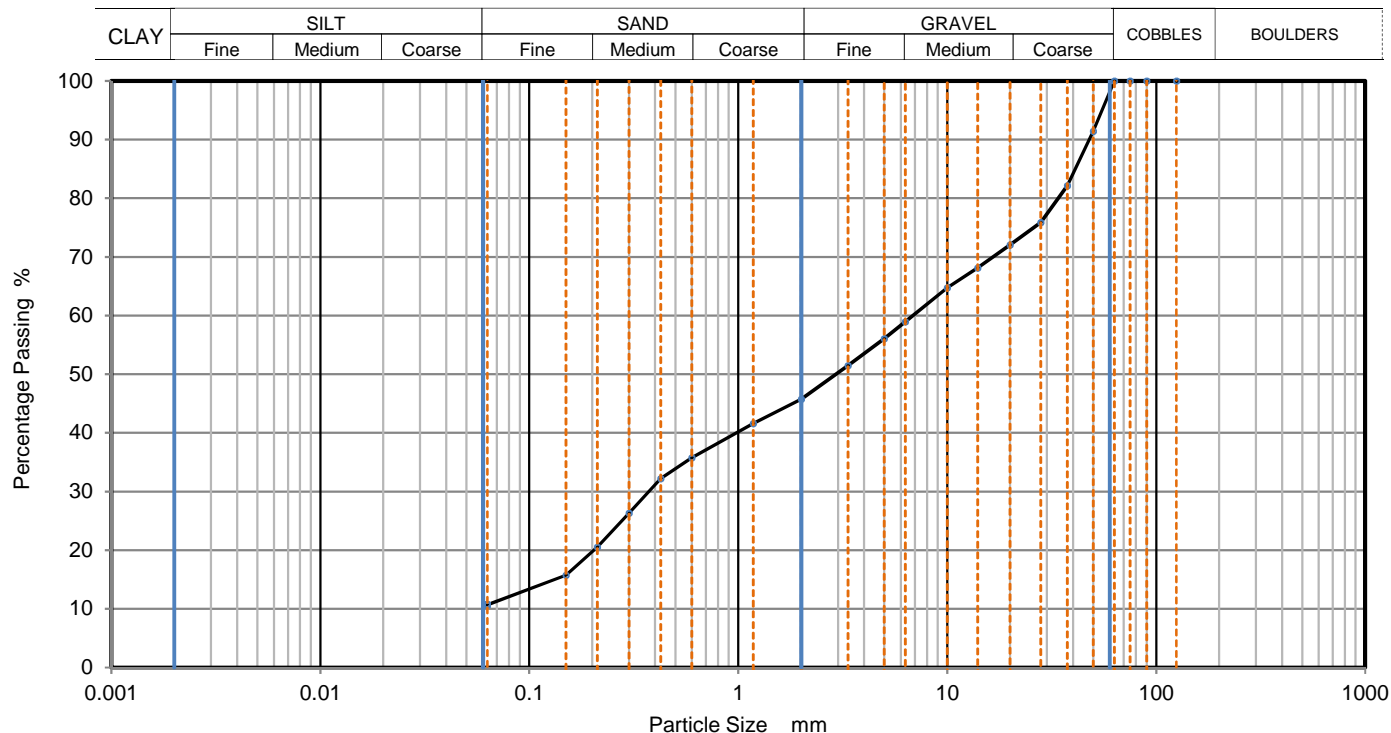
Sieving		Sedimentation	
Particle Size mm	% Passing	Particle Size mm	% Passing
125	100		
90	100		
75	100		
63	100		
50	91		
37.5	82		
28	76		
20	72		
14	68		
10	65		
6.3	59		
5	56		
3.35	51		
2	46		
1.18	42		
0.6	36		
0.425	32		
0.3	26		
0.212	21		
0.15	16		
0.063	11

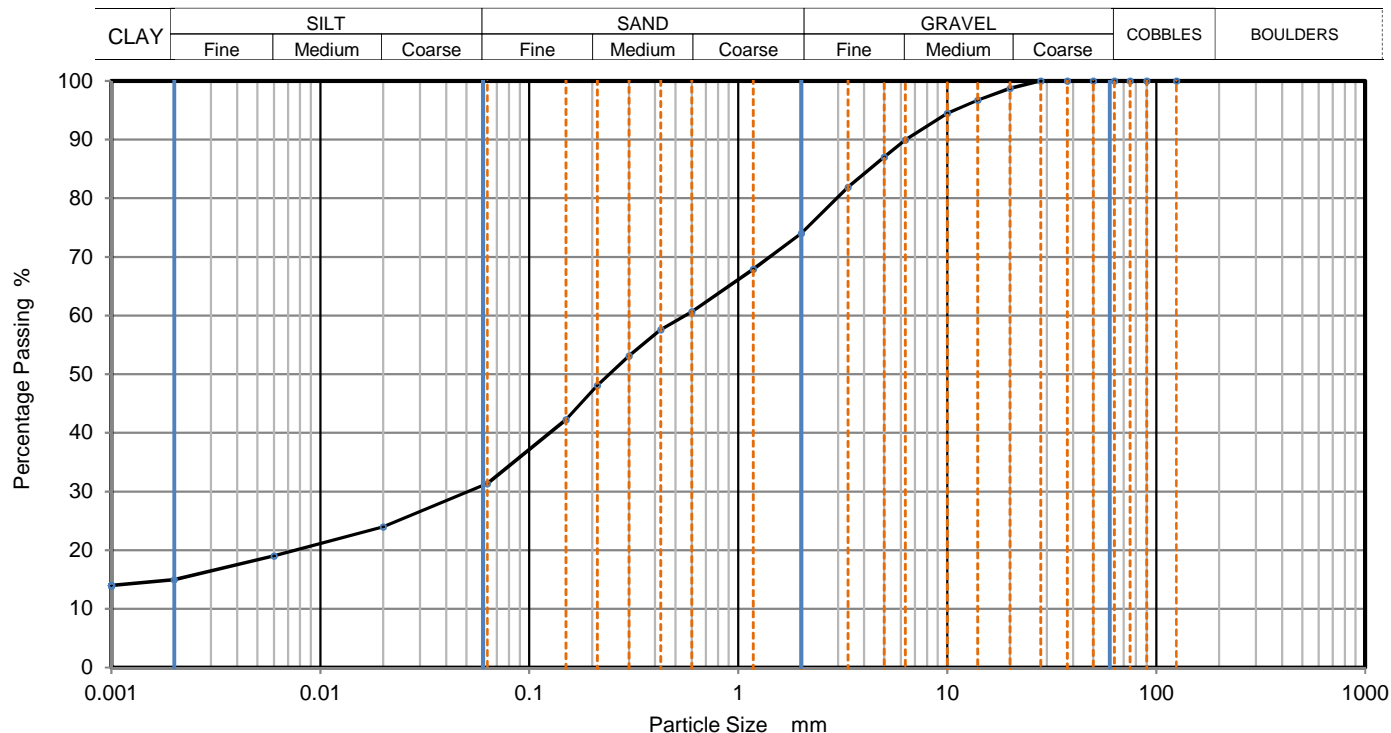
Sieving		Sedimentation	
Particle Size mm	% Passing	Particle Size mm	% Passing
125	100	0.0200	24
90	100	0.0060	19
75	100	0.0020	15
63	100	0.0010	14
50	100		
37.5	100		
28	100		
20	99		
14	97		
10	94		
6.3	90		
5	87		
3.35	82		
2	74		
1.18	68		
0.6	61		
0.425	58		
0.3	53		
0.212	48		
0.15	42		
0.063	31
