Appendices

Innovative Thinking - Sustainable Solutions

Appendix A. Comments Log

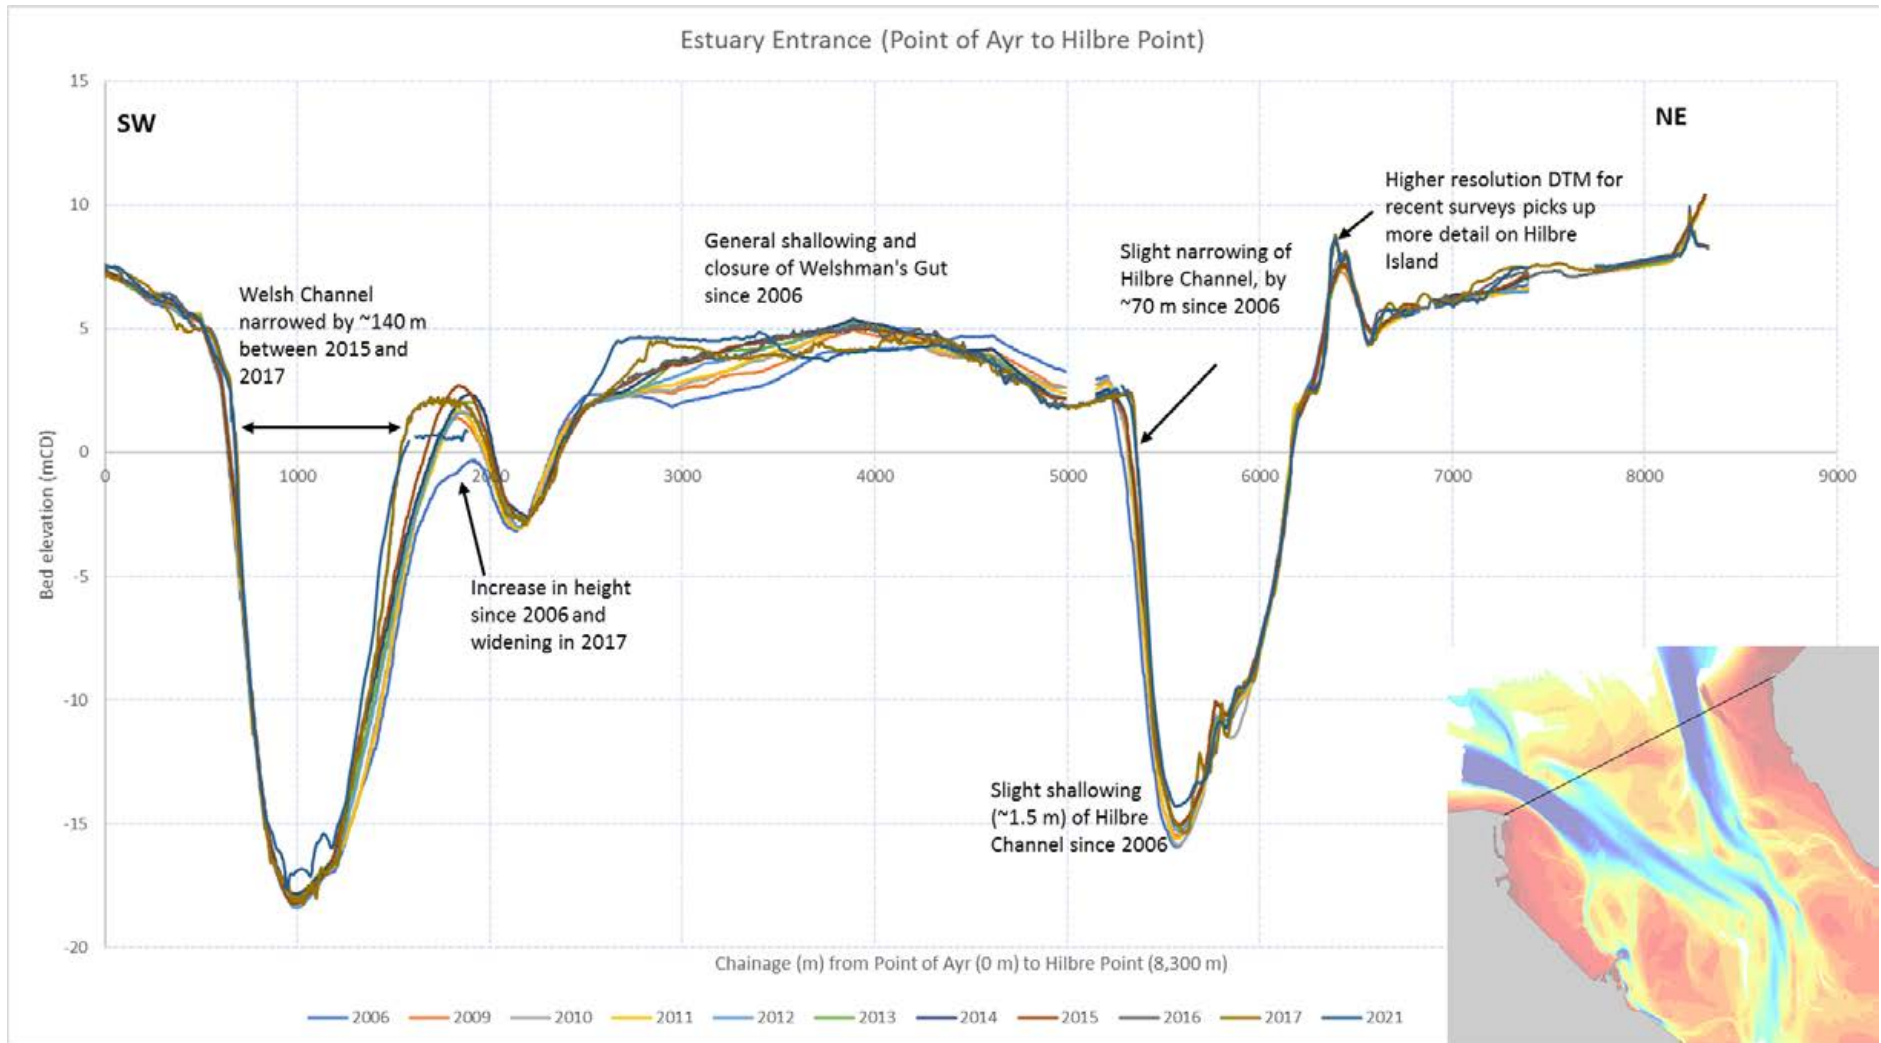
Figure 5. Temporal variation in bed elevation across profile at the mouth of the Dee Estuary

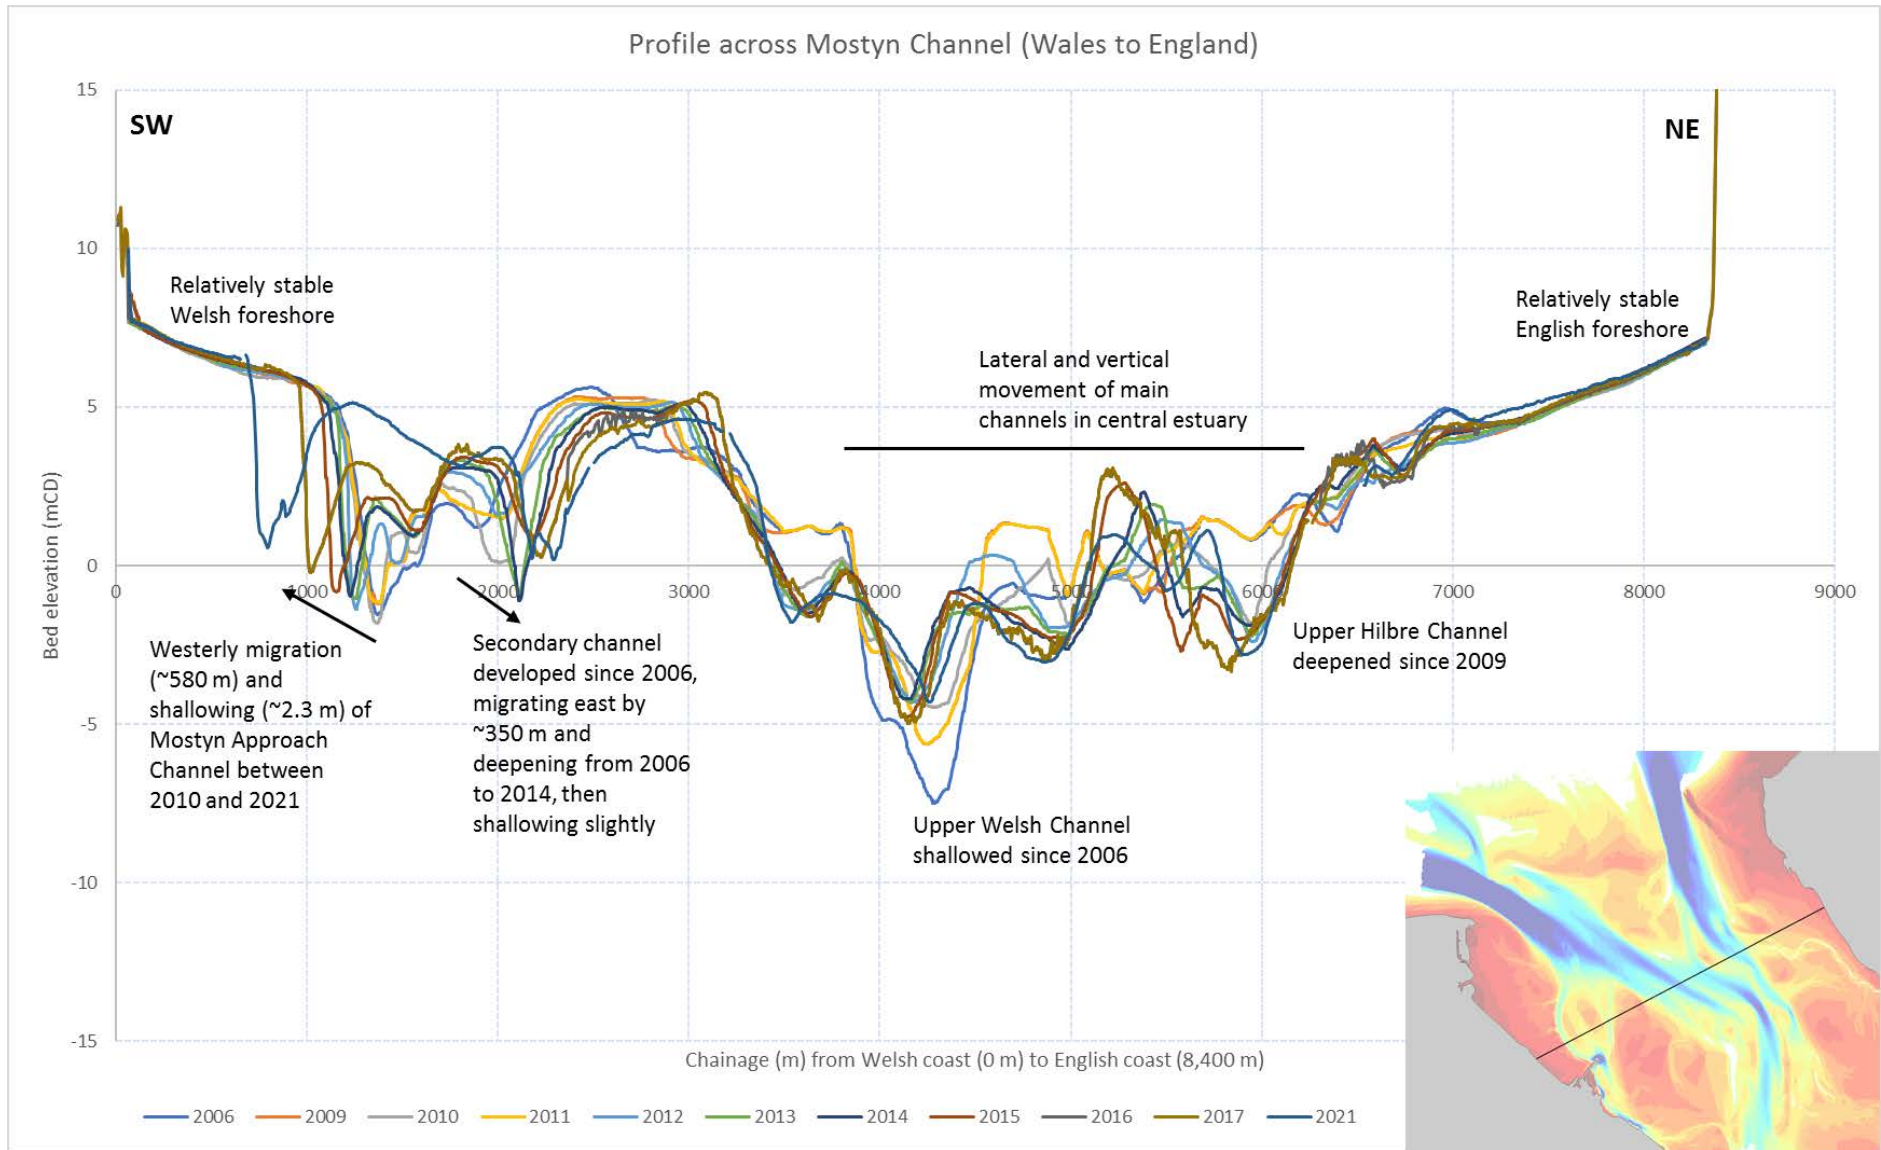
Figure 6. Temporal variation in bed elevation across profile down-estuary of the Port of Mostyn

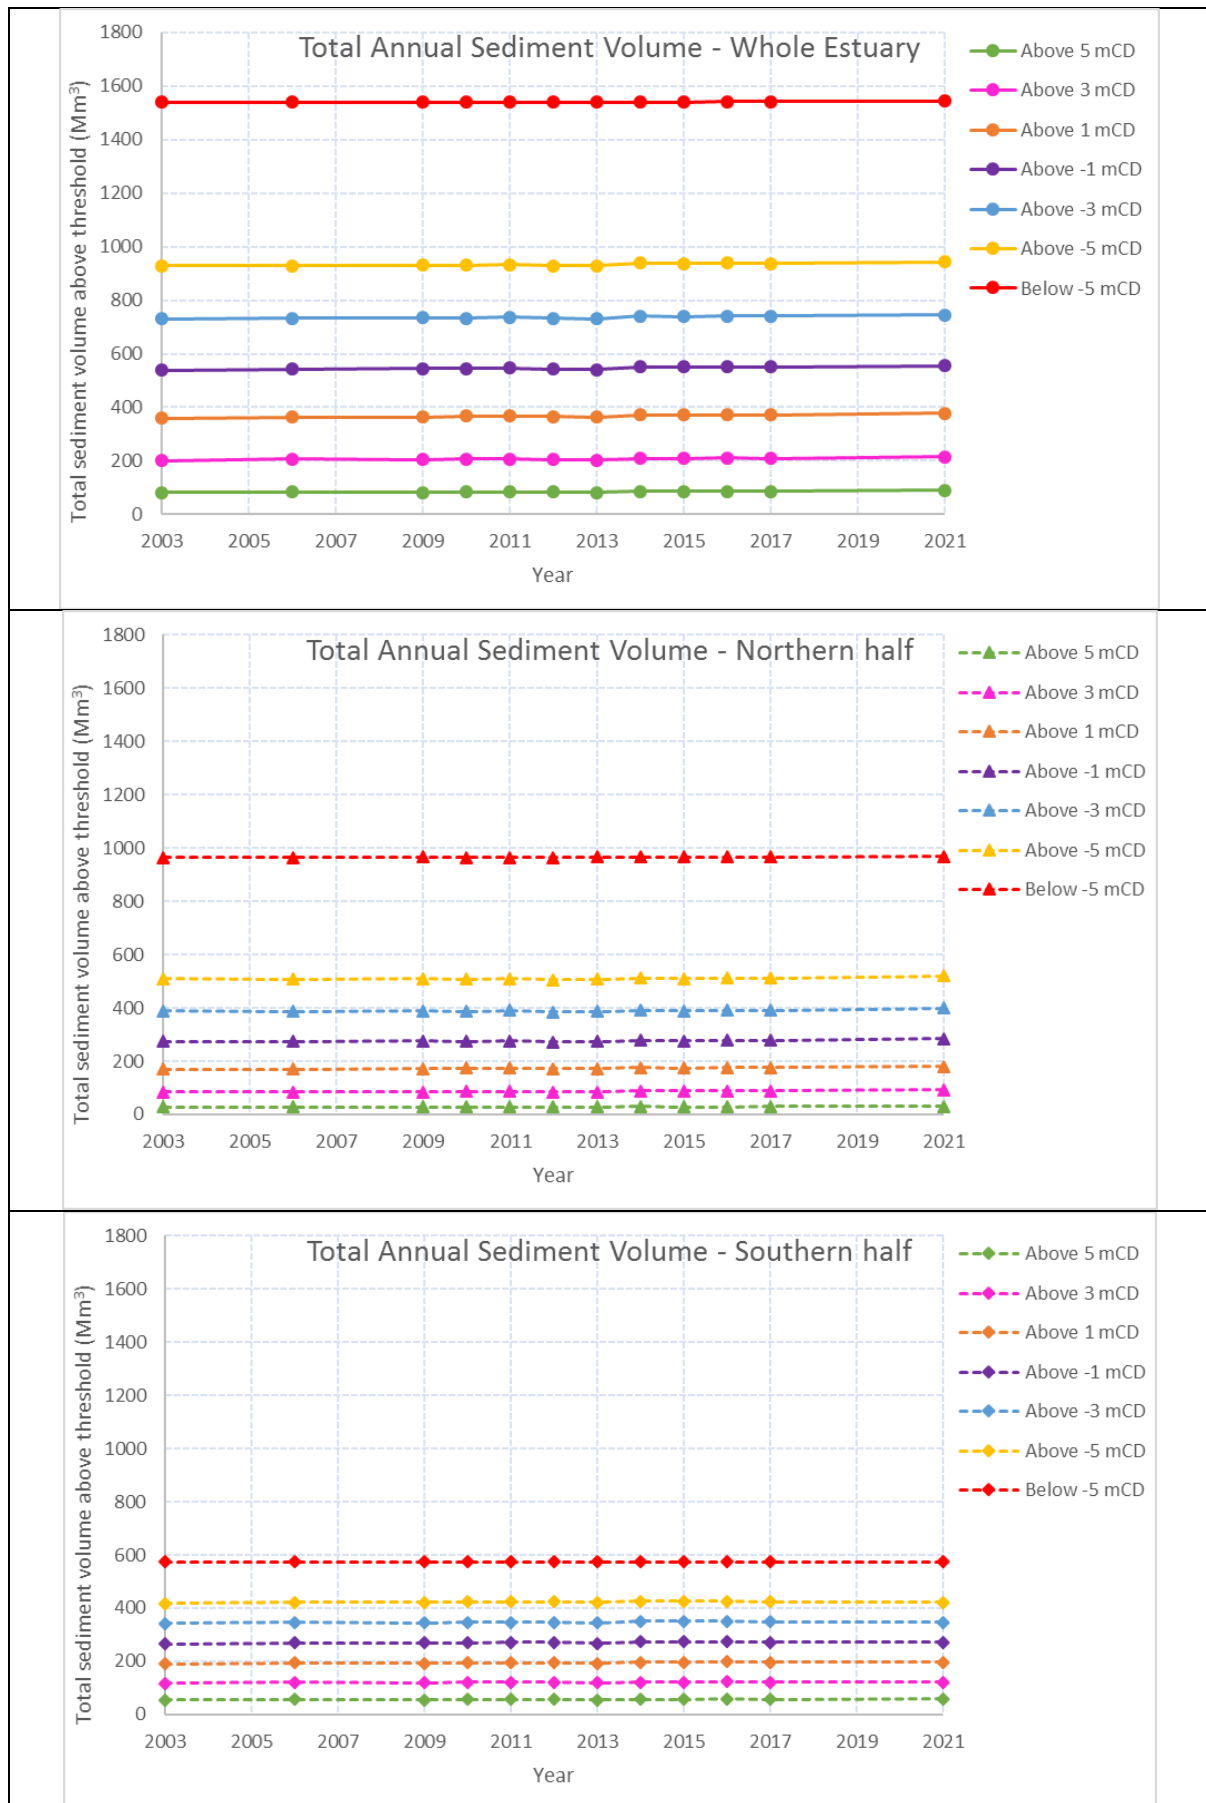
Figure 10. Total annual sediment volume above given thresholds for estuary sections

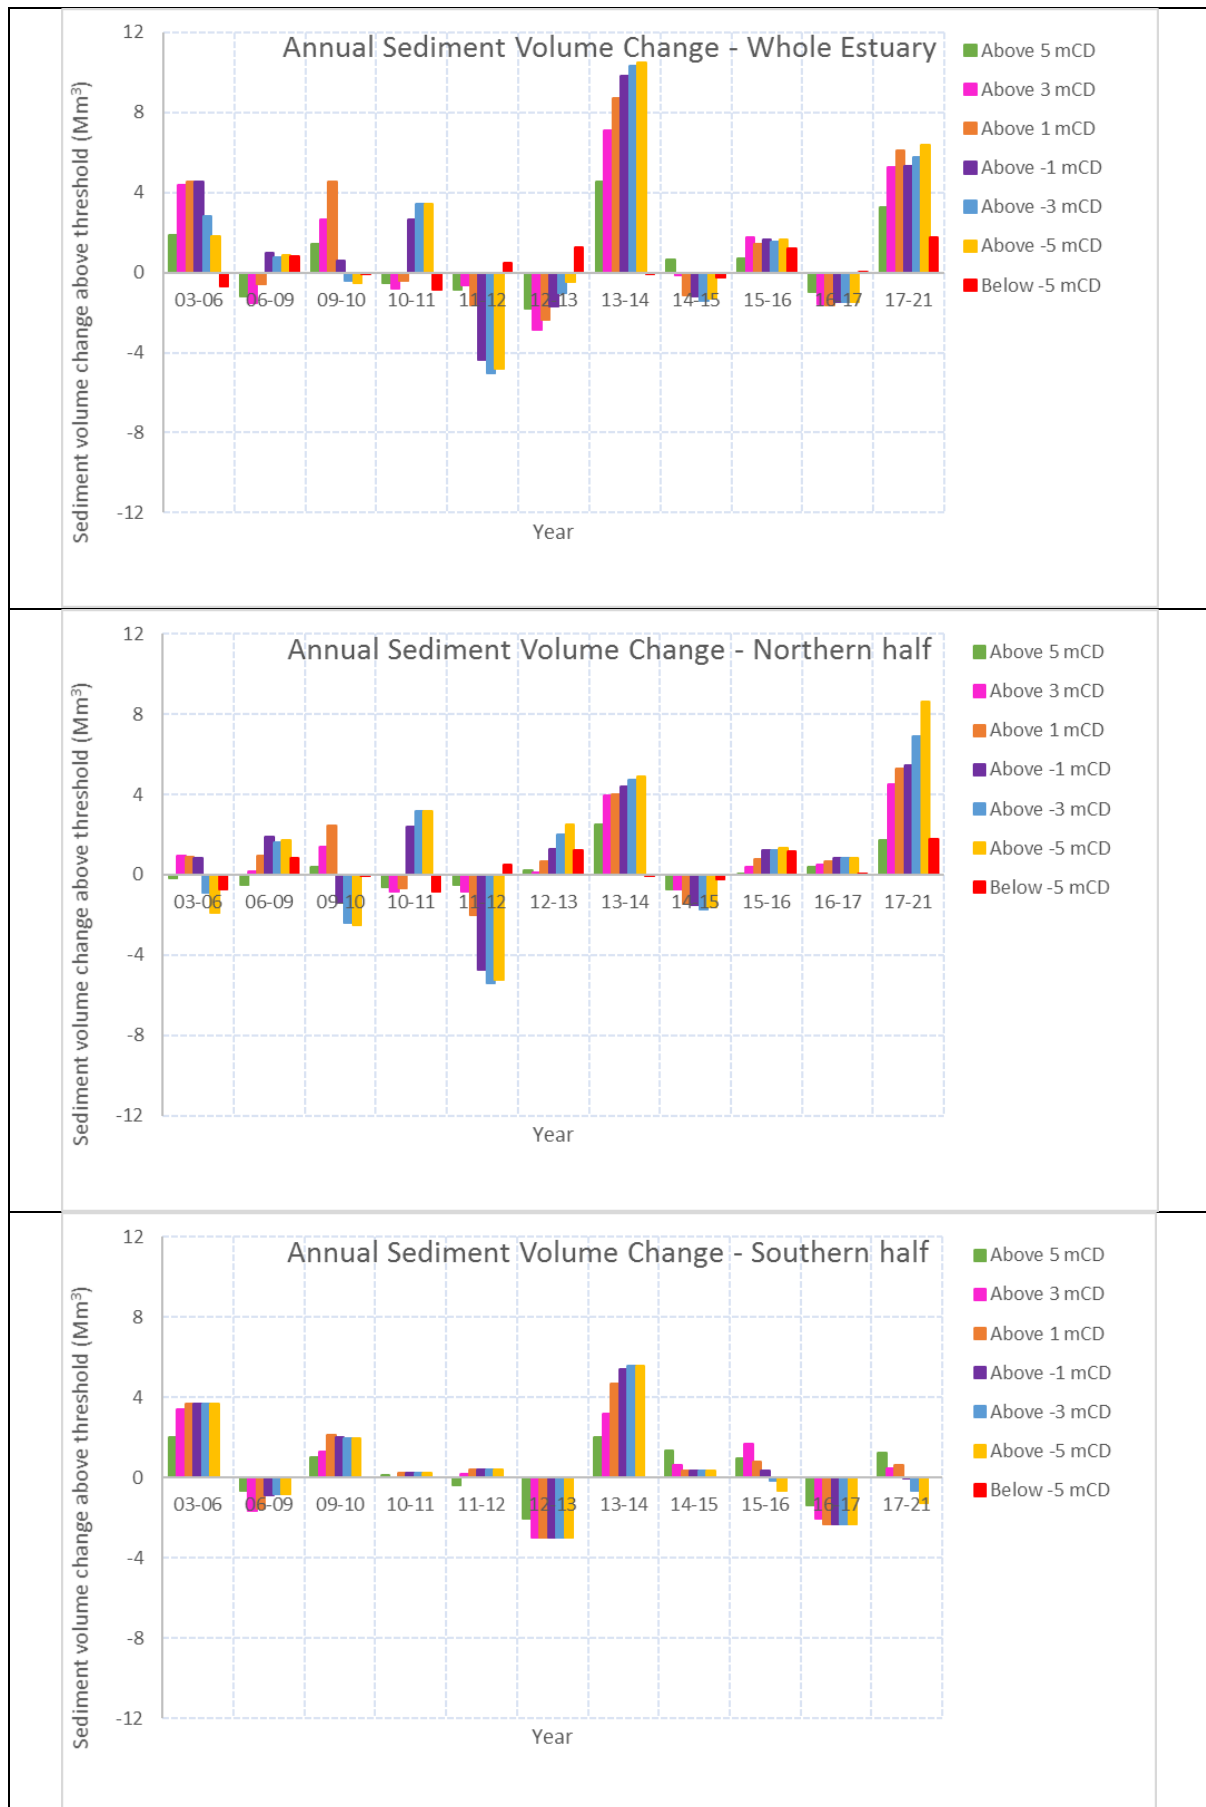
Figure 11. Total annual sediment volume change above given thresholds for estuary sections

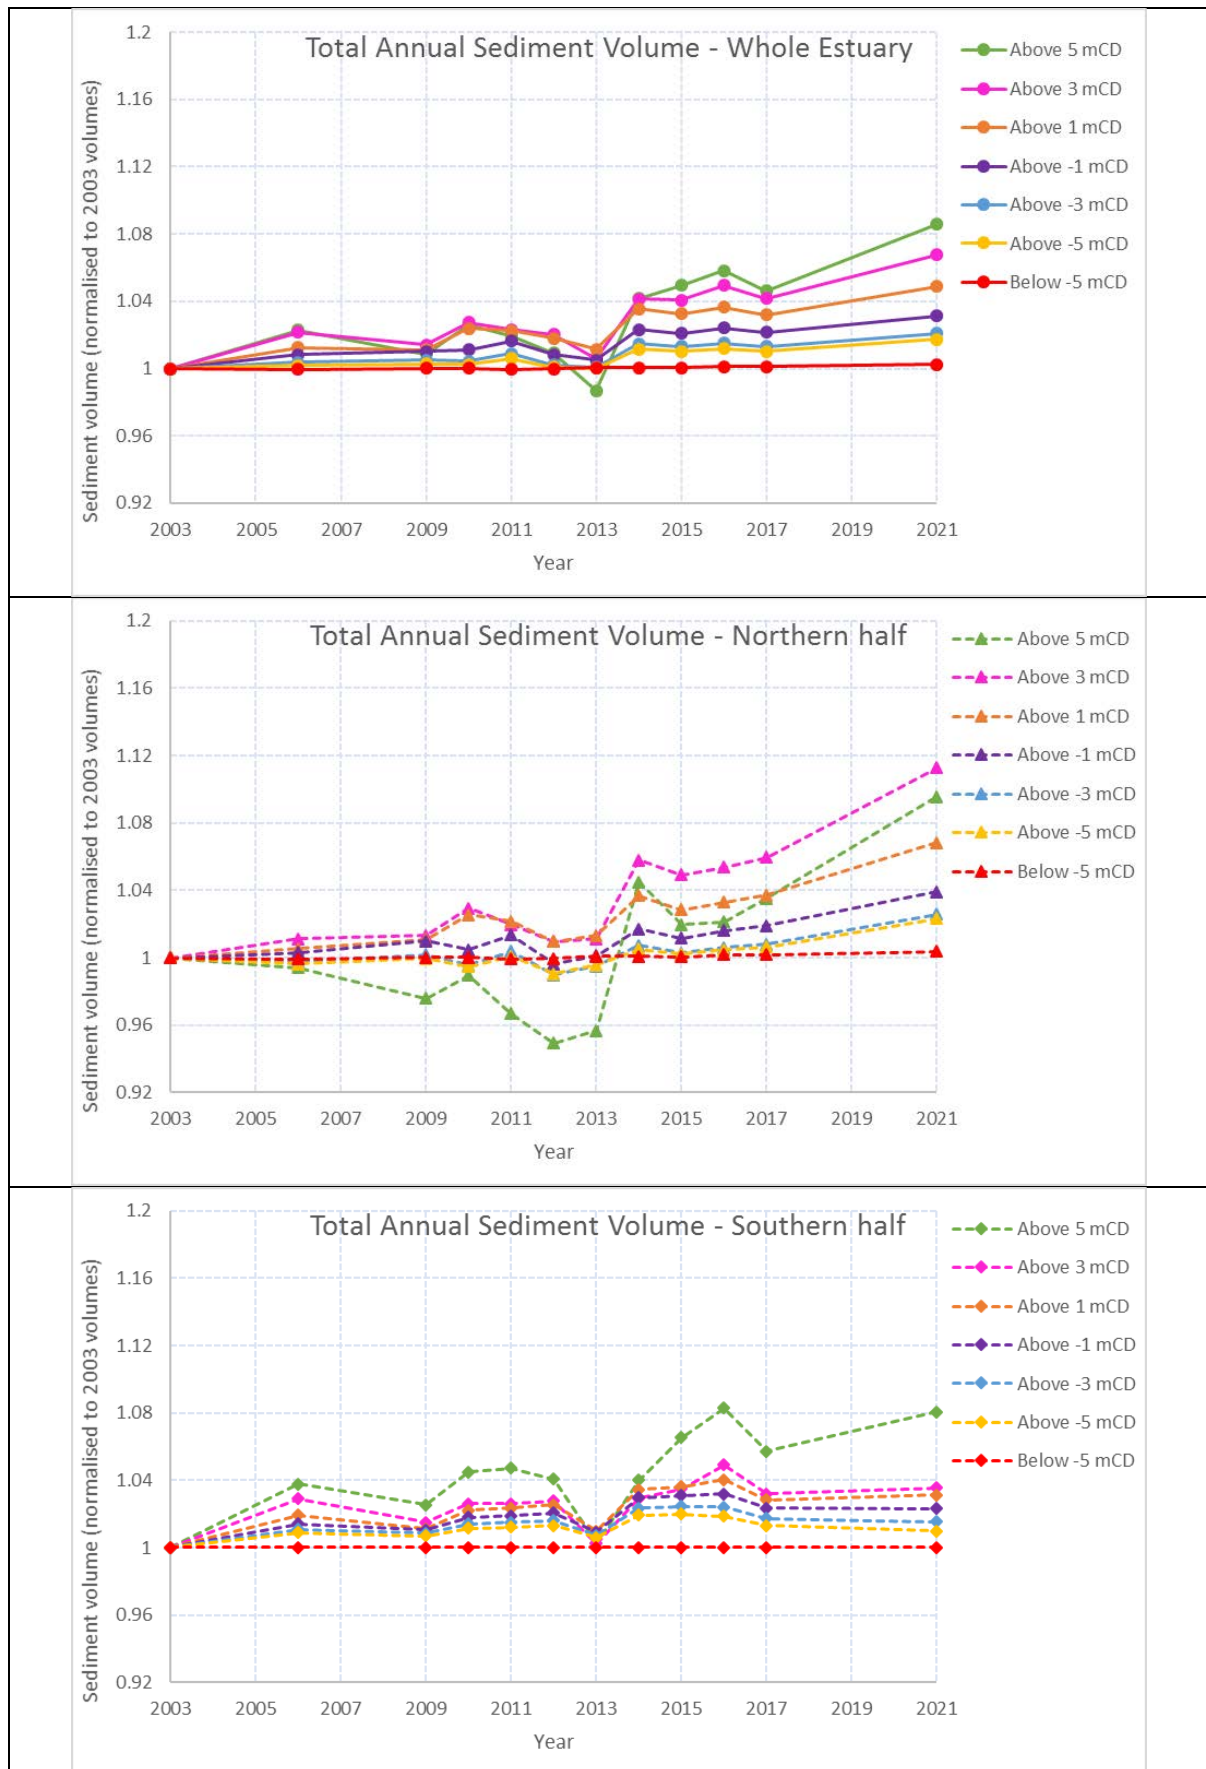
Figure 12. Total annual sediment volume above given thresholds, normalised to 2003 volumes, for estuary sections

Over the duration of the monitoring, the normalised volume plot (Figure 12) confirms an established view that the estuary is generally infilling with time. The greatest changes occur higher up on the banks, with the smallest change below -3 mCD. The largest year-on-year change tends to be observed around the ± 1 mCD thresholds.

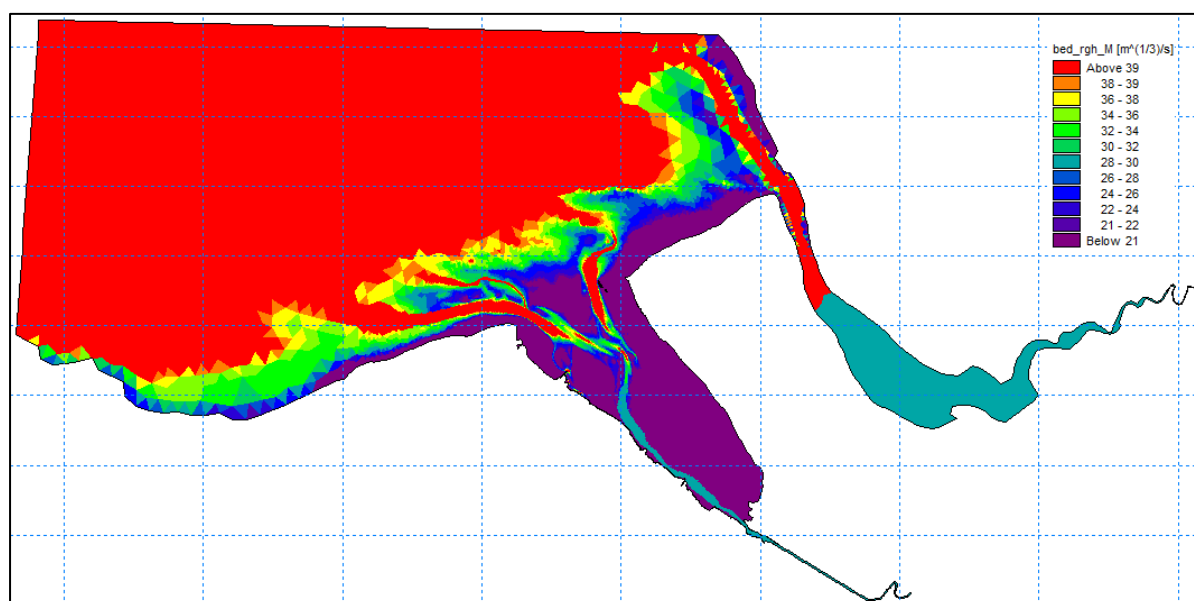
Figure 14. Spatially varying bed resistance map

Through the model calibration stage, the response of the model, particularly the upstream sections, was found to be sensitive to the definition of the bed resistance applied. The magnitudes of the bed resistance were also important in ensuring that sufficient tidal volume was able to pass through the estuary (and the Mersey) and into the upstream river sections, thus helping the model to provide representative flow conditions across the primary area of interest.

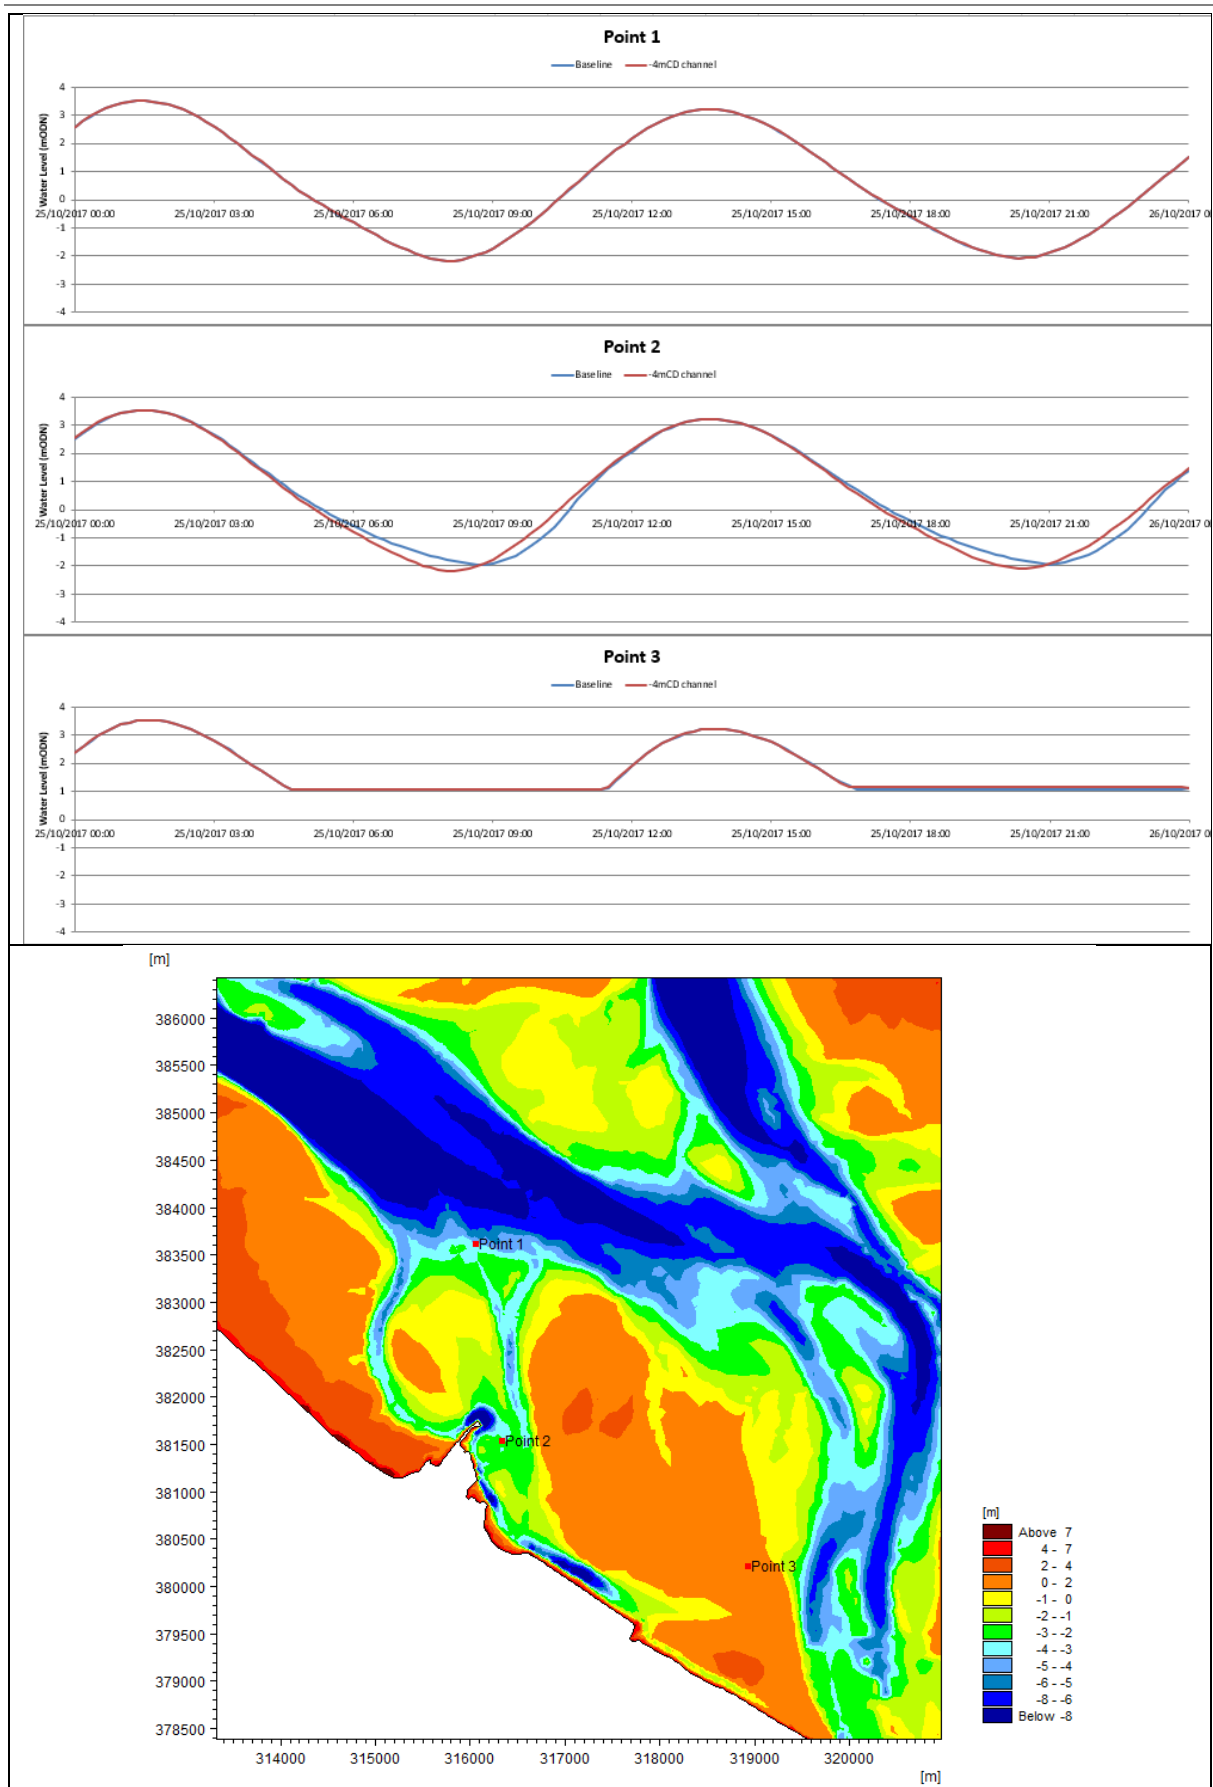
Figure 22. Timeseries comparison of water levels with existing and dredged channel

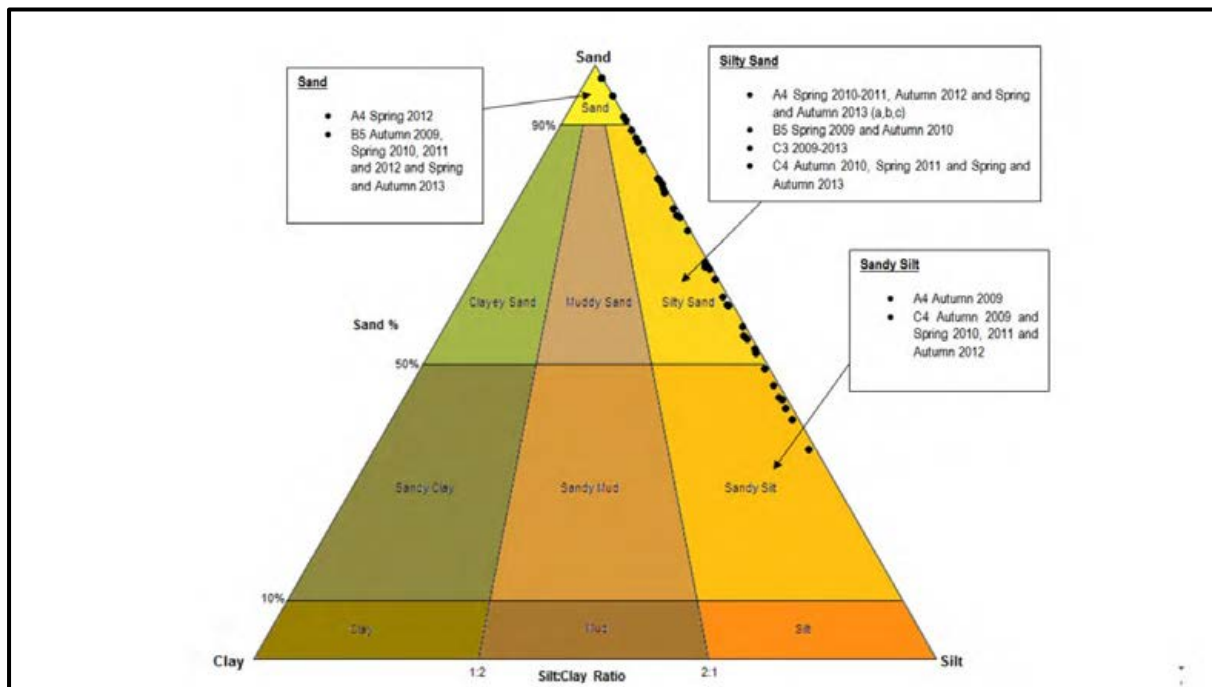
Image 9. Sediment types at Sites A4, B5, C3 and C4 (2009-2013) using 'GRADISTAT' analysis

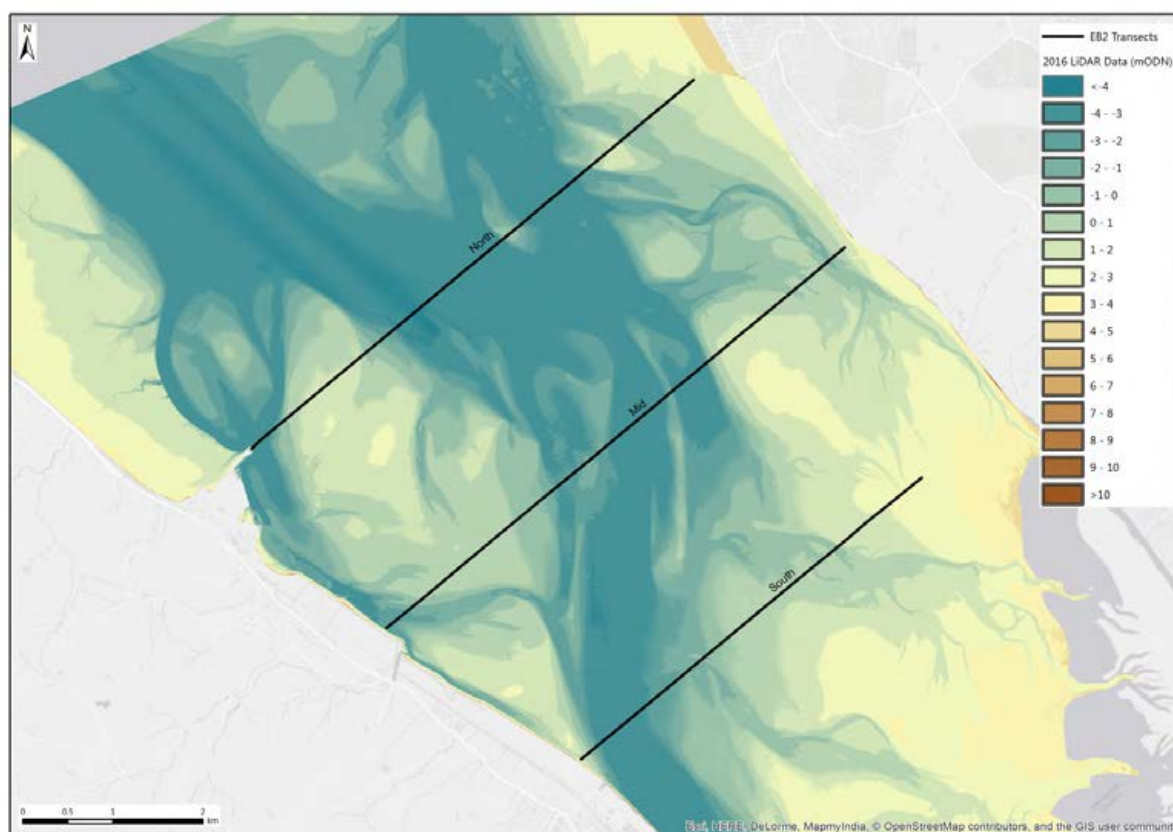
Image 12. Location of the three cross-estuary transects

The aim of Task EB2 is to complement the EB1 tasks and help to further understand the morphological changes in the estuary. This is done by carrying out bathymetric surveys along three fixed cross-estuary transects and using these to examine the changes to the channel and bank locations on a regular basis. These transect are illustrated in Image 12.

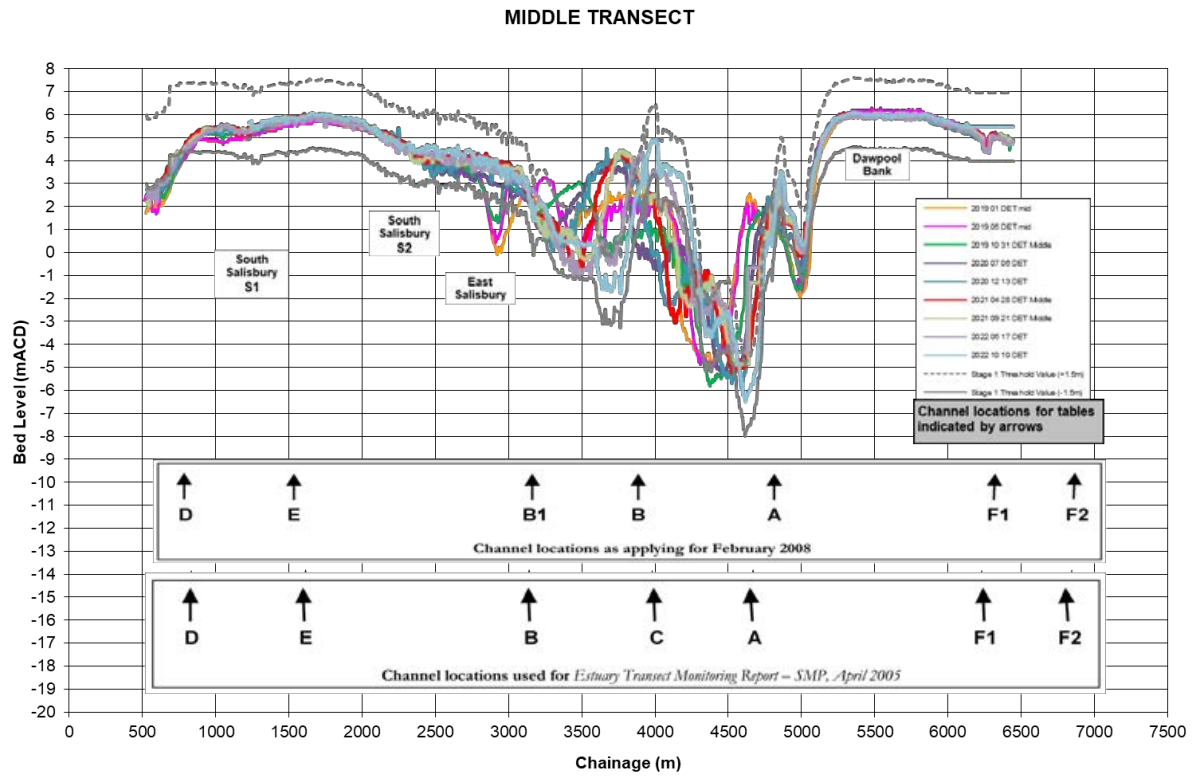
Figure 11. Comparison of change along the Middle Dee Estuary Transect (January 2019 to October 2022)

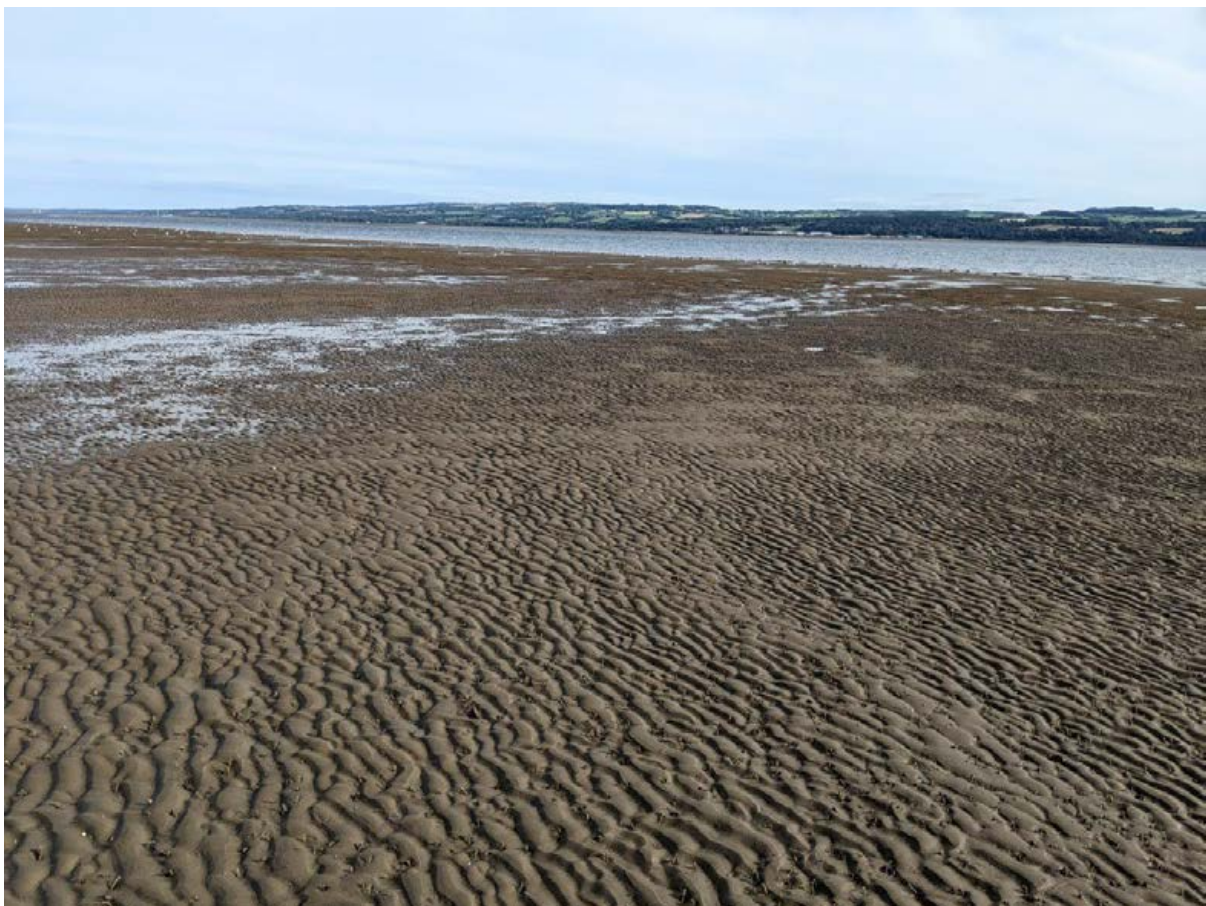
Figure 17. Image of the 'clay bank' area from July 2022 indicating sand cover is maintained

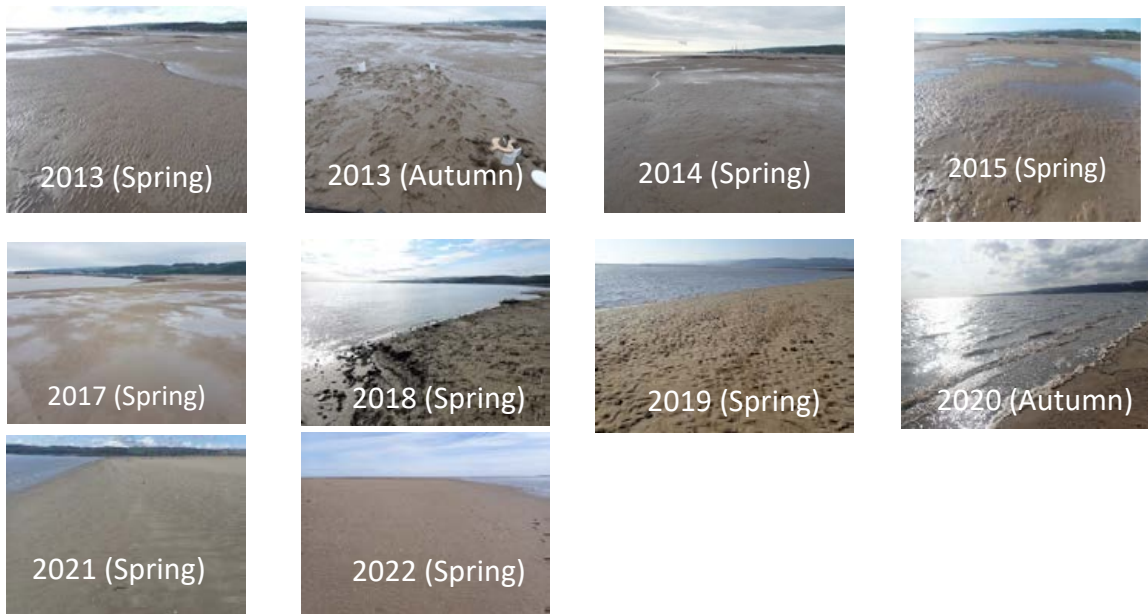
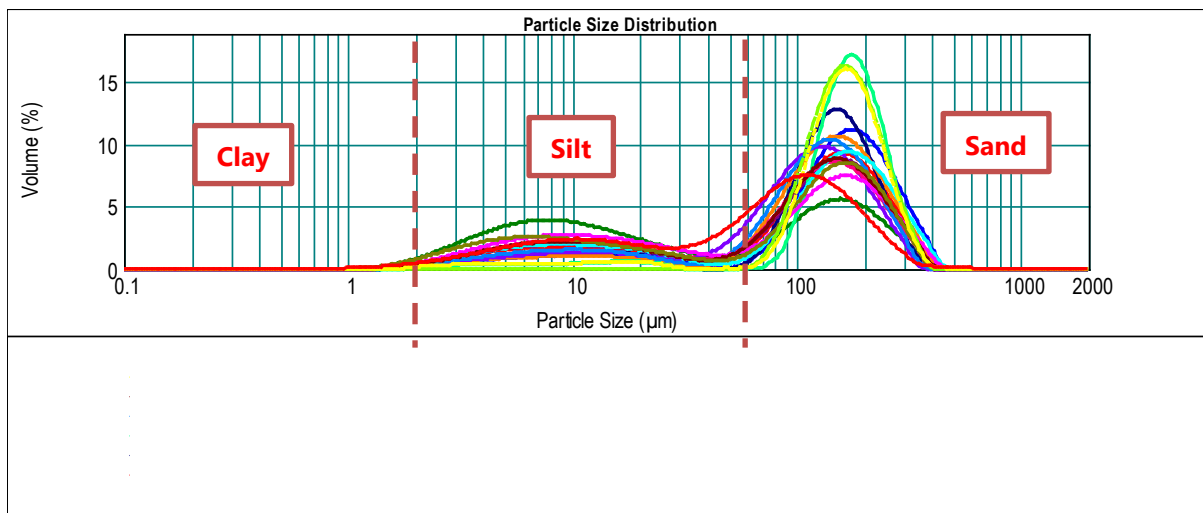
Summary: Throughout most of the monitoring period this area was characterised by rich muddy sand habitat (with some variation in sedimentary conditions recorded). In 2019, the station was located on a sandy bank edge shoal and in 2020 it was subtidal due to the westerly migration of the Mostyn Channel. In 2021 and 2022 it was located on a sandy slope on the channel margin.

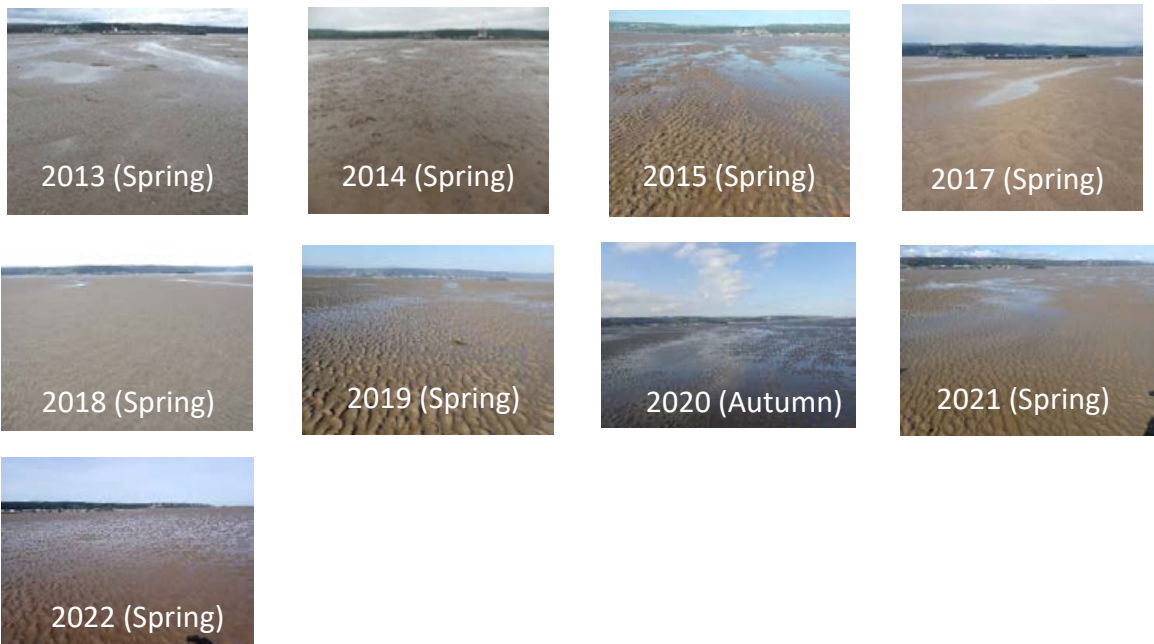
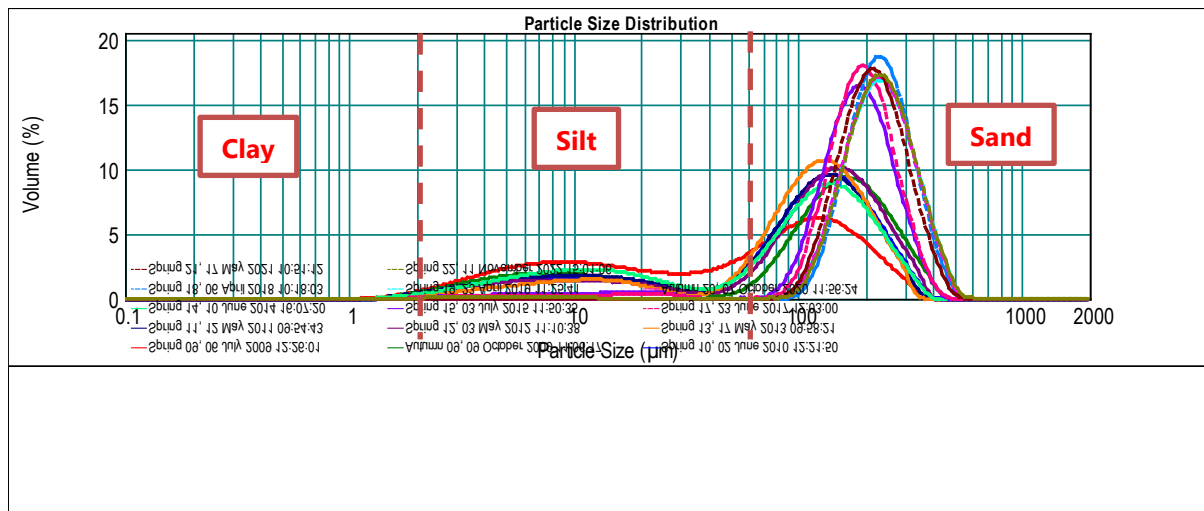
Summary: This site has changed from mud habitat (observed between 2009 and 2015) to flat fine sand habitat (with no visible fauna evident) observed since 2017.
