## Compliance Assessment Report CAR\_NRW0042642

**Permit being assessed:** AW1002901

For: LLANDRINDOD WELLS STW PARK LANE, held by DWR CYMRU CYFYNGEDIG  
At: LLANDRINDOD WELLS STW, PARK LANE, LLANDRINDOD WELLS, POWYS, LD1  
5NN.

**Type of assessment carried out:** Site Inspection, Reason: Routine.

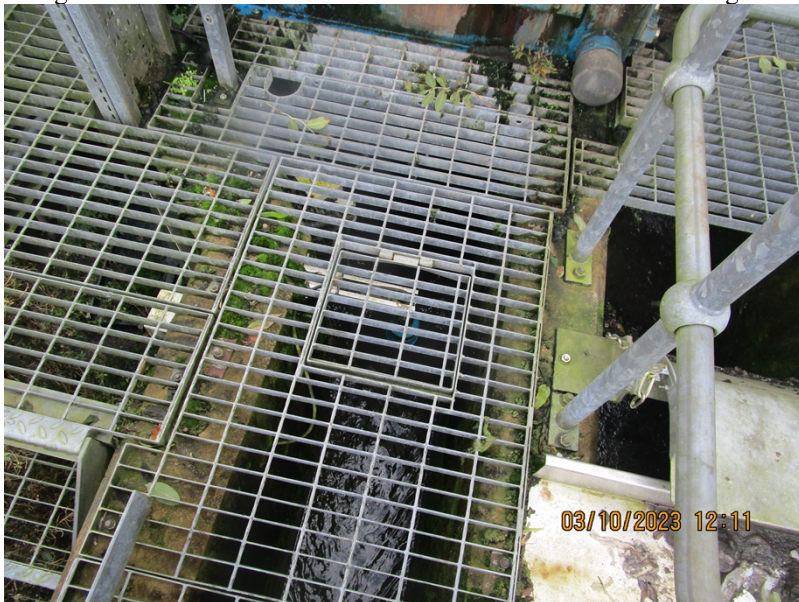
The inlet of the works is raised and the top of the site. There is a powered step screen in place to remove any rag and large solids, this was clearly operating as expected at the time of inspection. There is a nearby skip containing the removed rag and solids. There did not appear to be any significant solids passing through.

There is a bypass screen which flow can be diverted through if required. This is activated manually using penstocks to change the flow channel at the inlet of the works. This was not being used at the time of inspection.

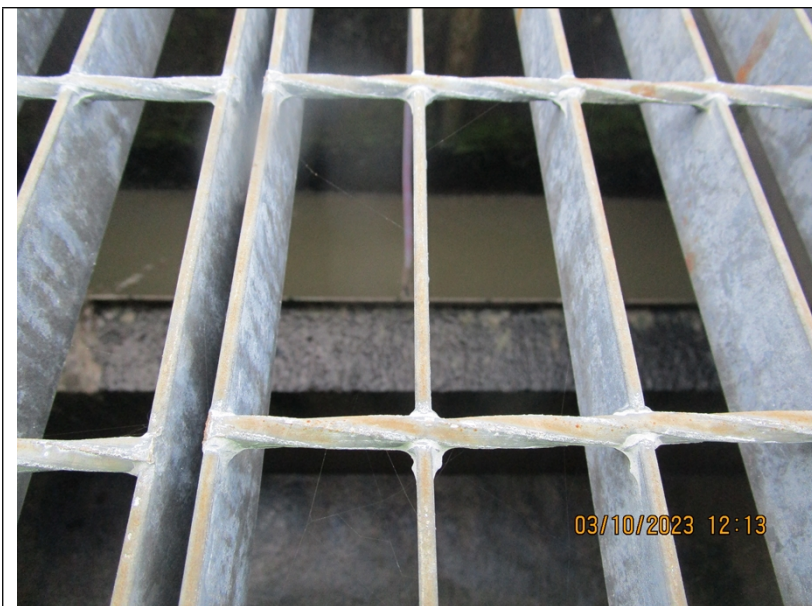
The inlet appeared to be running clear of any contamination or blockages. There were no signs of solids or rag present at the inlet. The storm weir in place is hard-set. At the time of inspection, incoming flows were below the weir height, and no storm discharge was occurring. The storm channel was clear of any solids or rags, There is a flow monitor in place at the inlet, which is located after the screens

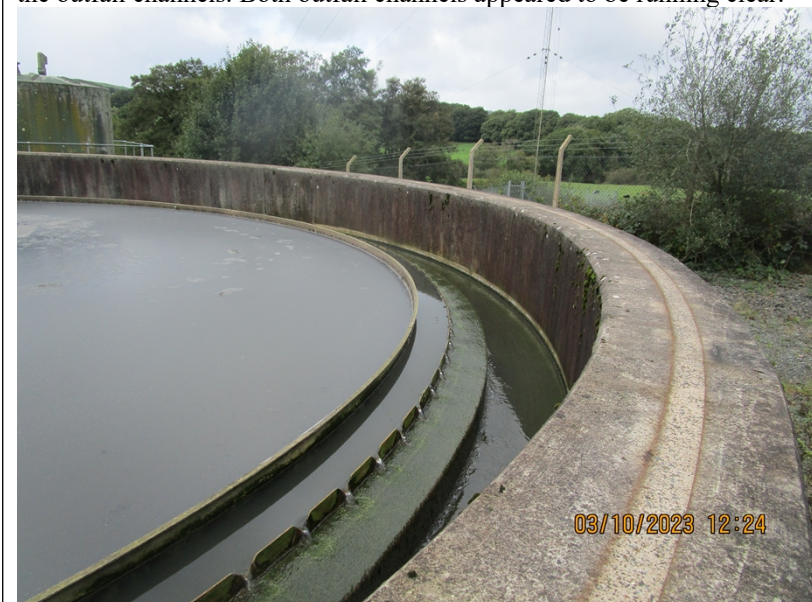
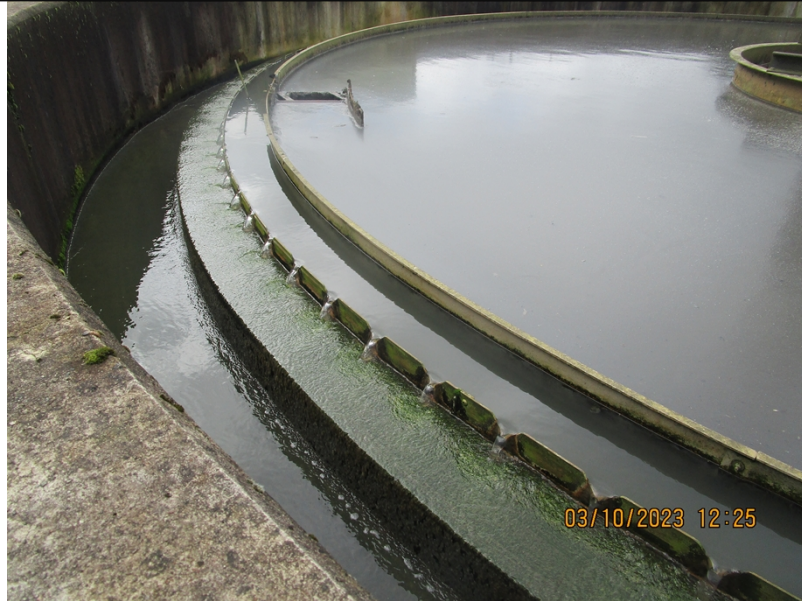
The flow from the inlet of the works is sent to a distribution chamber, where powered motors distribute the effluent to the two primary settlement tanks. In the mixing chambers ferric Sulphate is manually added by operatives for Phosphate. The motor is in place also mixes in the ferric dose, this was clearly operational whilst on site.

The works has two circular primary settlement tanks with rotating bridges, scum scrapers and outfall channel brushes. The two primary settlement tanks appeared in good working order and clearly holding back solids as designed. There were no signs of significant solids carrying over from either of the settlement tanks or signs of sewage fungus within the outfall channels. Both outfall channels appeared to be running clear.

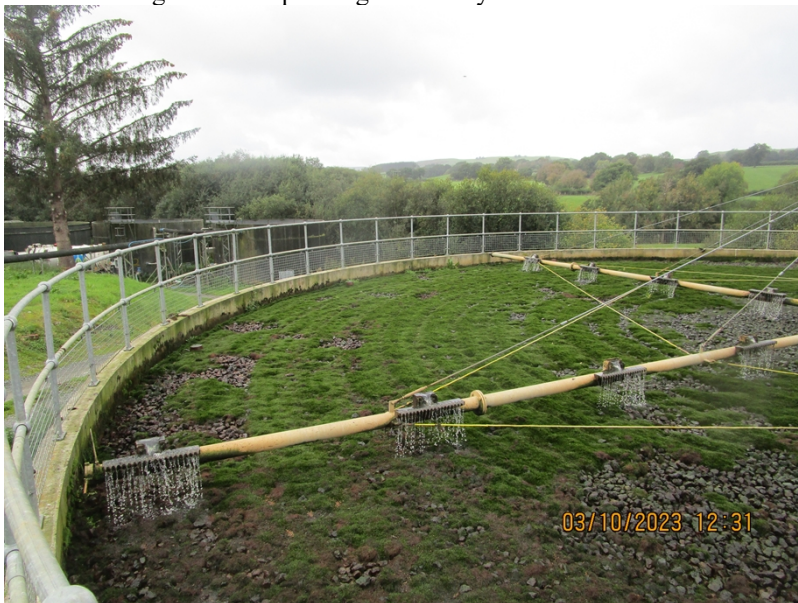
The site has 4 rotating distributor arm filter beds. Filter bed 4 is a newer self-contained stone media filter, which is located uphill from the remaining 3. Filter bed 4 had a large coverage of moss on the surface of the filter bed, which could affect influent reaching the filter media if not managed effectively. There were clear signs that some moss removal had been completed and we were advised that a moss removal will be organised, and we were advised that moss growth removal is an ongoing maintenance task at this time of year. There were no signs of pooling on the surface of the filter and the rotating arm was operating effectively.

The moss coverage on the 4 filter beds is a cause for slight concern, as it can lead to issues with infiltration and affect the treatment process. Indications currently are that is not impacting on the treatment process; however it is advised to undertake moss removal from the filter beds before the issue develops further.

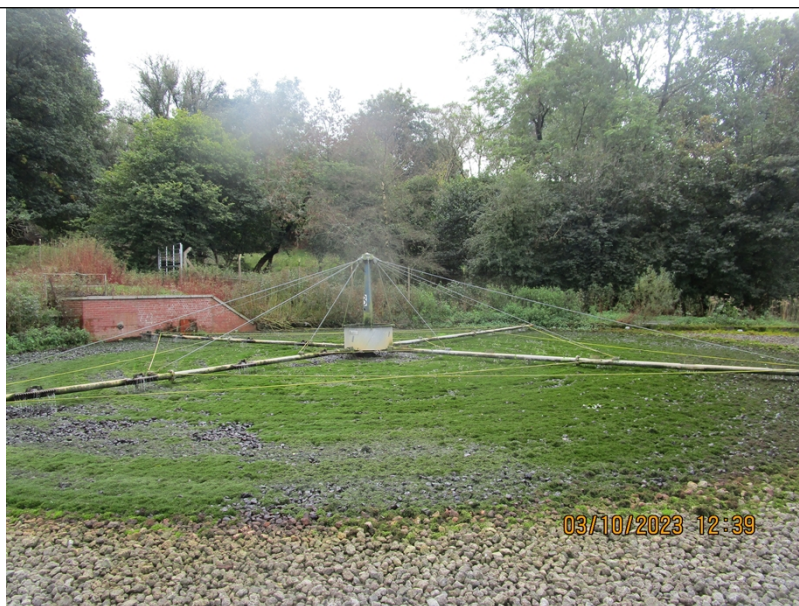
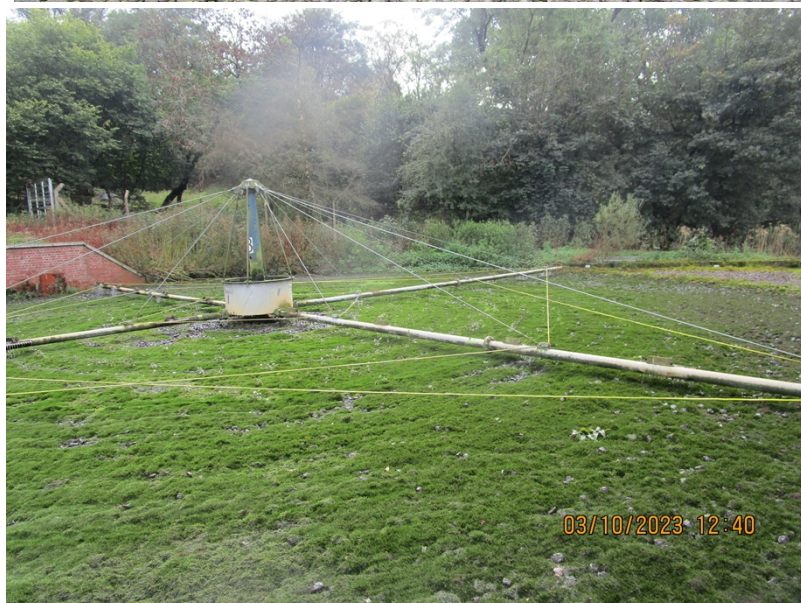
Filter Beds 1-3 are also rotating distribution arms onto stone media, however all three are contained within one large rectangular filter bed housing, which contains stone media of approximately 2m deep. Each filter bed is clearly labelled. All three filters appeared in working order, there were no signs of blockages within the distribution arms. The filter beds also had large areas of moss coverage, there were some signs of surface pooling within the three filter beds, which could lead to issues with infiltration. The pooling appeared to be surface level at the time of inspection and predominantly where moss coverage was thicker.

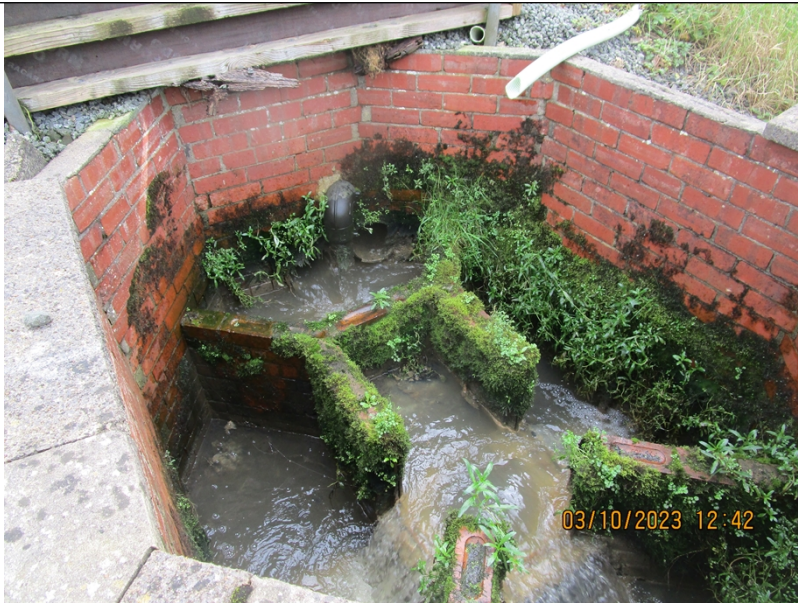
The filter beds otherwise appeared in working order. The outfall from the filter beds was running clear. This then passes through a distribution chamber, leading to the humus tanks. Within the distribution chamber there appeared to be some sewage fungus growth, which suggests potentially high ammonia content, but not a noncompliance at this time.

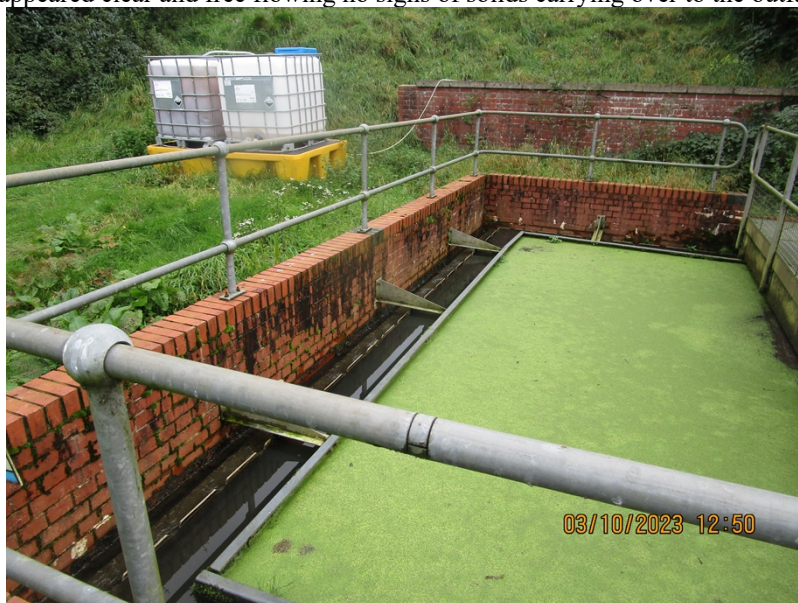
There are four rectangular “Dortmund” type settlement tanks in use, which have a scum retaining board. Solids are retained behind this board and settle down into the tapered edges into the centre of the tank for collection. The humus tanks appeared to be operating effectively and there were no signs of solids in the outfall channels. There was a layer of duckweed present on these tanks, however this was largely contained within the scum boards. The eluent from the tanks appeared clear and free flowing no signs of solids carrying over to the outfall.

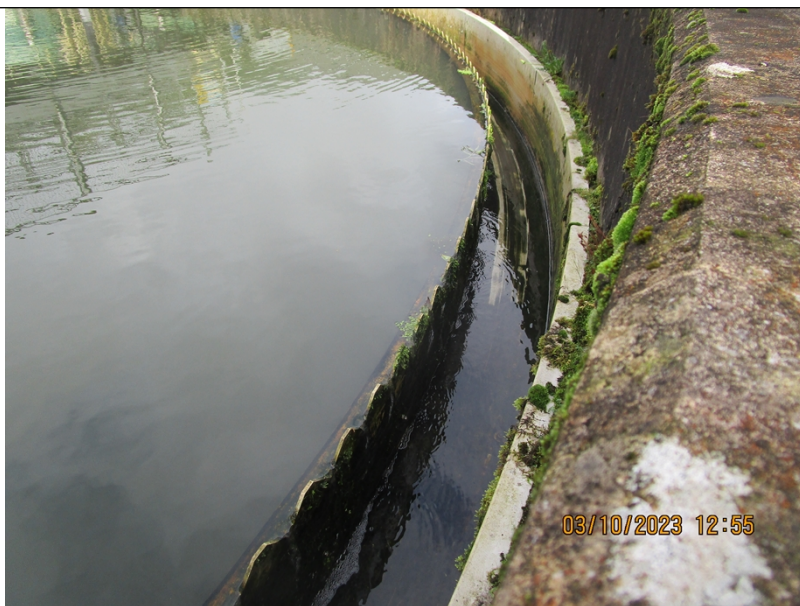
There is a single radial humus tank with a rotating bridge and scum scraper. This appeared in good working order. There were no signs of solids passing over into the outfall of the tank and the effluent appeared clear.

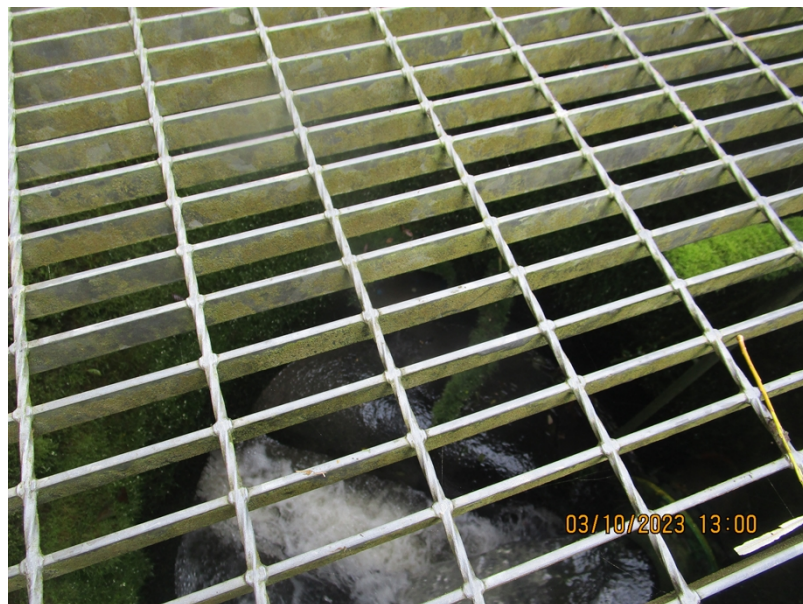
The Final effluent sampling point was clearly marked and easily accessed. The chamber appeared clear, and effluent was flowing freely. There were no signs of solids or contaminants within the effluent. The UWWTV final effluent sampling point was clearly labelled and accessible.

At the side of the chamber there is an additional pipe, which I was advised was the outlet from the storm tanks.

At the time of inspection, the storm pipe was discharging into the outfall. This will be addressed in a separate CAR Form for storm permit AN0357501 as this is a noncompliance of the storm permit, as the storm outfall was discharging outside of storm conditions.
