## Compliance Assessment Report CAR\_NRW0042523

**Permit being assessed:** PP3993VS.

**For:** Atlantic Recycling Limited, **held by:** Atlantic Recycling Limited

**Type of assessment:** Site Inspection,

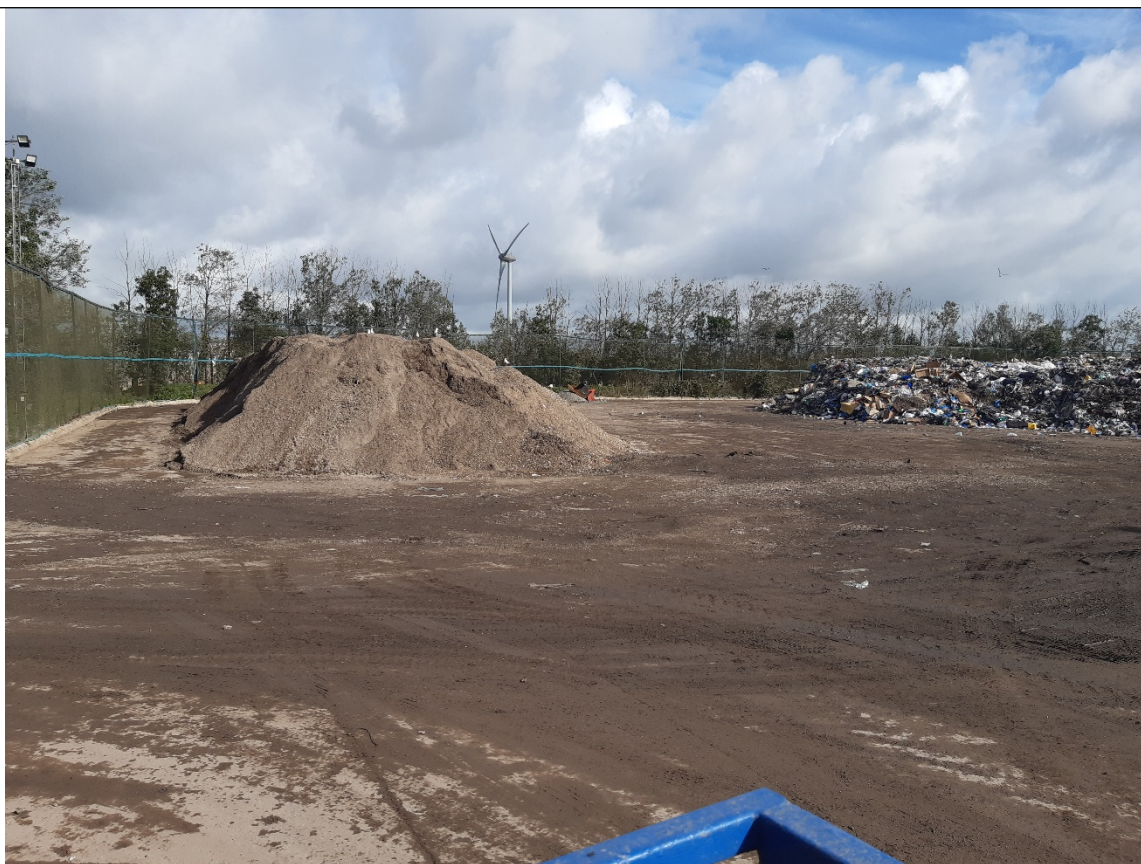
*Picture 1 - Trommel Fines on the Transfer Station*

The image above shows the trommel fines that have come off the trommels on Phase 1 and Phase 2. The trommel fines stockpile is quite large, as this material is waiting to be sent off site. Questions were asked regarding the testing regime of the fines. Neither Phil nor John was able to answer this during the visit but an action has been placed in CAR\_NRW0042332, which will be able to address this point. No dimensional measurements were taken of the stockpile on the visit.

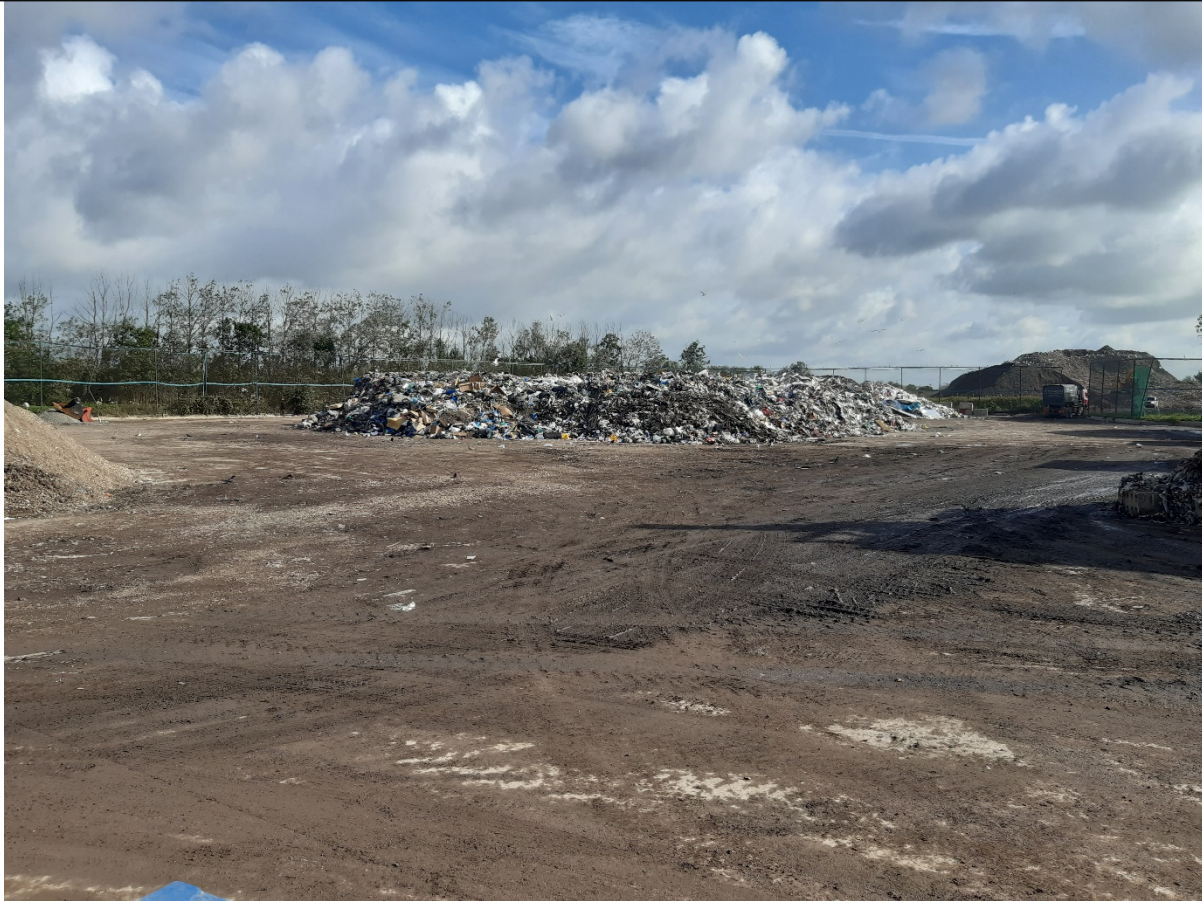
To the right of the trommel fines is a stockpile which has been processed through the phases and is due to be sent to landfill.

*Picture 2 - Processed RDF material on the Transfer Station*

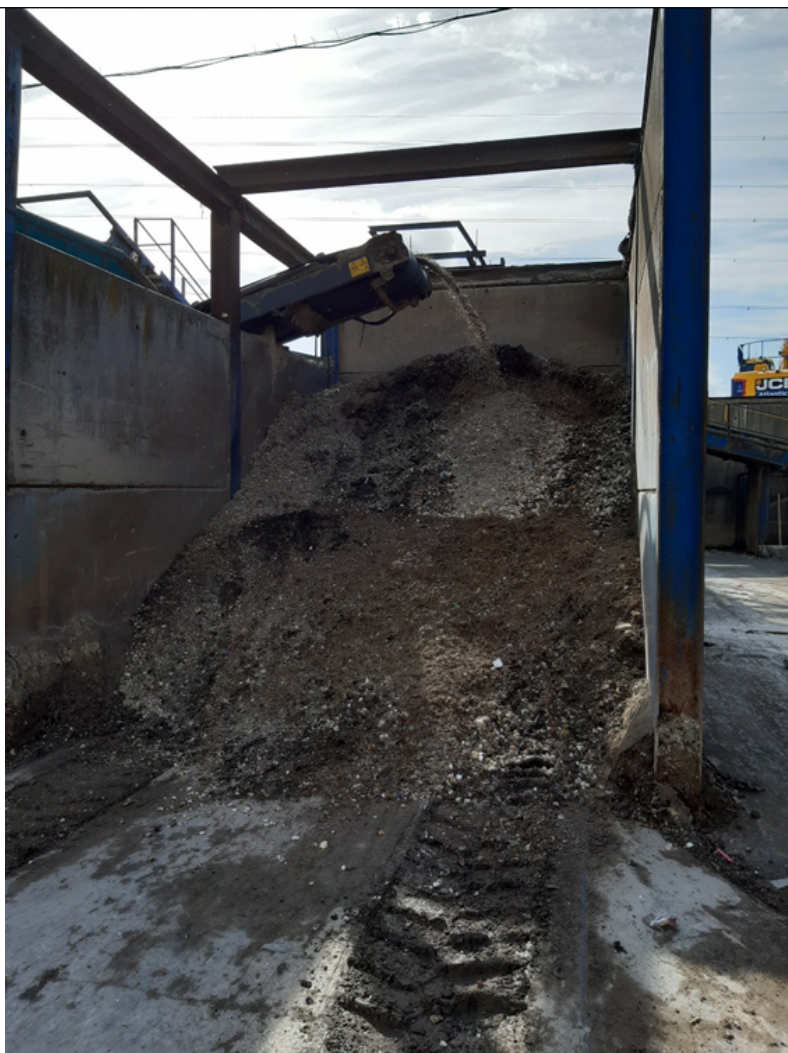
Both Phase 1 and Phase 2 were online on the day with material being picked off and being dropped into the appropriate areas. Some residual SRF fractions material which were coming off the two phases were collected which was being mixed in with the incoming SRF material, as seen in the image below.

*Picture 3 - SRF fractions being deposited into designated bay prior to mixing with imported SRF*

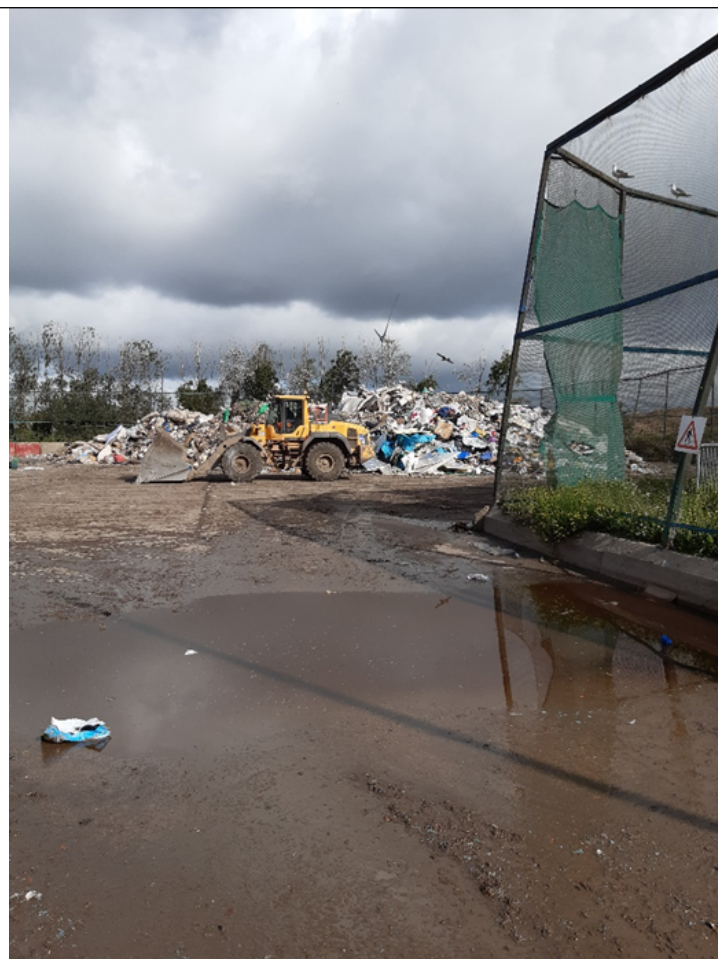
*Picture 4 - Material to be processed on the far-right area of the Transfer Station*

In the picture above, this is material that is waiting to be processed through MRF. Material will then be sorted into the associated area and recycled where possible.

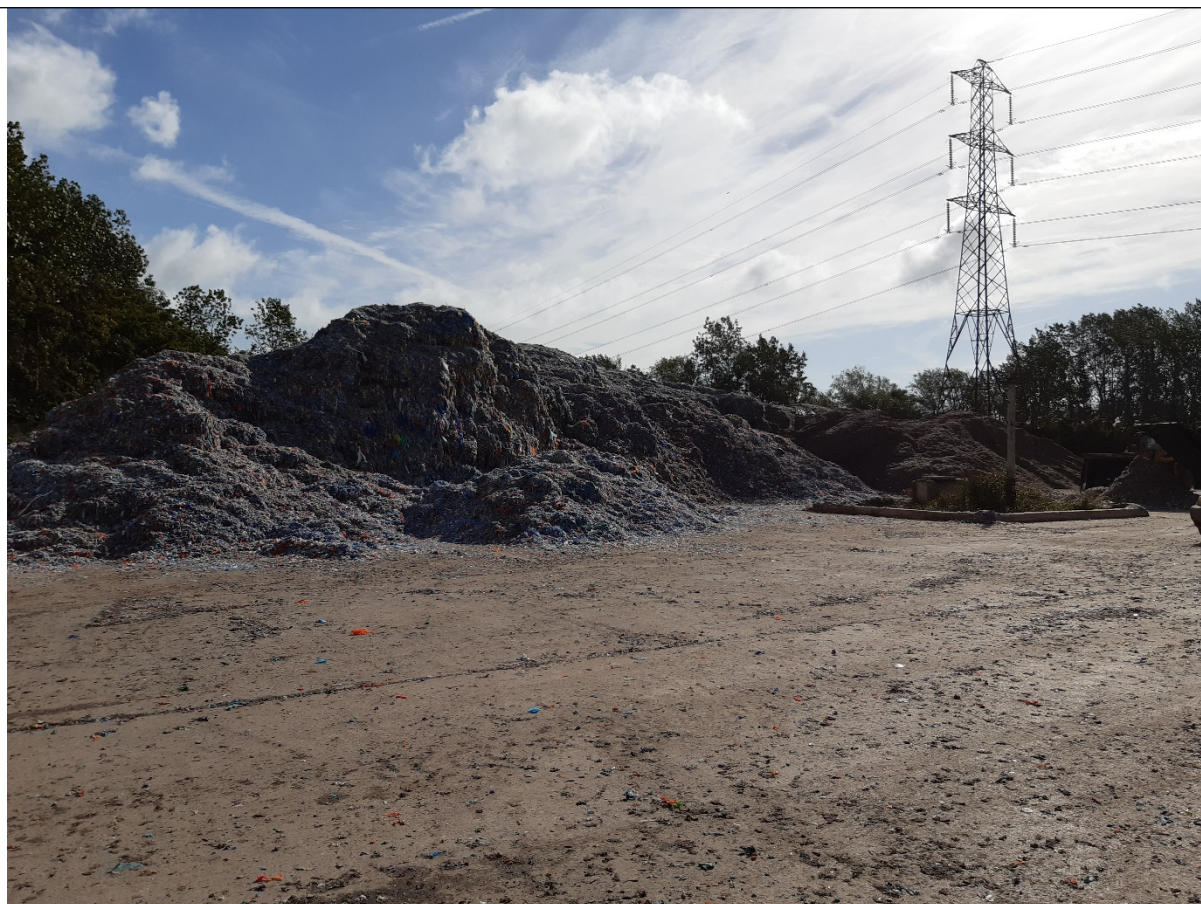
Picture 5 – Incoming SRF Material with SRF fractions from site to the right (brown in colour)

The picture above shows a stockpile of unprocessed SRF material that is waiting to be processed inside the building behind the camera.

Permit condition 2.1.1 states

*“The operator is only authorised to carry out the activities specified in schedule 1 table S1.1 (the “activities”).” Table S1.1 then states “Storage of all non-hazardous waste prior to treatment shall take place inside a building on an impermeable surface with sealed drainage.”*

Several documents in Table S1.2 Operating Techniques, such as the email Received on the 15<sup>th</sup> of October 2019 stating SRF will be stored inside the building, the Operating techniques update v4 (dated Jan 2019) state that the SRF / RDF material will be stored inside the building prior to treatment. When questions on the matter were asked on the visit, it appears that ARL believe that the unprocessed material can be stored outside, uncovered, with the processed material stored inside the building.

We consider outside storage of the SRF prior to processing is non-compliant with permit condition 2.1.1 and may result in reduced SRF quality due to exposure to the weather, lowering the calorific value of the final product and increasing the potential for contamination of surface water run-off. This is a **minor category 3 non-compliance** at this stage due to the continued export of the material for use in cement kilns and current surface water

management practices.

**ACTION:** Please can you explain how you are going to comply with the requirements in your permit to cover or house the unprocessed material? Given that the impact on the SRF quality may decrease with it being exposed to the weather which lowers the calorific value of the final product and the increased potential for contamination of surface water run-off.

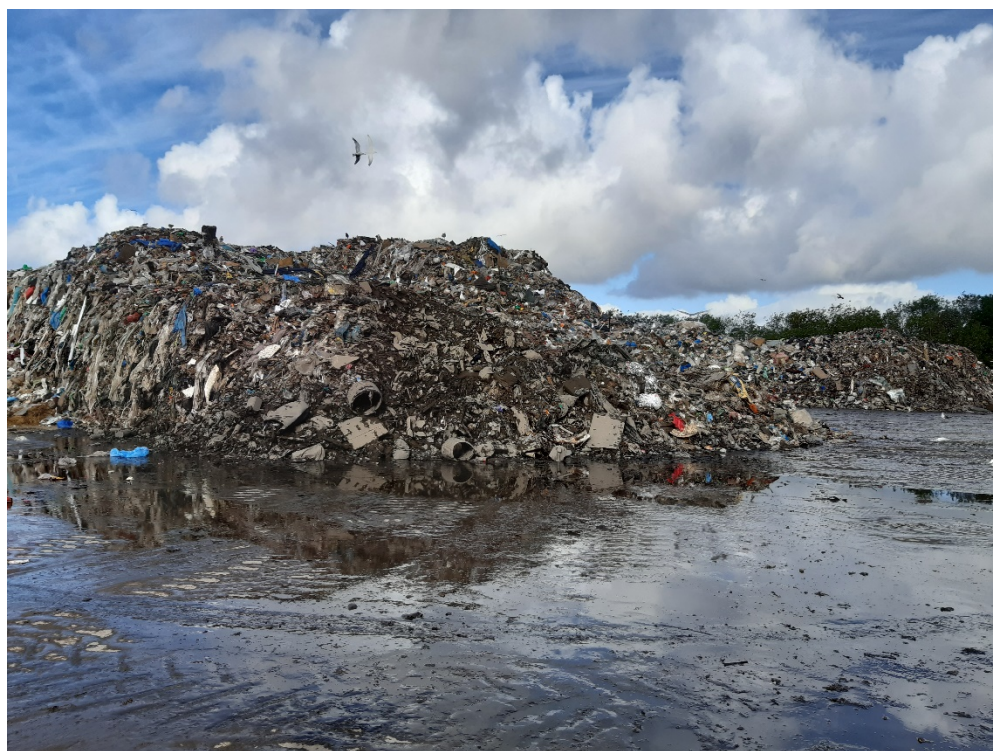
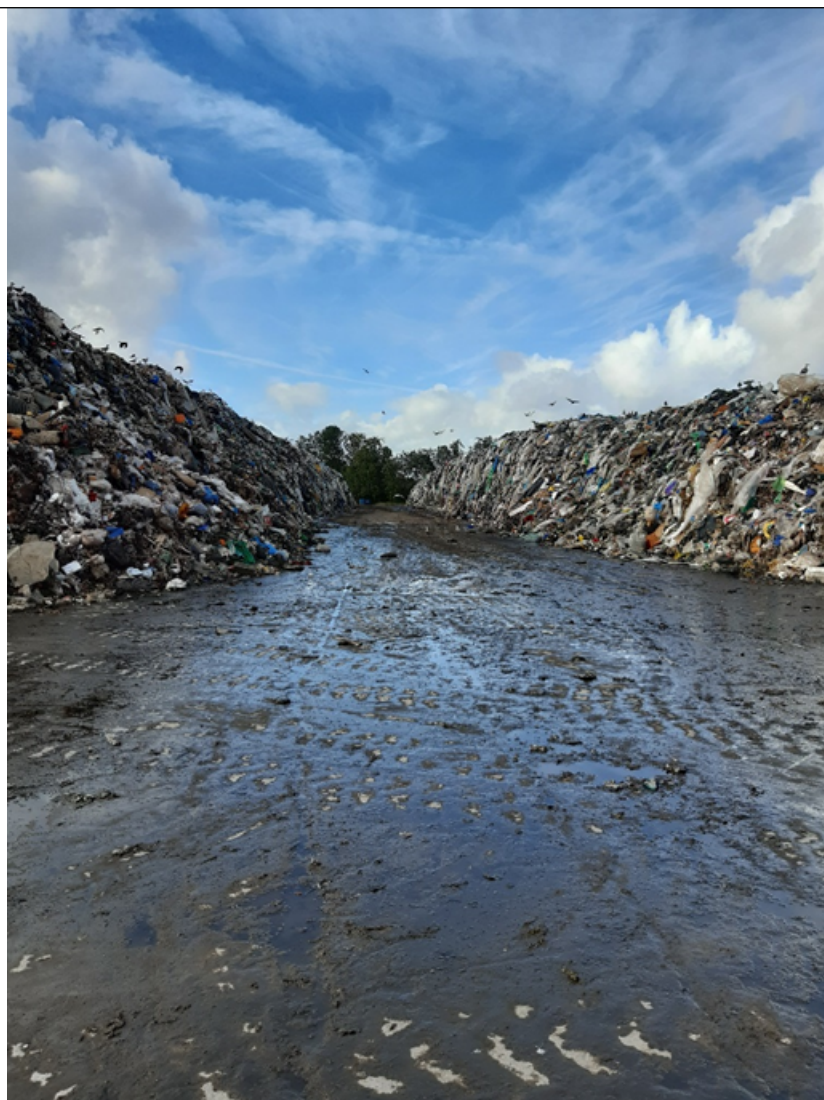
*Picture 8 - Image of unprocessed RDF material*

*Picture 10 - Image of the stockpiles on Field 1*

Picture 8 and 10 show material that is waiting to be processed through the MRF. The material is stated to have been on site between 6 weeks to two months. This material will be processed and have been removed from site by late December. The material at the rear of Field 1 is the oldest material which is to be processed first and working their way backwards towards the front of Field 1 which is the newest material on site. As picture 10 shows there is a firebreak between the stockpiles of material. It was stated on the visit that the gap was 12m, however this was not measured on the day of the visit, but it appears to be sufficient distance. The width of the stockpiles was stated to be around 20m, again no measurements were taken but again this would appear to be approximately around that figure. Sources for incoming material have slowed down which could indicate the processing of the material that was on Field 1. It was stated that Field 1 has around 23,000 tonnes of material in total and there aren't plans to increase the amount of material on Field 1.

Temperature probes have been installed in the stockpiles to monitor the temperature;

however, these have not been connected to the monitoring system located in the security house. Version 8 of the Fire Prevention and Mitigation Plan dated April 2023 was submitted to NRW on the 5<sup>th</sup> of June 2023, this has yet to be approved by NRW. It states within that material which has been on site for greater than three months will have permanent means of temperature monitoring on them. As the material on Field 1 had been on site for between 6-8 weeks at the time of the visit, which is below 3-month time window temperature monitoring was not required at that time. However, at the time of the issuing of the CAR, the material should have temperature monitoring implemented.

The height of the stockpiles on Field 1 (although were not measured at the visit) appear to not meet the heights set out in NRW's FPMP Guidance and this will be addressed once the latest FPMP submitted by ARL (version 8 Dated April 2023) has been reviewed against the guidance.

**ACTION: Confirm that waste stockpile temperature probes have been connected to the monitoring system and provide photo and data evidence to support this by the 27<sup>th</sup> of October.**

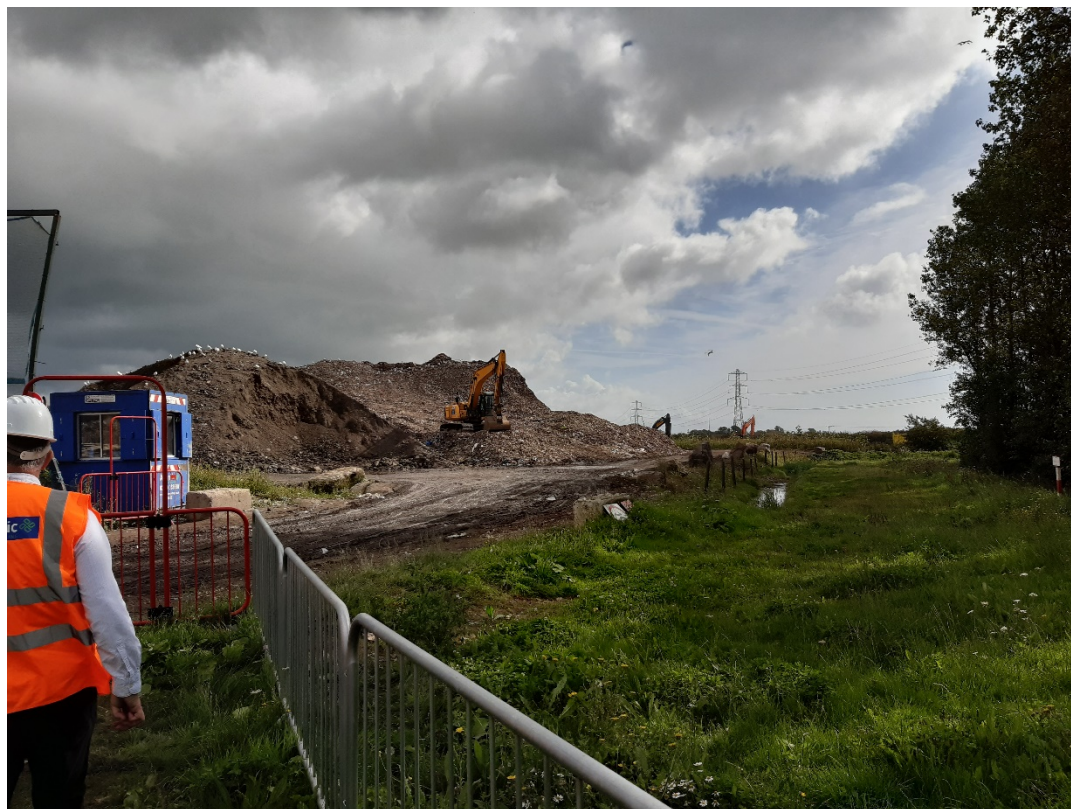
Picture 11 - Image of earth material on Field 2

The above pictures were taken on Field 2 during the walkover of the site. Picture 11 is material that has come off the MRF on site which was described as “dirty hardcore”. It was stated that the material will be processed to remove the recyclable materials within. The remaining material will be going off site to landfill following this. The material that will be sent to landfill will be tested every 1000 tonnes.

**Action: As per CAR\_NRW0042332 – Action 5 please submit to NRW to include the material from Field 2. A new revised due date on Action 5 will be in place. Please submit to NRW by the 9<sup>th</sup> of November 2023.**

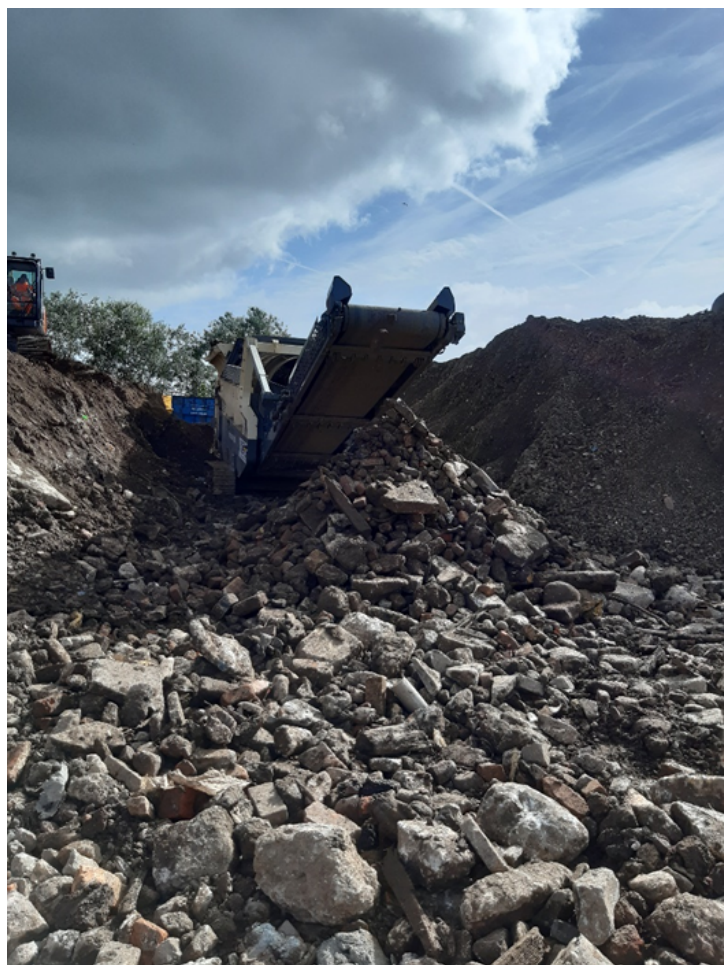
Picture 12 - Stone crusher in operation on Field 2

Picture 12 shows the soil passing through the soil processor on site. On the day two large excavators were working in the area feeding the soil and rubble into the machine. The soil material on the left-hand side is to be processed and the right-hand side the soil having been processed. The large stone that can be seen in front of the machine are due to be sent over to Neals to be crushed to different sizes and will be sent out as product.

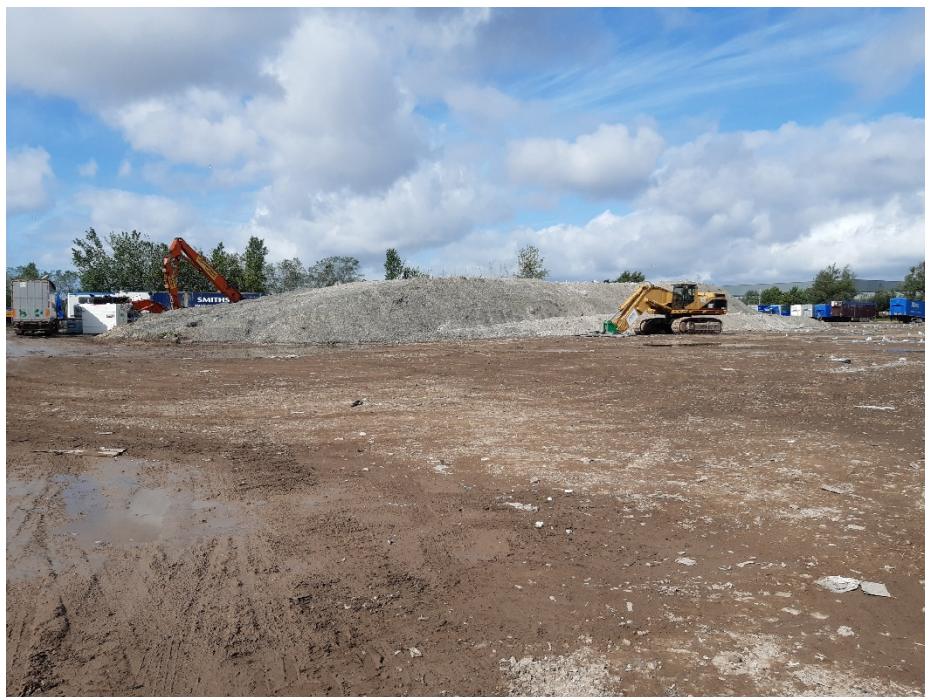
*Picture 13 - Inert material with glass stockpile on Field 4*

Field 4 currently holds a large stockpile of glass and rubble mixed material as can be seen in picture 13 above. This is being processed and being sent to Europe. The other areas of field 4 is being used for articulated lorry trailer parking. Now the fleet size has increased to approximately 42 lorries, the plan at ARL is to clear the entire field and put hardcore as a base for the lorry parking.

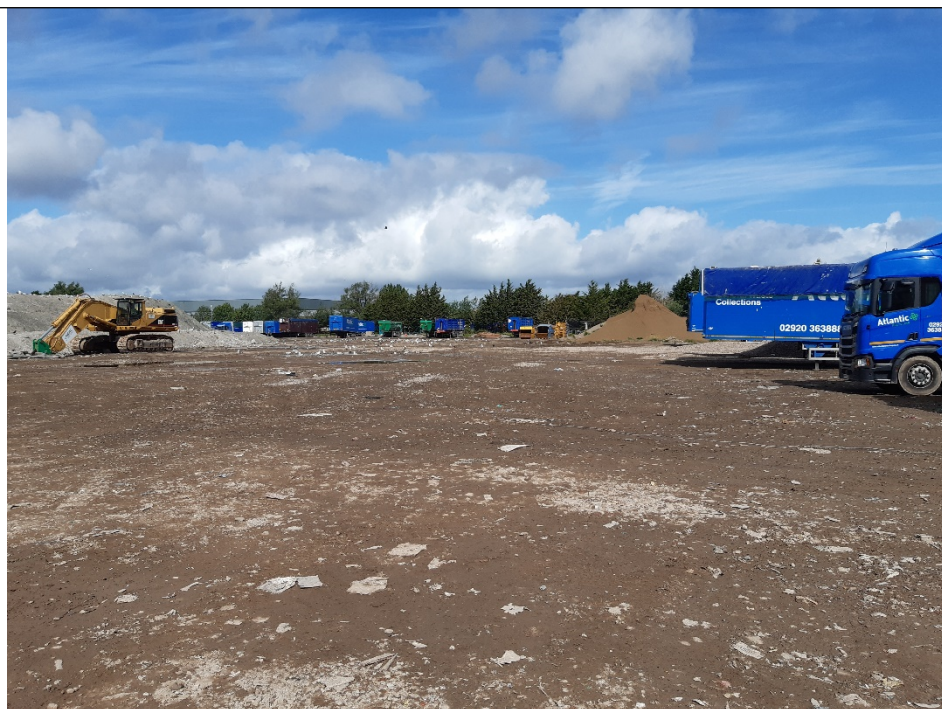
*Picture 14 - Field 4 being used as parking for lorry trailers*
