## Compliance Assessment Report CAR\_NRW0042682

**Permit being assessed:** BB3298HN.

For: Green Steel Works Ltd, held by Green Steel Works Ltd

**Type of assessment carried out:** Site Inspection, Reason: Routine.

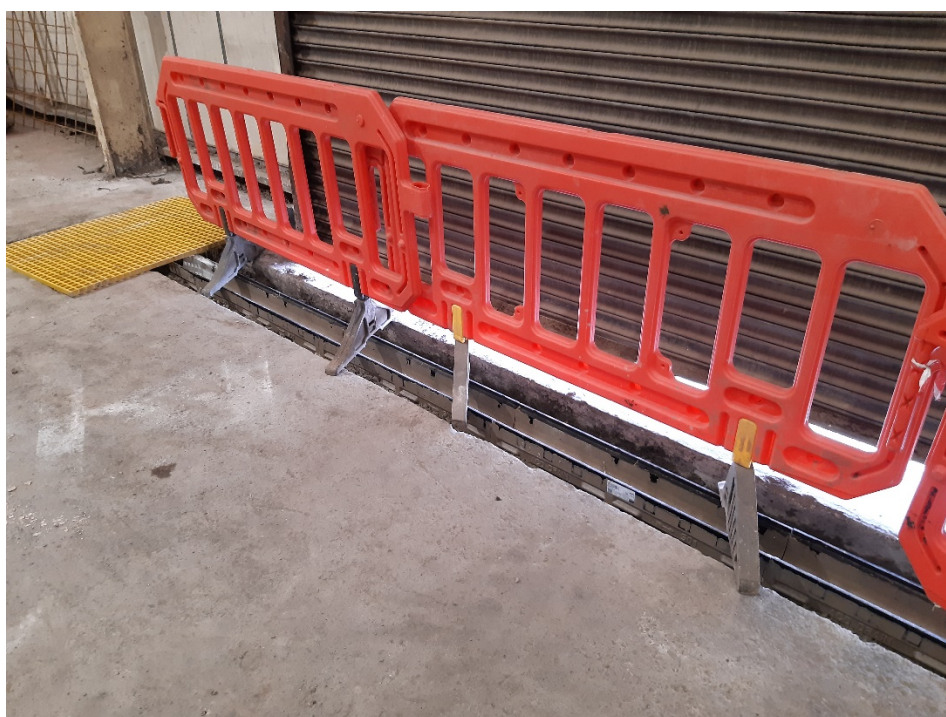
This building is where the mattresses are stored and houses the wash plant and the shredded wastes. Officers were first shown the areas around the perimeter of the building where the channel strip drains channels have been installed by GPT Environmental. There have been extensive structural works to get these installed as per the requirements of the Regulation 36 Notices (see above).

These will all drain to sealed sumps to allow the correct management of spilled materials. Regular collection of water from the sump would be via pumps into suitable containers for offsite disposal. The operator is unsure as to how often this would need to take place, once a pattern of maintenance is determined it must be incorporated into the Environment Management System (EMS) to ensure that the correct collection timescales are adhered to.

**Photo 1** – newly installed channel strip drains along one of the entrances of Unit 5.

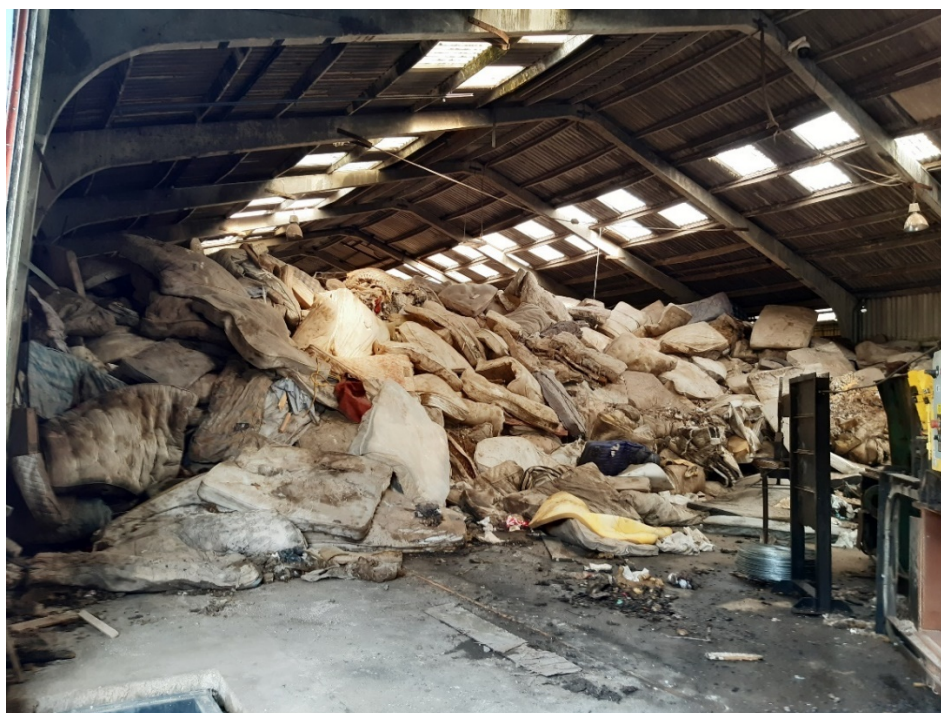
There were significantly large stockpiles of mattresses within Unit 5. Mattress imports were stopped by the operator on 13/10/2023 to reduce the amount inside the unit. The baler has been down for several weeks due to mechanical issues but should be resolved once parts are delivered and fitted in the next couple of weeks.

Officers were able to see a fire break in between two large stockpiles with concrete blocks, however the management of the volumes within the unit must be improved. The current FPMP must be followed, an extract is taken below:

**Photo 2** – mattresses within Unit 5, photo taken by Jak Rose on 17/10/2023.

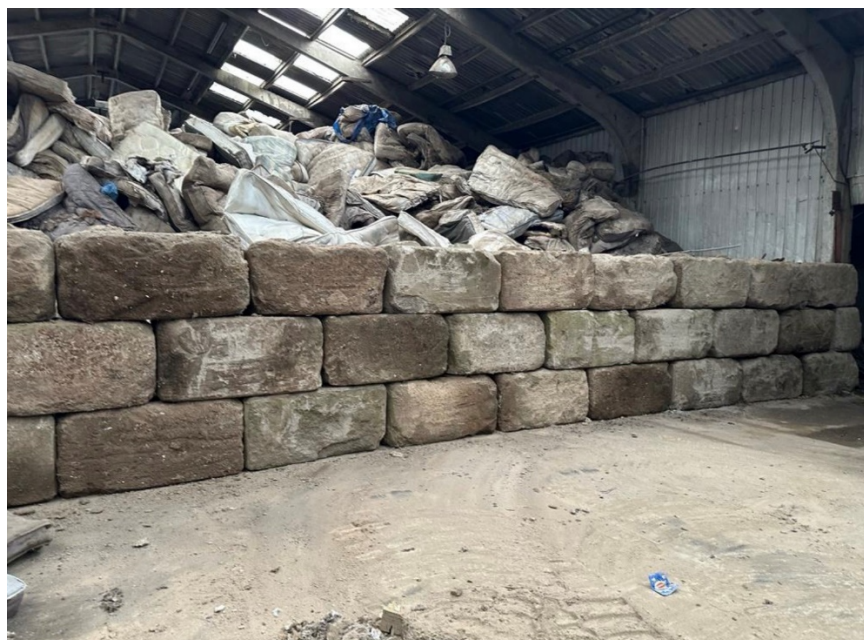
**Photo 3** – provided by operator Milo Thomas on 20/10/2023 showing reduction in mattress stockpile.

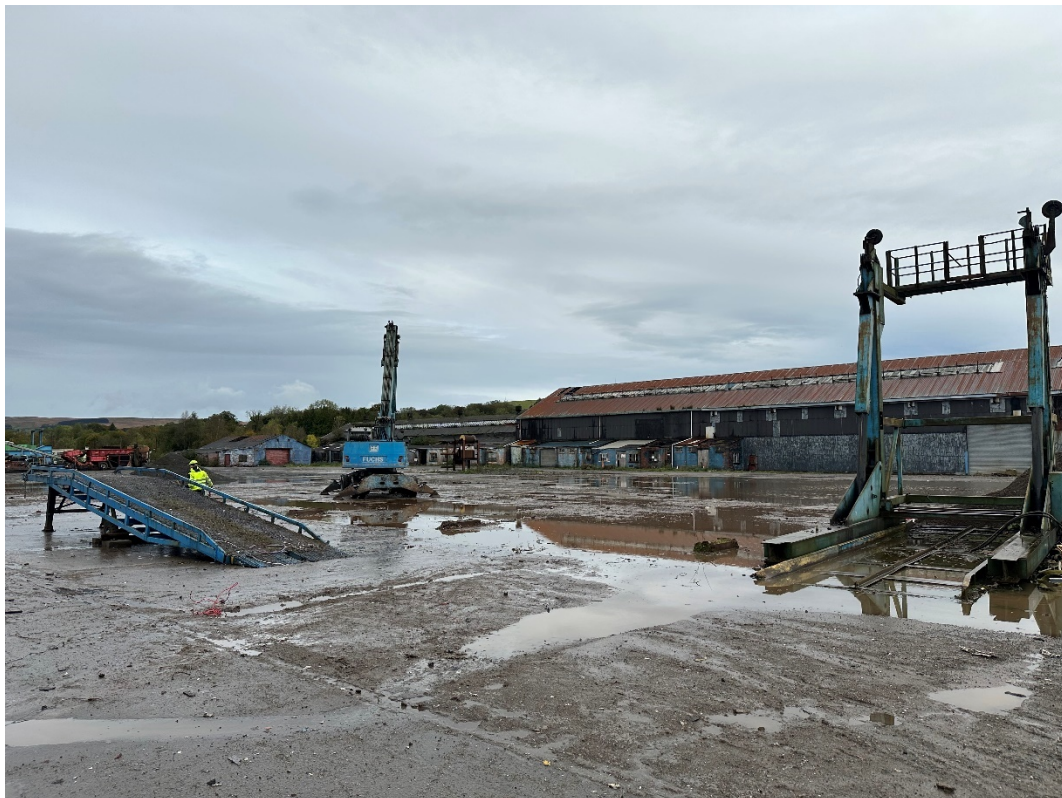
At the time of the inspection there were some bales of cables that had been recently accepted to site. These were stored loosely and were within the permitted area. The cables were removed by 20/10/2023 and a photo showing the area clear. The operator must be reminded that there can only be *specified waste* stored outside of the building.

**Photo 4** – provided by operator Milo Thomas on 20/10/2023 showing outside area.

This area has seen a vast improvement with just a small pile of 19 12 09 remaining outside which is a *specified waste*.

Outdoor areas of permitted areas show signs of wear (cracking/gaps) and therefore not fully sealed. Therefore, any storage of waste in these areas will be an issue for run-off from any wastes stored outside of the building.

The purpose of the newly installed drains would be purely to prevent loss of contaminants through the access doors of Units 5 and 6 to external storm water drains. Please be reminded that any wastes that are stored outside of the building which are not *specified waste* will not comply with the operating techniques and will breach the conditions of the permit. Please adhere to the permit

**Action required:** Ensure that the Operating techniques in Condition 2.3 are always followed. If waste is stored outside, then they must be within a secure container unless they are specified waste.

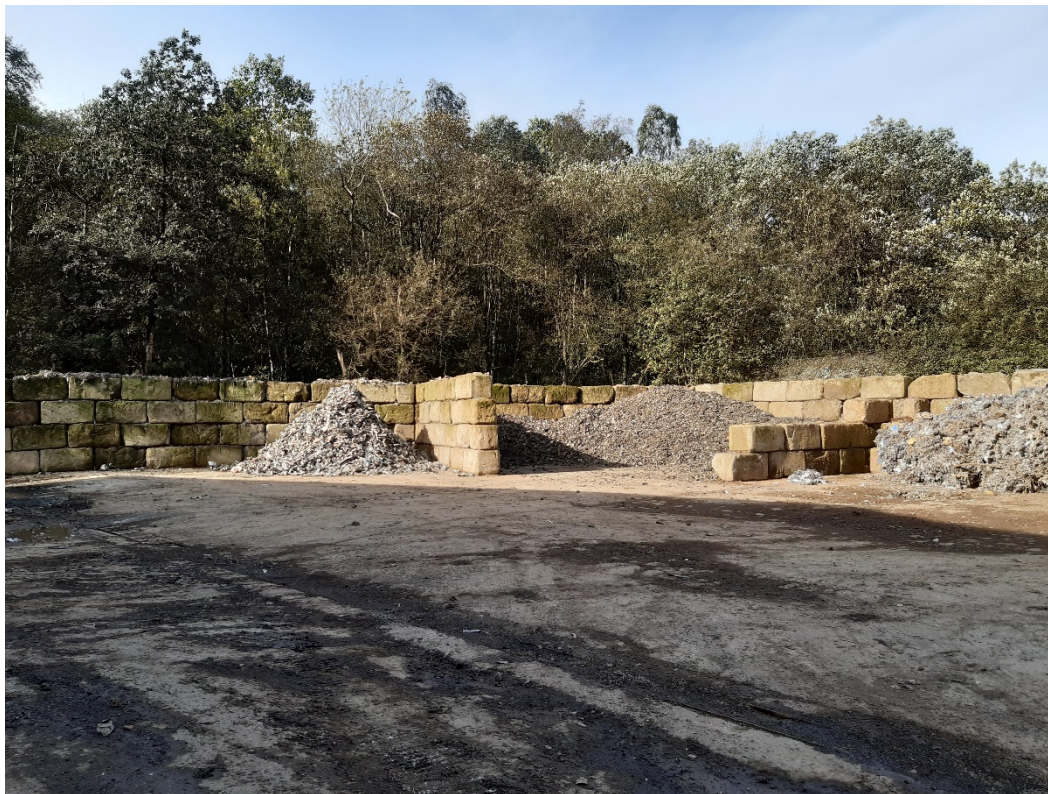
This area to the rear of Unit 6 where materials are stored prior to collection and are therefore stored temporarily. This cannot be used to store material for long periods as it does not benefit from a sealed drainage system.

**Photo 5** – loading out area with various wastes that are not specified waste

The use of the loading area must only be used for the temporary storage of outgoing wastes. It must not be used as an area to store wastes for longer periods as the permit does not allow these waste types as pictured unless it is *specified waste*.

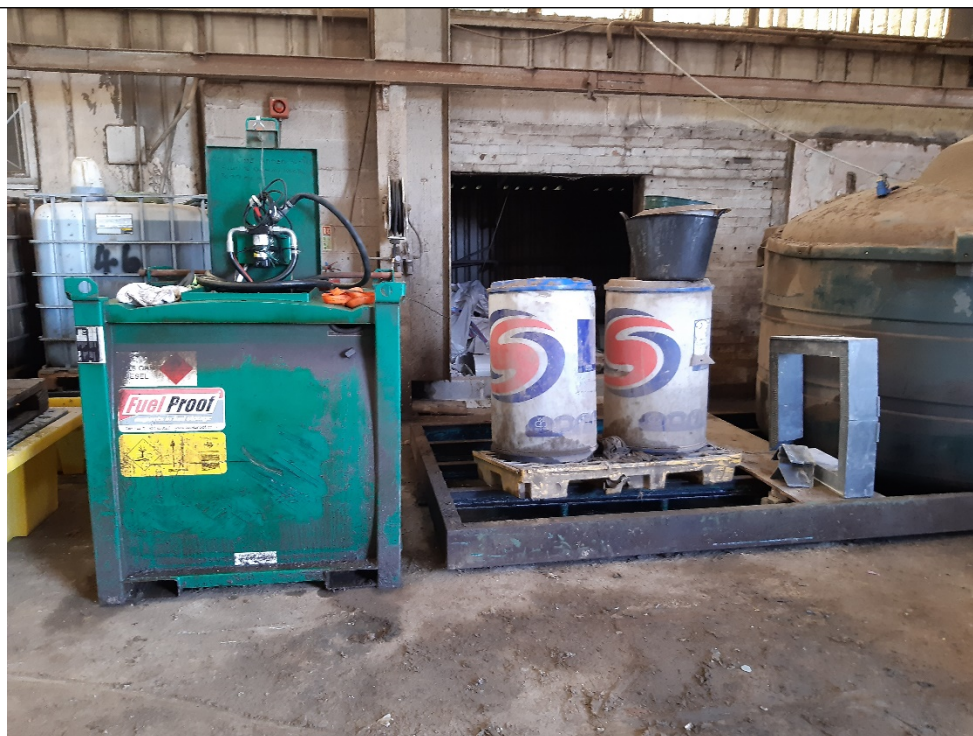
The designated area for fuel storage and oils are now situated on bund trays within the building. Spill kits are stocked and within a reasonable distance from this area.

**Photo 6** – bundled trays with IBCs within Unit 6 and other chemicals placed on them.

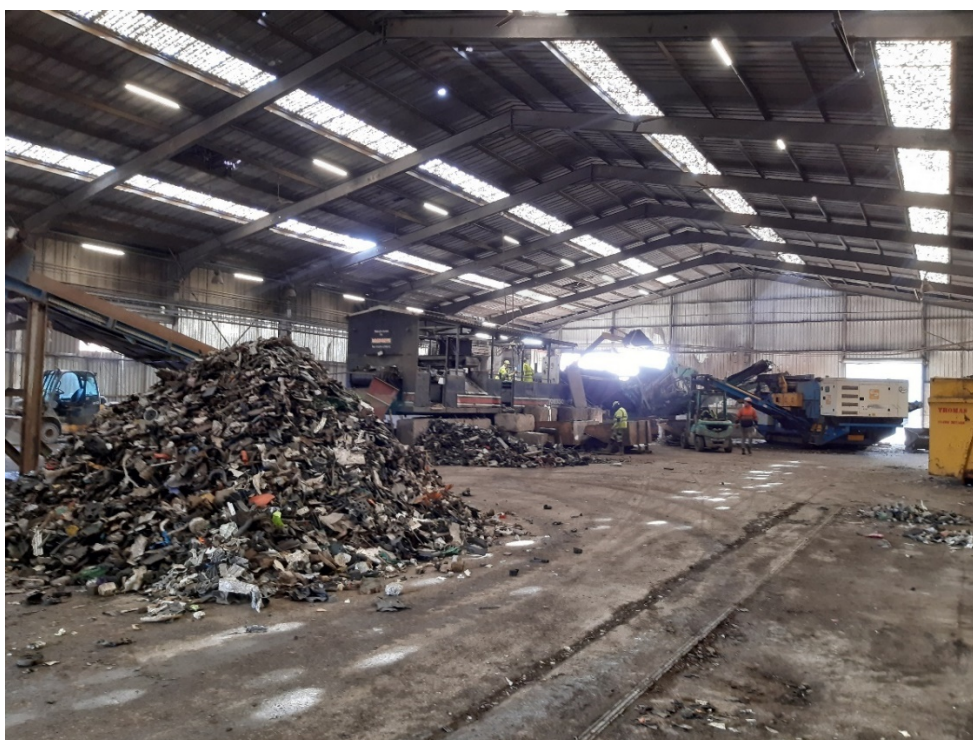
**Photo 7** – processing line within Unit 6, various fractions of metal and fines.

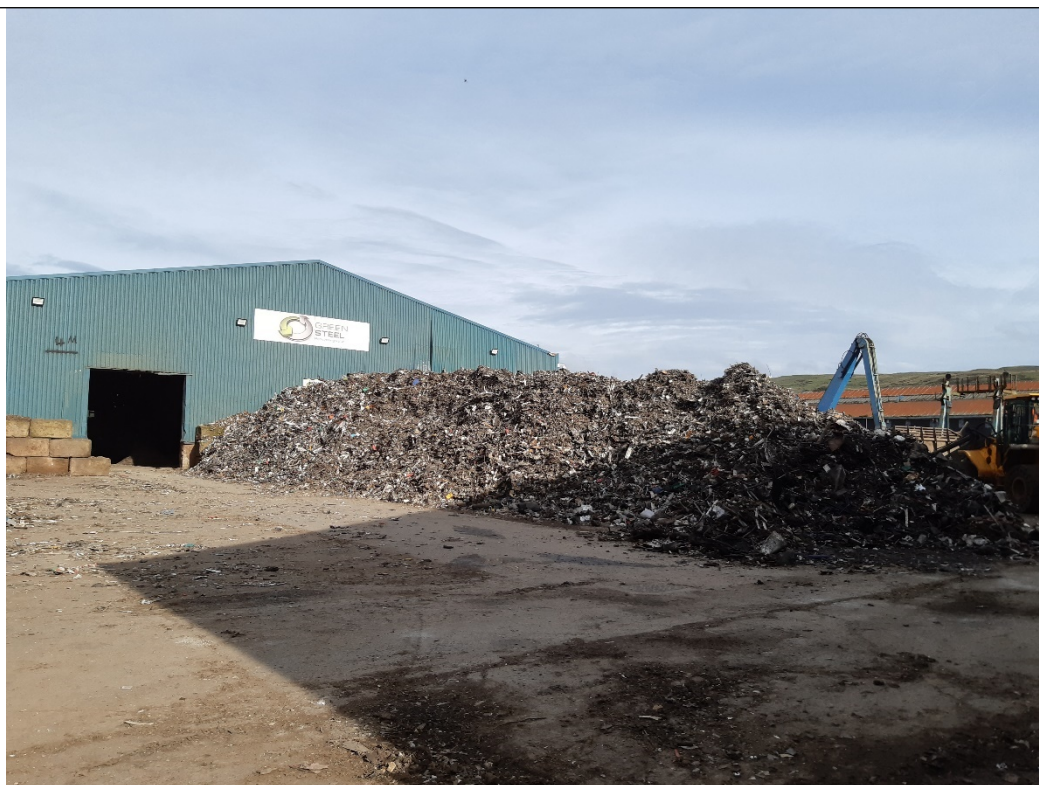
The entrance to Unit 6 had excessive amounts of incoming metal waste and the operator was asked to reduce this as soon as possible. This was partly due to the ongoing drainage works along the entrances within the unit, but they had recently received approximately 220 tonnes which is having to be stored temporarily due to limited access.

**Photo 8** – Photo of feedstock waste in excessive amounts on 17/10/2023.

This matter was communicated before NRW Officers attended site. The operator informed the regulating officer that this is predominantly shredded downstream material 20 01 40.

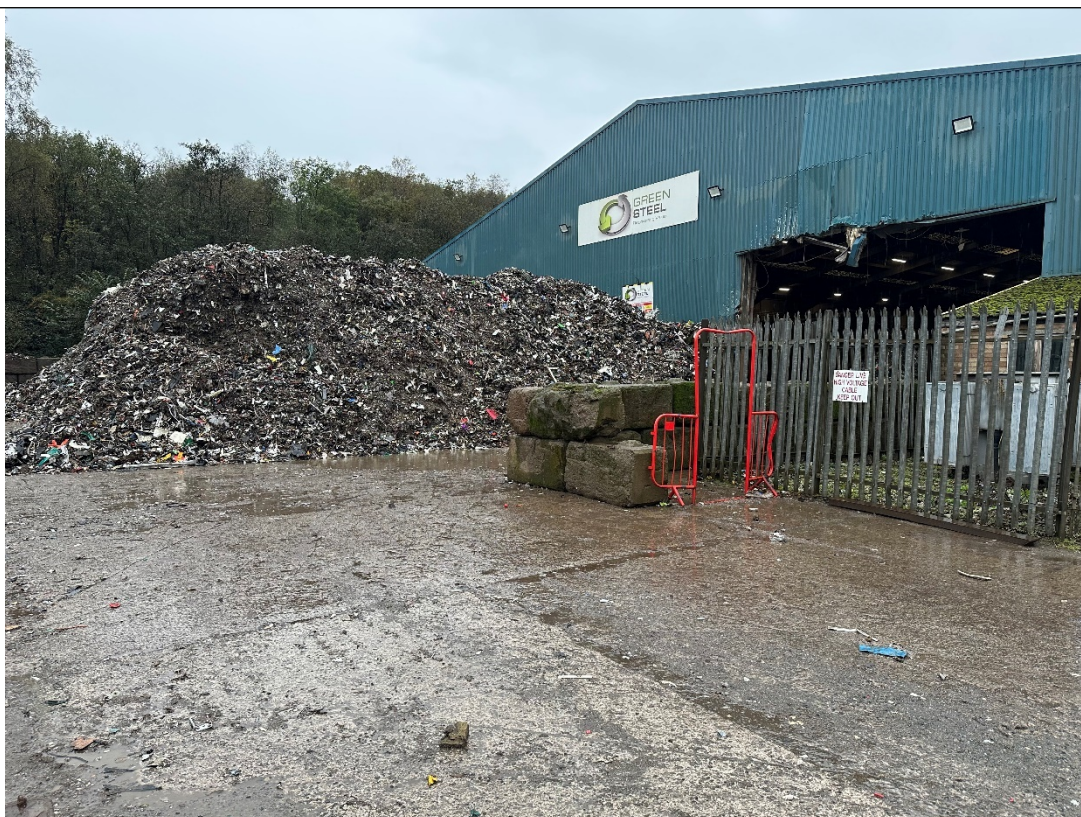
It was apparent that the site had started processing the material through one end of the building, some wastes are currently being stored outside Unit 6 in the bays due to the ongoing drainage works. Once the drainage has been completed it would be expected that no wastes are stored outside unless it is *specified waste* as defined by Condition 4.4 of the permit.

**Photo 9** – taken by Milo Thomas on 20/10/2023 showing reduction of feedstock waste.

The operator advised NRW on previous inspections that that due to height restrictions imposed by roller shutter doors to both units (see photo above) incoming waste may be loaded/unloaded directly in front of buildings. NRW appreciate that wastes may need to be temporarily stored outside of site buildings due to these restrictions. However, looking ahead, the operator may wish to store some wastes in a secure container as outlined earlier in the report. If it is determined that these are being stored outside in the manner that they have done previously, then it will be a breach of the permit. The agreement between NRW and the operator to store these wastes outside *temporarily* cannot be a long-term solution and therefore improvements in the infrastructure and equipment will need to be addressed.
