**Salmon For Tomorrow 2 –  
Llanfair Talhaiarn**

**Llanfair TH Design Philosophy**

290013-ARP-CP-LF-GE-0001

P03 | 22 September 2023

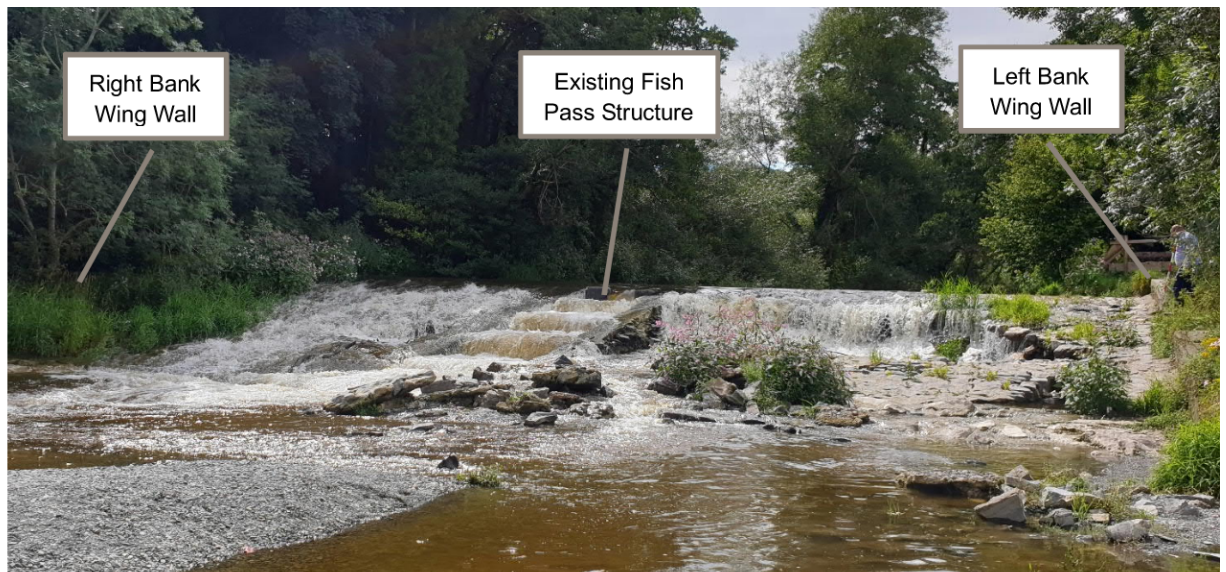
Figure 2 .View of weir from downstream, taken by topographic surveyors, extracted from the Weir Condition Assessment (August 2020).

The weir is in very poor condition having been heavily degraded and is collapsing in some locations. On the left (West) side of the river there are signs of undercutting. Deterioration is also noticeable throughout the rest of the structure, albeit less advanced. The weir has been observed to deteriorate from the start of the design process to the current time. The central fish pass has five steps each of around 0.5m and is not thought to function well, limiting which species and which size of fish can migrate upstream. The poor condition of the weir may cause attraction flows away from the fish pass.

Although the weir is still impounding water, it is expected that the centre and right channels in particular will eventually fail in the same way as the left. A large flood event could cause collapse of the structure. The consequences of such a failure are outside the scope of this and previous studies. It should be noted that only a visual inspection was conducted and it was not invasive.

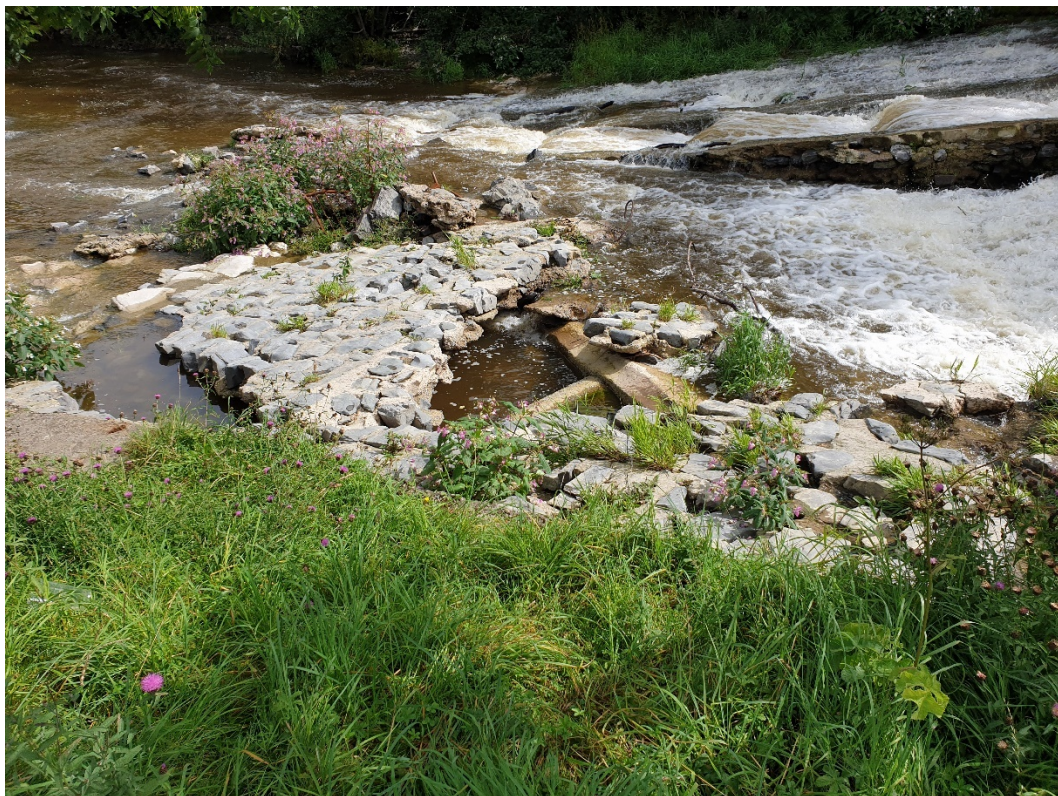
Figure 3: Photo of weir taken during August 2020 site visit

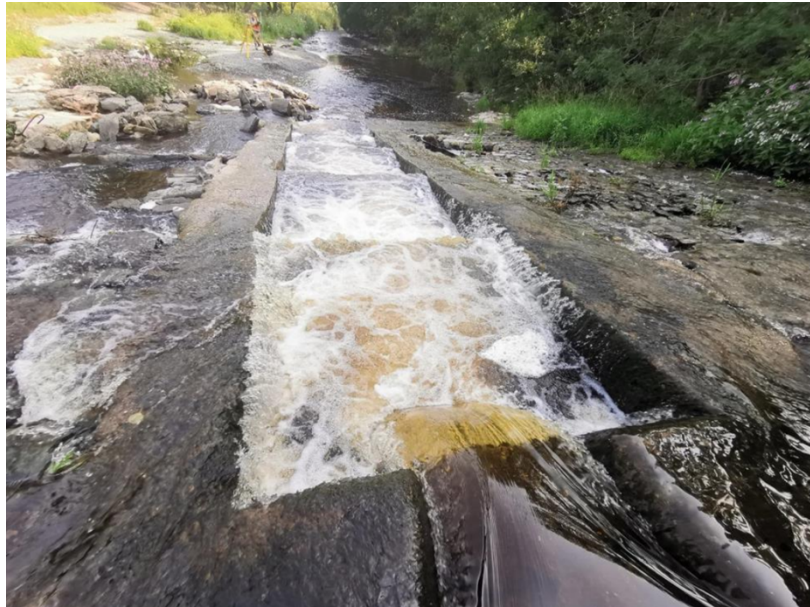
Figure 4. View of weir from upstream, taken by topographic surveyors, extracted from the WCA(August 2020).

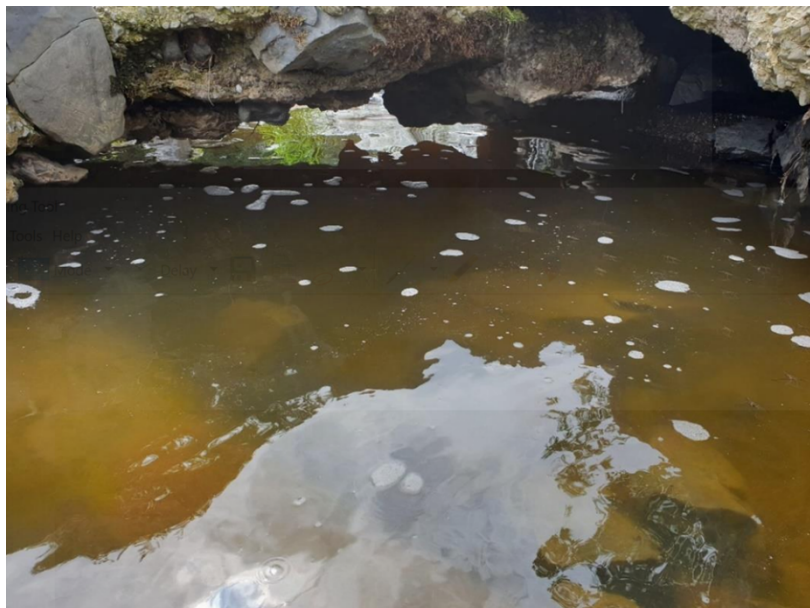
Figure 5. Evidence of undercutting under the upstream left weir channel, extracted from the WCA (August 2020).

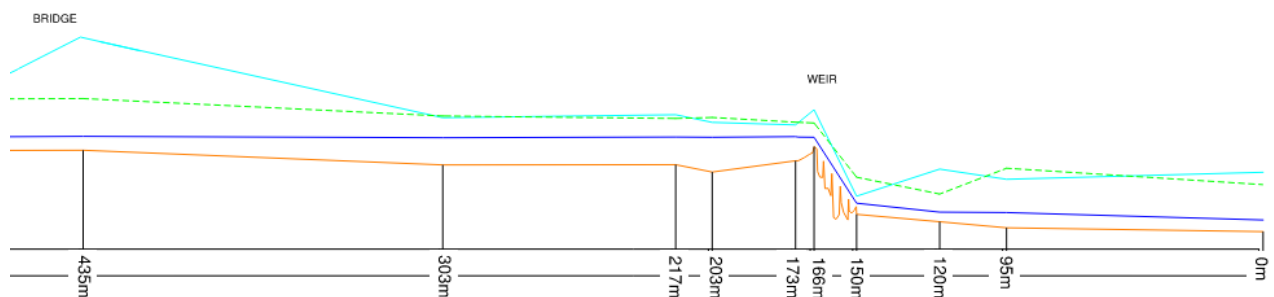
Figure 6. Chainages up the river

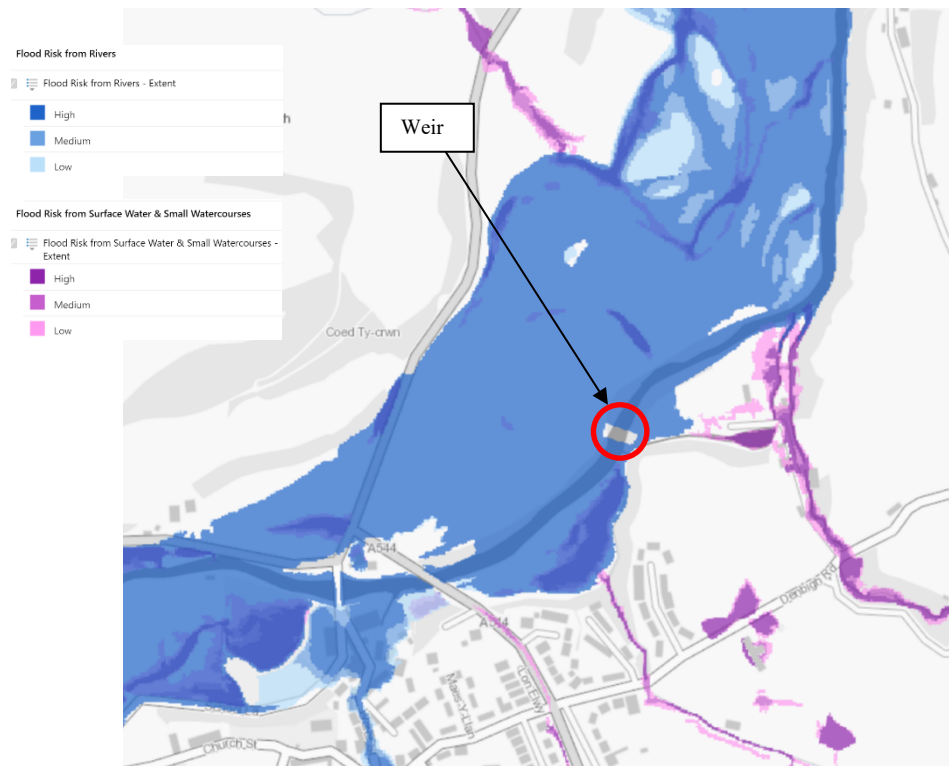
Figure 7: Flood Zone map, extracted from NRW flood risk maps (2021)

The weir is located within flood zones 2 and 3. After the village of Llanfair TH was flooded in February 2020, Arup was appointed under a separate commission by Conwy Borough Council to write a Flood Investigation Report in October 2020. The investigation gave no mention to the weir, thus it can be assumed that there is no flood risk arising due to the weir.

According to the Weir Condition Assessment (2020), although the impact on flood risk due to the weir was not assessed, the risk would be relatively minor as the local flood plain has a high level of connectivity to the river. Thus currently, flood flows will be bypassing the weir.

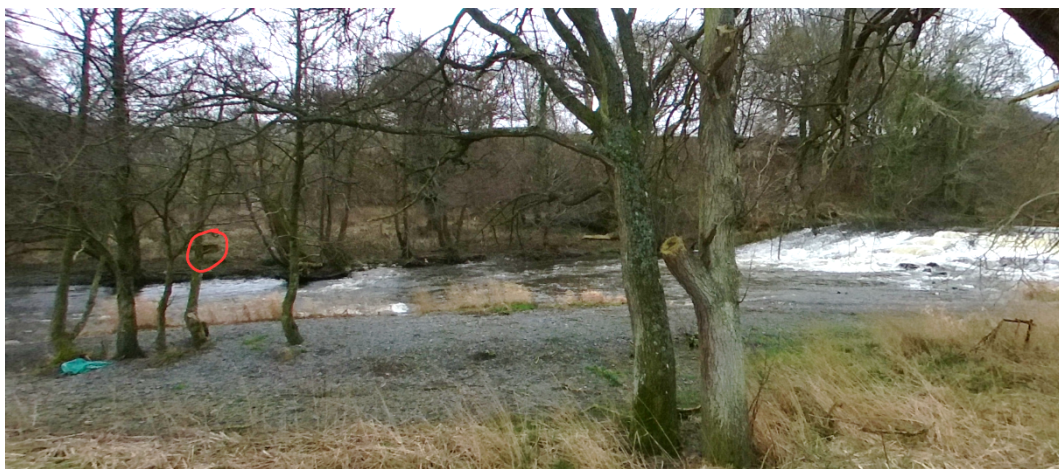
Figure 9: Headwall identified downstream of weir

Two outfalls on the right-hand side are shown on the DCWW mapping. A headwall was identified a combined outfall (Figure 9) approximately 40m downstream of the weir toe on a site visit. It is set back from the river channel and was heavily silted in front of the headwall apron.

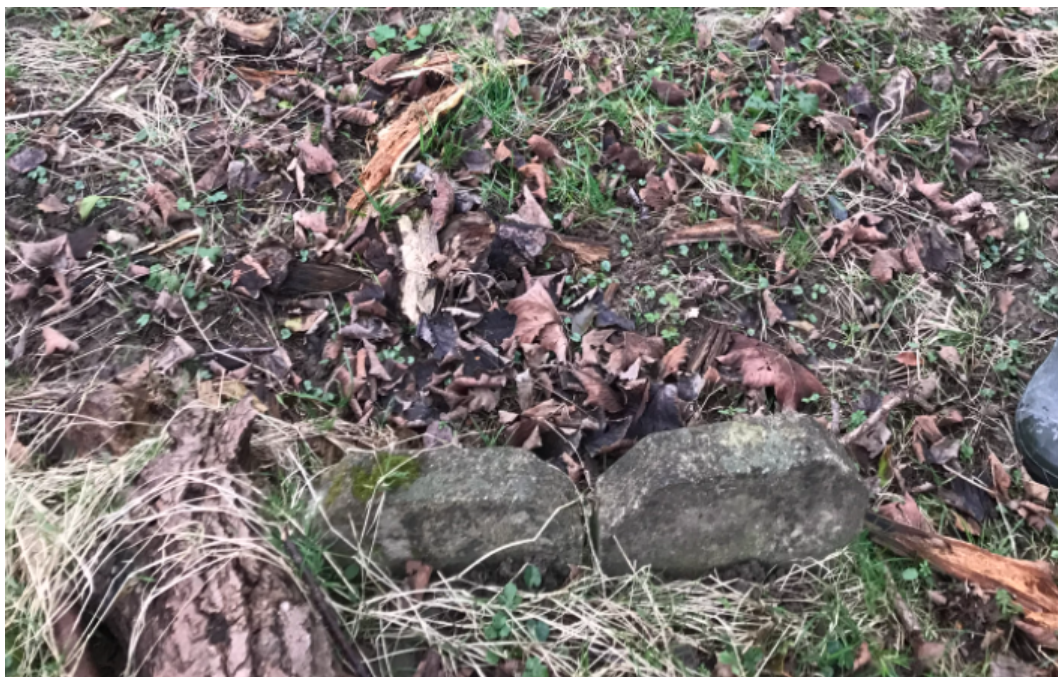
Figure 12: Marker posts indicating presence of buried Welsh Water pipe

A utilities search had previously been carried out at this site by Aecom and since by Arup (November 2021), see Figure 10 and Figure 11 . Of note, a buried water main was located approximately 45m downstream of the Bridge. The depth of the 4-inch diameter pipe is unknown. The presence of the water main was confirmed on site by Arup (February 2022), who identified 3 concrete markers on the banks, Figure 12.
