**EAWML30093  
Mill Services Site  
Site Condition Report (SCR)**

**Application for Permit Variation for  
an Extension of Licensed Area  
under The Environmental Permitting  
(England and Wales) Regulations 2010**

**CELSA Manufacturing (UK) Ltd.  
Cardiff, South Wales, UK**

**Document No R-010-0003 Celsa Minerals Extension Area SCR**

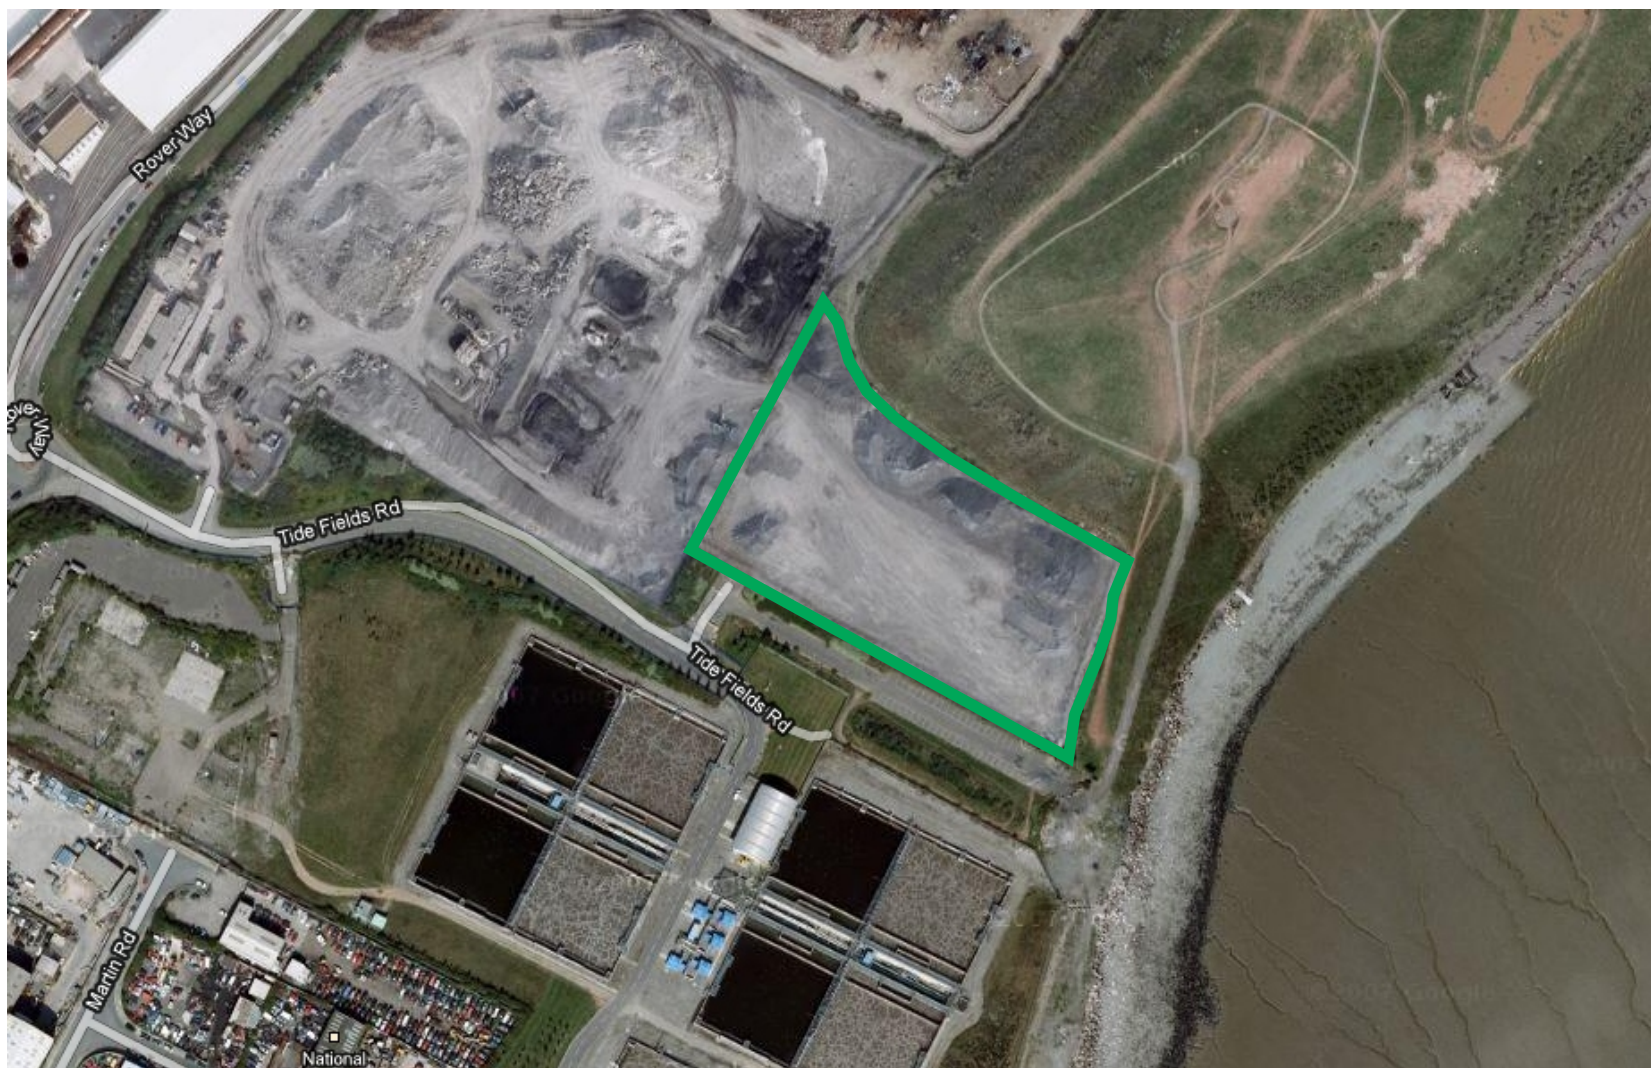
**Figure 2: Site Boundary and  
Layout Plan**

Plans showing the location of installation and the installation boundary are provided in Annex A (Figure 1 Site Location and Figure 2 Installation Boundary and Layout Plan).

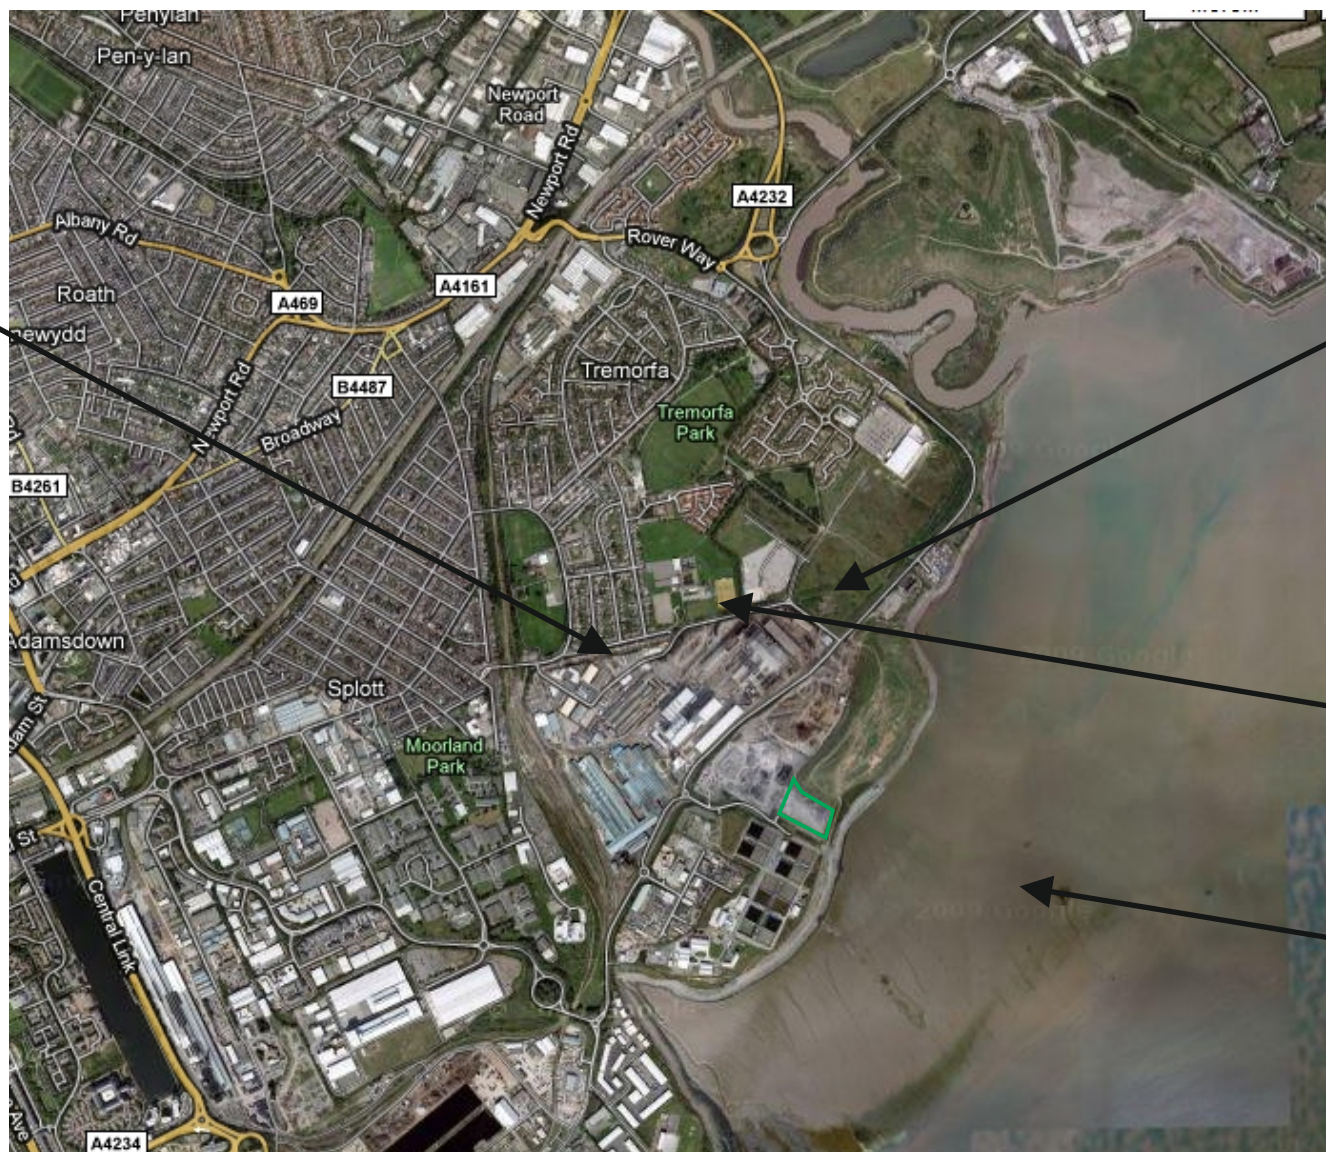
**Figure 3: Sensitive Receptors  
Within 500m**

Nearest Residential  
Housing

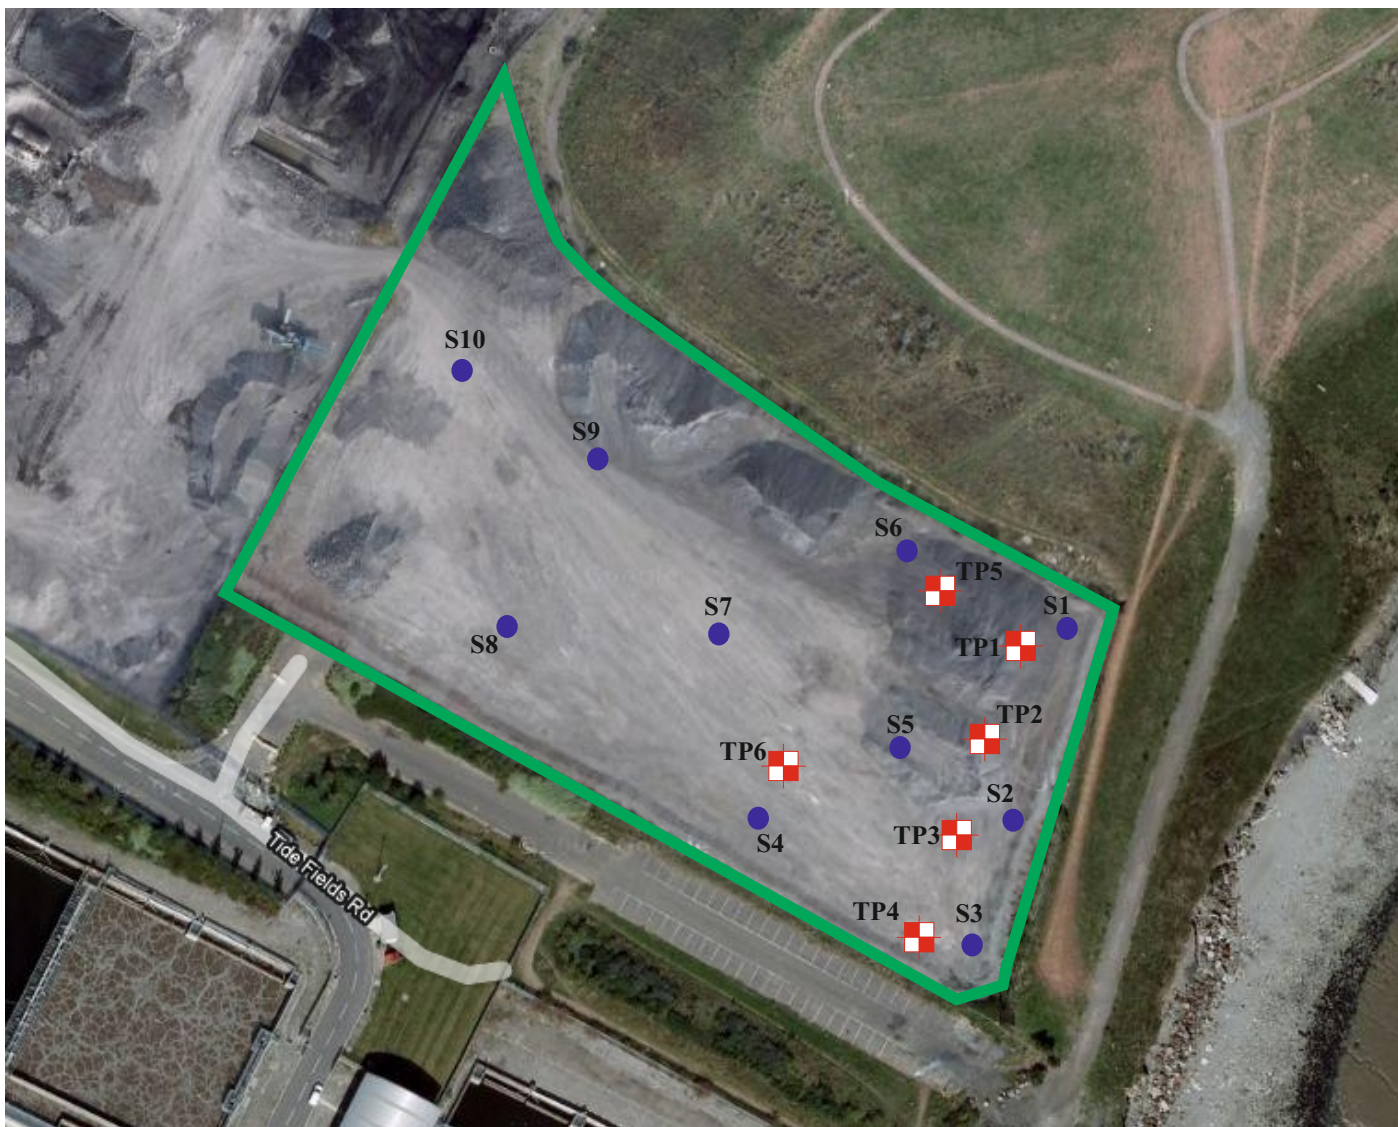
- the excavation of six (6) trial pits (TP1-TP6) to depths 4.0m (TP4) using a JCB-type mechanical excavator in order to permit discrete sampling of soils and to enable the visual assessment of the material in order to ascertain whether any suspect materials (e.g. stained soils, odorous soils or asbestos) were present or if indeed, the material was uncontaminated soil and vegetation as stated. The trial pits following excavation and sampling were backfilled to ground level with the excavated material.

- Site Boundary
- Surface Soil Samples
- ✖ Trial Pits
