Carew Quarry ROMP Review

Appendices Volume 2

December 2012

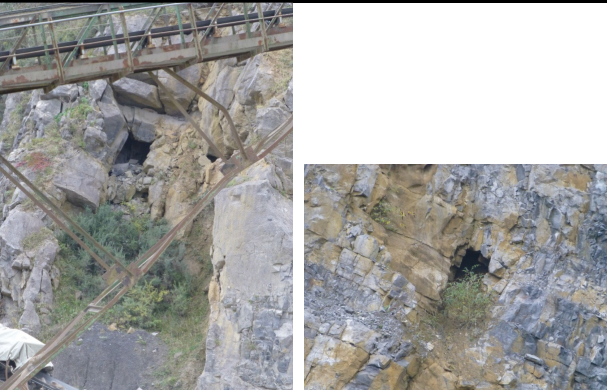
Target Note Number	Description	Photo
1	<p><u>Solution Holes</u> Rock fissures and solution holes x 4 in collapsed bedding planes or where blocks have fallen. The holes are approximately 1.5m x 2m in dimensions and of undetermined depth. They are situated at height (>20m) in vertical cliffs within the operational quarry.</p>

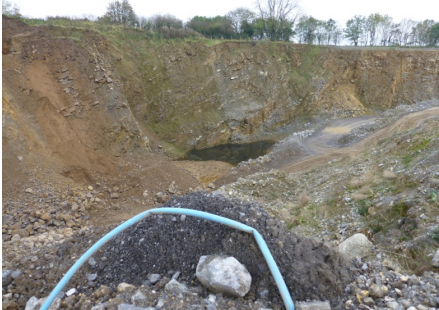
2	<p><u>Waterbody</u> Formed in part of the quarry floor which has been recently excavated. Approximately 30m x 10m in area and of recent origin. No aquatic vegetation is present.</p>

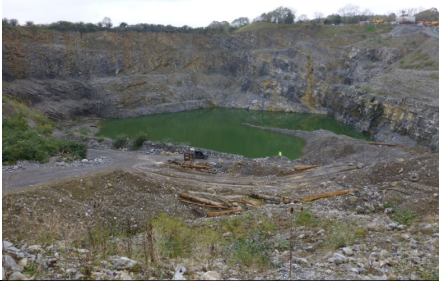
3	<p><u>Waterbody</u> Flooded quarry void. Approximately 100m x 60m in area and of unknown depth. No aquatic vegetation is present. A small amount of buddleja (<i>Buddleja davidii</i>) scrub is present on the bank.</p>

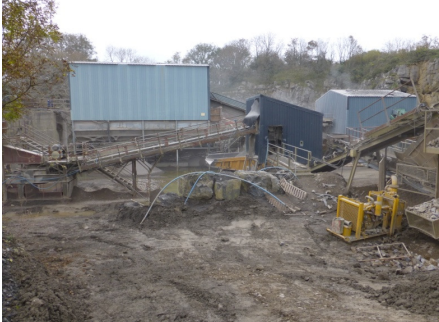
4	<p><u>Processing Yard</u> An area of un-vegetated crushed aggregate with rock crushing and concrete batching equipment used for making concrete products. No vegetation is present and the area is subject to and high levels of activity and noise.</p>

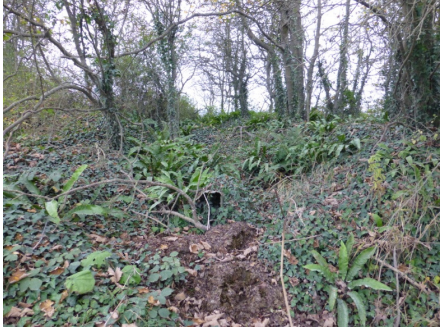
<u>Scrub and trees</u>		
6	<p>Growing on a long unworked cliff overlooking the active plant area. Dominated by blackthorn (<i>Prunus spinosa</i>), ivy and bramble (<i>Rubus fruticosus</i>), abundant sycamore and red valerian (<i>Centranthus ruber</i>). Frequent semi-mature and seedling ash, English oak (<i>Quercus robur</i>), occasional western gorse (<i>Ulex gallii</i>), teasel (<i>Dipsacus fullonum</i>), pendulous sedge (<i>Carex pendula</i>), barren strawberry (<i>Potentilla sterilis</i>) and a locally dominant patch of montbretia (<i>Crocsmia x crocosmiiflora</i>).</p>

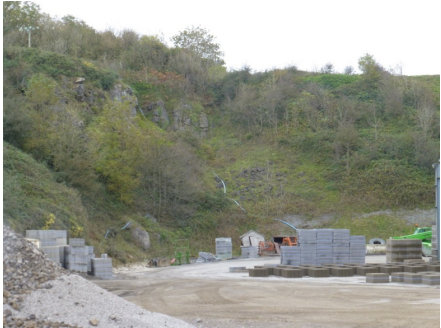
<u>Developing calcareous grassland on cliff slope.</u>		
7	<p>With abundant cock's foot and occasional ragwort (<i>Senecio jacobea</i>), ribwort plantain (<i>Plantago lanceolata</i>), rough hawkbit (<i>Leontodon hispidus</i>), bristly ox tongue (<i>Picris echioides</i>), birds foot trefoil (<i>Lotus corniculatus</i>), creeping cinquefoil (<i>Potentilla reptans</i>), teasel and curled dock</p>

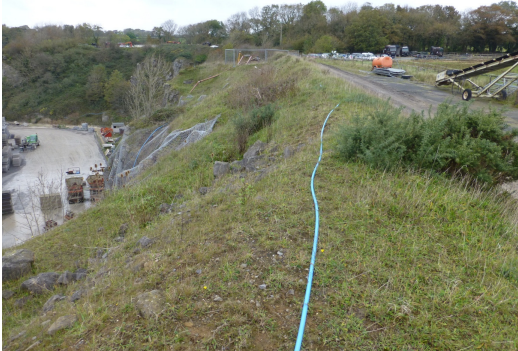
Target Note Number	Description	Photo
10	<p><u>Ruderal vegetation on bund</u></p> <p>With frequent false oat-grass (<i>Arrhenatherum elatius</i>), common nettle, cock's foot and common bent (<i>Agrostis capillaris</i>) with ragwort, common figwort (<i>Scrophularia nodosa</i>), teasel, silverweed and bramble.</p>
