<b>Job Title</b>	<b>Newport Transporter Bridge</b>		
<b>Job Number:</b>	<b>2376</b>		
<b>Subject:</b>	<b>Otter Fencing</b>		
<b>Prepared by:</b>	<b>SS</b>	<b>Approved by:</b>	<b>PMcC</b>
<b>Date:</b>	<b>25/05/2021</b>	<b>Date:</b>	<b>26/05/2021</b>

This document summarises the available background information, the proposed compound fencing, and the recommendations to reduce the risk of otter access into the working areas on both embankments.

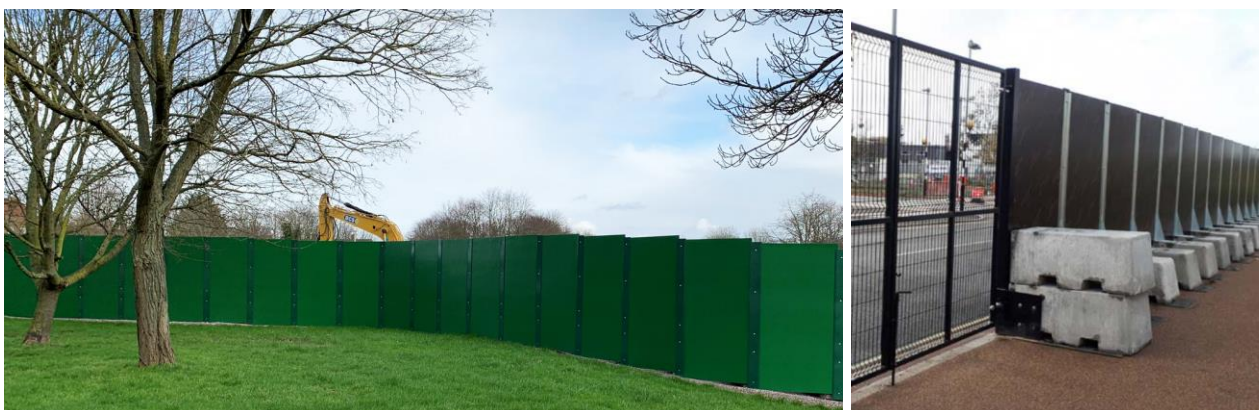
The site compound and works area on the western embankment covers the existing visitor centre, car park area, and informal amenity area. The site compound and work area will be fenced to the non-river sides using a non-dig 'hoard-it' solution, as shown below:

This fencing provides a solid barrier that is 2.0m tall with panels secured between full length uprights supported by concrete blocks. The panels are designed to sit at ground level with no gap beneath.

This fencing is taller than standard otter resistant fencing, which is 1.5m tall, with a 0.3 cranked section, and therefore is considered sufficient to reduce the likelihood of otters attempting to climb over the fence. The solid nature of this fencing further reduces this as there would be no visual encouragement for them to do so.

The western embankment site is uneven in places and some small gaps may occur with the hoard-it option. To ensure that there is minimal risk of otters attempting to access the site through these, sand and/or gravel bags can be pushed into and against these gaps from inside the compound area. These would block the gaps without being easily moved by otters and can be monitored and repaired easily during the construction period. Where there are larger gaps, plyboard panels can be pinned between the hoarding and the sand/gravel bags as an additional measure.

It is noted that there is no below ground element to this fencing, which is part of standard otter resistant fencing in the form of a 500mm below ground section with a 300mm underground return. However, this standard fencing specification is designed for permanent use and where otter passage is being prevented, neither of which apply in this instance. The measures detailed above to ensure that there are no gaps beneath the hoard-it fencing are considered sufficient to minimise the likelihood of otters attempting to access the site beneath the fencing.

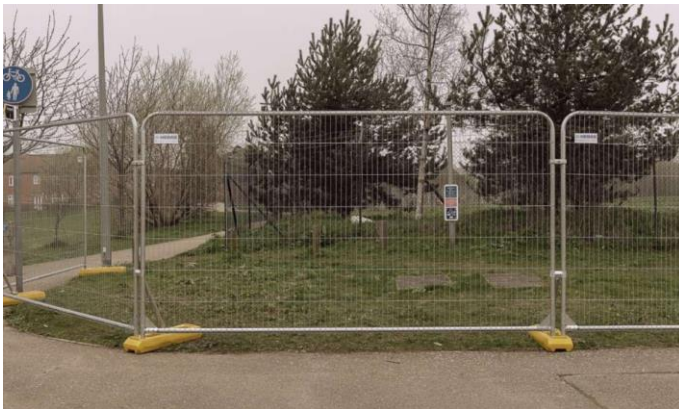
The river side of the western embankment area is to be fenced with the Heras HSG 151 System, as shown below:

This fencing is more open than the hoard-it approach but is more flexible and therefore allows fencing to be adjusted to permit drainage outfall and retaining wall works.

This fencing provides a fencing height and small mesh size comparable to standard otter resistant fencing, with the gaps between panels also small enough to limit otter egress. Where gaps are over 200mm wide, 25mm galvanised wire netting will be attached to the outside of the fencing and tie wired into place for the full length of the panel.

The gaps at the base of the fencing will be addressed by adding 25mm galvanised wire netting to the bottom of each panel, on the outside of the fencing, using tie wires or similar to fix these in position. This netting will overlap at the edges of each panel and be tie wired in place, as well as extending over the ground at the base of each panel by a minimum of 500mm creating an above ground 'return'. This overlap will be either battened or pinned down depending on the ground surface. Sand and/or gravel bags, or similar weighted items will be used where netting does not sit flush with the ground. This overlap will also be attached to access gates and weighted down appropriately at the end of each working day. This netting will act in a similar way to the below ground section and return of standard otter resistant fencing, preventing otters from digging beneath the fence to access the site.
