GEOENVIRONMENTAL DESK STUDY REPORT

Plot B The Airfields Deeside

4671-JPG-XX-XX-RP-G-0644-S2-P01

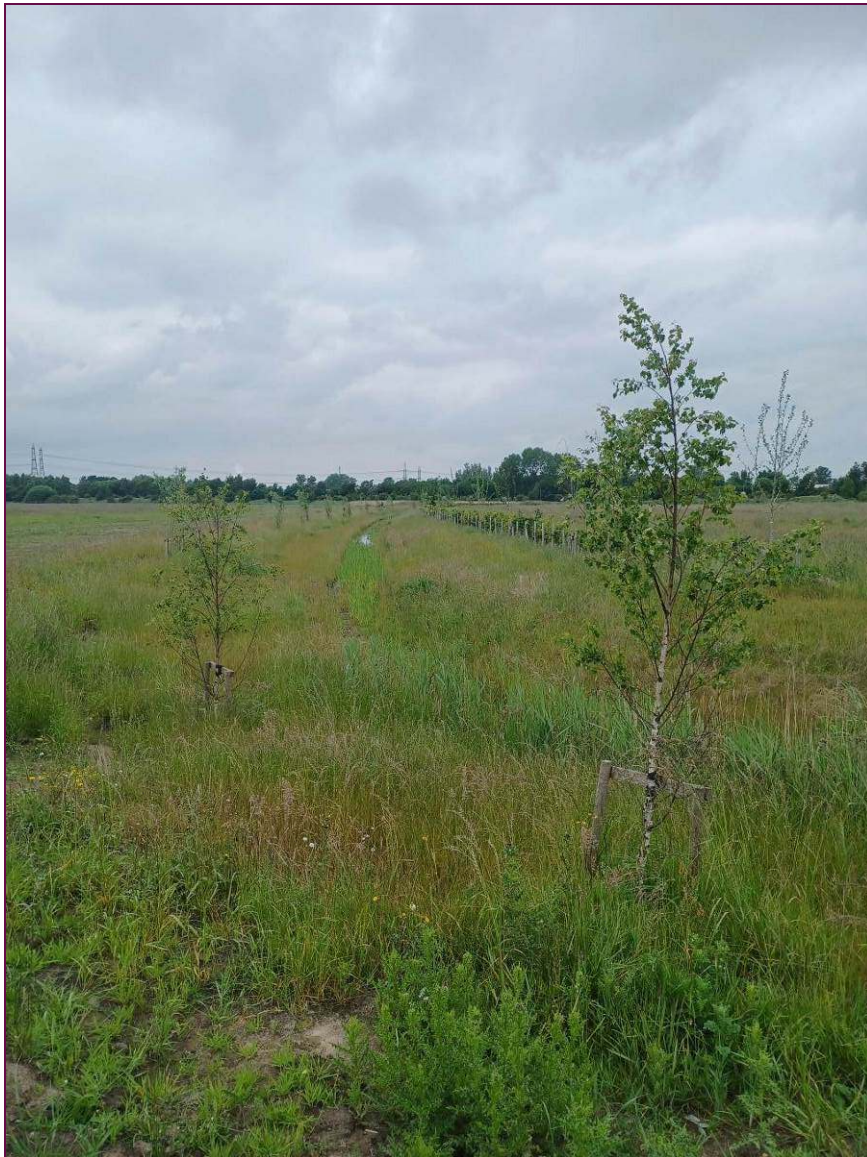
Photograph 4: View looking north towards the Swale, along the site's eastern boundary.

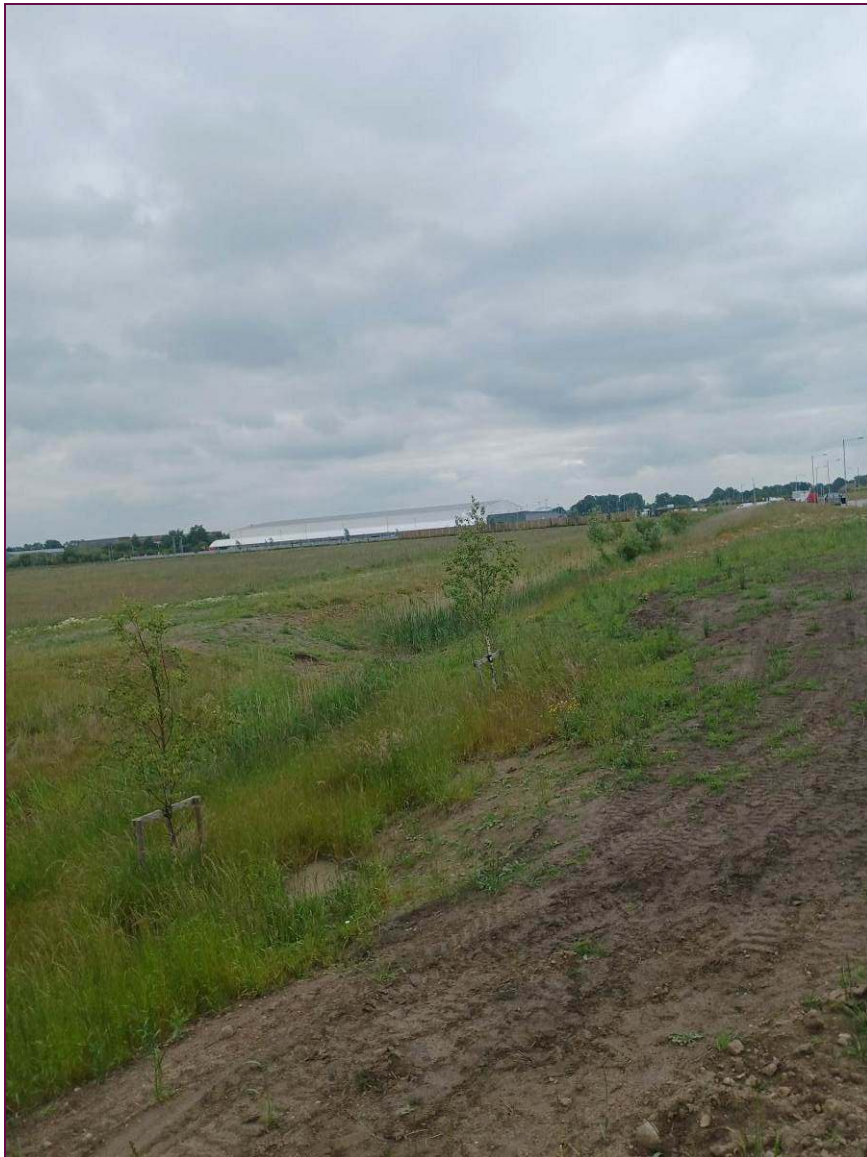
Photograph 6: View looking east towards the swale bordering the site's southern border.
