## Compliance Assessment Report CAR\_NRW0043024

**Permit being assessed:** AF4027401

For: TIRYBERTH COUNCIL DEPOT NEW ROAD TI, held by CAERPHILLY COUNTY BOROUGH COUNCIL

**Type of assessment carried out:** Site Inspection, Reason: Routine.

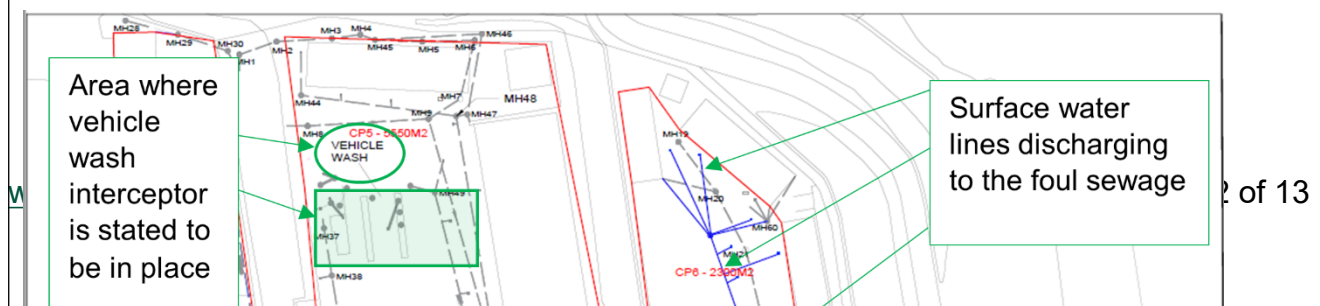
Figure 1 – Tiryberth Council Depot site plan provided by CCBC on 13/12/2023.

I confirmed with CCBC staff that the wastewater treatment system is a bio-disc unit, but they were unsure on the make, model or capacity. This system serves all foul/wastewater from site but also takes some of the surface water from one section of the site around buildings B8, B9, B10 and B11. An updated site plan was provided, on which CCBC staff highlighted the area in question as seen in Figure 1. CCBC staff are aware that this surface water should not be discharging to the treatment system and have been given actions from the previous visit to redirect surface water to an appropriate drainage system and not to discharge to the foul water system. At the time of the visit it was noted that these surface water flows still discharge to the foul drainage system and subsequently are processed through the sewage treatment system.

It was made clear that the runoff from the car washing facilities on site (used to maintain CCBC's fleet vehicles only) does not discharge via the sewage treatment system but via a surface water line. It was stated that an interceptor was in use. This can also be seen in Figure 1.

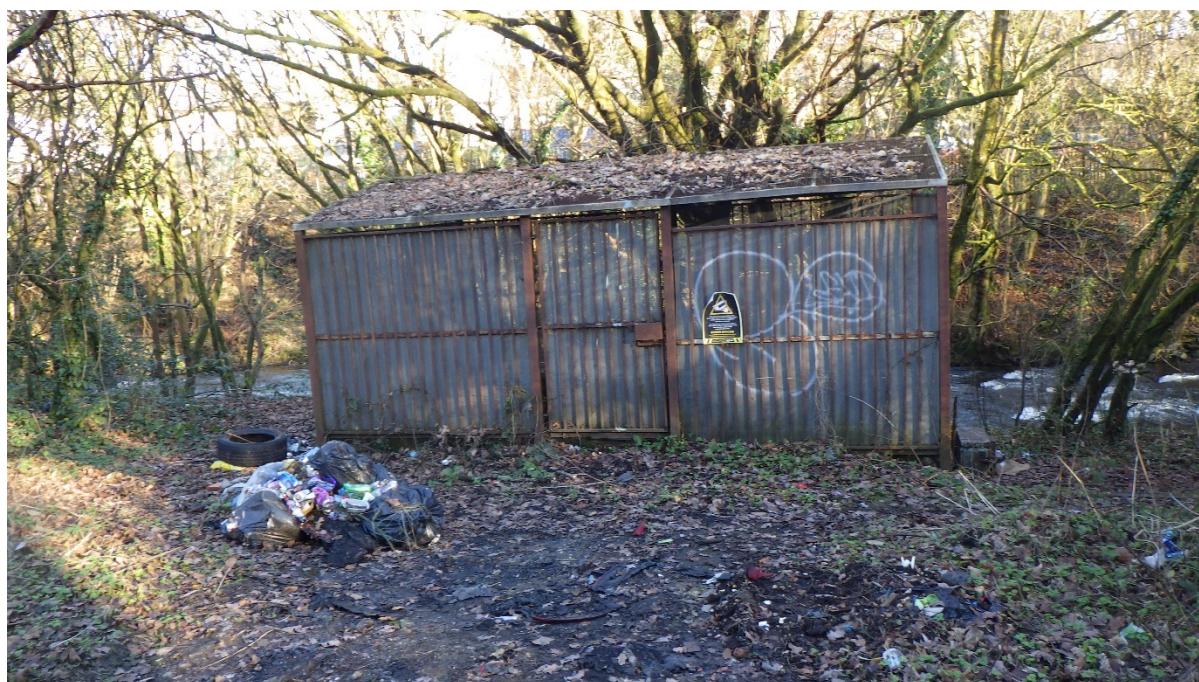
Figure 2 – Site visit photo: The secure compound where the treatment system is located.

The sewage treatment system itself is located within a secure compound off site at ST1530296949 as seen in Figure 2. The discharge from the system was previously monitored/sampled monthly but is now undertaken quarterly.

| Criteria | Action needed | Complete by |
|---|---|---|
| WQ-A1 | Access to the sewage treatment system was very limited at the time of the visit, having to access the compound via a small side door. Please ensure that the compound is accessible from the primary door at the front of the building to facilitate efficient and safe access for future maintenance and assessments. | 29/02/2024 |

1. Access to the sewage treatment system was very limited at the time of the visit, having to access the compound via a small side door. Please ensure that the compound is accessible from the primary door at the front of the building to facilitate efficient and safe access for future maintenance and assessments.

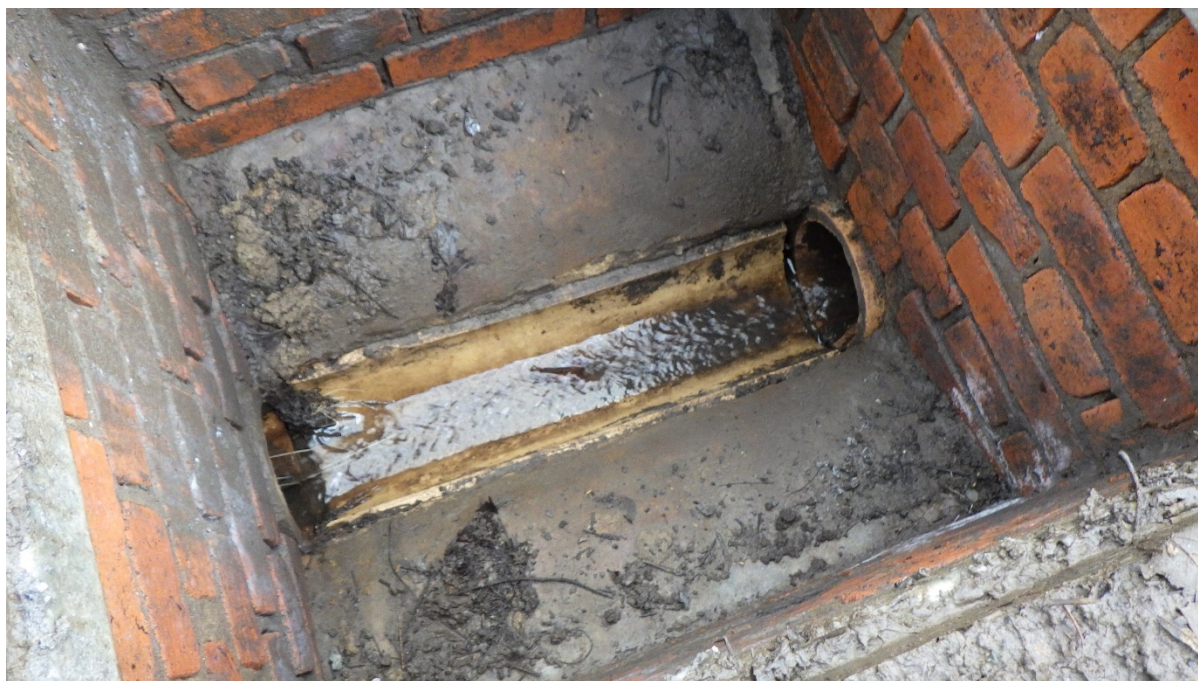
Figure 3 – Site visit photo: The final treated effluent as seen from the sampling point chamber before it is discharged to the Rhymney River.

It was stated the discharge composition has always been within consent limits, but the discharge volume has consistently been higher than the contested limits due to the ingress of surface water. There is currently no flow monitoring being undertaken at the site. The system is checked daily to ensure it is operational and working as designed with a yearly service undertaken by Egan Waste. It is noted that the permit does not contain any sampling, servicing or maintenance conditions.

The sampling point was located at ST1530796941 and was fully accessible. CCBC staff lifted the manhole cover so that flow could be observed. The flow itself appeared clear with no particulate matter or untreated effluent present. The discharge rate was very high at the time of the visit, with CCBC staff noting that it is the highest they have ever seen it. This is evidenced in Figure 3.

**Justification:** From visual observations and the understanding that surface water discharges are being made via the sewage treatment system it is clear that the discharge rate is greater than the limit outline in the permit.

| Criteria | Action needed | Complete by |
|---|---|---|
| WQ-B1 | Inform NRW on if/when the improvements opportunities identified by Arcadis will be scheduled for completion. | 19/03/2024 |

1. Inform NRW on if/when the improvements opportunities identified by Arcadis will be scheduled for completion.

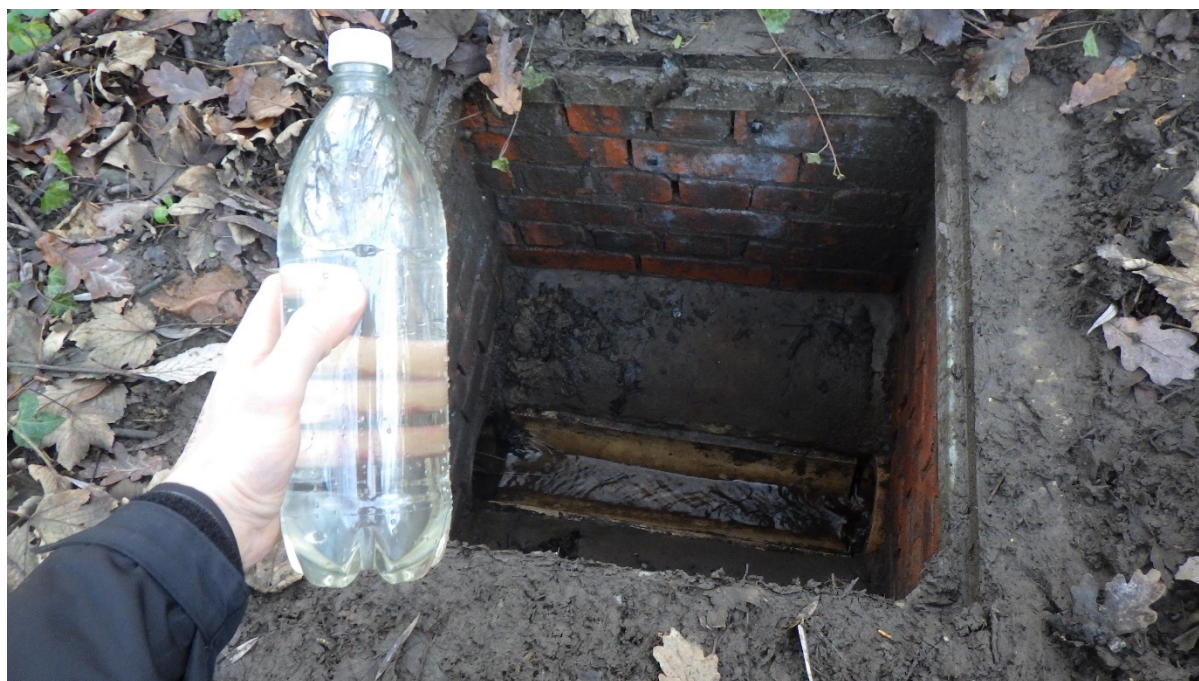
Figure 4 – Site visit photo: Water quality sample taken during the site visit.

While on site I took a water quality sample of the final treated effluent from the monitoring point to check if the increased flow due to surface water ingress has had a significant

impact of the quality of the discharge. The sample taken can be seen in Figure 4. Visually the sample was clear with very minimal suspended solids or visual sewage material. The sample results as seen in Table 1 below show that the discharge is within compliance on all parameters outlined in the permit conditions.

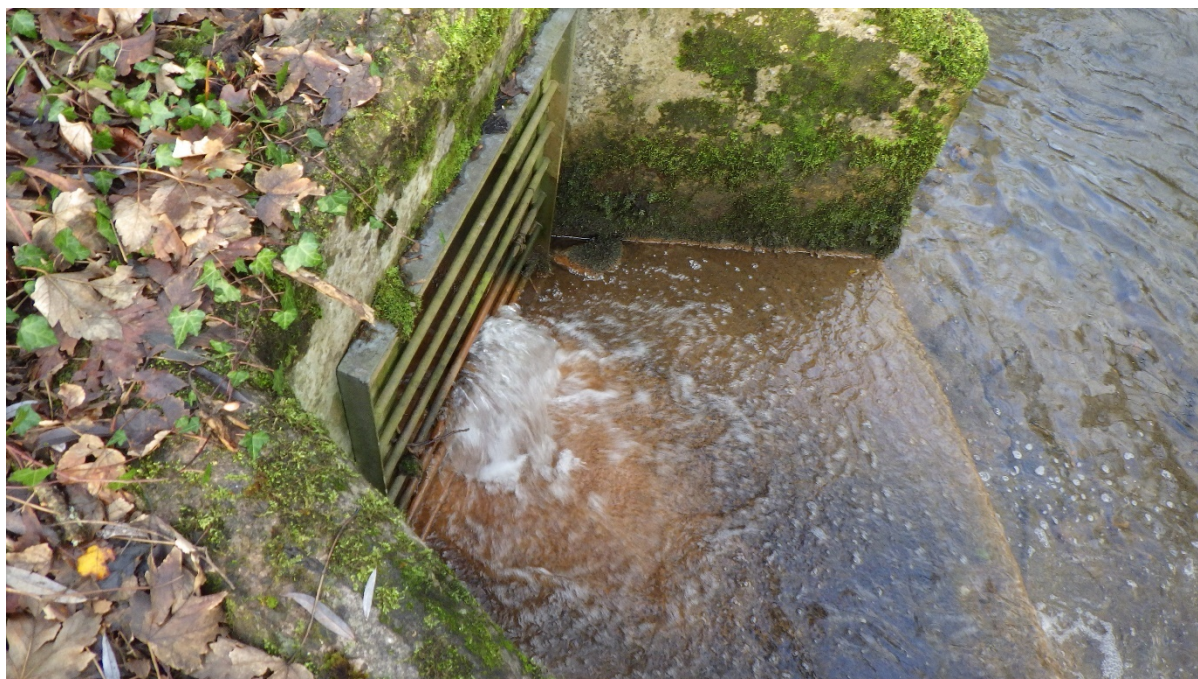
Figure 5 – Site visit photo: The discharge point as observed during the visit.

The discharge point to the Rhymney River was checked and was observed to be clear of any pollution or evidence of sewage material. It is noted that the outfall is also the discharge point of a DCWW surface water line, hence the visibly increased flow apparent, as seen in Figure 5. The river was also clear of any pollution, as seen in Figure 6.
