LIFEDeeRiver

Restoration of Freshwater Features

Horseshoe Falls Weir

Final Report

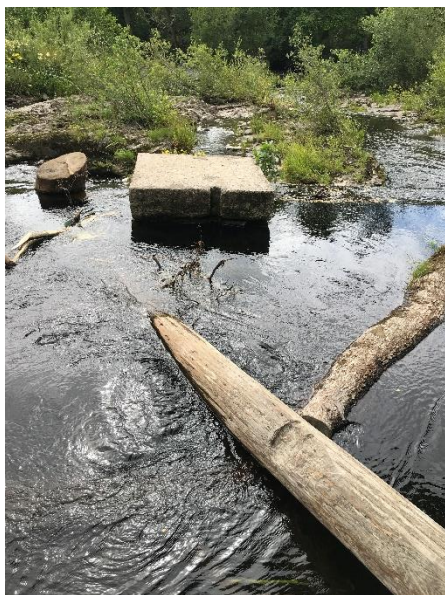
Plate 4-11. Structure in channel at weir (one end of where stoplogs can be inserted to dry up channel to canal for when that is maintained)

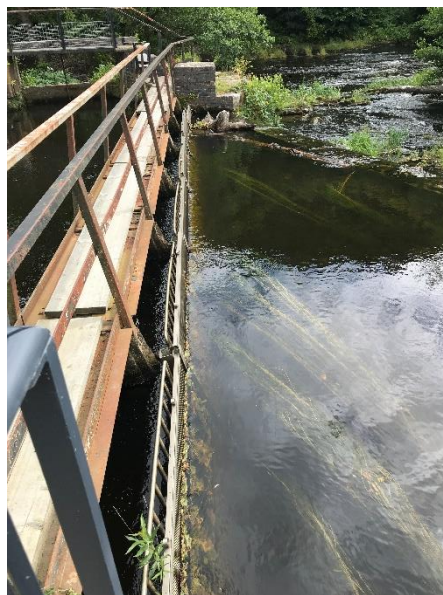
Plate 4-12. Screens at entrance to canal feeder stream

The abstraction for this is managed by CRT. The existing screens are not compliant with the Eels (England and Wales) Regulations 2009, for which an exemption has been granted by the EA. United Utilities are currently investigating the provision of new screens to prevent eel entrainment at the abstraction from the River Dee into the canal feeder stream. It is understood that the current preferred screening option also entails notching the weir just downstream of these screens to help prevent trash building up at the screens.

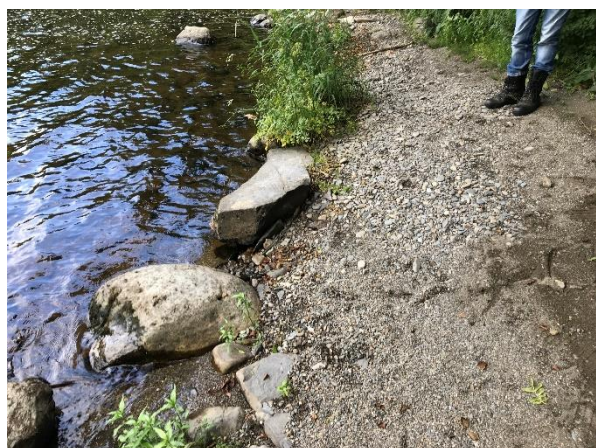
Plate 4-26. Deposited materials downstream of Horseshoe Falls weir (RHB)

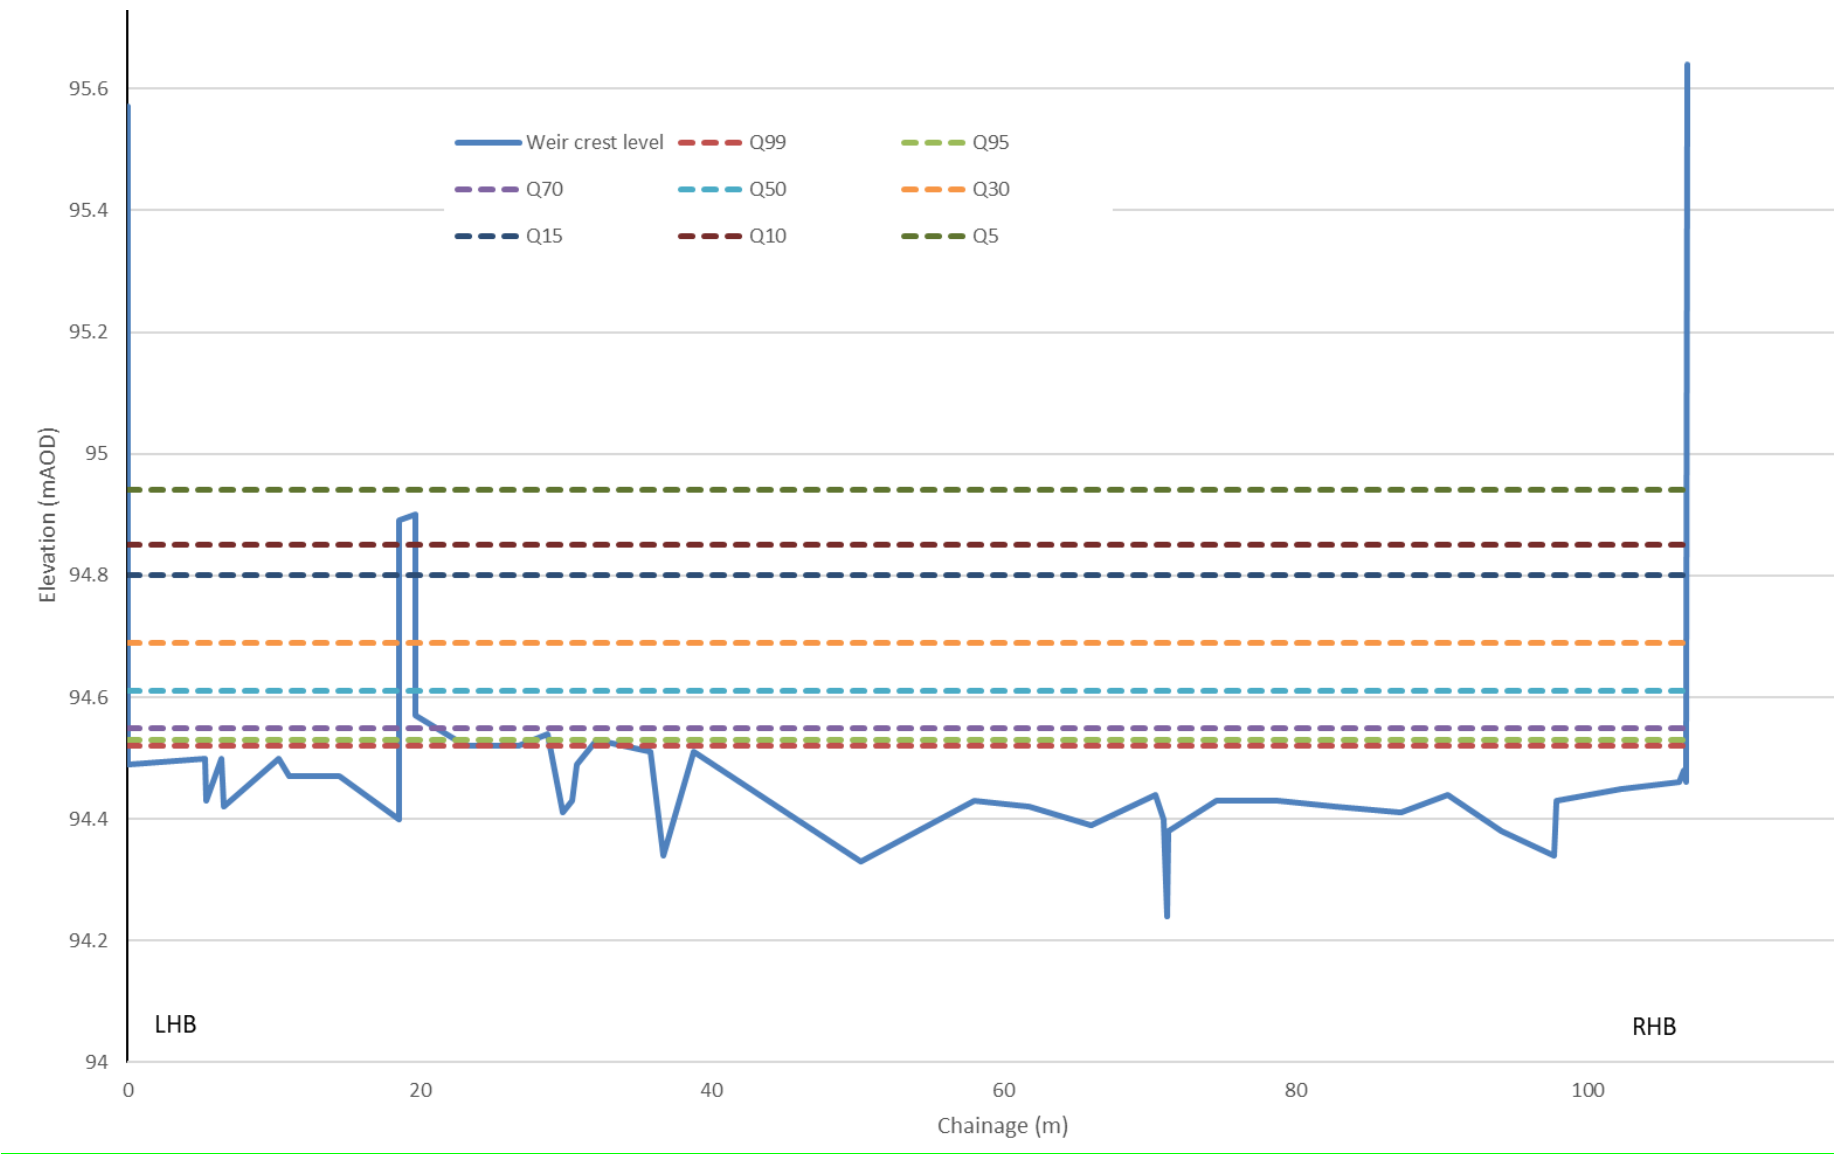
Figure 4-4. Baseline Water Level Analyses

The water level analysis for the baseline is presented in Figure 4-4 below. Structural levels were informed by the topographical survey while flow estimates were as outlined in Table 3-2. Results show that flow occurs over most of the weir even at times of very low flow and that the weir crest is relatively uneven, providing further evidence that its condition is not pristine.
