Horseshoe Falls Fish Pass

Design Report

Natural Resources Wales

Project number: 60672359

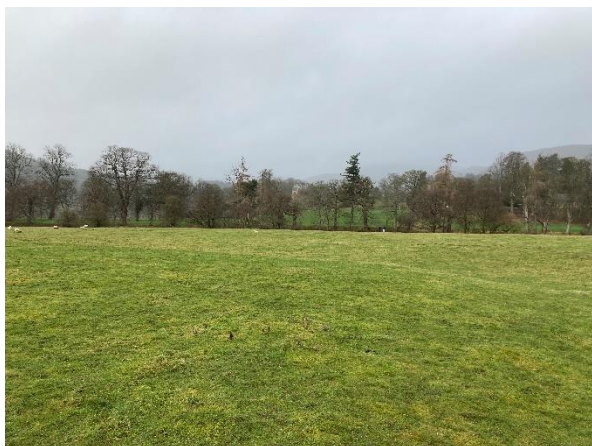
Plate 2-11 Visible paleo-channel on River Dee true right floodplain

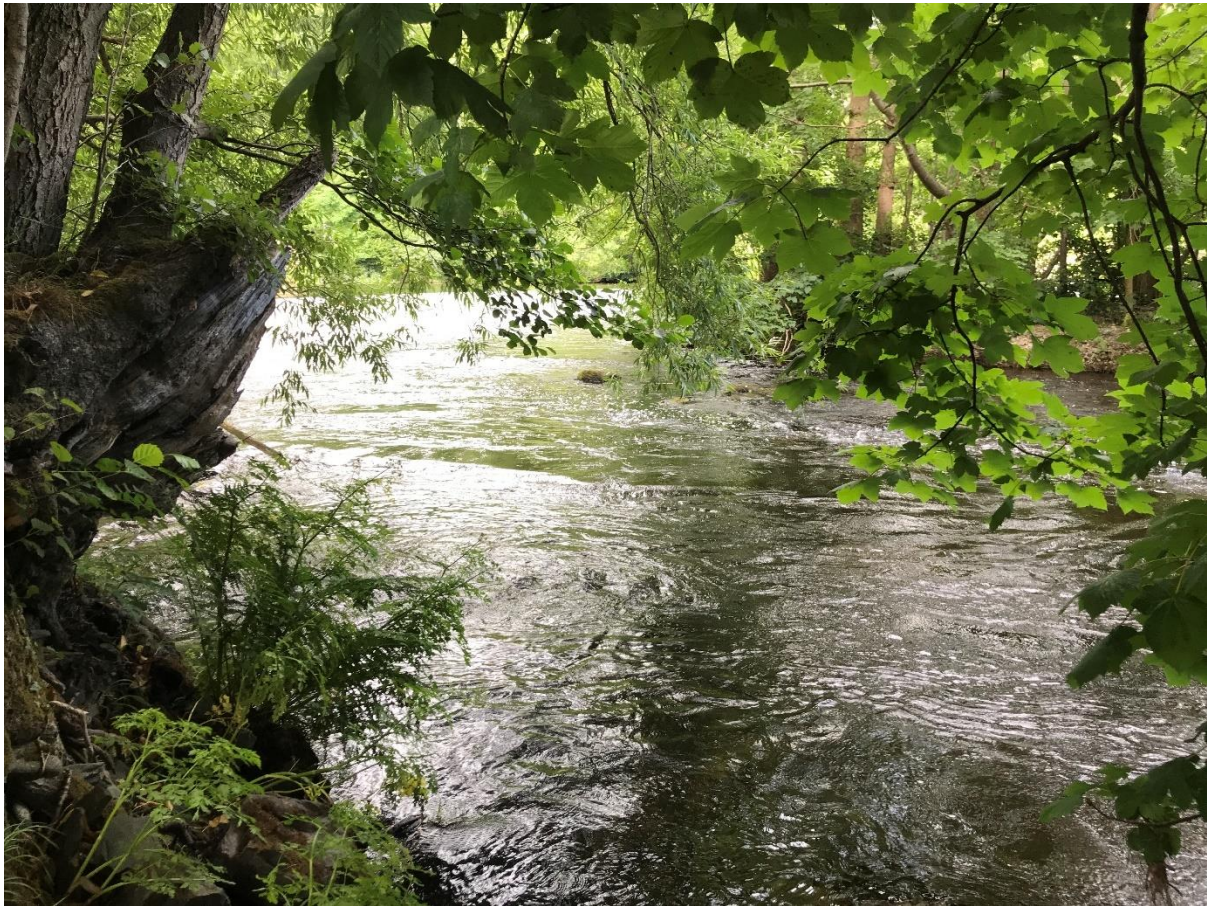
Figure 10 Water depth along riverbank in the vicinity of proposed channel (deeper areas)

Due to limited detailed topographic survey in the River Dee at the downstream end of the proposed fish pass channel, there is uncertainty regarding exact river bed levels and consequently uncertainty in water depths shown in the hydraulic model. Site inspections have confirmed areas of deeper water in this location, although there are also areas of coarse sediment that create shallower pools. See Figure 10 and Figure 11.

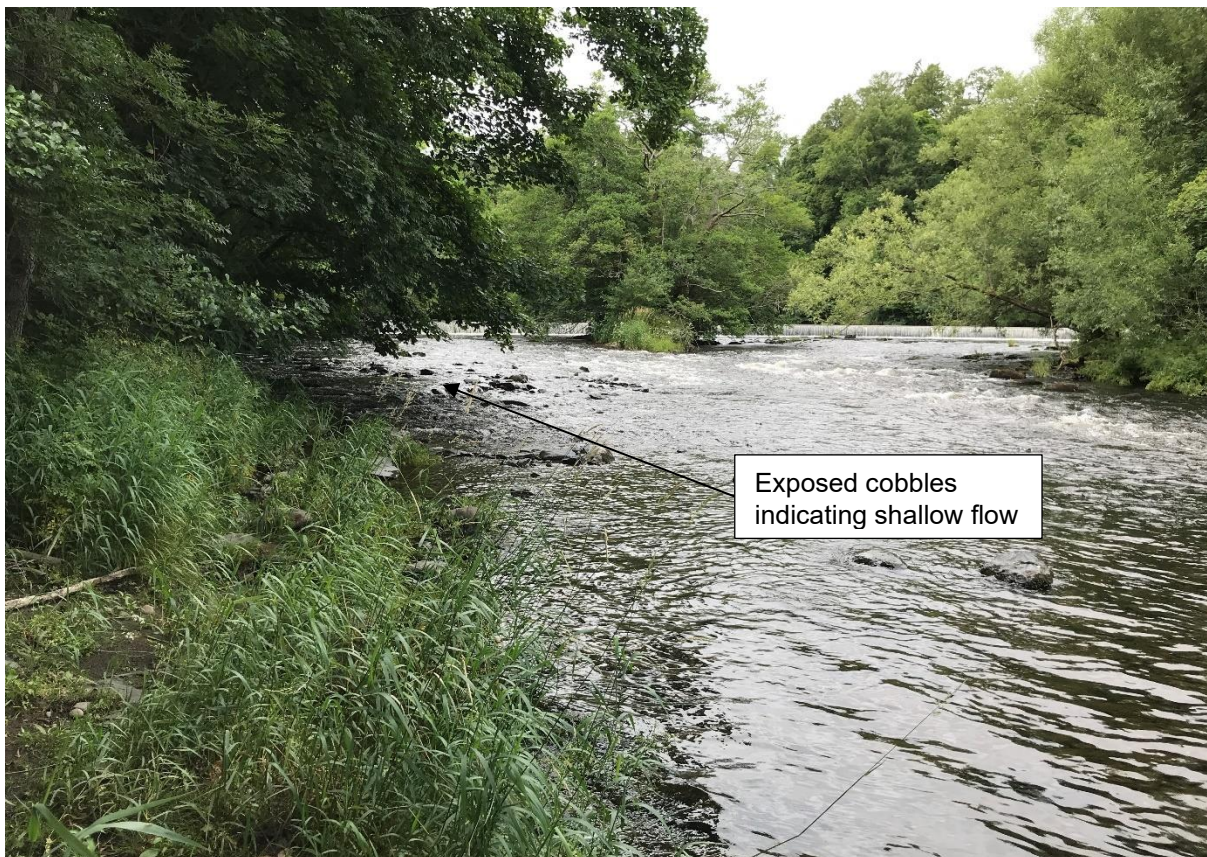
Figure 11 Water depth along riverbank in the vicinity of proposed channel (shallower areas)
