Compliance Assessment Report CAR_NRW0043505

Permit being assessed: AN0243901

For: Creigiau Quarry, held by TARMAC TRADING LIMITED

Type of assessment carried out: Site Inspection, Reason: Routine.

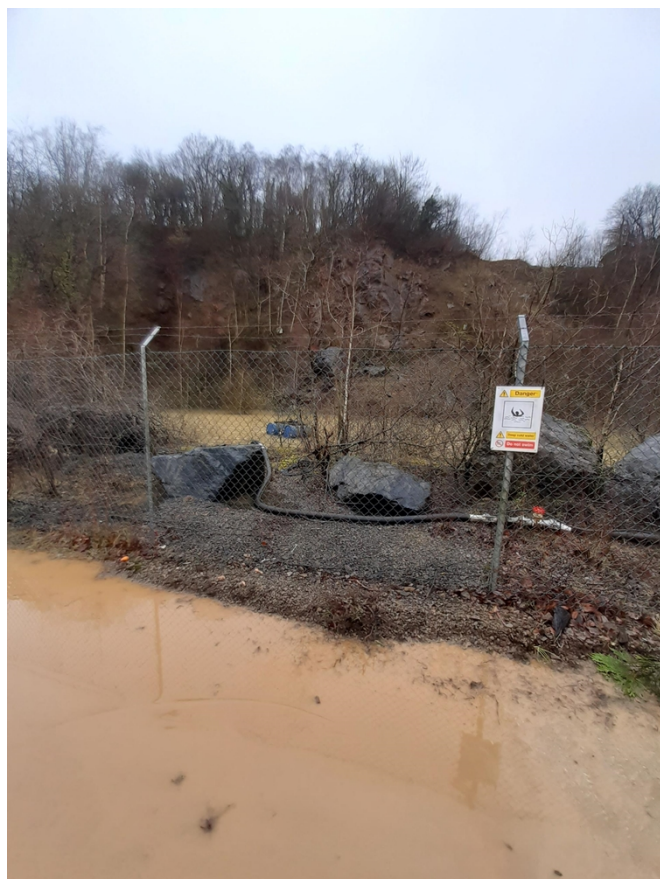
The wheelwash facilities on-site are pumped directly into lagoon 1, for which the levels were high due to recent heavy rain - pictured above left. A breakout from the yard downhill into lagoon 2 was observed and photographed - above right - and Officers asked the Site Manager if lagoon 1 could be expanded to prevent a breach and short circuiting of the settlement system. The Site Manager confirmed there is some room to expand this in the interim ahead of the full Site Improvement Plan and instructed a 6-metre bund to be installed imminently to stem overspill – which was completed before Officers left site around midday - pictured below right.

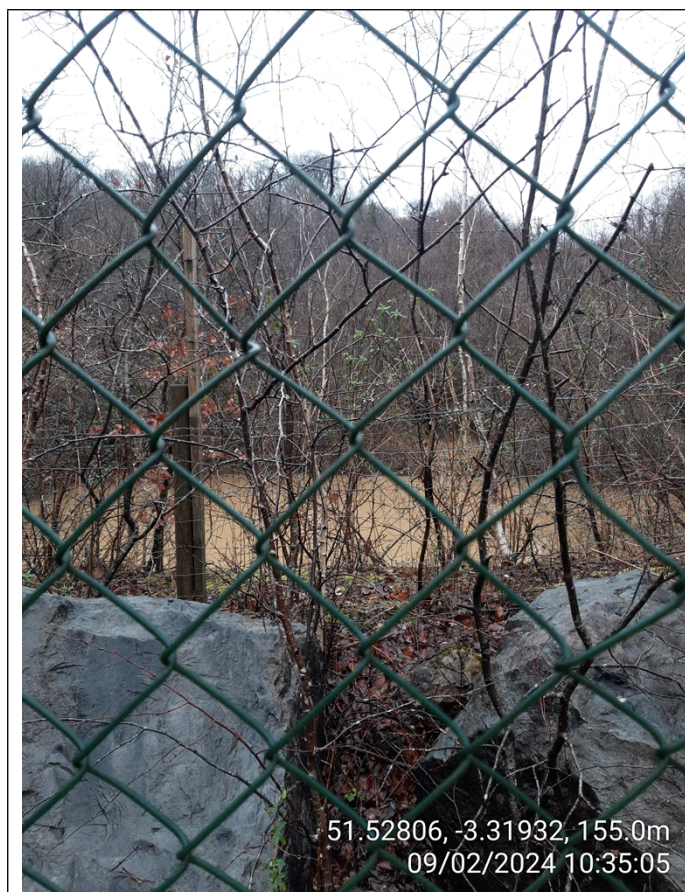
Between lagoons 2 and 3 there lies a bund but this was heavily silted and overgrown, pictured below left.

1. Tree surgeons already booked in to clear the lagoons of vegetation would instead begin with the sample point to reinstate it – **in line with Condition 4** – working their way around the lagoons afterwards.
2. Dye tracing was to be arranged ASAP to check the integrity of the lagoons and aim to identify the

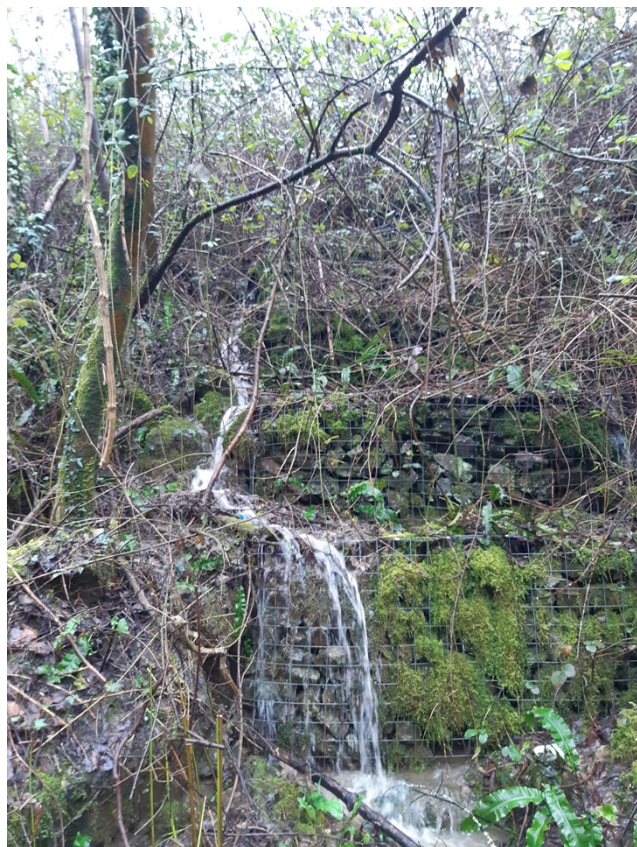
Condition 3(b)(c)(d) – discharge was leaving site at the permitted location. See photo below left.

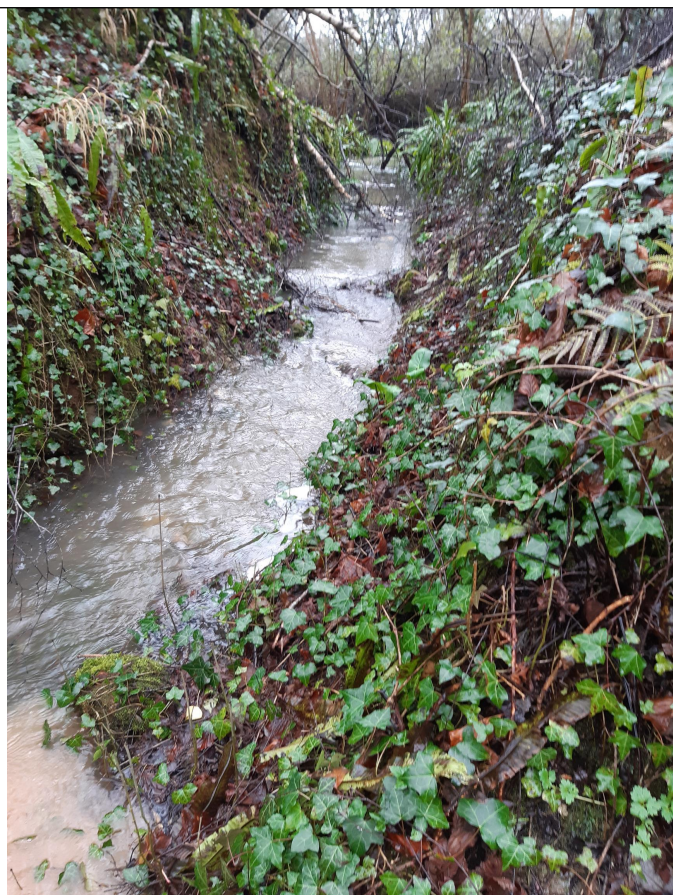
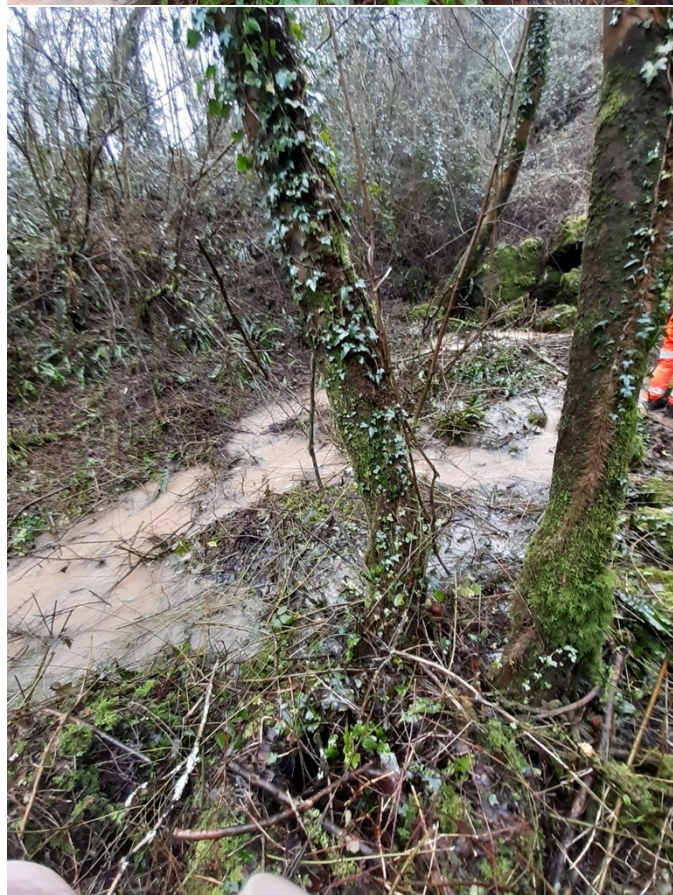
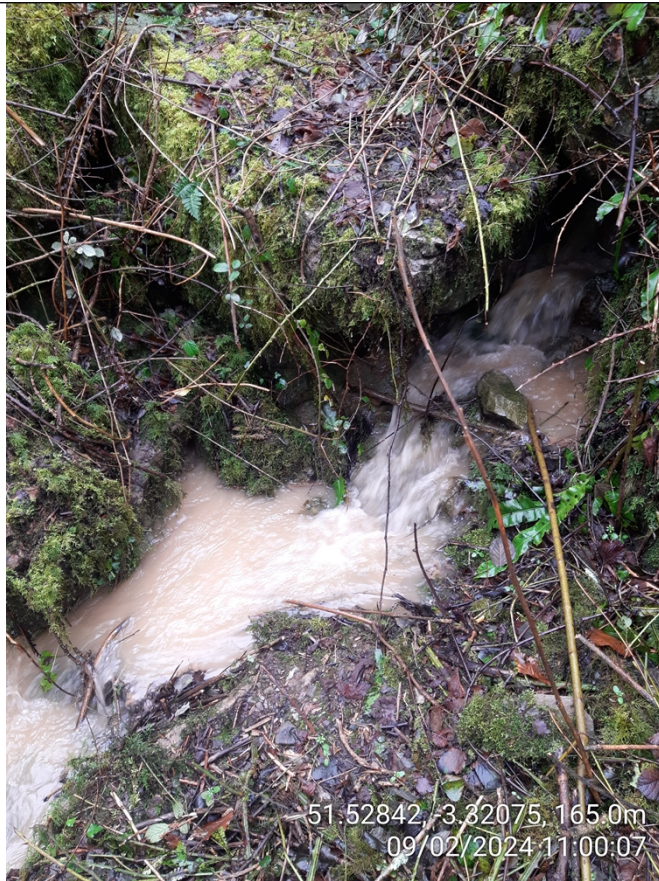
On the way to the permitted discharge point, the watercourse had been heavily silted all the way through the woodlands. Upon reaching the discharge, a stone's throw North of this point, the silt-laden flow appeared to be emanating from underneath large boulders – upstream of which was not visible. The site manager stated that upon conducting their re-opening checks in October, this channel had not been flowing. Photos below show the confluence of silted channel meeting clear flowing water; the flow of silted discharge immediately downhill of the discharge point and silted channel; and the source of the silted channel left-to-right respectively.

Officers were informed that old mines and workings are situated to the left of the quarry, but that although not part of the quarry, the land was Tarmac owned. At this point, Officers advised that under Environmental Permitting Regulations 2016 – separate to permitted discharges – landowners have a responsibility to **manage unpermitted discharges containing polluting matter** such as this and that Tarmac must investigate accordingly.

Action 3 therefore should also apply to updates on investigations as to the source of this discharge.
