Port of Mostyn

Mostyn Energy Park Extension Project

Further Clarification in Support of Marine Licence Application
CML2283

March 2024

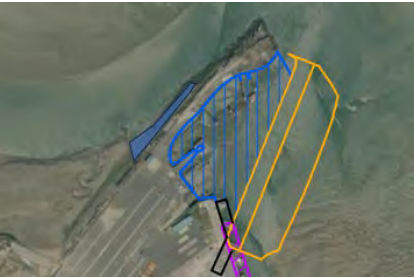
<p>Approximately 20 m from the reclamation works and 100 m from the quay wall piling.</p>	<p>Supports large numbers of roosting birds including Redshank in Autumn passage and Oystercatcher during high water periods (see the <i>Breakwater West</i> sub-section in Section 8.6.5 of the ES).</p>	<p>The visual/acoustic screen along the breakwater will mean that machinery, workers and plant operating in the reclamation footprint and harbour construction area will not be visible to birds roosting on the breakwater ledge roost and is therefore considered effective at preventing waterbirds from being exposed to close range visual stimuli. On this basis, visual related disturbance effects are anticipated to be negligible.</p>	<p>Based on information provided in IECS (2013), noise of up to 72 dB at the receptor (i.e., the bird) is generally considered acceptable for the species that typically use this area (see Table 4 above).</p> <p>With the use of the proposed piling noise suppression system noise and acoustic screen/barrier, piling is predicted to cause noise up to 65 dB on the breakwater roost.</p> <p>While it is also acknowledged that noise above 60 dB at the receptor has the potential to cause disturbance responses in some situations, given the existing background sound levels (levels in the range of around 60-70 dB and above regularly occur near the foreshore) and evidence from the ornithology surveys of existing habituation, any responses would be anticipated to be limited (IECS, 2013). Furthermore, the existing ambient sound levels are likely to mask to some extent the noise associated with the piling.</p> <p>Noise levels associated with other construction activity (such as bulldozers and compaction plant) are predicted to be much lower on the nearby breakwater roost (up to around 50 dB). Noise at this level will not be discernible from background sound levels and are unlikely to cause any responses.</p>

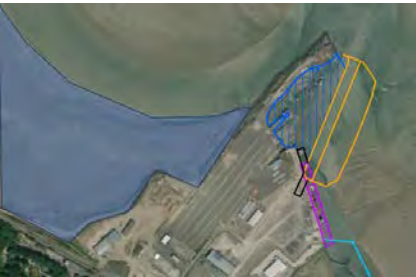
<p>Approximately 50 to 100 m from the reclamation works and 200 m from the quay wall piling.</p>	<p>Regularly supports large numbers of feeding birds including Oystercatcher, Redshank, Black-tailed Godwit, Knot, Dunlin and Shelduck during low water periods (see the <i>Ffynnongroyw Bay South</i> sub-section in Section 8.6.5 of the ES).</p>	<p>The visual/acoustic screen along the breakwater will mean that machinery, workers and plant operating in the reclamation footprint and harbour construction area will not be visible to birds feeding on the Mostyn Bank and is therefore considered effective at preventing waterbirds from being exposed to close range visual stimuli. On this basis, visual related disturbance effects are anticipated to be negligible.</p>	<p>Based on information provided in IECS (2013), noise of up to 72 dB at the receptor (i.e., the bird) is generally considered acceptable for the species that typically use this area (see Table 4 above).</p> <p>With the use of the proposed piling noise suppression system noise and acoustic screen/barrier, piling is predicted to cause noise up to 65 dB on mudflat in this area.</p> <p>While it is also acknowledged that noise above 60 dB at the receptor has the potential to cause disturbance responses in some situations, given the existing background sound levels (levels in the range of around 60-70 dB and above regularly occur near the foreshore) and evidence from the ornithology surveys of existing habituation, any responses would be anticipated to be limited (IECS, 2013). Furthermore, the existing ambient sound levels are likely to mask to some extent the noise associated with the piling.</p> <p>Noise levels associated with other construction activity (such as bulldozers and compaction plant) are predicted to be much lower on nearby mudflat habitat in this area (up to around 57 dB). Noise at this level will not be discernible from background sound levels and are unlikely to cause any responses.</p>

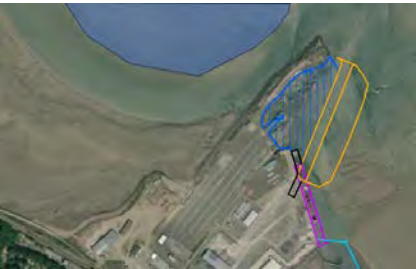
<p>Approximately 50 to 100m from the reclamation works and 200 m from the quay wall piling.</p>	<p>Regularly supports large numbers of feeding birds including Oystercatcher, Redshank, Black-tailed Godwit, Knot, Dunlin and Shelduck during low water periods (see the <i>Ffynnongroyw Bay South</i> sub-section in Section 8.6.5 of the ES).</p>	<p>The visual/acoustic screen along the breakwater will mean that machinery, workers and plant operating in the reclamation footprint and harbour construction area will not be visible to birds feeding on the mudflat and is therefore considered effective at preventing waterbirds from being exposed to close range visual stimuli. On this basis, visual related disturbance effects are anticipated to be negligible.</p>	<p>Based on information provided in IECS (2013), noise of up to 72 dB at the receptor (i.e., the bird) is generally considered acceptable for the species that typically use this area (see Table 4 above).</p> <p>With the use of the proposed piling noise suppression system noise and acoustic screen/barrier, piling is predicted to cause noise up to 65 dB on mudflat in this area.</p> <p>While it is also acknowledged that noise above 60 dB at the receptor has the potential to cause disturbance responses in some situations, given the existing background sound levels (levels in the range of around 60-70 dB and above regularly occur near the foreshore) and evidence from the ornithology surveys of existing habituation, any responses would be anticipated to be limited (IECS, 2013). Furthermore, the existing ambient sound levels are likely to mask to some extent the noise associated with the piling.</p> <p>Noise levels associated with other construction activity (such as bulldozers and compaction plant) are predicted to be much lower on nearby mudflat habitat in this area (< 55 dB). Noise at this level will not be discernible from background sound levels and are unlikely to cause any responses.</p>

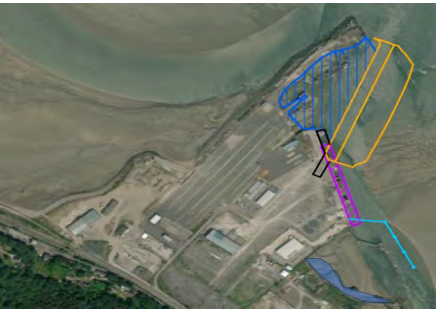
<p>Approximately 450 to 600 m from the reclamation and quay wall piling works. Approximately 150 m away from the piling required for the relocation of existing dolphins</p>	<p>Counts of over 1,000 roosting Oystercatcher and Redshank regularly recorded during high water periods with lower numbers of other waterbirds also recorded roosting (see the <i>Mostyn Dock Shore</i> subsection in Section 8.6.5 of the ES).</p>	<p>This area is outside of the zone of potential visual disturbance effects as a result of construction activity associated with reclamation and quay wall piling works. As a result of the existing Gwynt y Môr jetty and pontoon, visual stimuli associated with the relocation of existing dolphins will also be screened from this roost.</p>	<p>Based on information provided in IECS (2013), noise of up to 72 dB at the receptor (i.e., the bird) is generally considered acceptable for the species that typically use this area (see Table 4 above).</p> <p>With the use of the proposed piling noise suppression system noise and acoustic screen/barrier, piling is predicted to cause noise of less than 70 dB at this roost.</p> <p>While it is also acknowledged that noise above 60 dB at the receptor has the potential to cause disturbance responses in some situations, given the existing background sound levels (levels in the range of around 60-70 dB and above regularly occur near the foreshore) and evidence from the ornithology surveys of existing habituation, any responses would be anticipated to be limited (IECS, 2013). Furthermore, the existing ambient sound levels are likely to mask to some extent the noise associated with the piling. There is also an existing jetty and port infrastructure located between the proposed development and this roost which will act to screen the works to some extent.</p> <p>Noise levels associated with other construction activity (such as bulldozers and compaction plant) are predicted to be much lower in this area (<40 dB). Noise at this level will not be discernible from background sound levels and are unlikely to cause any responses.</p>

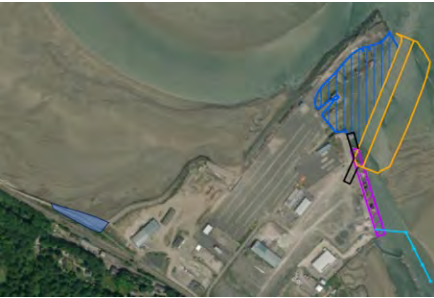
<p>Approximately 700 to 800 m from the reclamation and piling works</p>	<p>Used relatively infrequently by up to approximately 100 roosting Oystercatcher 60 Redshank and lower numbers of other waterbirds.</p>	<p>This area is out of the zone of potential visual disturbance effects as a result of construction activity associated with the proposed development.</p>	<p>Based on information provided in IECS (2013), noise of up to 72 dB at the receptor (i.e., the bird) is generally considered acceptable for the species that typically use this area (see Table 4 above).</p> <p>With the use of the proposed piling noise suppression system noise and acoustic screen/barrier, piling is predicted to be in the range of 55 to 60 dB at this roost.</p> <p>While it is also acknowledged that noise above 60 dB at the receptor has the potential to cause disturbance responses in some situations, given the existing background sound levels (levels in the range of around 60-70 dB and above regularly occur near the foreshore) and evidence from the ornithology surveys of existing habituation, any responses would be anticipated to be limited (IECS, 2013). Furthermore, the existing ambient sound levels are likely to mask to some extent the noise associated with the piling.</p>

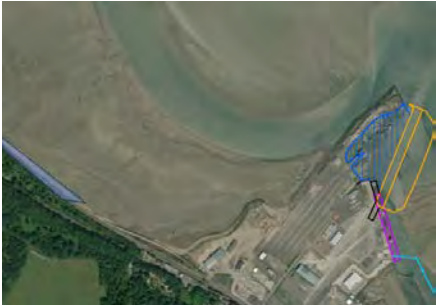
<p>Cockle shell/rock roosting habitat on the Mostyn Bank (known as count sector 'H' as shown on Figure 8.1 of the ES)</p>

<p>Approximately 1 km from the reclamation and piling works</p>	<p>Counts of over 5,000 roosting Oystercatcher regularly recorded on the roost during high water periods</p>	<p>This area is outside of the zone of potential visual disturbance effects as a result of construction activity associated with the proposed development.</p>	<p>Based on information provided in IECS (2013), noise of up to 72 dB at the receptor (i.e., the bird) is generally considered acceptable for the species that typically use this area (see Table 4 above).</p> <p>With the use of the proposed piling noise suppression system noise and acoustic screen/barrier, piling is predicted to be in the range of 60 to 65 dB at this roost.</p> <p>While it is also acknowledged that noise above 60 dB at the receptor has the potential to cause disturbance responses in some situations, given the existing background sound levels (levels in the range of around 60-70 dB and above regularly occur near the foreshore) and evidence from the ornithology surveys of existing</p>

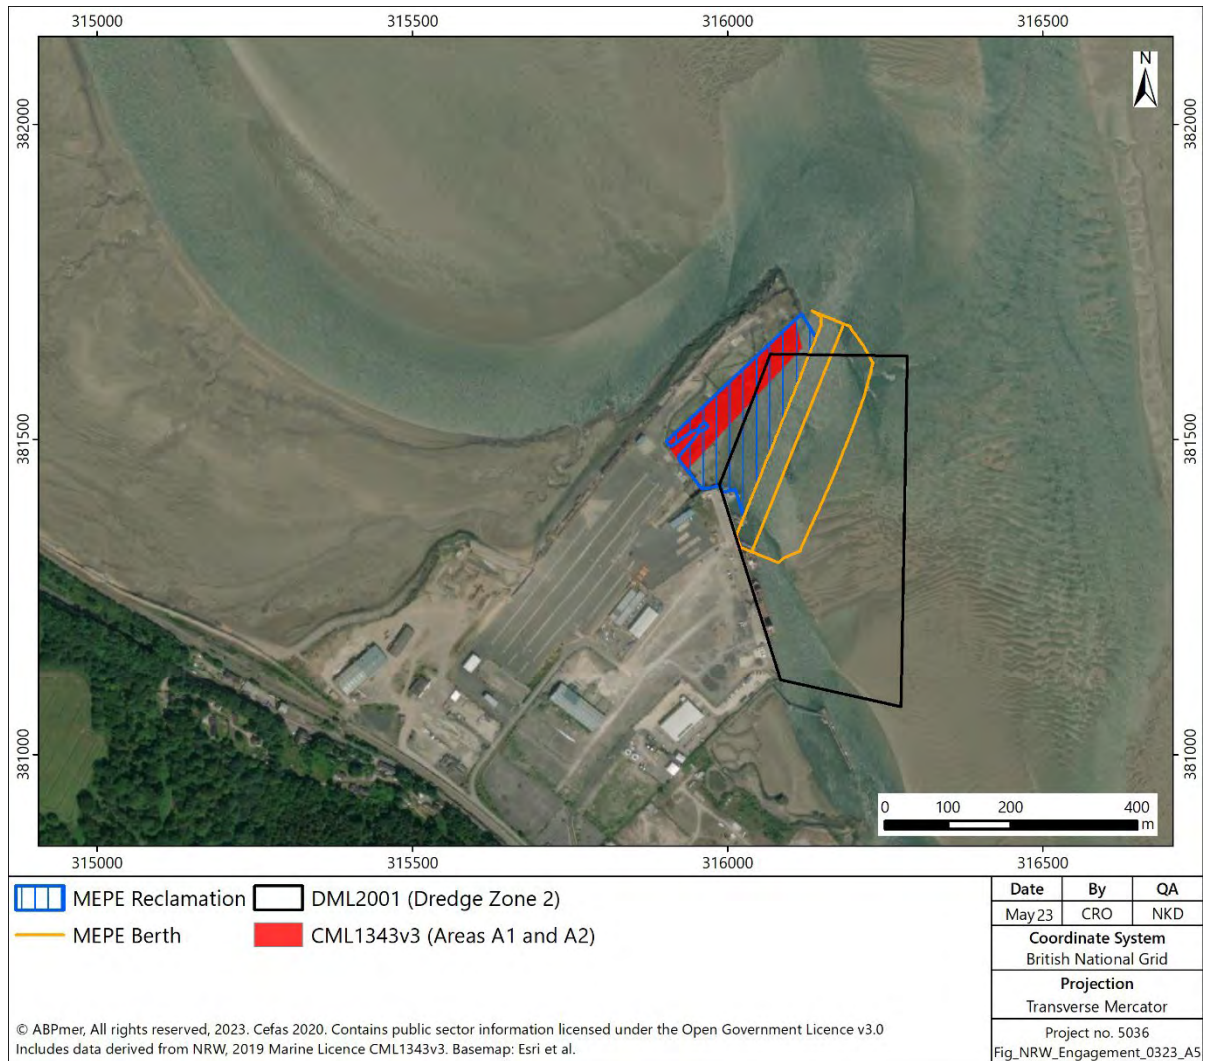
Figure 2. Existing permissions to remove and/or deposit materials within proposed MEPE reclamation and new berth

The areas covered by existing permissions (DML2001 and CML1343v3) overlap the majority of the marine habitat under the footprint of the proposed MEPE reclamation. The remaining area of Estuaries feature habitat (0.91 ha) under the footprint of the proposed MEPE reclamation that is not covered by either DML2001 or CML1343v3 is shown on Figure 3. A large part of this remaining area, including all of the intertidal mud, was included in a previous consent to reclaim 21.5 acres (8.71 ha) of land which was granted by Secretaries of State for Wales and Transport to the Port of Mostyn in 1996, and which at the time was not regarded as a significant adverse effect in the context of the whole estuary area. Further details regarding this past decision are provided in Section 4.5.

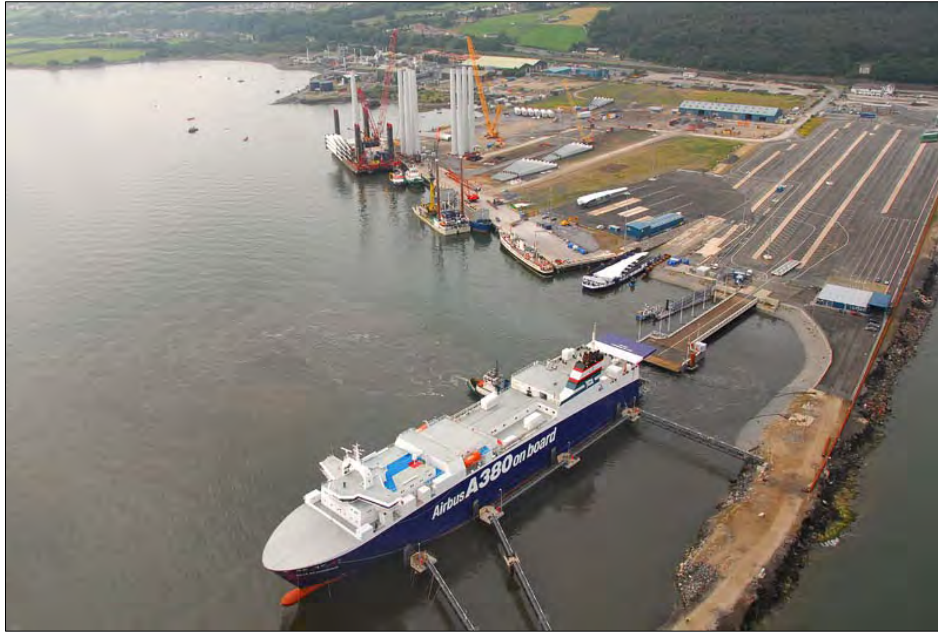
Image 1. Aerial view of Port of Mostyn with Airbus barge vessel berthed at the RoRo Terminal

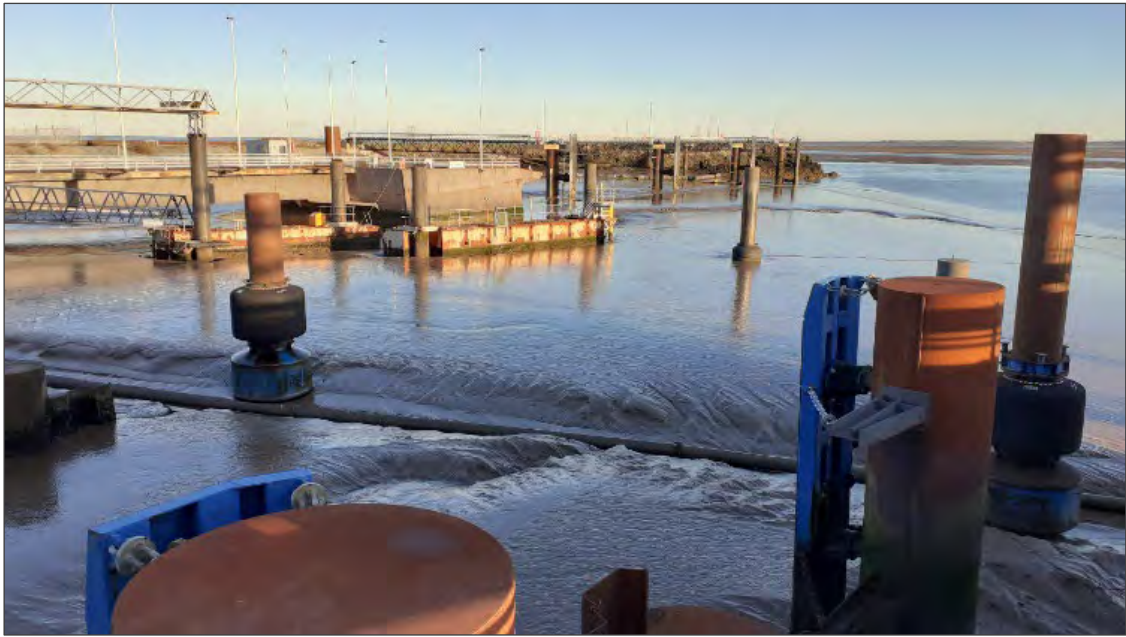
Image 2. Workboat re-fuelling pontoon berth and RoRo Terminal and berth at low water

The location of the habitat that will be lost under the footprint of the reclamation forms part of the existing operational harbour of the Port of Mostyn and currently overlaps the workboat re-fuelling pontoon berth and NAABSA barge berth, and the RoRo Terminal and berth (Image 2). Although tidally restricted, all of the berths are fully functional: the pontoon berth and NAABSA barge berth continue to be in use, and the RoRo berth was fully operational and dredged until recently (2019/2020) and could be used for general shipping at any time (Image 3). In other words, the habitat present in this area is disturbed by the movement and manoeuvring of vessels given its ongoing function as an operational harbour. This area has been highly modified throughout history, and these activities were taking place before the SAC was designated in 2009 and the Ramsar site was classified in 1985.

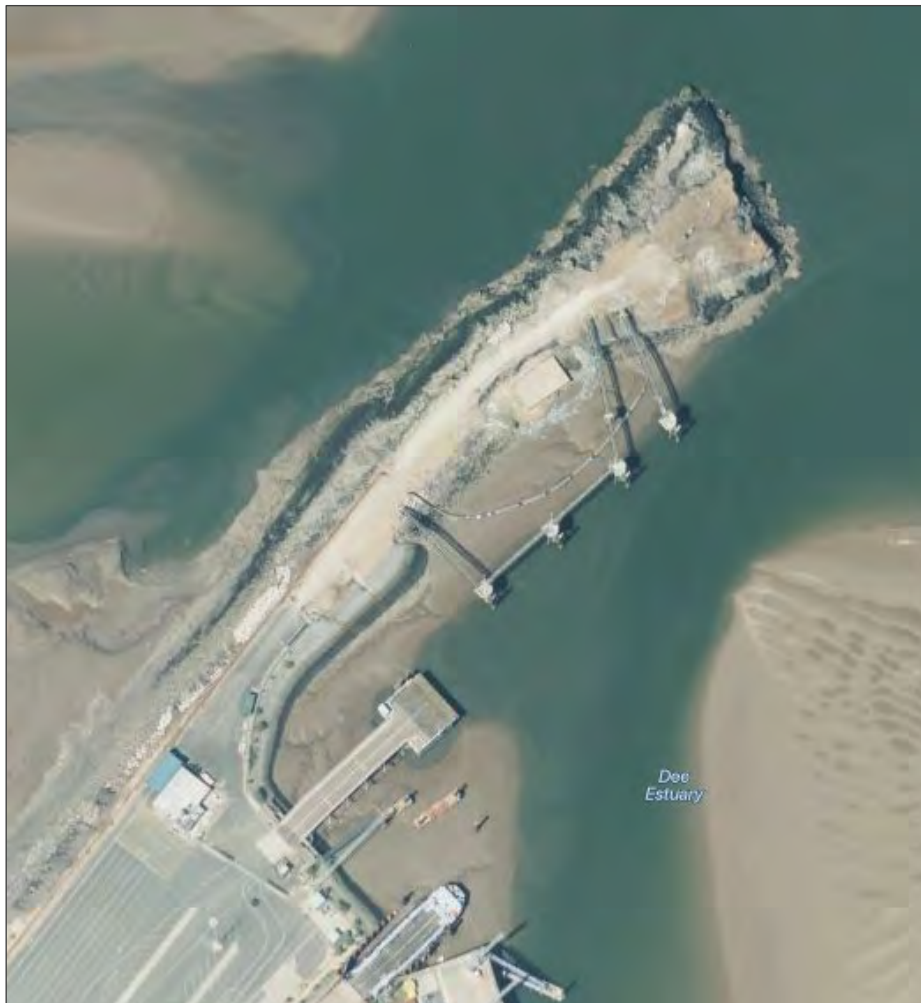
Image 3. Aerial image of the workboat re-fuelling pontoon berth, the NAABSA barge berth, and the RoRo Terminal at low water (2019)

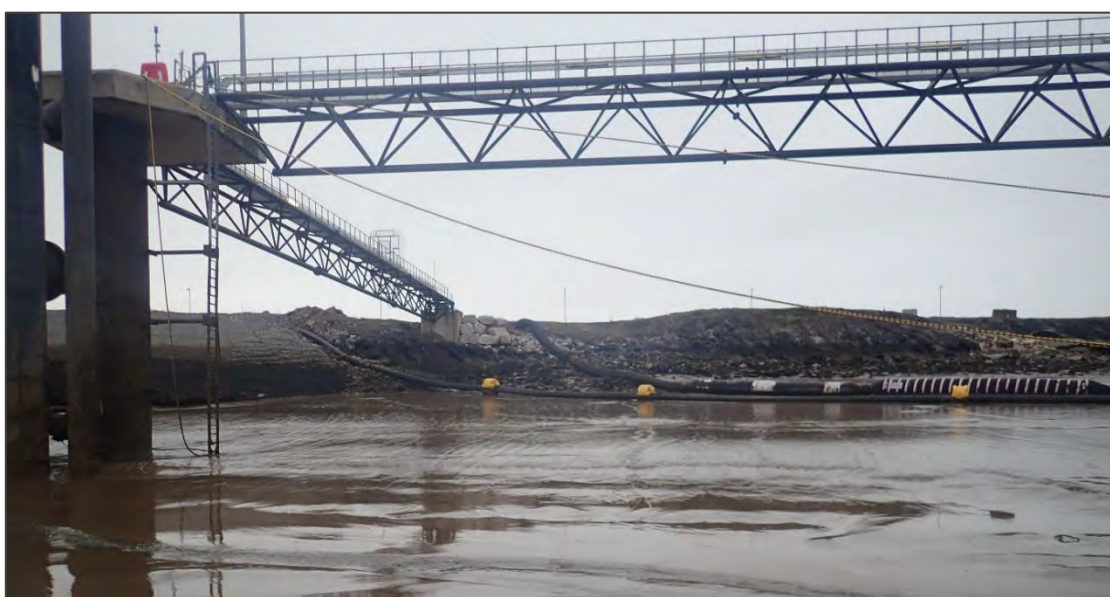
Image 4. Soft/fluid sandy mud habitat at the site of the RoRo Terminal and berth

The existing ecological structure of the Estuaries feature within the area of the reclamation in terms of the condition of habitats present is also an important consideration. The 2.57 ha of intertidal habitat that will be lost under the footprint of the reclamation is not considered Annex I mudflat and sandflat feature (as agreed by NRW A) and although it forms part of the Estuaries feature of the Dee Estuary SAC, it is not currently representative of any of the components of the Estuaries feature (see the 'Location' sub-section). This habitat comprises ephemeral soft/fluid sandy mud that has recently accreted since the RoRo Terminal and berth was operational and dredged until 2019/2020 (Image 4). Although tidally restricted, this berth is still fully functional and if its use were to be resumed by the Port, the movement of RoRo vessels would re-disturb a large area of the seabed at the berth and its approaches.

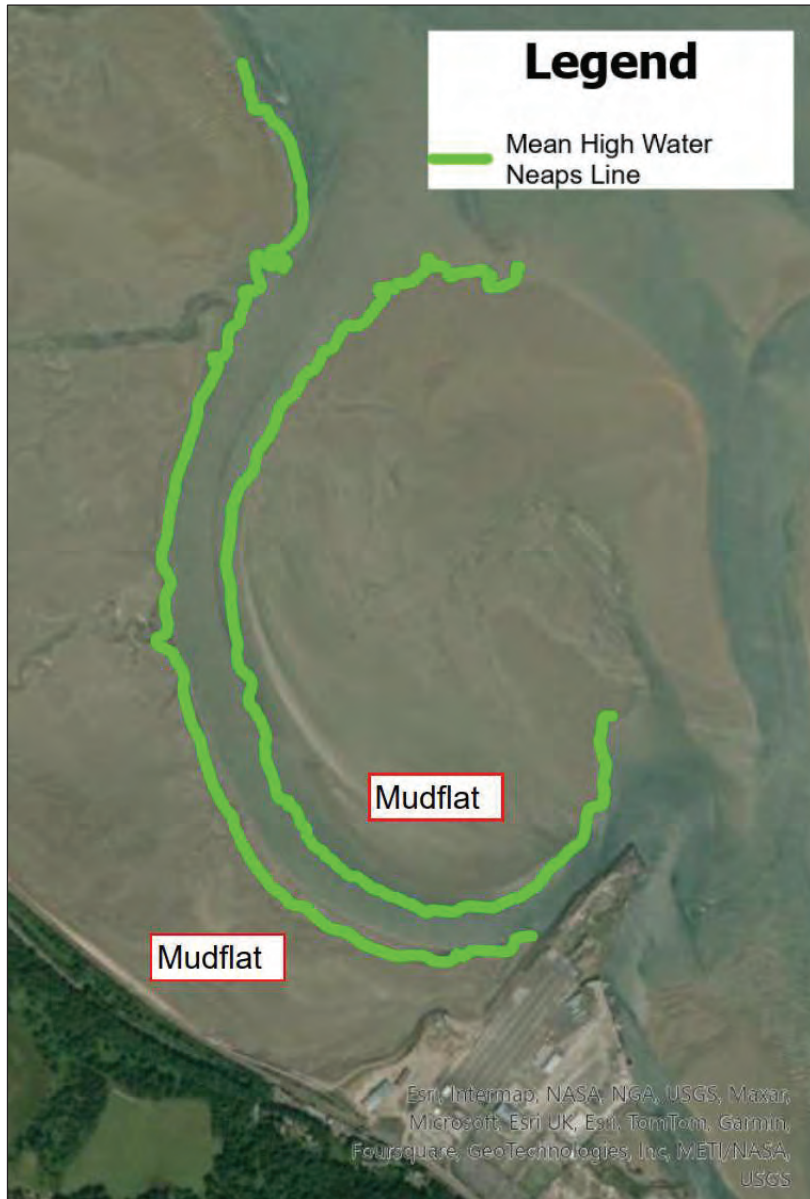
Figure 2 Location of Mudflats

In addition to the breakwater roost receptor, the location of the mudflats to the northwest of the port are shown in Figure 2.

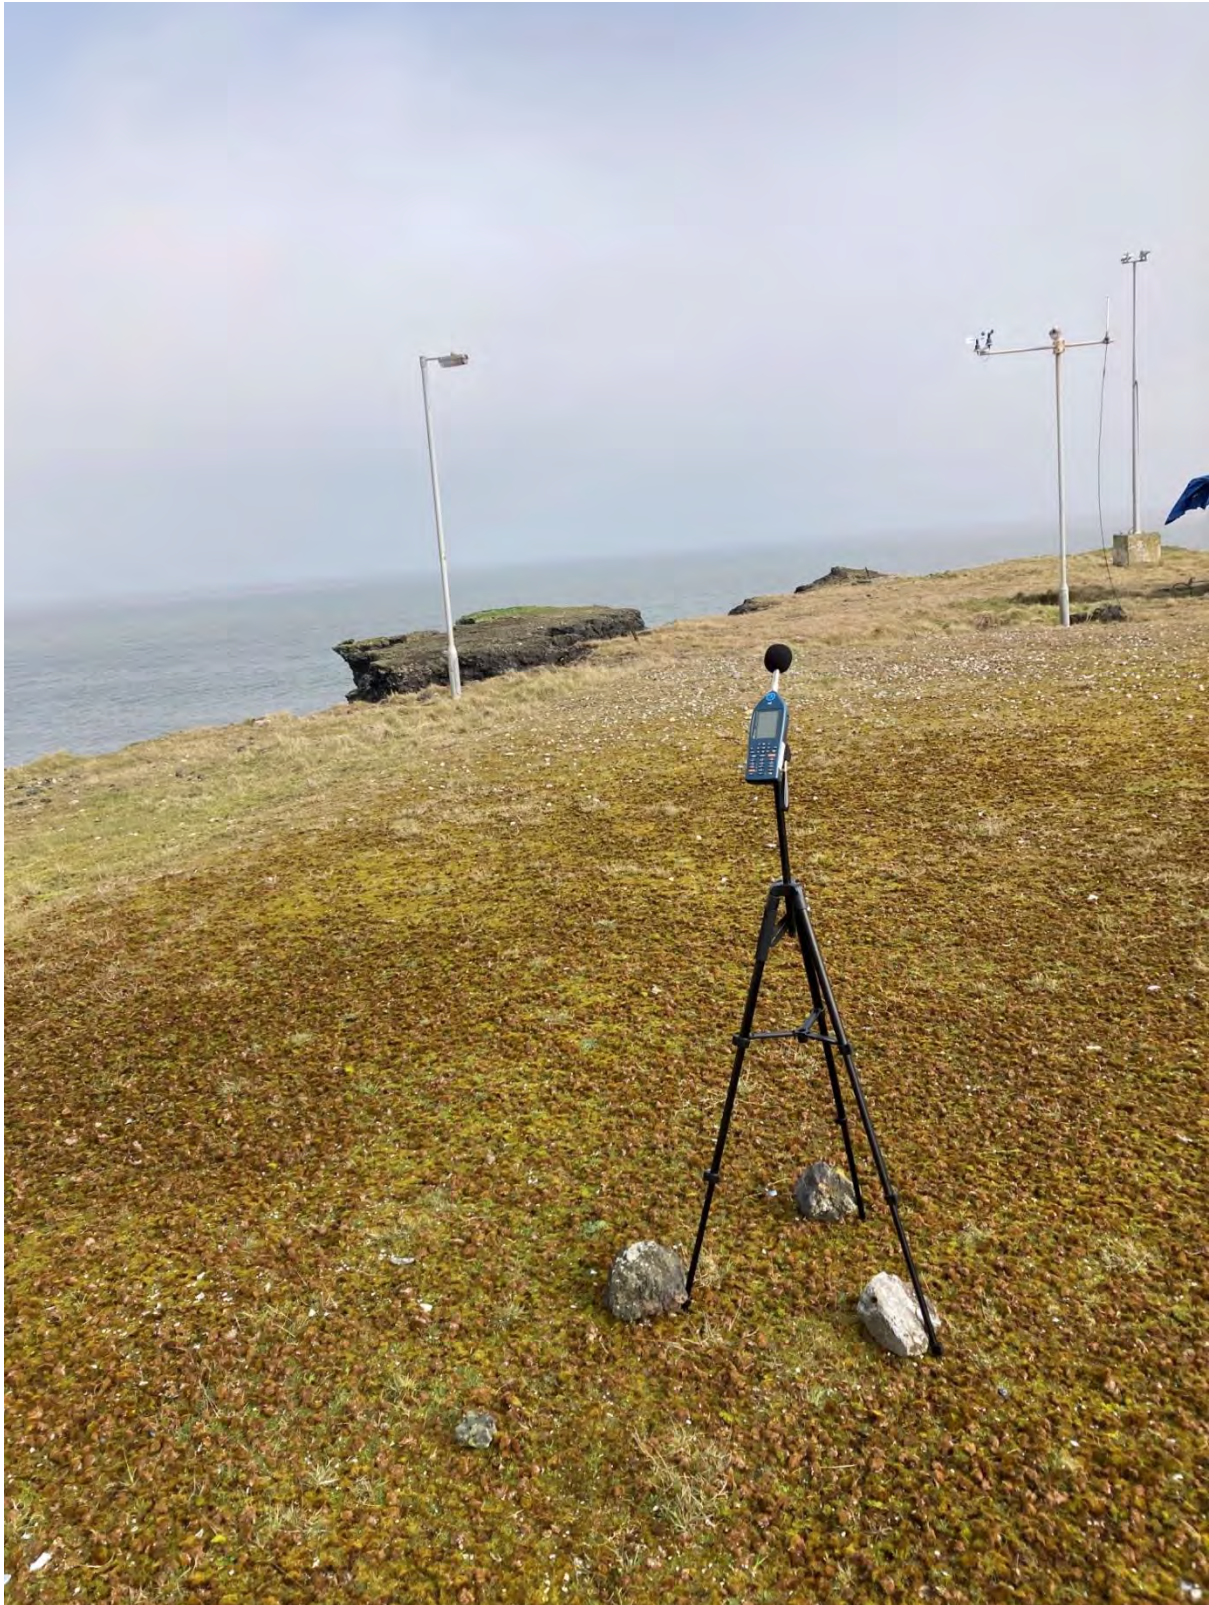
Figure 3 Attended measurement location ST1

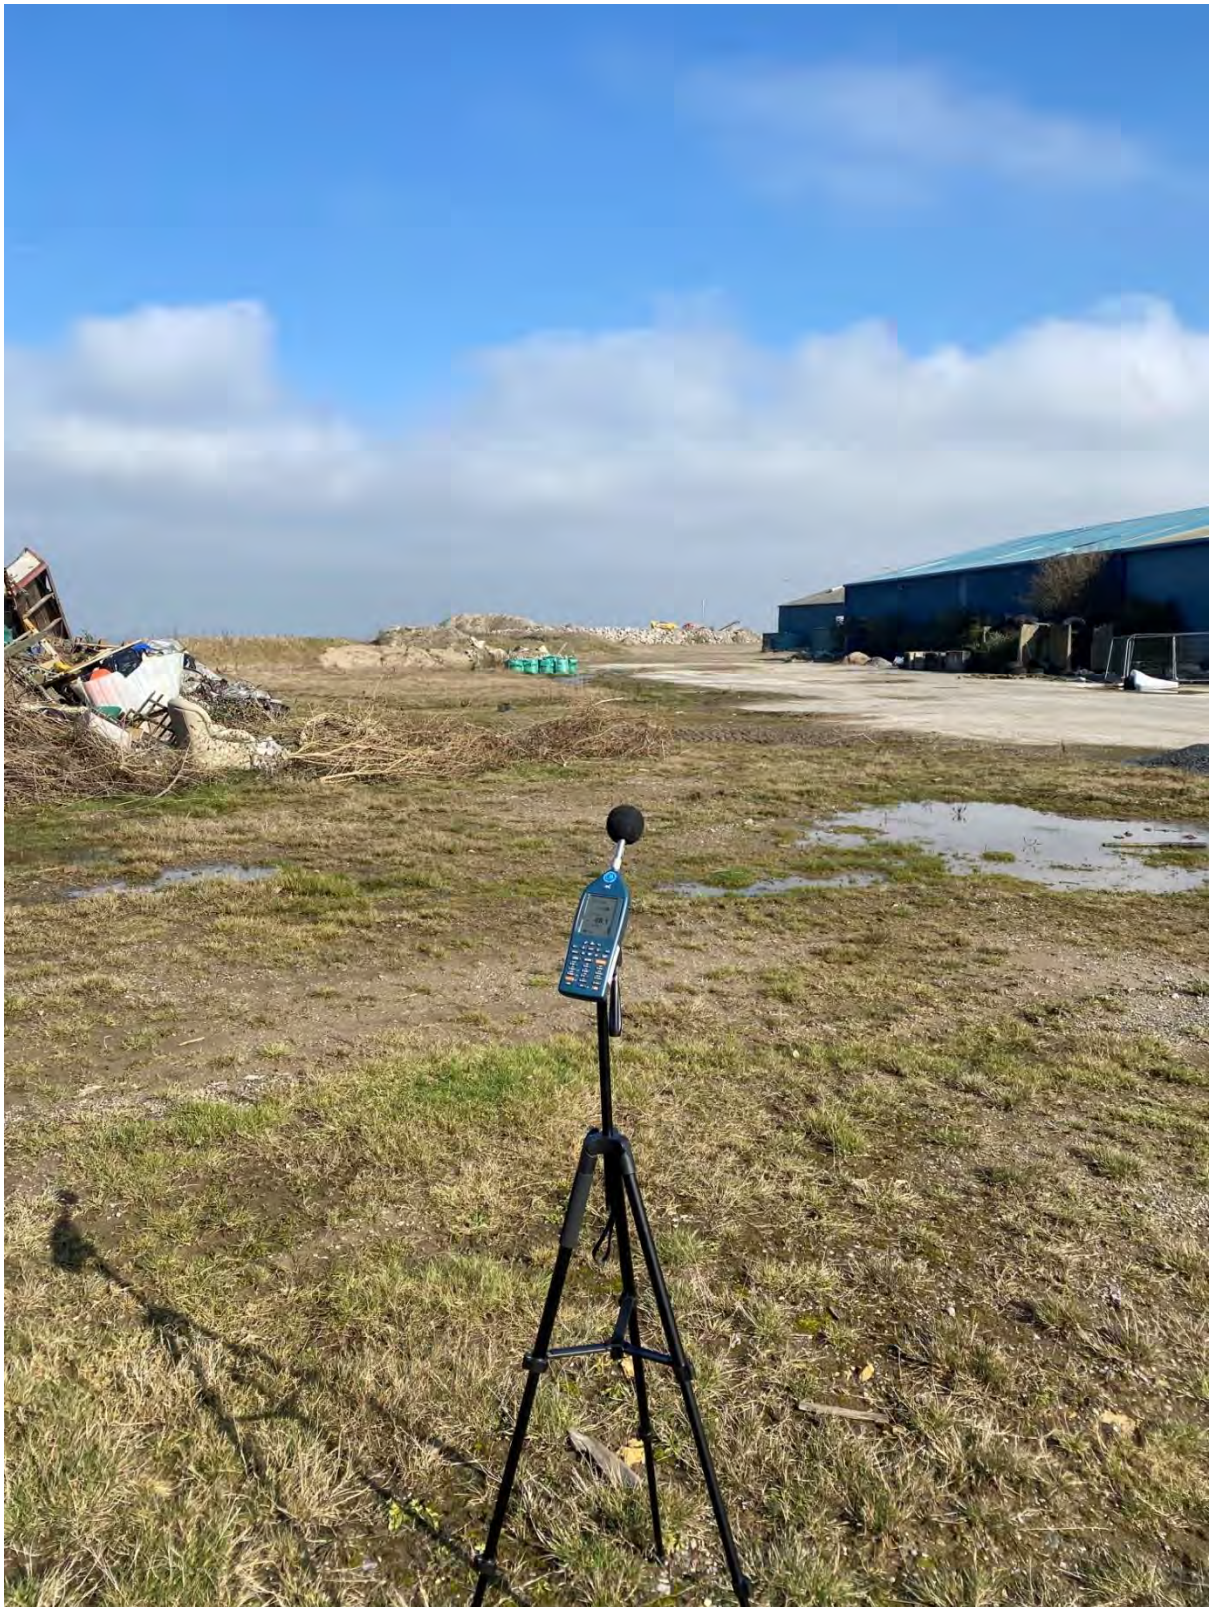
Figure 4 Attended measurement location ST2

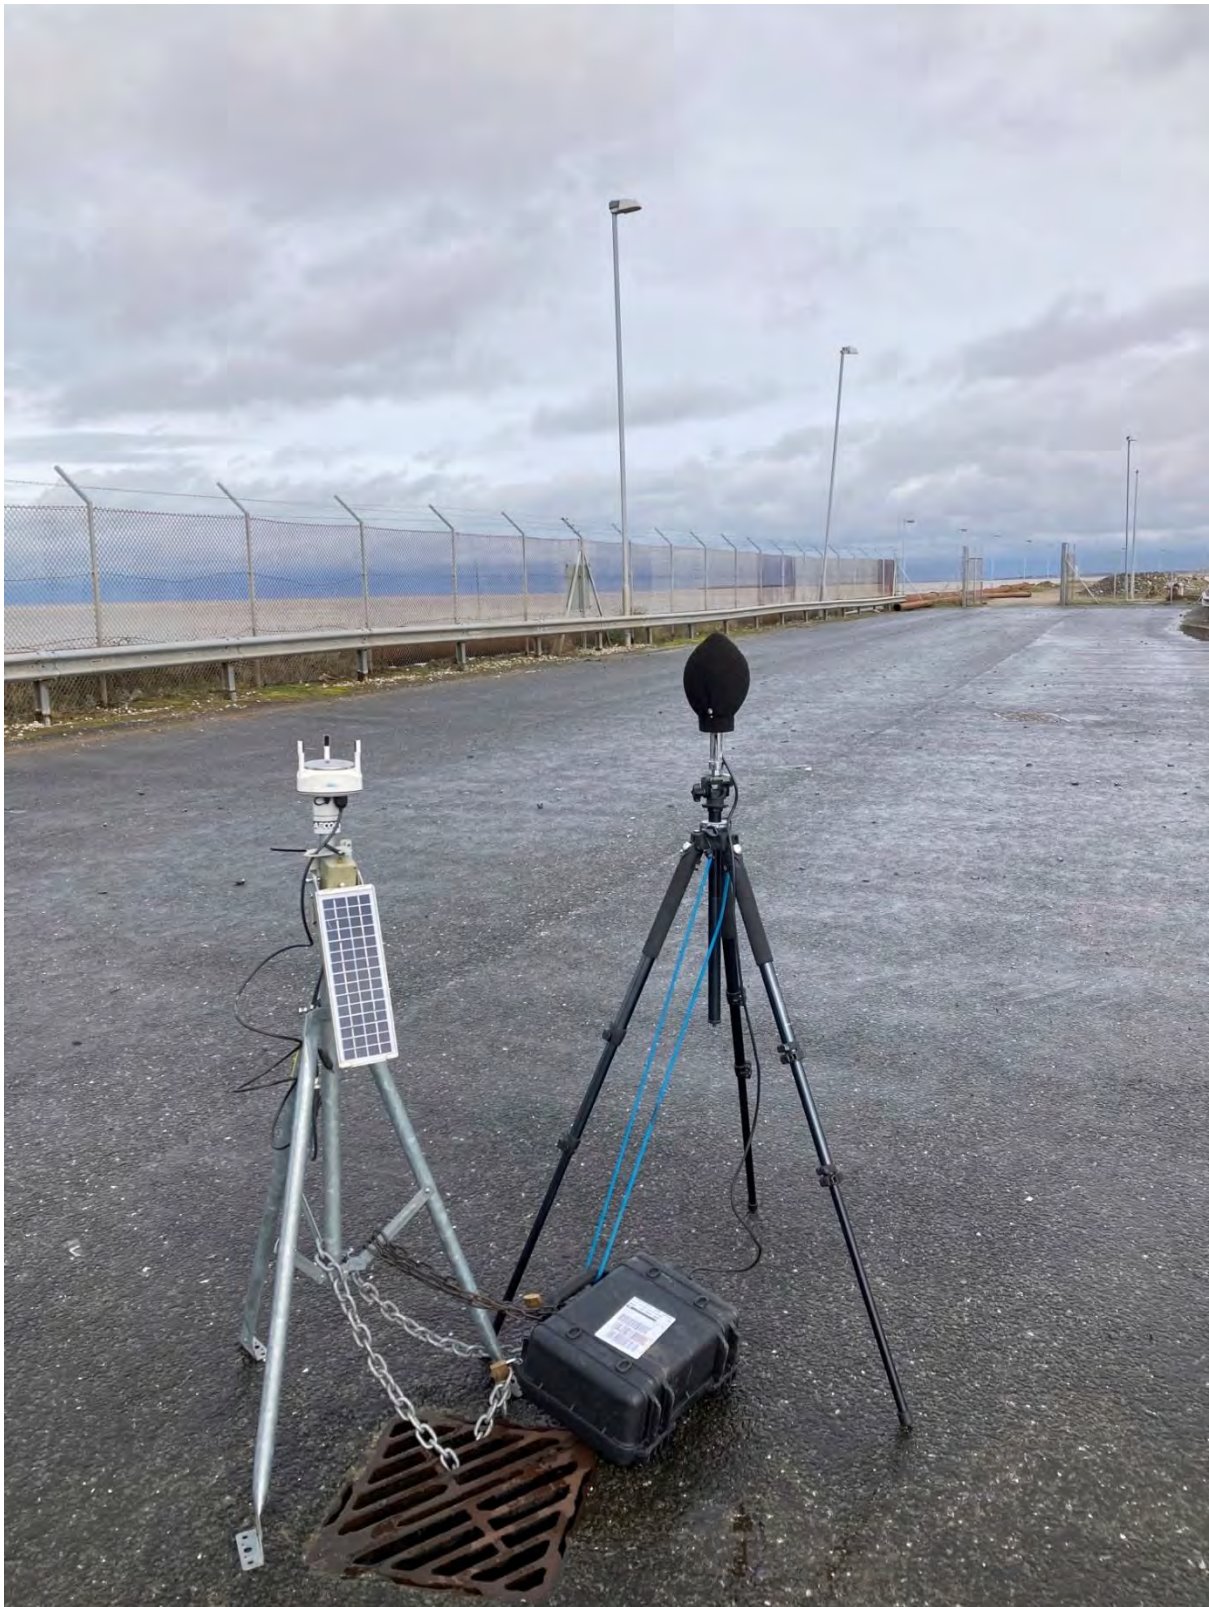
Figure 5 Unattended measurement location LT1
