## Compliance Assessment Report CAR\_NRW0043781

**Permit being assessed:** AG0004501

For: CILFYNYDD STW CILFYNYDD PONTYPRID, held by DWR CYMRU CYFYNGEDIG

**Type of assessment carried out:** Site Inspection, Reason: Routine.

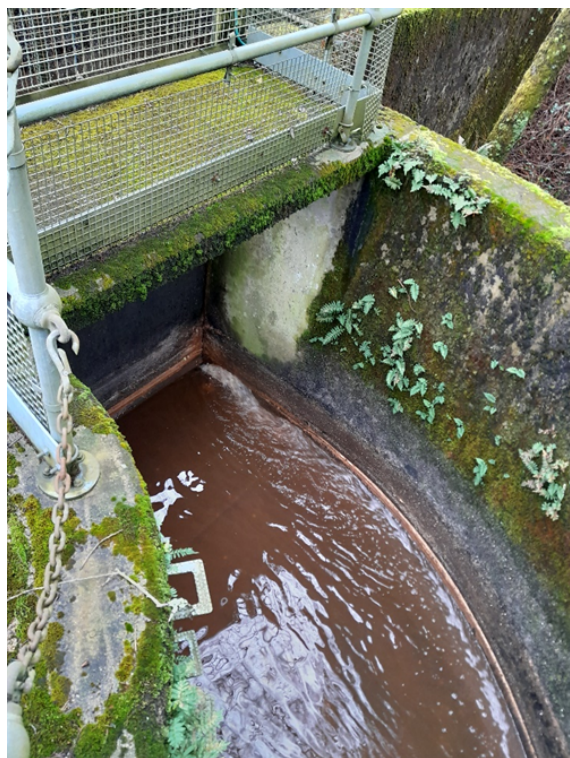
Storm treatment at the site flows through the same inlet and is screened in the same manner as normal effluent. If the flow is too high or during maintenance, it can be channelled through an adjacent bypass channel. At this point there was a leak from the main channel into the bypass channel from a screen door (Image 1). Water appeared to be filtered through bars rather than the 6mm screens. DCWW stated that a penstock was in place to stop any of this unfiltered water entering the works. After the 6mm screens storm water is diverted from all other effluent. A separate CAR form is to be completed for the settled storm permit (AG0004601).

*Image 1 – Bypass Channel Leak*

| Criteria | Action needed | Complete by |
|---|---|---|
| WQ-B2 | Fix the leak from the bypass door and ensure that no unfiltered effluent is able to enter the treatment process. | 15/06/2024 |

1. Fix the leak from the bypass door and ensure that no unfiltered effluent is able to enter the treatment process.

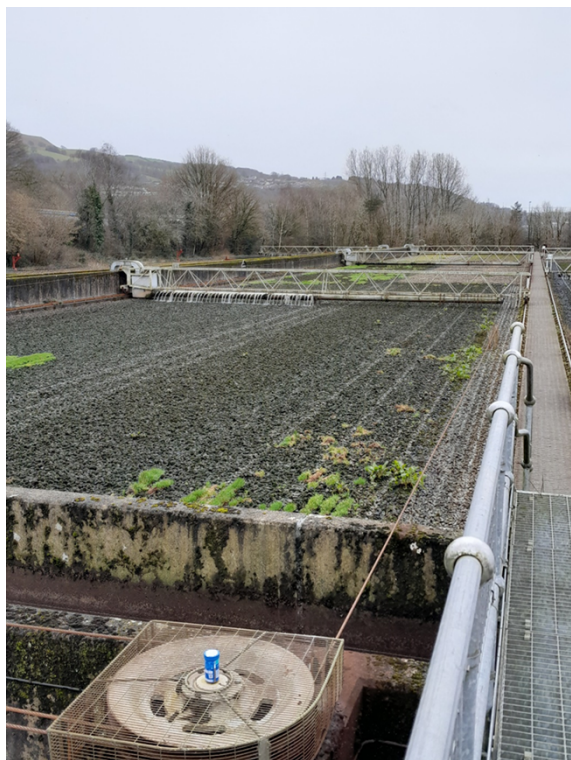
treatment at the site was a biological treatment using filter beds (Image 2). Effluent was distributed across the beds using a chain driven system where half of a bed is fed on the forward pass and half on the return. All of the filter beds appeared to be functioning as designed. Final treatment consisted of four hummus tanks. All were operational and fed the outlet, UWWTD sampling was located at this location. The site displayed correct signage at all the sampling points and event duration monitoring was in place.

*Image 2 – Secondary Biological Treatment*

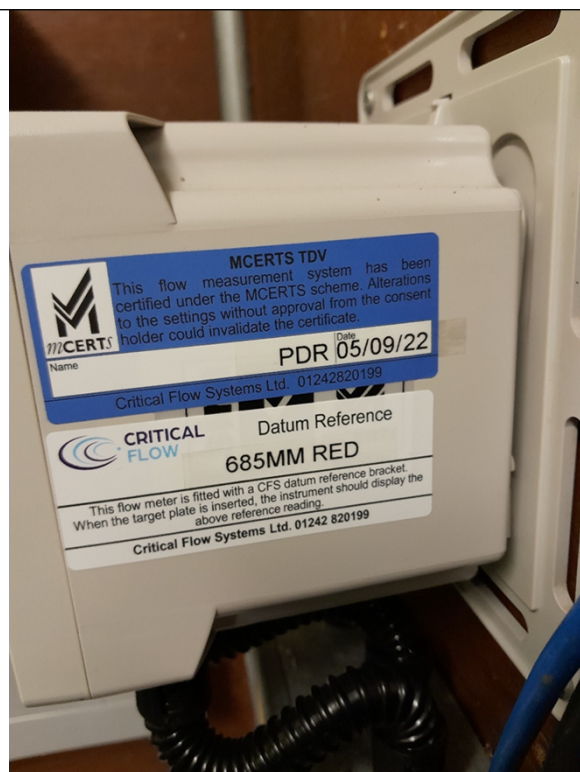
The MCERTS flow meters were within the 5-year certification period (last completed 05/09/2022 – Image 3) and positioned correctly throughout the site. DCWW stated that as well as the external certification an internal team checks MCERTS meters every 2.5 years. A flume was also in place to control flow with no vegetative growth visible.

*Image 3 – MCERTS Certification*
