# Project Biosecurity Plan

**DOCUMENT NUMBER:** BWL-299c

**PROJECT NAME:** Colwyn Bay Waterfront Project Phase 2b

**CLIENT NAME:** Conwy County Borough Council  
**CLIENT REFERENCE:** A.21

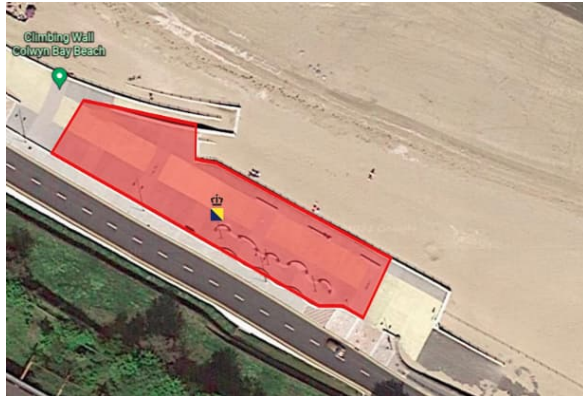
Figure 3 Proposed (mobilization) site office location

Colwyn Bay can be accessed easily from the A55 North Wales Express Way, and then by the West Promenade Road. The temporary (mobilisation) site office facilities, will be set-up directly on the West Promenade, in a fenced off section on the Pedestrian Promenade.

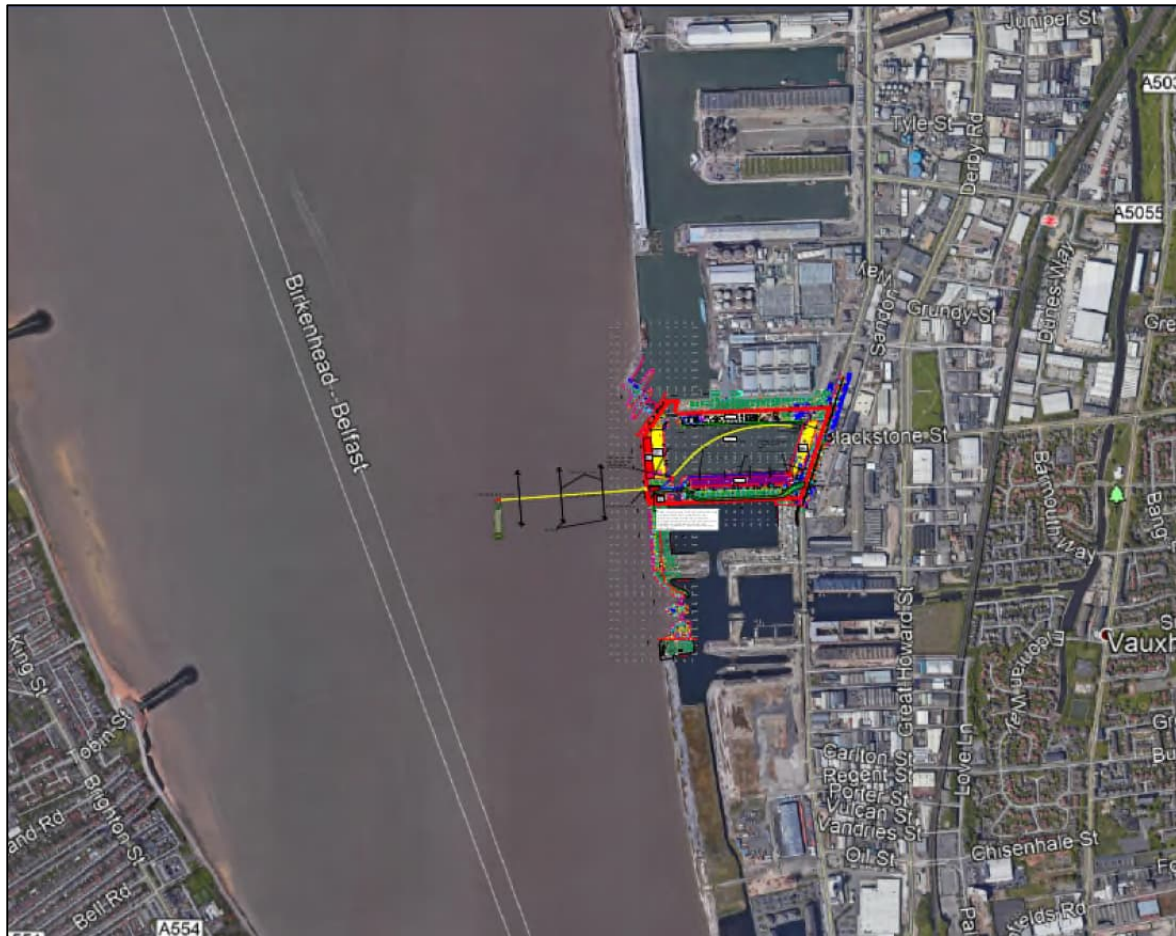
**Figure 8. A wide area view showing the Trailing Suction Hopper Dredger in its temporary mooring location on the River Mersey, coupled up to the floating pipeline.**
