## Menai Strait - Shellfish Waters Project

Hydrogeological Impact Assessment for Temporary Construction Dewatering

Draft 2 | 27 February 2024

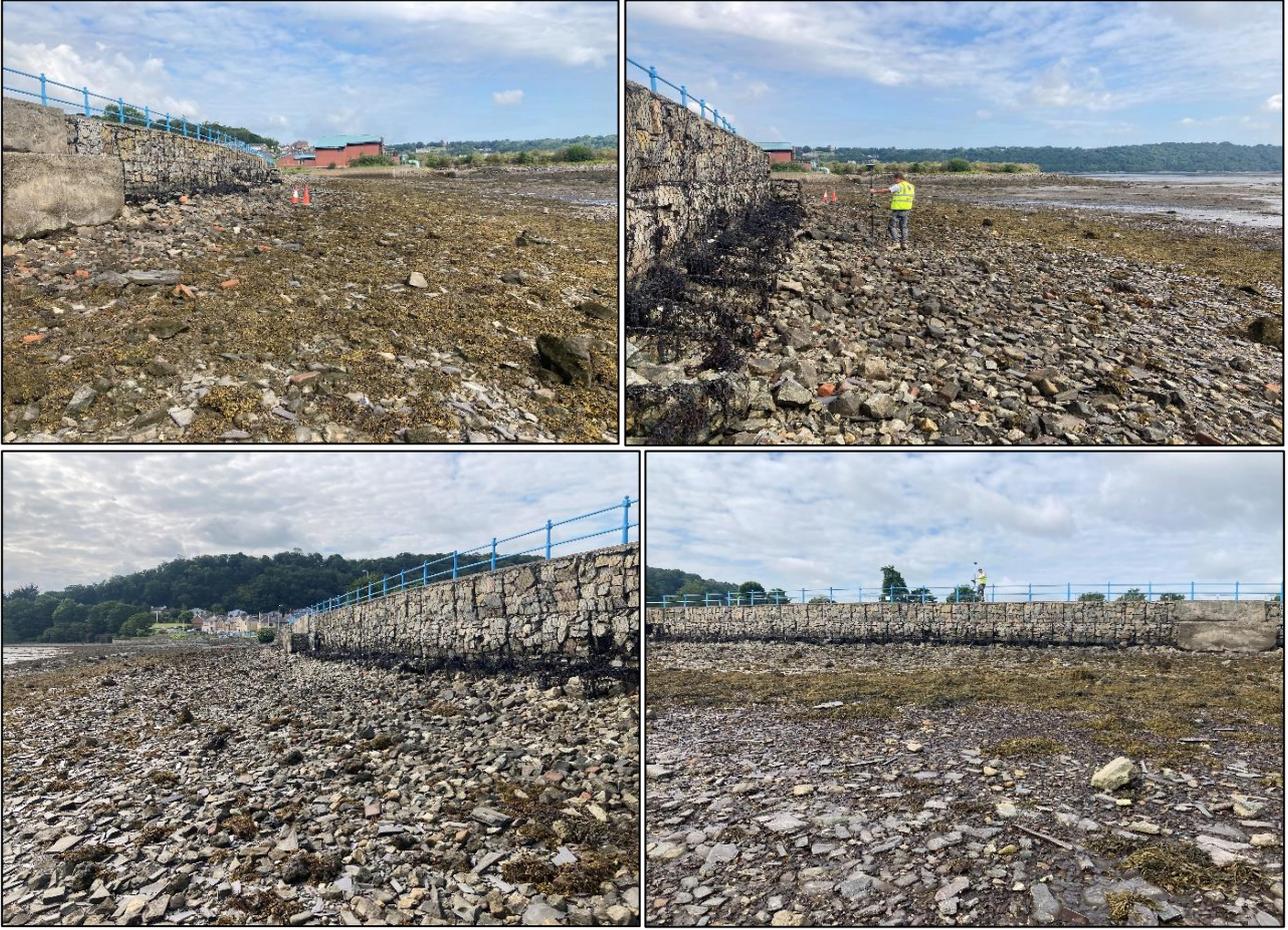
Feature Photo(s) 1

Results
Location	E: 258724.84 N: 372802.25 5.432m OD at top of wall, 3.115m OD at base of wall
Date and Time	20 <sup>th</sup> July 2023 at 09:00
Weather	Warm and cloudy. Heavy persistent rain over past two weeks.
Feature Type	Bangor Flats – Beach.
Use	N/A
Feature Dimensions	N/A
Water depth	N/A – Survey undertaken at low tide
Water flow observations	N/A
Water quality observations	N/A – No obvious signs of pollution.
Bed/base material/lining	Pebbly beach
Vegetation	Seaweed in places
General setting	Bangor flats adjacent to proposed location of SPS.
Other notes	No discharges visible in area.

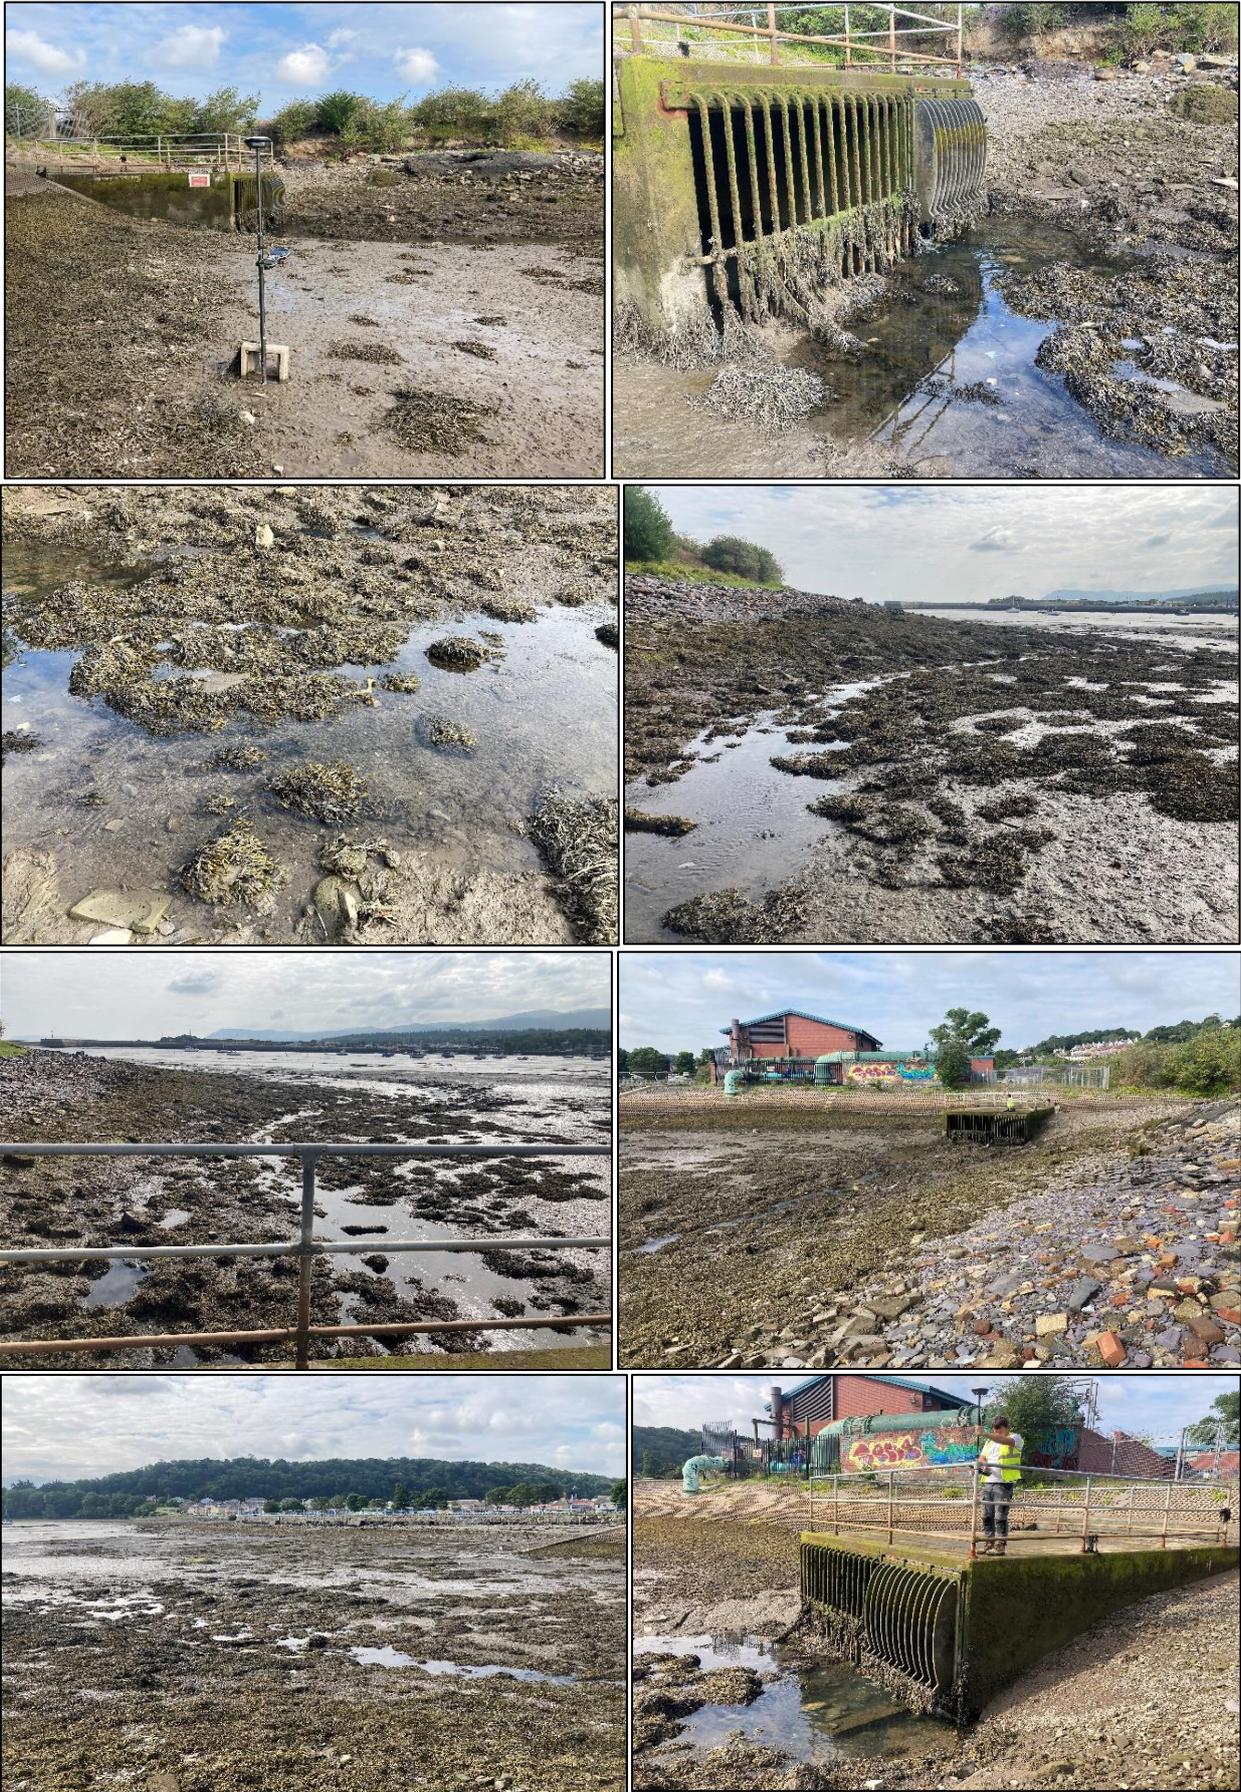
Feature Photo(s) 2

Results
Location	E: 258660 N: 372931
Date and Time	20 <sup>th</sup> July 2023 at 09:30
Weather	Warm and cloudy. Heavy persistent rain over past two weeks.
Feature Type	Discharge from culverted watercourse onto Bangor Flats.
Use	N/A
Feature Dimensions	Culvert circa 5m wide. Channel circa 300mm deep after exiting culvert (at time of survey but tidal mud flats, so varies)
Water depth	Level 1.114m OD
Water flow observations	Gentle
Water quality observations	Clear, no discolouration present
Bed/base material/lining	Sand/Mud after exiting concrete culvert.
Vegetation	Seaweed in places
General setting	Bangor flats adjacent to proposed location of SPS. Culverted water course discharge.
Other notes

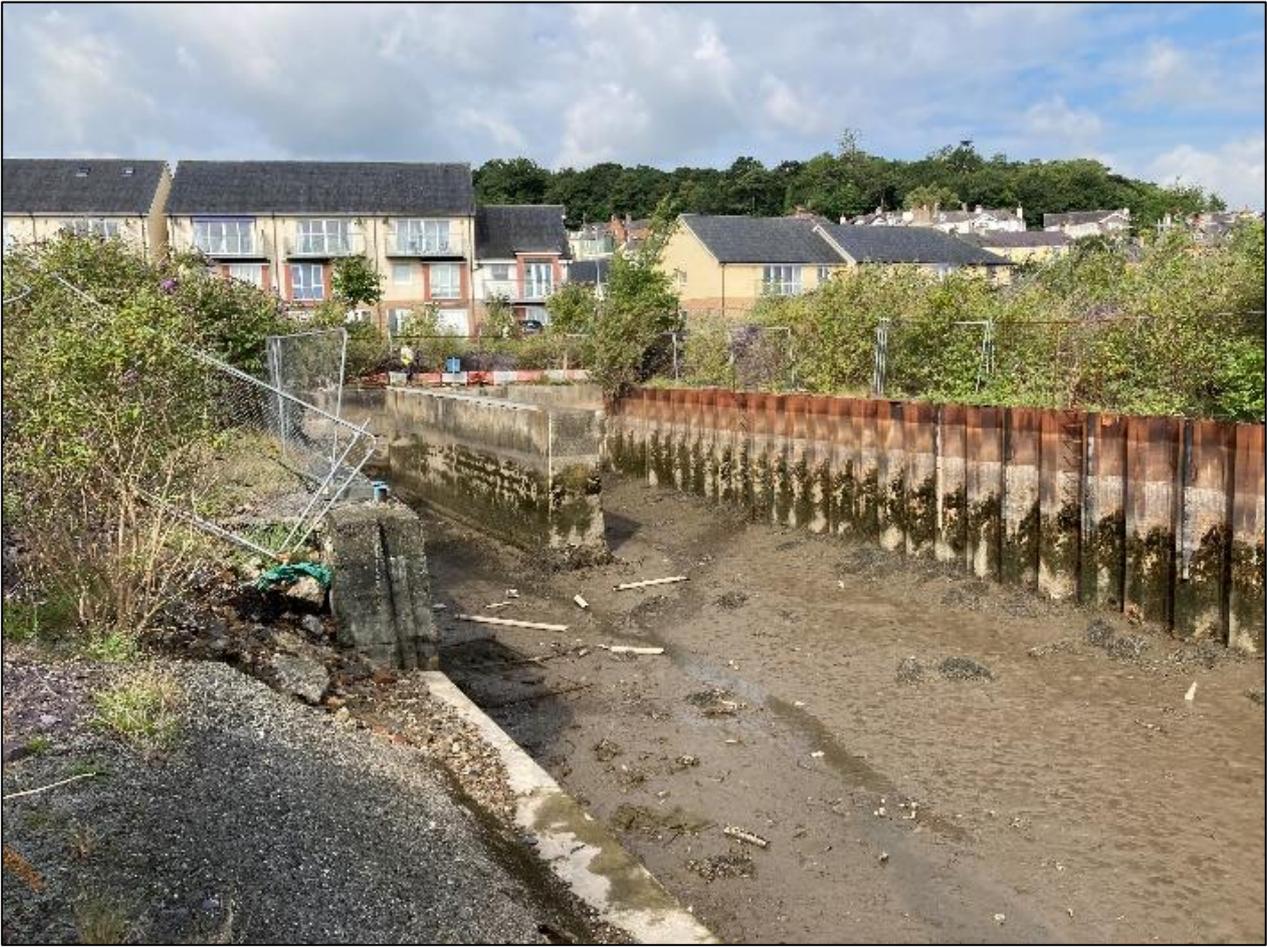
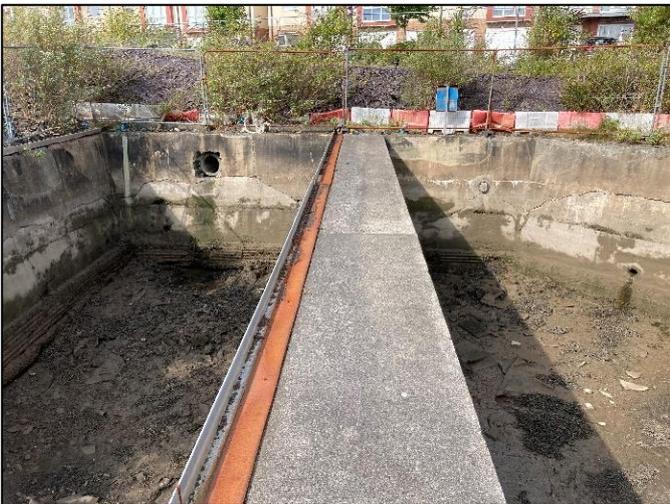
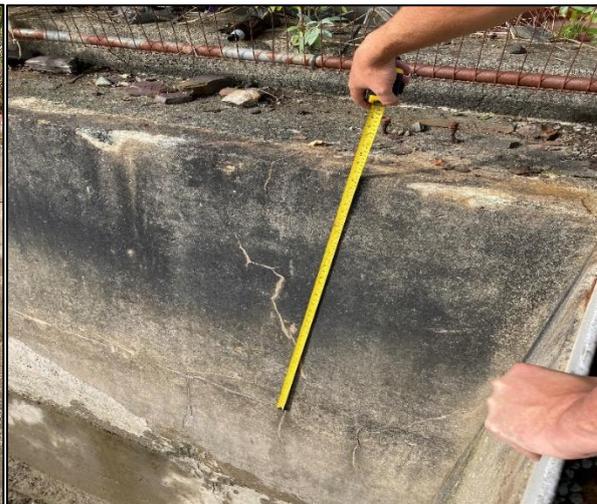
Feature Photo(s) 3

Results
Location	E: 258563.52 N: 372956.55 Top of wall: 4.836m OD
Date and Time	20 <sup>th</sup> July 2023 at 10:00
Weather	Warm and cloudy. Heavy persistent rain over past two weeks.
Feature Type	Outlet into sea from harbour wall in disused dock.
Use	Disused dock. Outfall source unknown (potentially surface water runoff)
Feature Dimensions	N/A
Water depth	Low tide – limited water in dry dock. No water from outfall
Water flow observations	None from outlet
Water quality observations	N/A
Bed/base material/lining	Muddy, Cobbles, Wood
Vegetation	Overgrown vegetation surrounding dry dock.
General setting	Disused dock. Overgrown vegetation and Heras fencing surrounding dock. Residential area beyond
Other notes

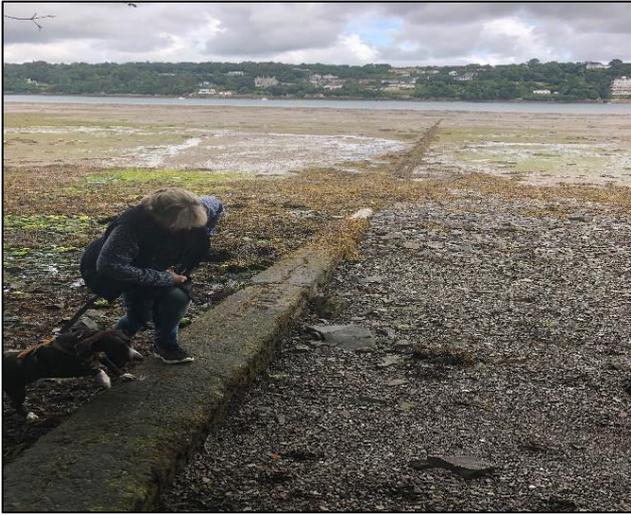
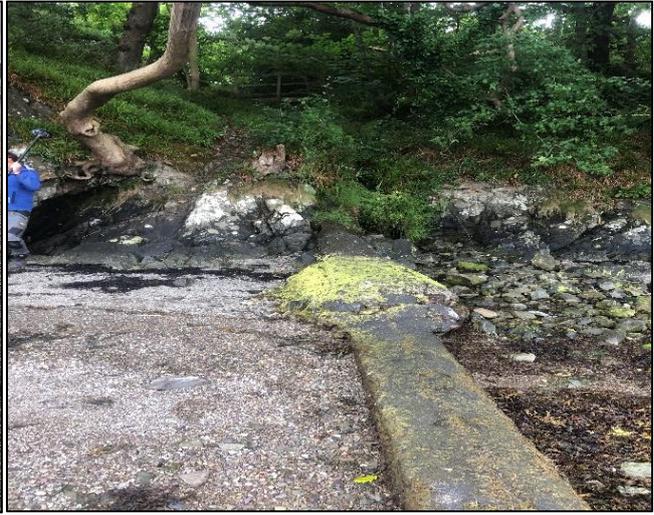
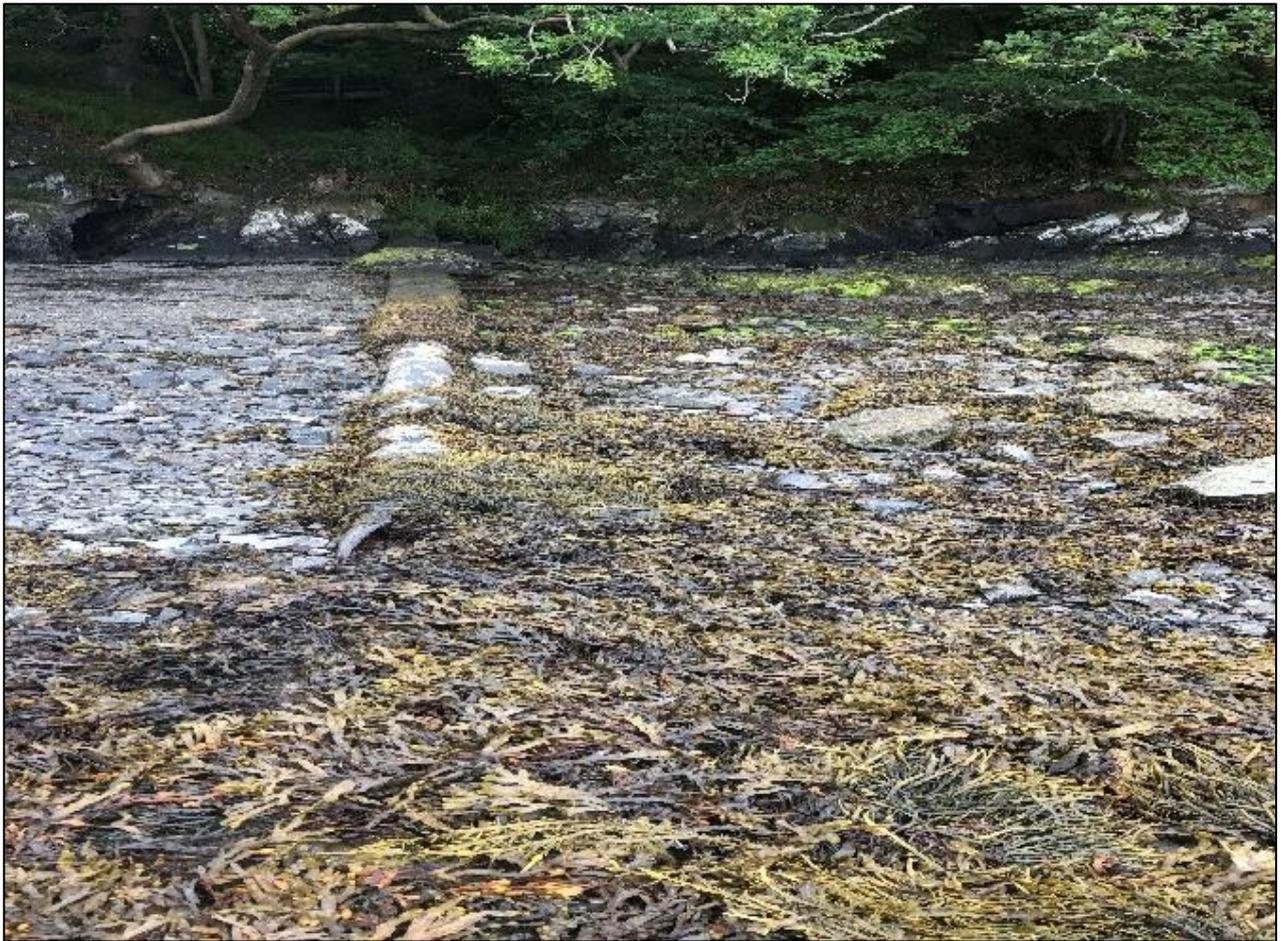
Feature Photo(s) 5

Results
Location	E: 257700.56 N: 372760.66 Elevation: 1.021m OD  E: 257707.45 N: 372750.39 Elevation: 2.579m OD
Date and Time	21 <sup>st</sup> July 2023 at 09:00
Weather	Sunny.
Feature Type	Outfall into sea
Use	N/A
Feature Dimensions	Circa 50cm diameter
Water depth	N/A
Water flow observations	N/A – None visible
Water quality observations	N/A – No clear signs of pollution
Bed/base material/lining	Towards land – cobbles/pebbles/gravels. Towards sea – sand and mud
Vegetation	Seaweed surrounding culvert. Wooded area at landside end of culvert.
General setting	Beach
Other notes	Pipe damaged

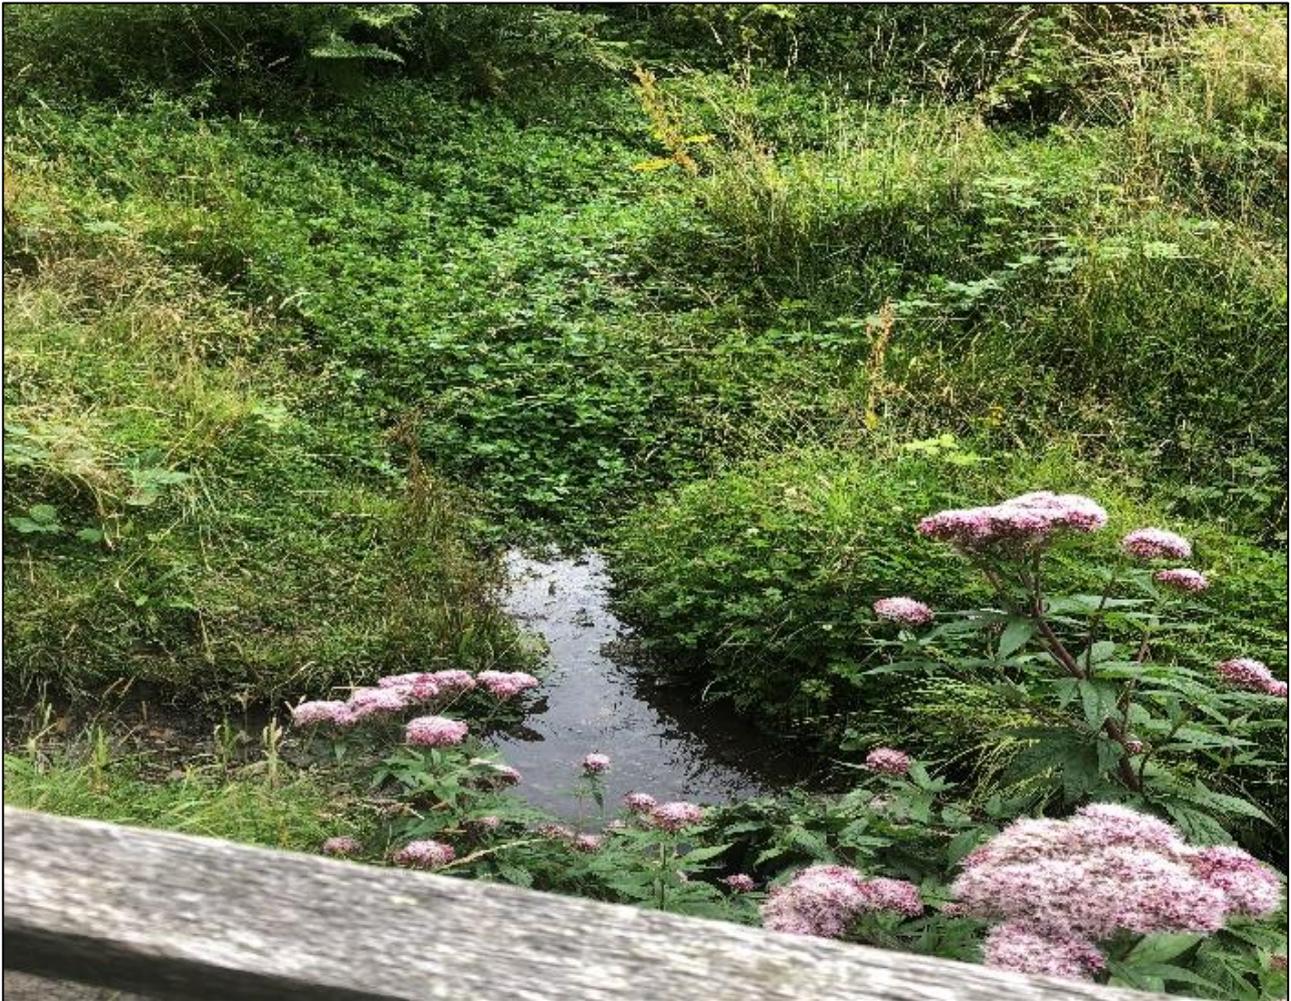
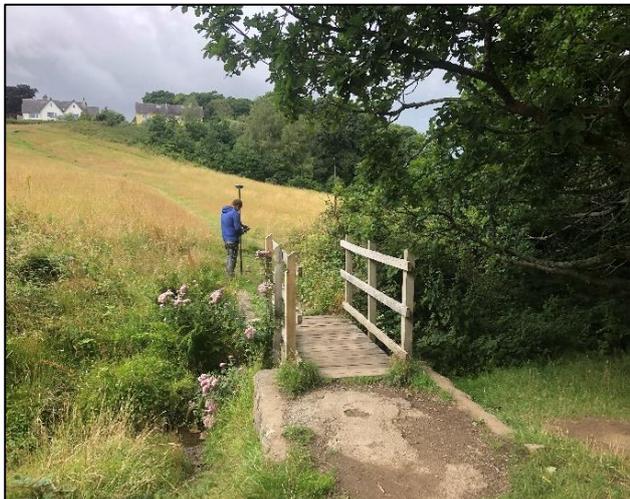
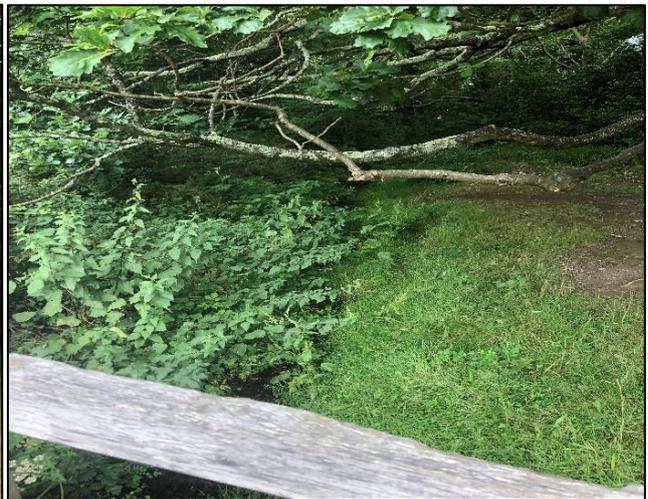
**Feature Photo(s) 6**

Results
Location	E: 257764.32 N: 372706.76
Date and Time	21 <sup>st</sup> July 2023 at 09:30
Weather	Cloudy
Feature Type	N/A
Use	N/A
Feature Dimensions	600/700mm wide
Water depth	Water depth c400mm. Level 16.686m OD
Water flow observations	Steady – slow.
Water quality observations	Clear – no sign of pollution
Bed/base material/lining	Unknown - vegetated
Vegetation	Dense vegetation along embankment. Trees.
General setting	Bridge over water course within public area
Other notes

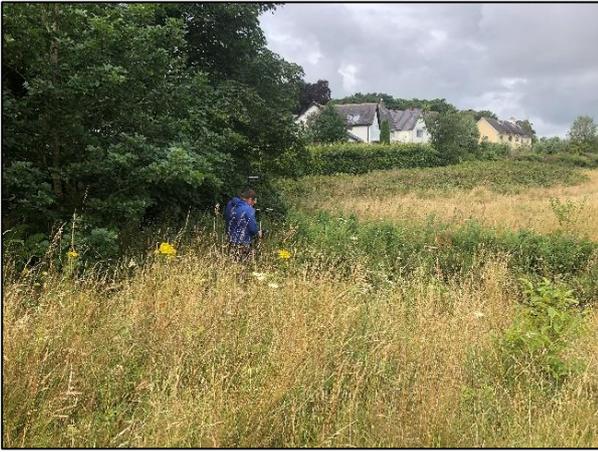
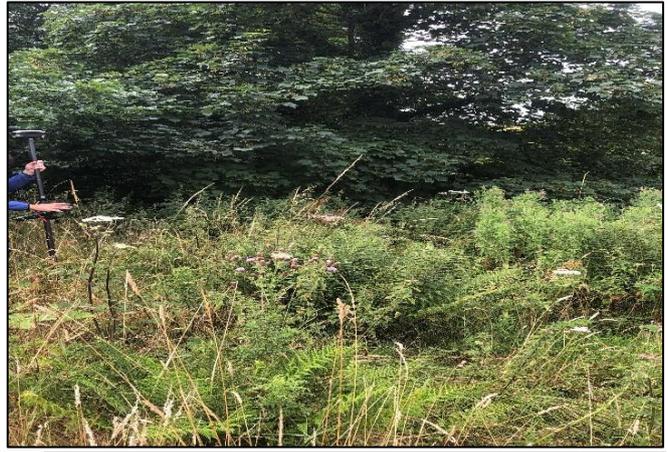
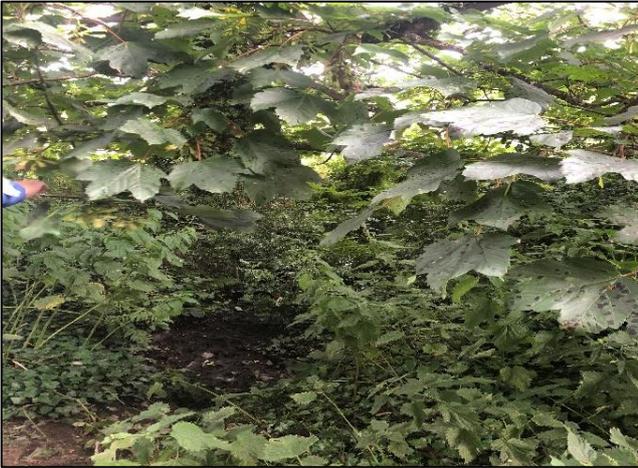
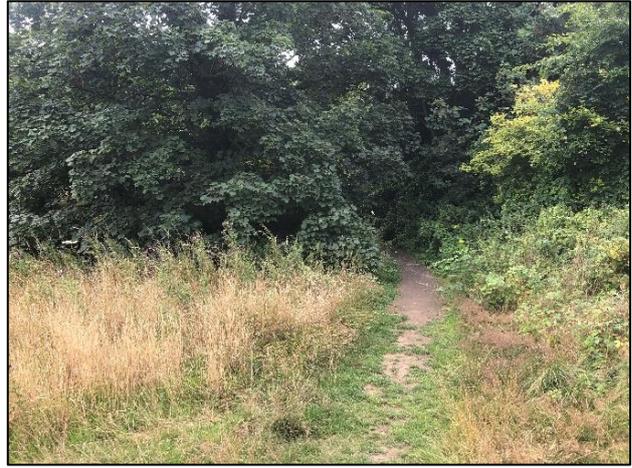
Feature Photo(s) 7

Results
Location	E: 257759.81 N: 372565.95 Elevation: 30.851m OD
Date and Time	21 <sup>st</sup> July 2023 at 10:00
Weather	Cloudy
Feature Type	Signs of spring. Wet, boggy ground.
Use	N/A – natural feature
Feature Dimensions	N/A
Water depth	<1cm where water visible – mainly boggy/wet ground
Water flow observations	Slow, diffuse spring flow.
Water quality observations	Clear, where visible
Bed/base material/lining	Mud/vegetation – geology not visible
Vegetation	Dense vegetation
General setting	Vegetated public open space
Other notes

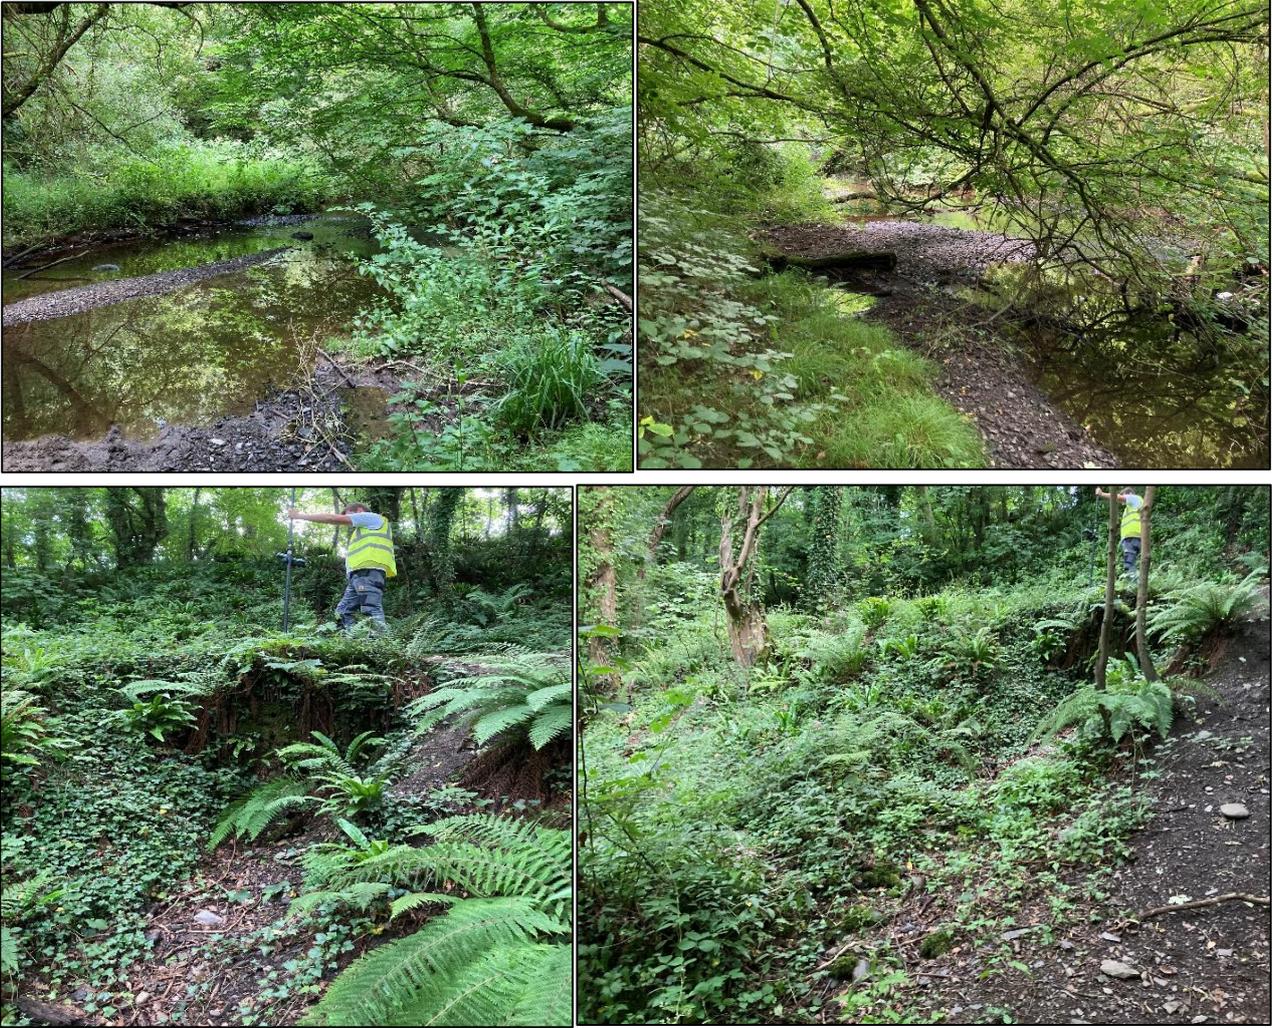
Feature Photo(s) 8

Results
Location	E: 259080 N: 371859
Date and Time	20 <sup>th</sup> July 2023 at 11:00
Weather	Sunny
Feature Type	Watercourse (Afon Cegin)
Use	N/A
Feature Dimensions	Couple of metres
Water depth	300-400mm
Water flow observations	Steady (non-turbulent flow)
Water quality observations	Muddy – poor visibility. No contamination visible
Bed/base material/lining	Mud and cobbles.
Vegetation	Vegetation on either bank and trees
General setting	Woodland
Other notes

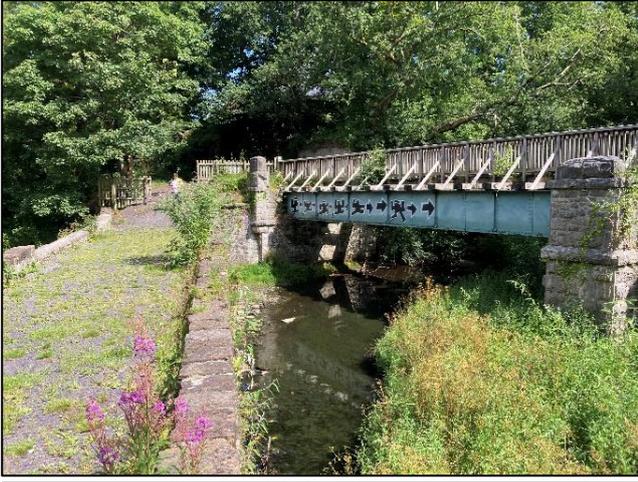
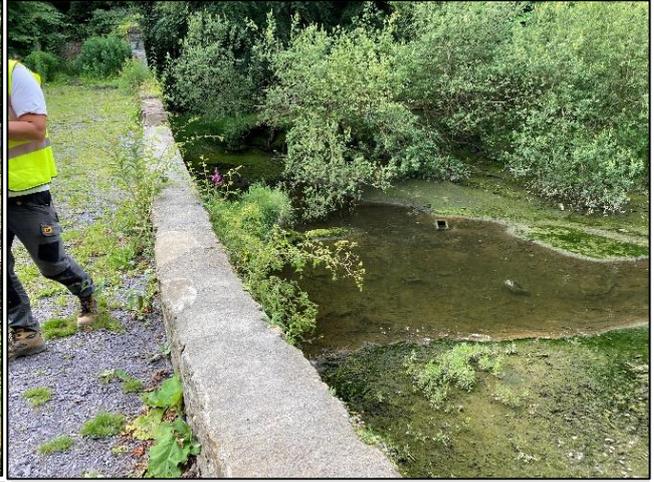
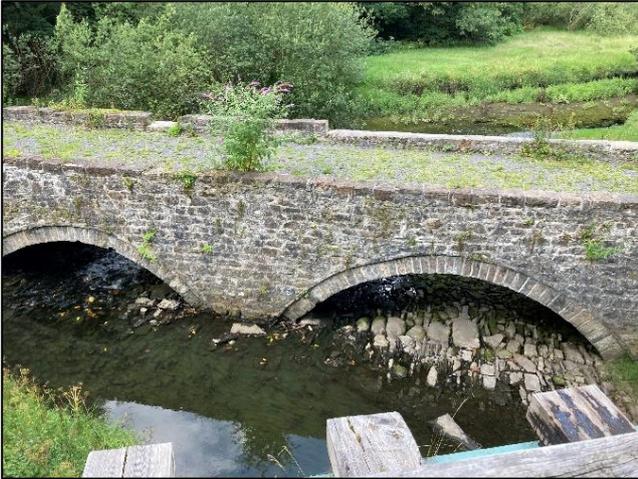
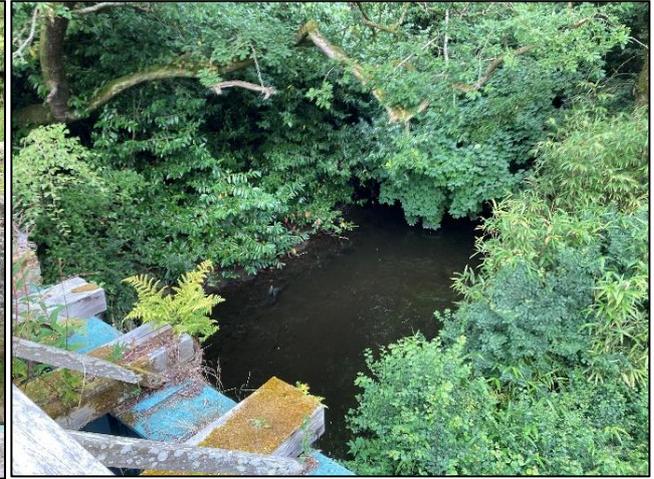
Feature Photo(s) 9

Results
Location	E: 259276.99 N: 372391.14 Elevation 8.241m OD (Lower Bridge)
Date and Time	20 <sup>th</sup> July 2023 at 11:30
Weather	Sunny
Feature Type	Watercourse - Two bridges (pedestrian and old cattle bridge) over Afon Cegin, upstream of Cegin Pool
Use	N/A
Feature Dimensions	Bridge >20m long.
Water depth	Fairly shallow (bottom visible)
Water flow observations	Steady water flow (non-turbulent)
Water quality observations	Clear generally – murky in areas. No clear pollution.
Bed/base material/lining	Mud, gravels and cobbles.
Vegetation	Dense vegetation + trees on verges. Grassland on verges downstream. Algae in water in areas.
General setting	Woodlands.
Other notes

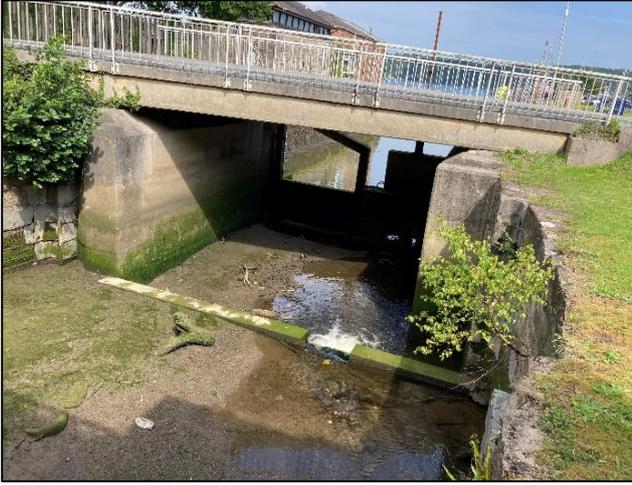
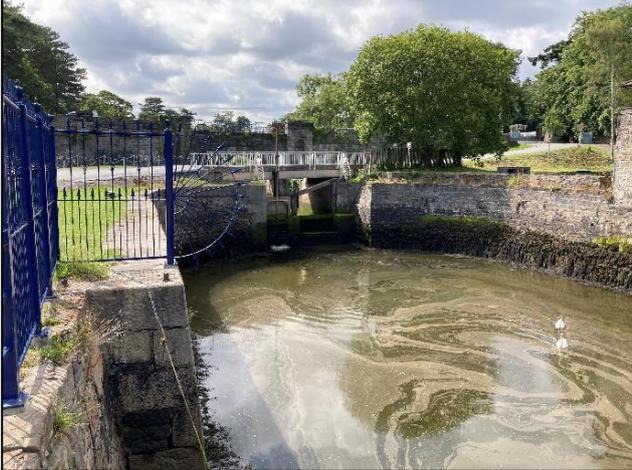
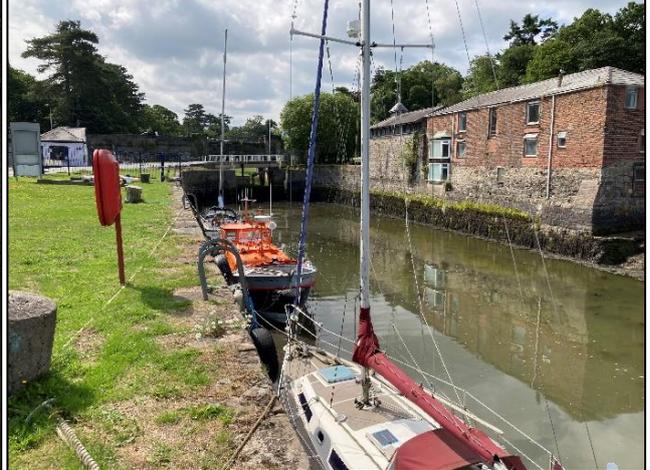
Feature Photo(s) 10

Results
Location	E: 259192 N: 372586
Date and Time	20 <sup>th</sup> July 2023 at 12:30
Weather	Sunny
Feature Type	Watercourse flowing underneath bridges into harbour area
Use	N/A
Feature Dimensions	Watercourse circa 5m wide under bridge
Water depth	Tidal (low tide during survey) Upstream of bridge shallow. Downstream depth not visible
Water flow observations	Steady water flow from upstream
Water quality observations	Very murky downstream of bridge. Clear upstream of bridge
Bed/base material/lining	Muddy sandy bed. Gravels in places
Vegetation	Cut grass, occasional trees/shrubs
General setting	Harbour, adjacent to Porth Penrhyn. Upstream of bridge meandering river through field.
Other notes

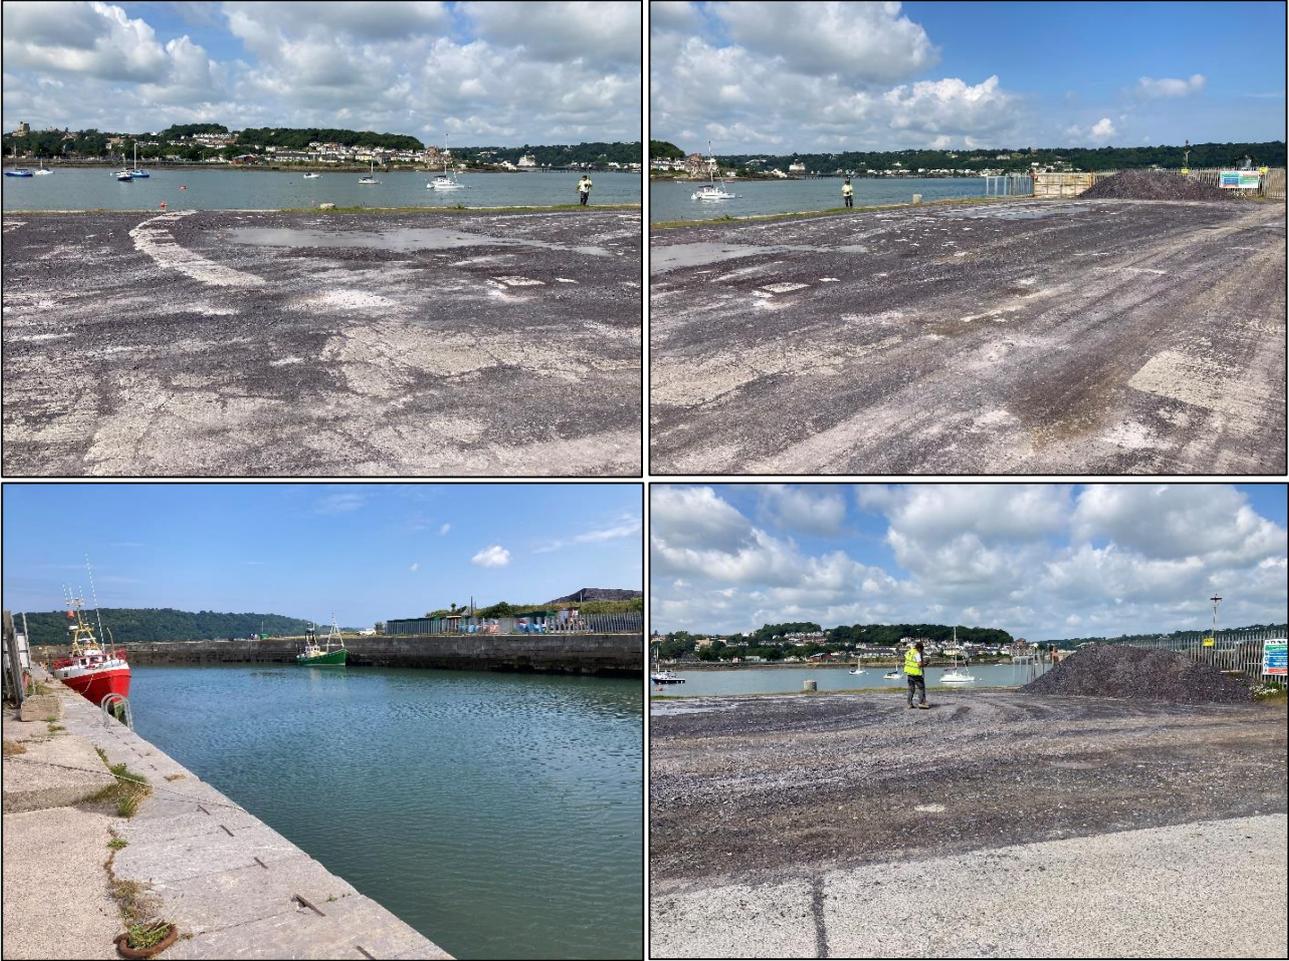
Feature Photo(s) 11

Results
Location	E: 259108.00 N: 373002.00
Date and Time	20 <sup>th</sup> July 2023 at 13:30
Weather	Sunny
Feature Type	Menai Strait at Porth Penrhyn (Harbour)
Use	N/A
Feature Dimensions	N/A
Water depth	Unknown (deep)
Water flow observations	N/A
Water quality observations	Clear water conditions. No clear contamination
Bed/base material/lining	Not visible – assume sands to gravels
Vegetation	N/A
General setting	On Wharf at Porth Penrhyn
Other notes	No signs of discharge or outlets (potentially submerged)

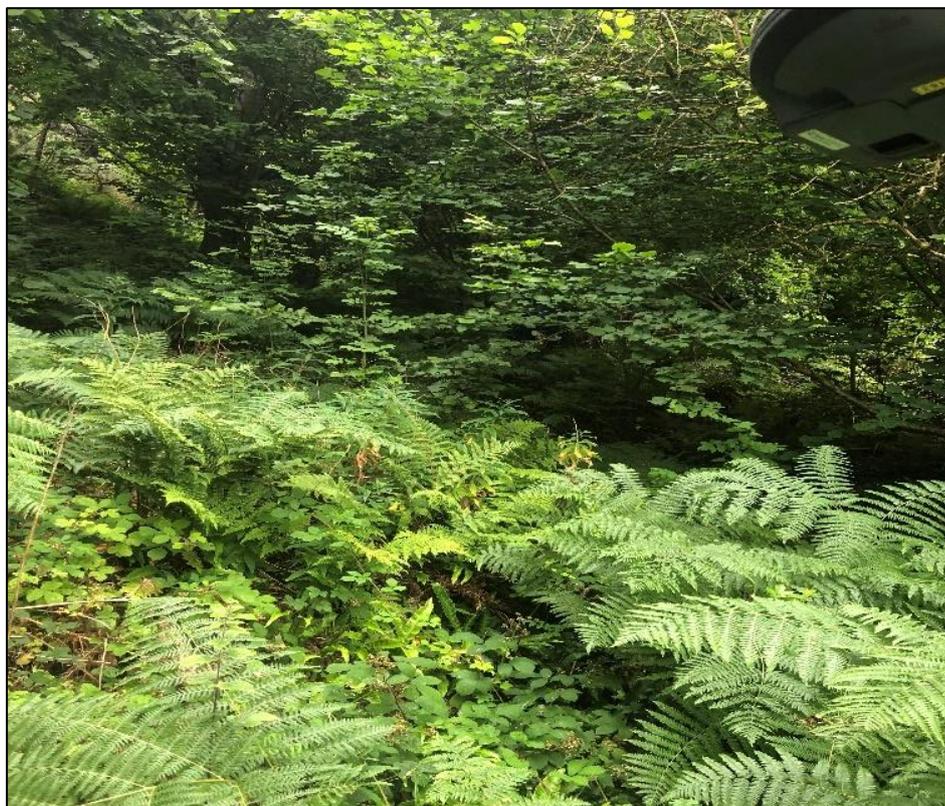
Feature Photo(s) 13

Results
Location	E: 258298.48 N: 372041.51 GL: 37.808m OD
Date and Time	21 <sup>st</sup> July 2023 at 13:30
Weather	Cloudy
Feature Type	Potential spring – unable to locate any signs.
Use	N/A
Feature Dimensions	N/A
Water depth	N/A
Water flow observations	N/A
Water quality observations	N/A
Bed/base material/lining	Muddy underfoot
Vegetation	Dense overgrown vegetation
General setting	Back of housing estate on Bangor Mountain
Other notes

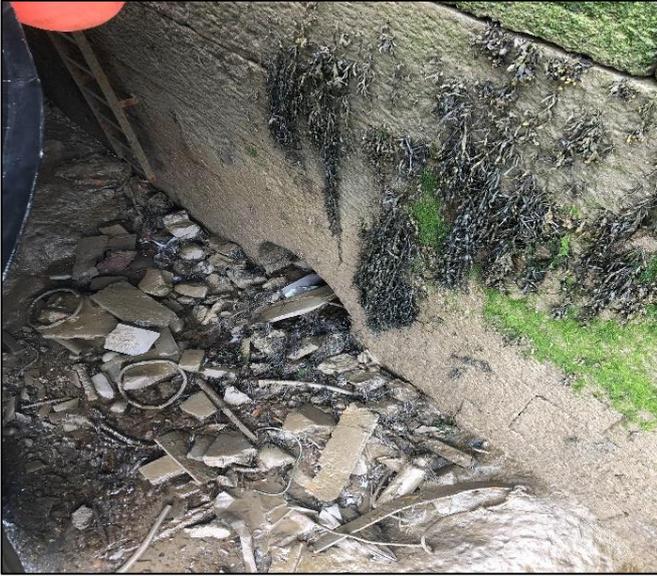
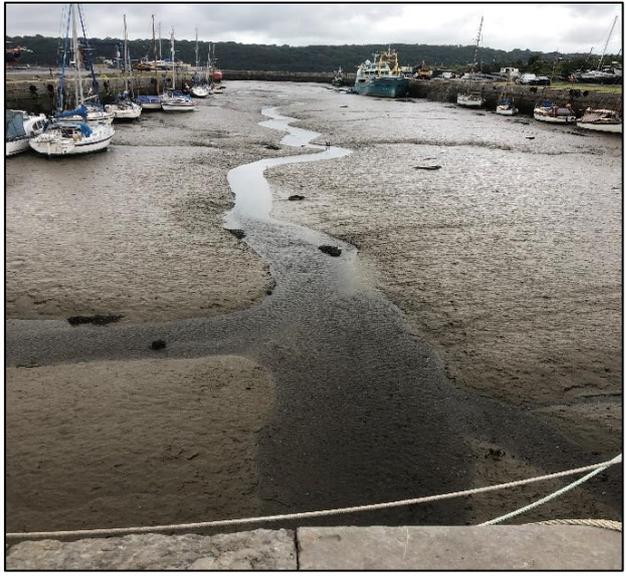
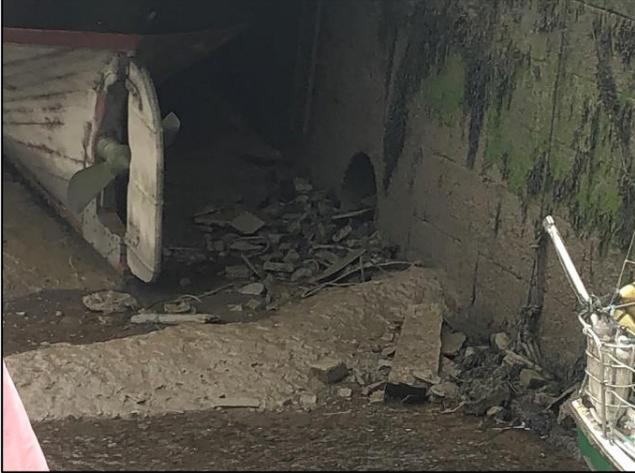
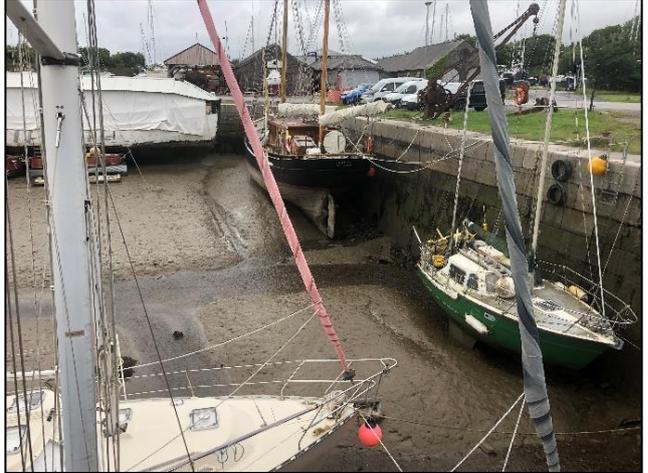
Feature Photo(s) 14

Results
Location	E: 259227.54 N: 372802.14
Date and Time	21 <sup>st</sup> July 2023 at 08:30
Weather	Cloudy
Feature Type	Outfall/discharge onto Bangor Flats from harbour wall (marked as issues on map)
Use	N/A
Feature Dimensions	Unable to measure
Water depth	Tidally dependent Outfall Invert: -0.793m OD
Water flow observations	No discharge visible, but a lot of debris at outlet location.
Water quality observations	Unknown
Bed/base material/lining	Lots of debris. Muddy/sandy seabed
Vegetation	None
General setting	Penrhyn Wharf
Other notes

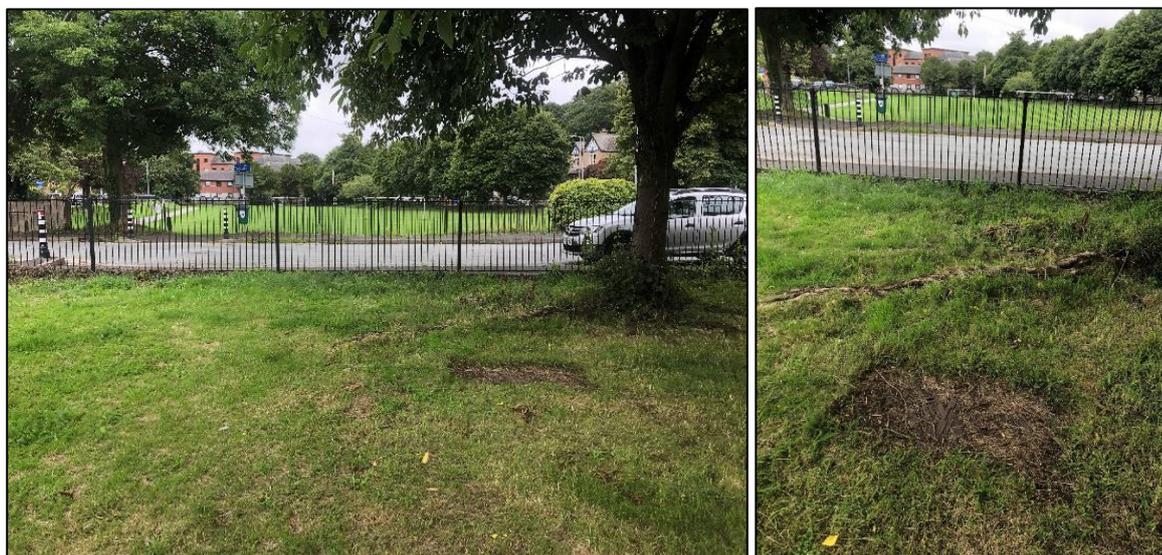
Feature Photo(s) 15

Results
Location	E: 258331.66 N: 372626.69 Elevation: 6.635m OD (Manhole)
Date and Time	21 <sup>st</sup> July 2023 at 14:00
Weather	Cloudy
Feature Type	Culverted watercourse.
Use	N/A
Feature Dimensions	N/A
Water depth	N/A
Water flow observations	Could hear flows under manhole cover.
Water quality observations	N/A
Bed/base material/lining	N/A
Vegetation	N/A
General setting	In field by Bangor swimming baths
Other notes	Could not find any visible culvert/ watercourse upstream or downstream of location
