Natural Resources Wales

Salmon for Tomorrow 2 - Llanfair Talhaiarn

Flooding Technical Note

Reference: 290013-ARP-CP-LF-RP-CX-0004

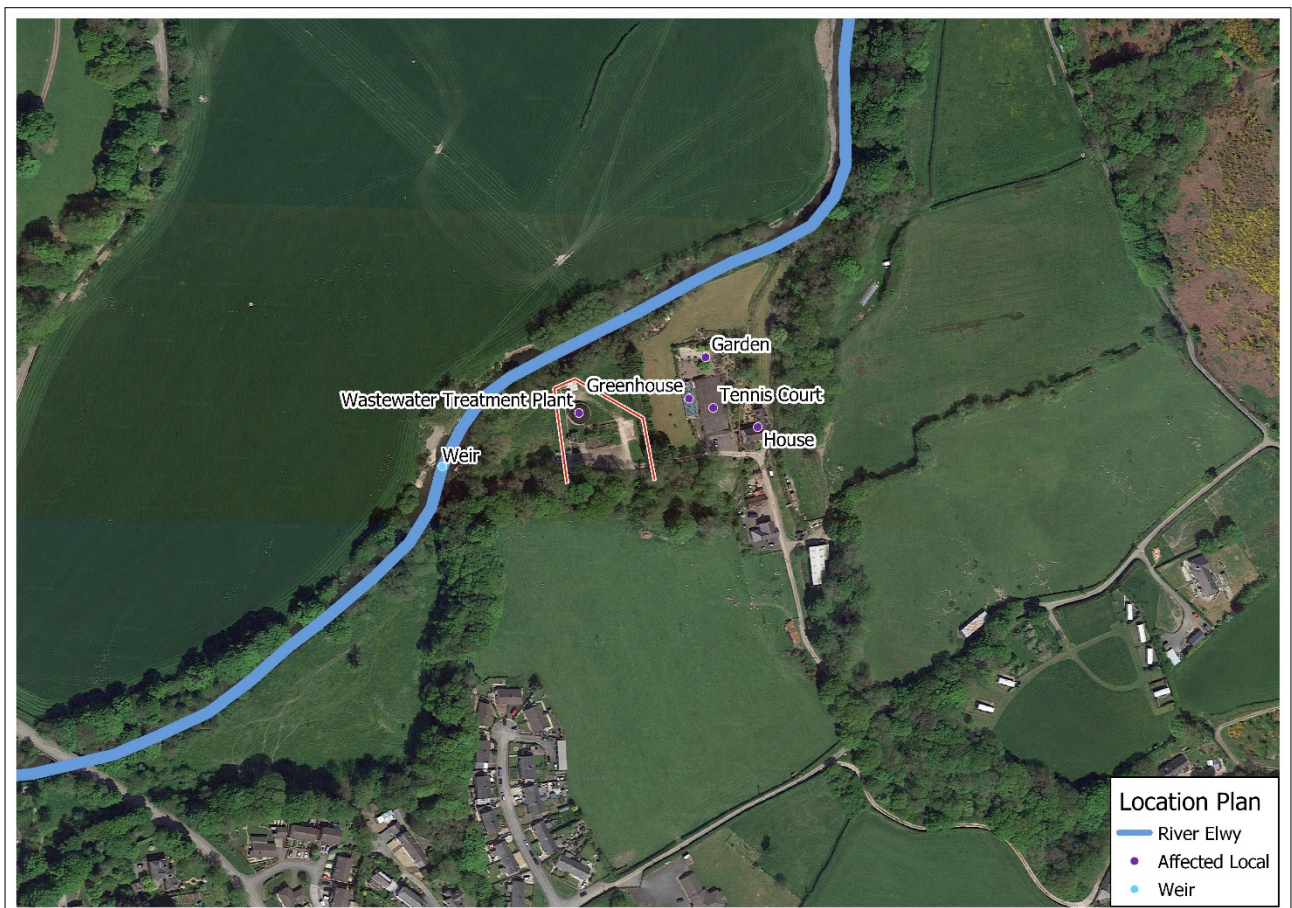
Figure 1: Site plan showing the Wastewater Treatment Plant and private property

The weir is situated on the River Elwy, downstream of the School Lane Bridge and the A544 Road Bridge, at Ordnance Survey National Grid Reference (NGR) SH 93052 70474. On the left bank of the River Elwy is a public footpath alongside agricultural fields that are regularly inundated during flood events. On the right bank, immediately upstream of the weir is a disused leat which has been blocked off. A wastewater treatment plant and private residential property are also located on the right bank

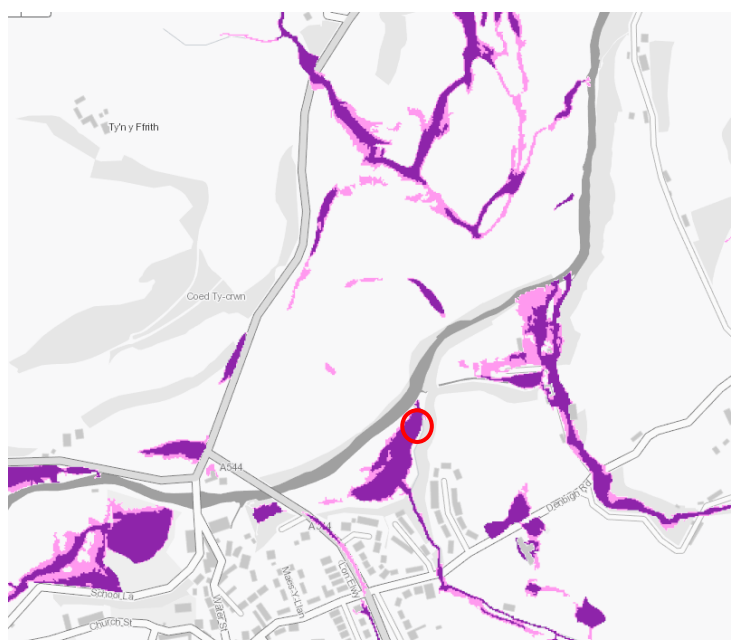
Figure 4: Surface water and small watercourse flood extents around the weir (circled in red) extracted from NRW mapping [1]

The area surrounding Llanfair is in both the fluvial and surface water Flood Zones 2 and 3. Mapping illustrates this in Figure 3 and Figure 4 for fluvial and surface water respectively. Flood risk at this location is summarised in Table 1.

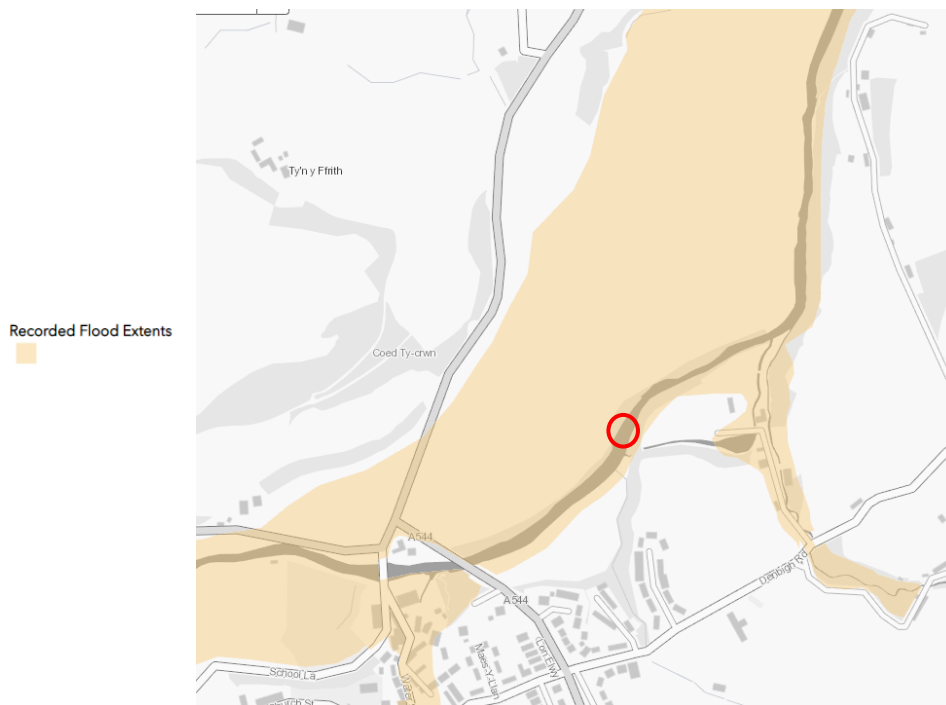
Figure 5: Recorded flood extents around the weir (circled in red) extracted from NRW mapping [1]

Llanfair has historically flooded to the extents shown in Figure 5. This flooding would have arisen from fluvial and surface water/small watercourse sources.

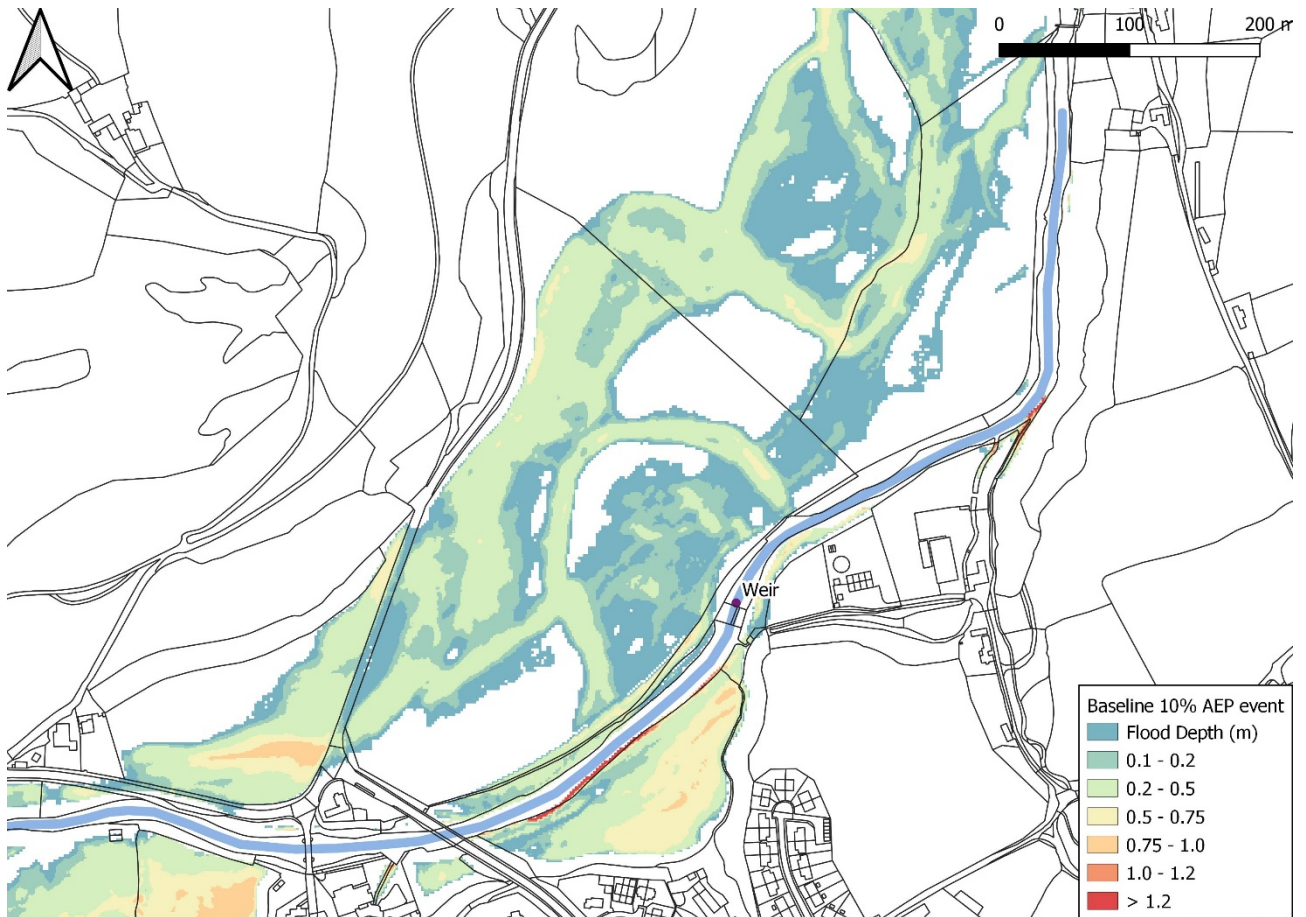
Figure 6: Baseline flood depths in the 10% AEP event

The flood model was run for a range of return periods, from a 0.1% to 50% AEP. Full results are given in Appendix A. Figure 6 shows the baseline flood depths at the 10% AEP (illustrating the onset of flooding to the property garden on the right-hand bank) and Figure 7 shows the baseline 0.1% AEP event. The 0.1% AEP event causes more flooding of greater depth and extent on both banks, notably at the wastewater treatment works (at NGR SH 93148 70506) and the private property (at NGR SH 93244 70504) on the right bank.
