Felin Puleston Weir Optioneering DRAFT Report

Welsh Dee Trust

Document name	Prepared by	Date	Reviewed by	Approved By
Felin Puleston Weir Optioneering and Design DRAFT Report v1.0	Seb Bentley and Rob Williamson	11 th November 2022	George Heritage	George Heritage

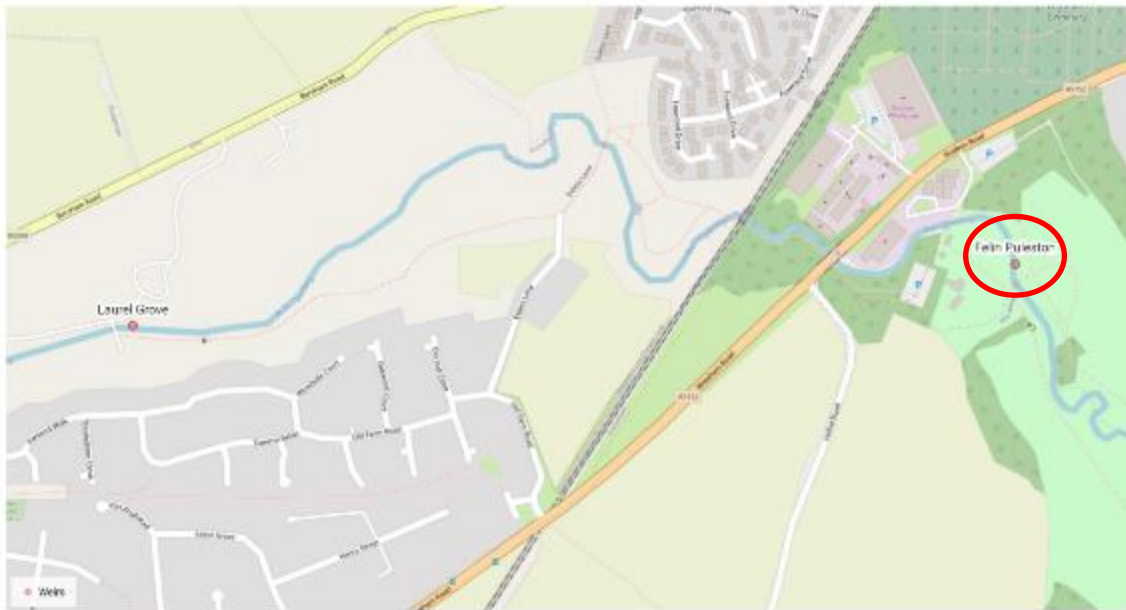
Figure 1.1. Felin Puleston Weir location (image provided by the client).

The Welsh Dee Trust commissioned Dynamic Rivers to undertake the optioneering and design for providing fish passage and improving the geomorphological functioning for a weir on the Afon Clywedog to the south west of Wrexham at Felin Puleston, located on land owned by the National Trust (Figure 1.1).

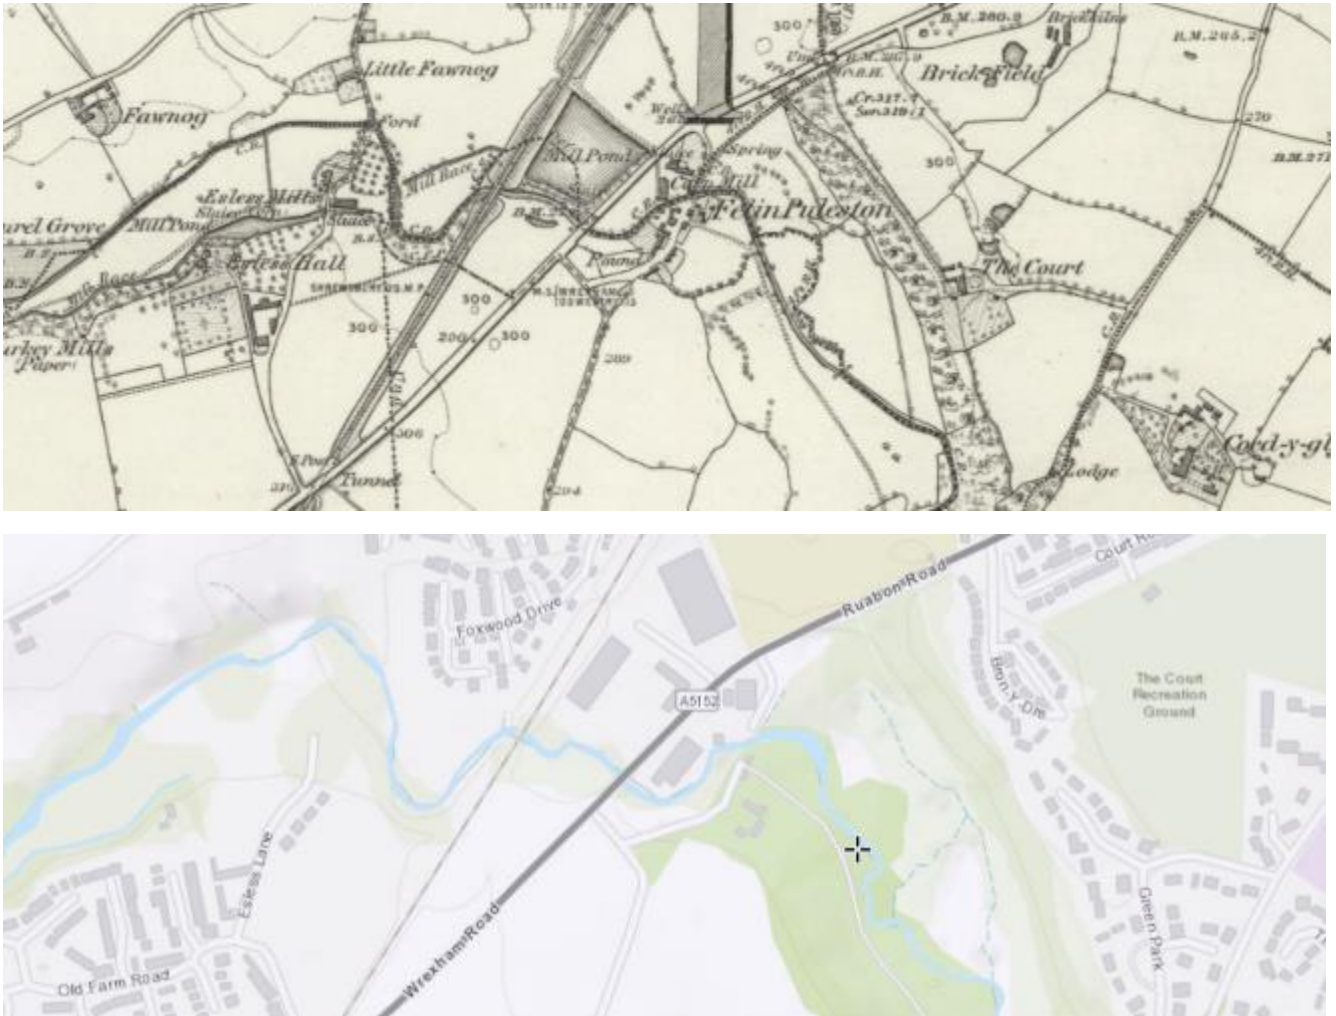
Figure 2.1. Comparison of 1879 historic map and current mapping for the Afon Clywedog study reach.

The Afon Clywedog may be classified as a steep, modified, alluvial single thread channel through the study reach at Felin Puleston. It has been modified from its natural state and constrained as a single-thread channel, mainly as a result of bank protection works upstream of the weir in the form of gabion baskets. These are in a poor state, as described in the field audit section below. Modifications to the planform of the watercourse predate the earliest available OS maps, with Figure 2.1 showing historic channel straightening and creation of in-channel structures associated to a series of Mills along the reach, with a corn mill being located just upstream of the current weir together with an associated mill race over the left-hand bank. The watercourse appears to have begun to reform a more natural planform downstream of the weir structure, with a series of meanders developing since the straightening pre-1879. This is demonstrated in the Google Earth imagery shown in Figure 2.2 below where development of these bends and associated gravel morphology is clear together with potential attempts to restrict the movement and protect the nearby footpath (which is also considered in the options development for this scheme local to the weir) in 2018. This demonstrates the active nature of the river and highlights the potential for significant lateral erosion and response along the study reach. Figure 2.2 shows the presence of trees over both banks upstream of the weir, masking the channel itself, however there is also a footbridge linked to the path shown that spans across the Afon Clywedog.

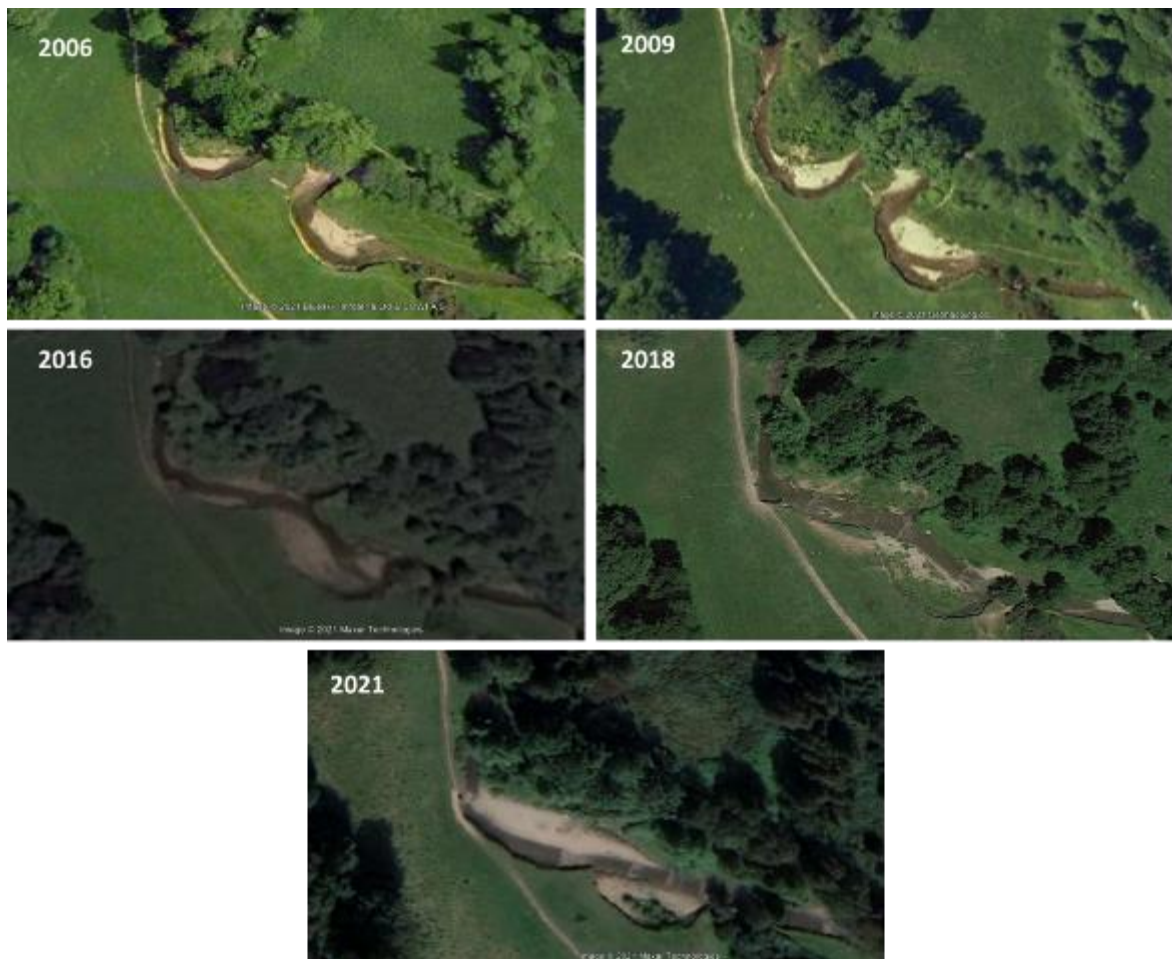
Figure 2.2. Meander bend development on the Afon Clywedog downstream of Felin Puleston weir (copyright Google Earth).

The present watercourse flows mostly over river alluvium (Figure 2.3) along the study reach, with a belt of alluvium around the weir and upstream indicating a wider historic floodplain. Use of this floodplain by the present river has been significantly constrained by development and modification over time. This is demonstrated by the Flood Map for Planning (Figure 2.5), showing a much more constrained Flood Zone 3, highlighting the significant modification to the floodplain and disconnectivity. The alluvial deposits overlay the Etruria Formation Mudstone (Figure 2.4). This bedrock is not significantly exposed along the study reach. The dominant control on the current river processes is the alluvium layer that is being reworked across a limited area, as demonstrated by Figure 2.2.

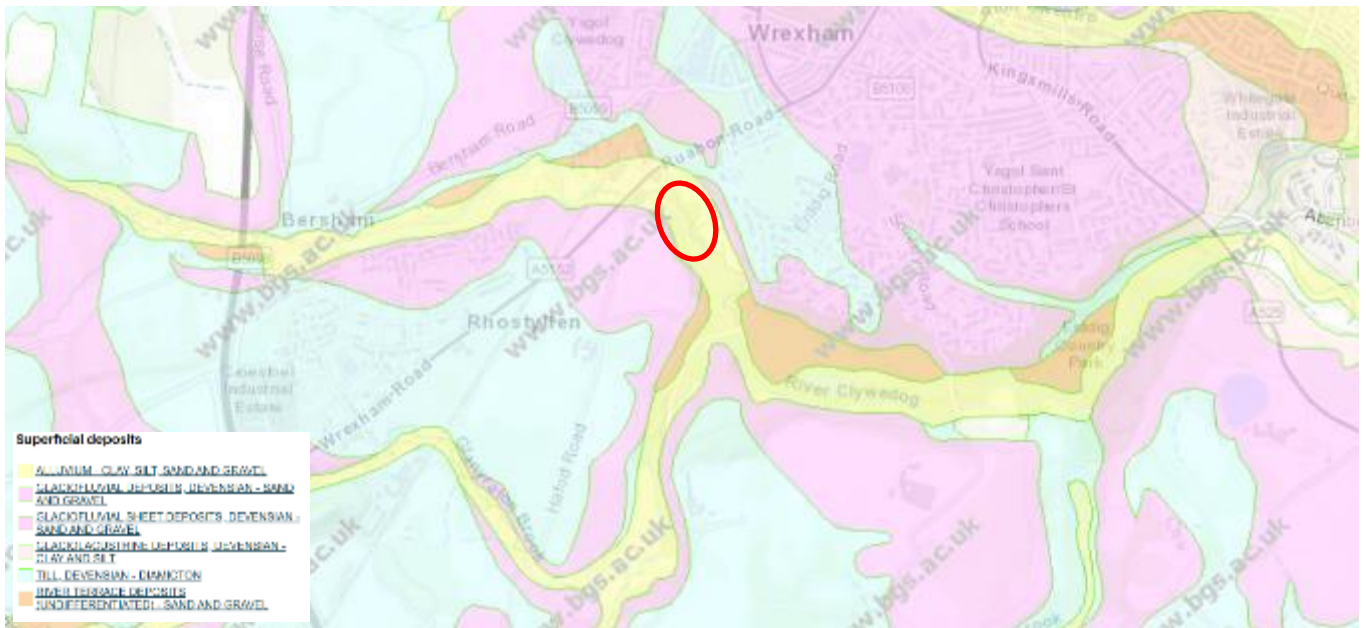
Figure 2.3. Drift geology of the Afon Clywedog study reach

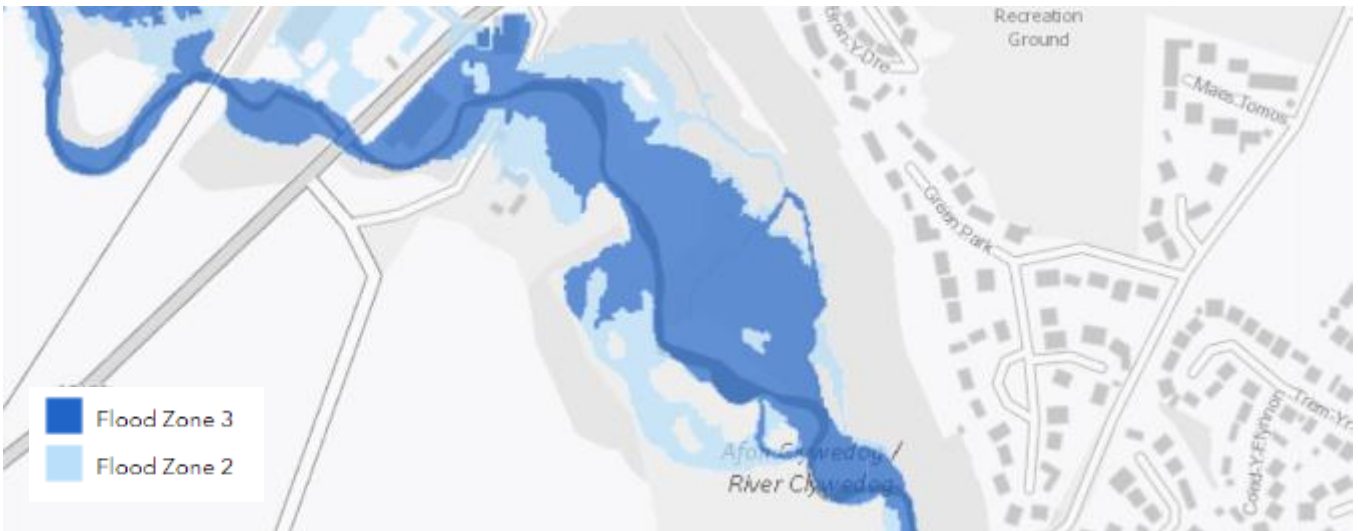
Figure 2.5. Flood map for planning along the study reach showing the extent of Flood Zones 2 and 3

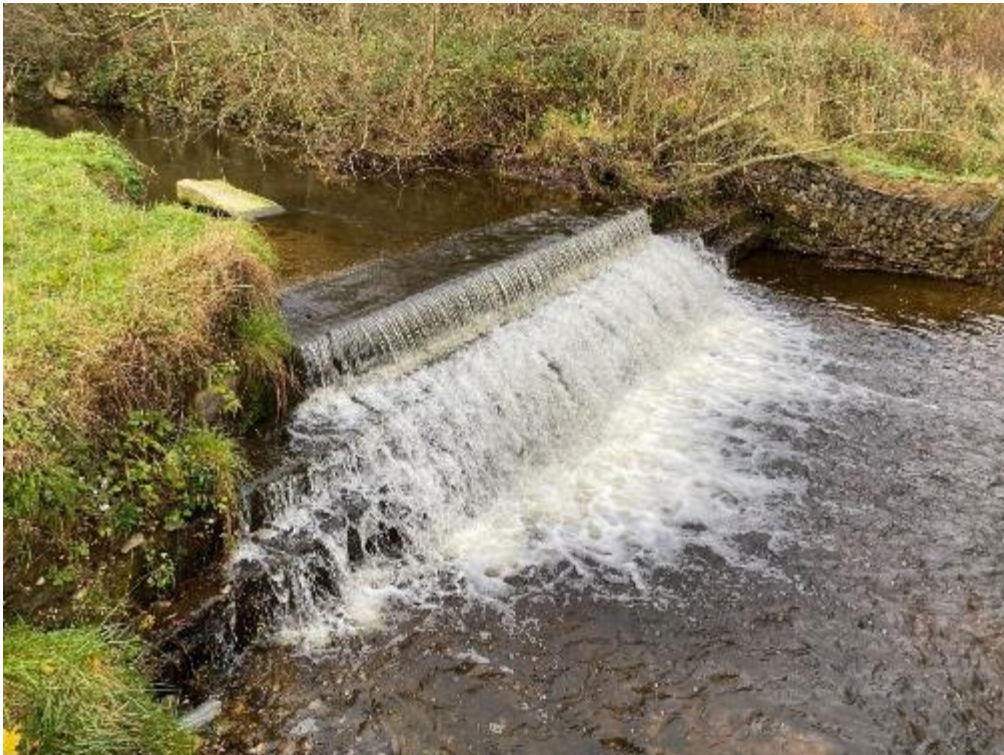
Figure 2.7. Weir structure showing three step concrete construction

The weir provides a head difference of approximately 1m under summer/winter flow conditions across the structure (Figure 2.7). There are recent repairs to the weir over both banks, with gabion baskets present over the left-hand bank immediately downstream (Figure 2.7 and 2.8). These also appear to be in a poor state. The weir appears to be composed of concrete forming a three-step structure. Erosion issues in the vicinity of the weir remain and are continuing as a result of high energy flows and the influence of the weir structure (Figure 2.9). Continued repairs are likely to be required to mitigate against failure or outflanking of the structure with or without any restoration works. The weir is no longer interrupting transport of gravels and cobbles downstream, with dynamic gravel features evident approximately 200m downstream (Figure 2.2), this is unsurprising given the steep gradient, flashy flows and the likelihood that the weir is drowned out during flood flows when material is being transported.

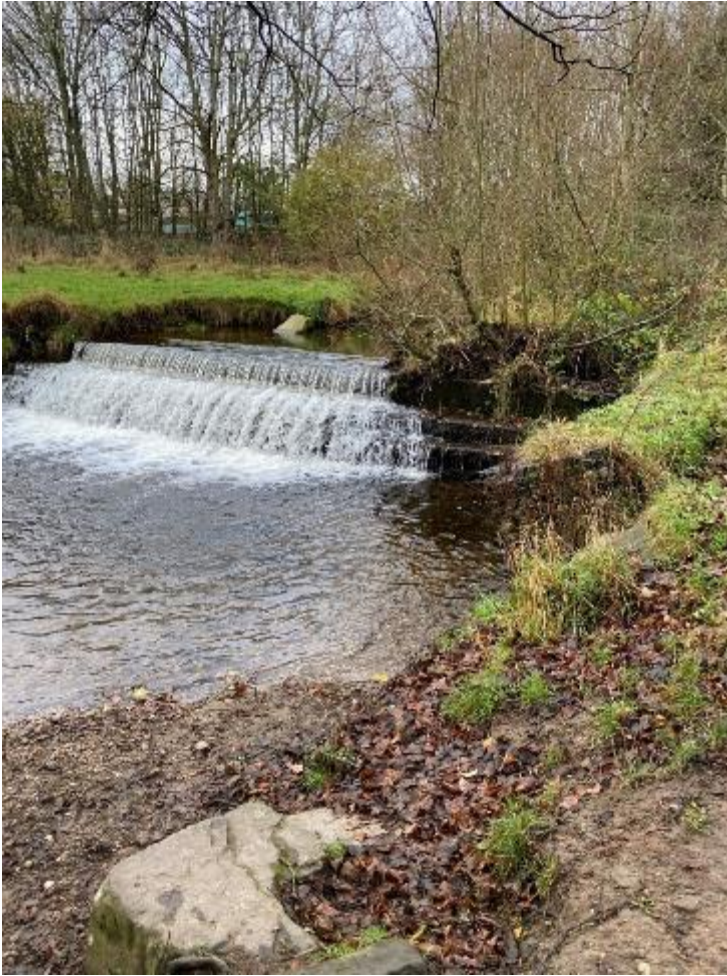
Figure 2.8. View of weir from left bank also showing leaning gabion basket repairs

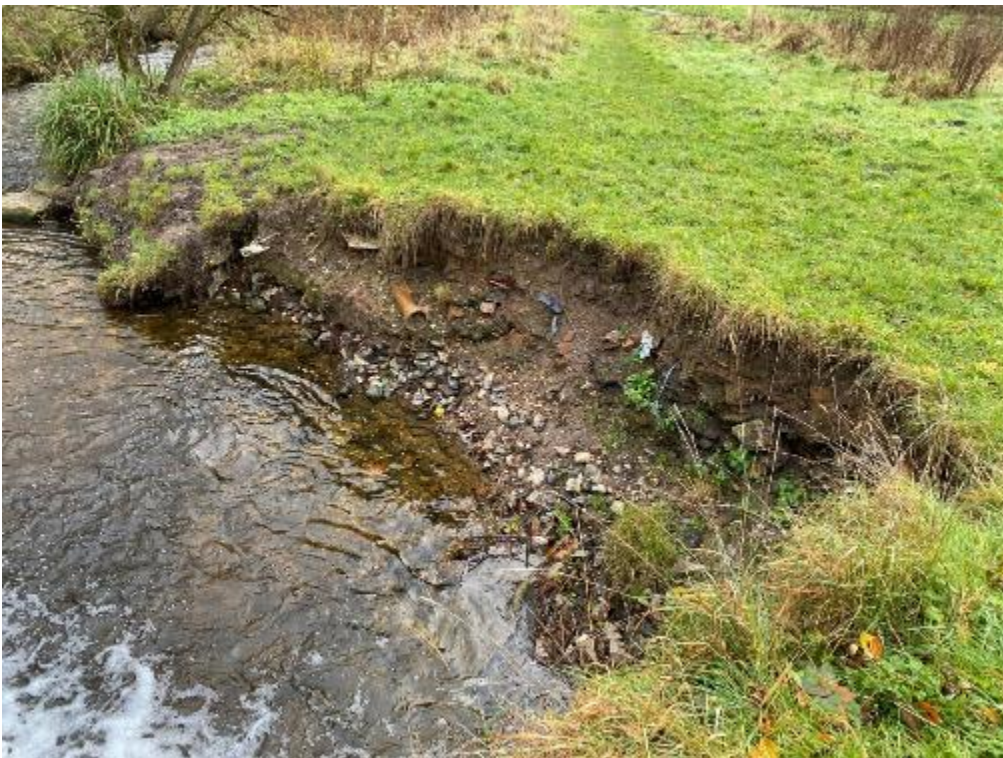
Figure 2.9. Erosion of the right bank immediately downstream of the weir structure

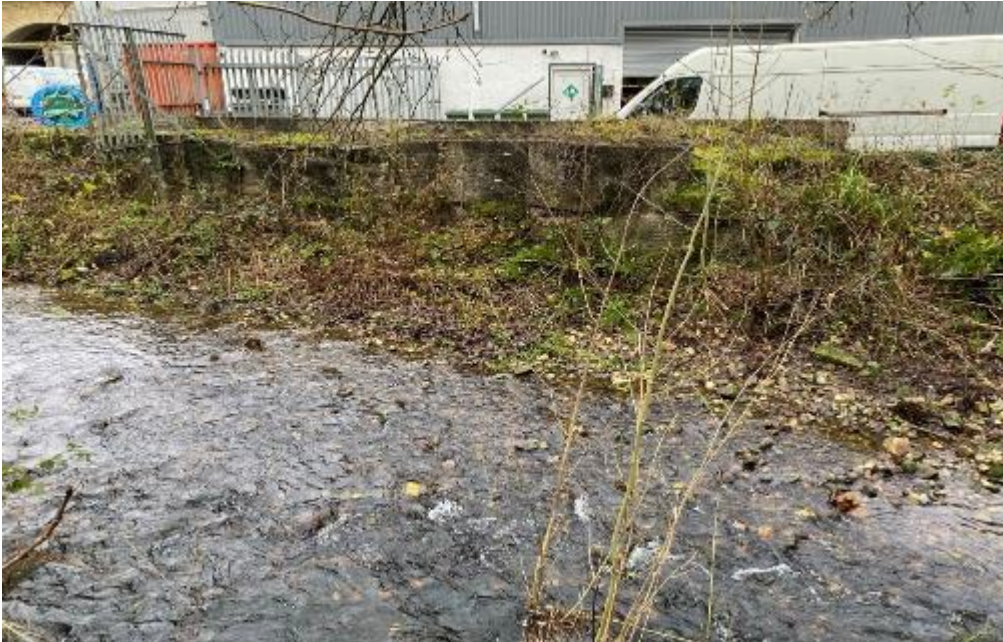
Figure 2.10. Failing gabion basket bank protection upstream of the weir at Felin Puleston adjacent to Wrexham Tyres Warehouse and the A5152 bridge

Bank protection upstream of the weir along the reach is also in a varying state of disrepair with some walling and gabion baskets requiring attention evident on site (Figure 2.10 and 2.11). The structure does not impound a significant distance upstream due to the steep gradient along the study reach. There is some stored sediment behind the weir as a result of the impounding influence with riffle-rapid features evident not far upstream of the weir (Figure 2.12). These and other transverse bar features are common through the reach (Figure 2.13 and 2.14) and are composed of mobile gravel and cobble material.

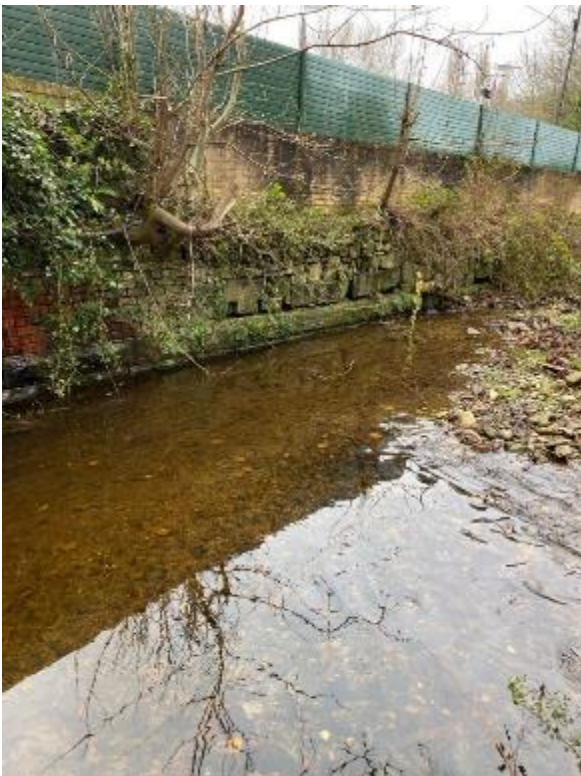
Figure 2.11. Failing walling just downstream of the footbridge

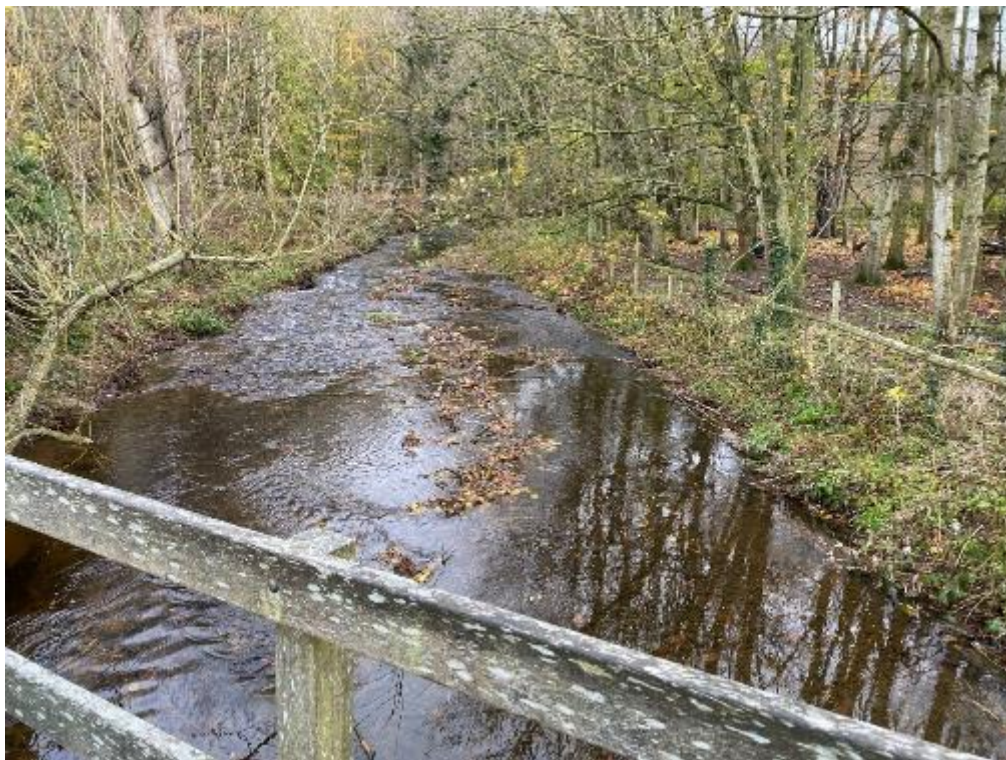
Figure 2.12. View from footbridge downstream showing flow dynamics across riffle-rapid features

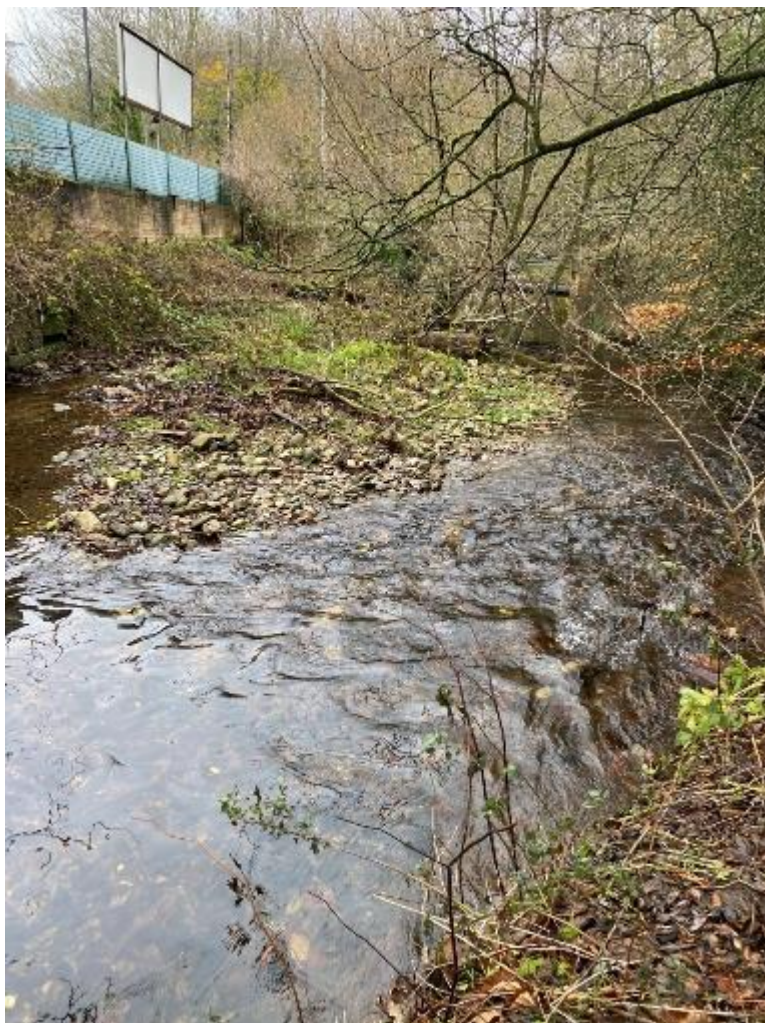
Figure 2.13. Transverse bar development showing gravel/cobble composition

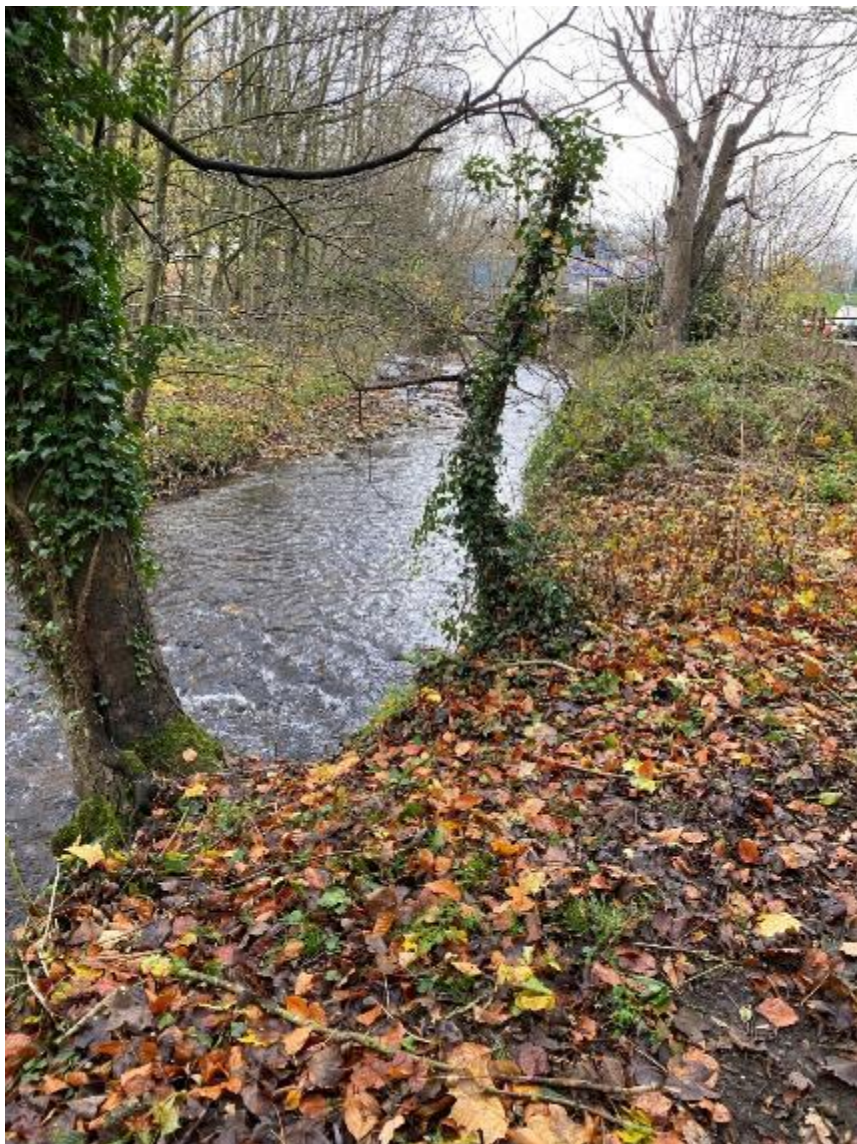
Figure 2.14. Bar development showing gravel/cobble composition along the study reach upstream of the weir

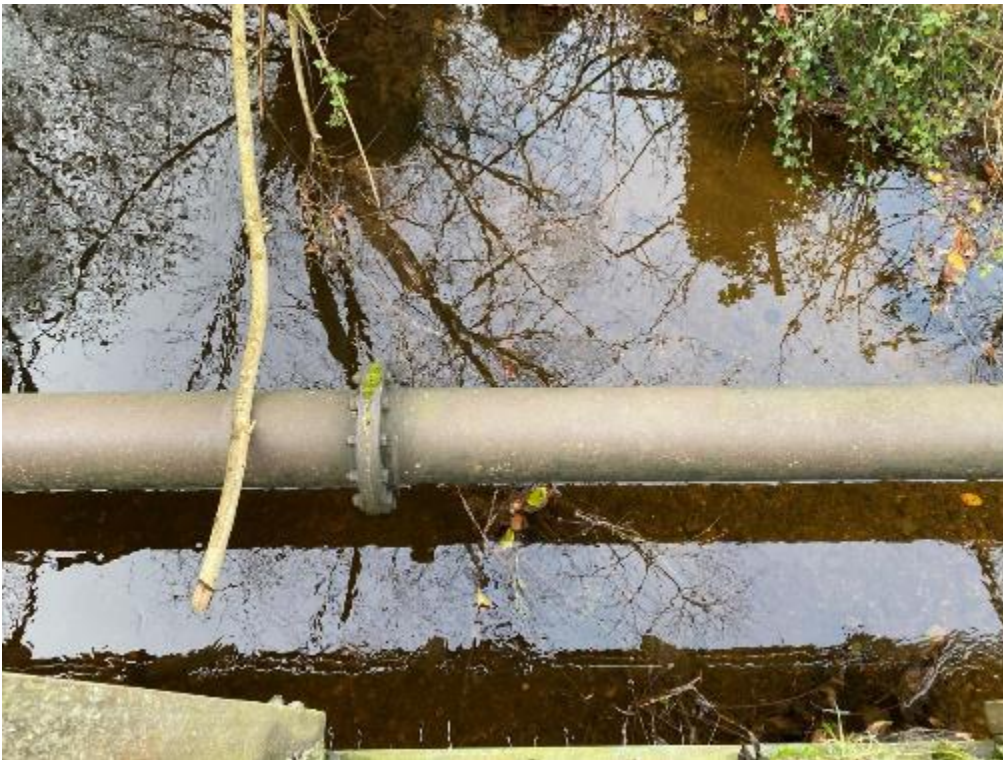
Figure 2.15. Service crossing the river along downstream face of footbridge

A footbridge crosses the river approximately 95m upstream of the weir structure, with evidence of services also crossing the river at this location (Figure 2.15, see Figure 3.14 for further services information).

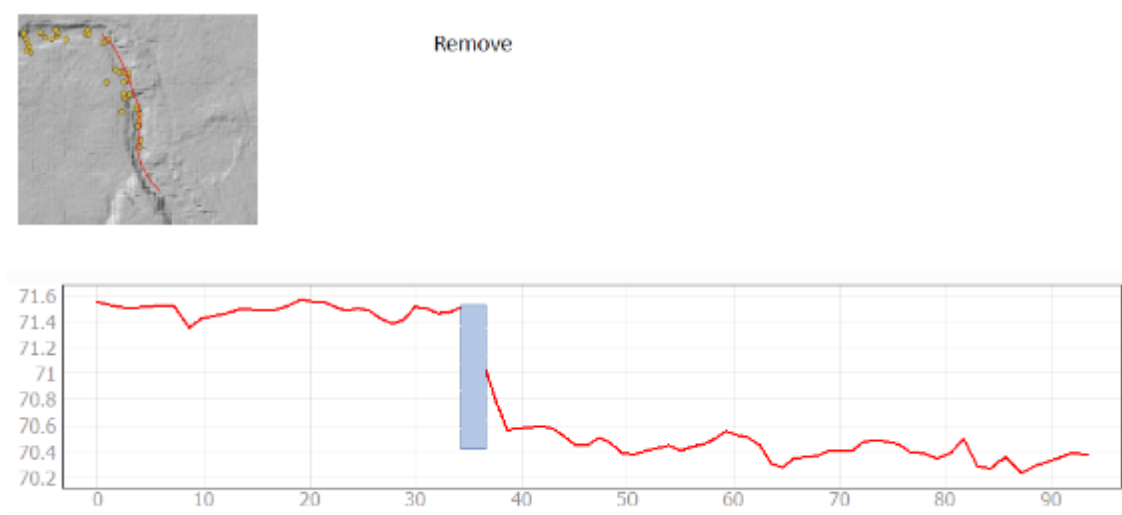
Figure 3.1. Full weir removal concept for Felin Puleston weir.

Under this scenario, the weir would be removed in full with no associated regrading of the river bed upstream and downstream, see Figure 3.1 (effectively demonstrating a complete failure of the weir). The river would quickly respond to the new hydraulic conditions, incising upstream as a result of the knickpoint created where the weir is removed and the flow allowed to cascade into the downstream weir. This could have significant impacts to infrastructure upstream and is therefore rejected on this basis.

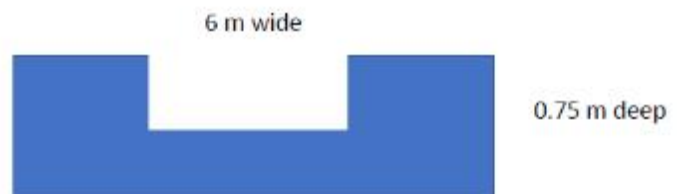
Figure 3.6. Bypass channel around weir over right bank concept for Felin Puleston weir.

Under this scenario, the weir would be bypassed through creation of a bypass channel over the right-hand bank around the structure over an approximate ~130m length, tying into upstream and downstream bed levels at the connection points. This bypass channel would be steep and laterally active but would provide a passage for most fish. The current channel could be retained to retain flood capacity but ongoing maintenance of the remaining weir structure is likely. The option is demonstrated below in Figure 3.6 and has been considered in the initial modelling described in section 3.5 and 3.6 below.

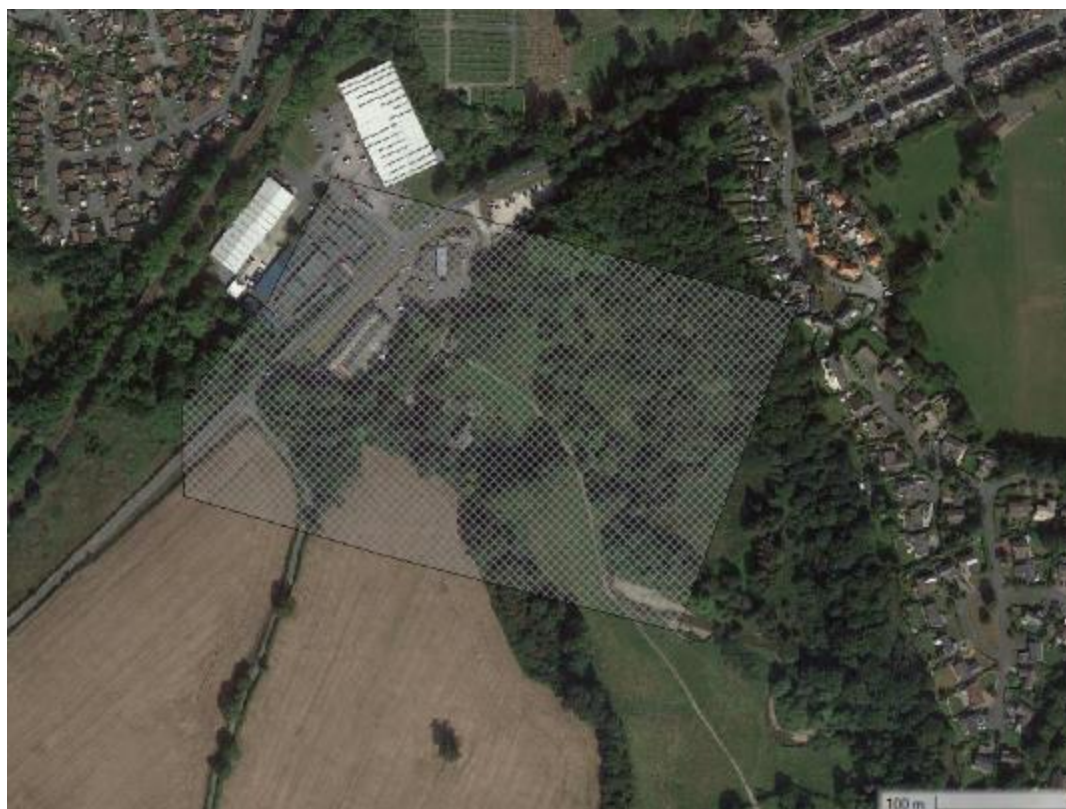
Figure 3.8. Model extent for the Afon Clywedog study reach

The model has been built using a Digital Elevation Model (DEM) across the model domain that provides a ground elevation value for each 1 m grid cell. The model extent is shown in Figure 3.8 below.

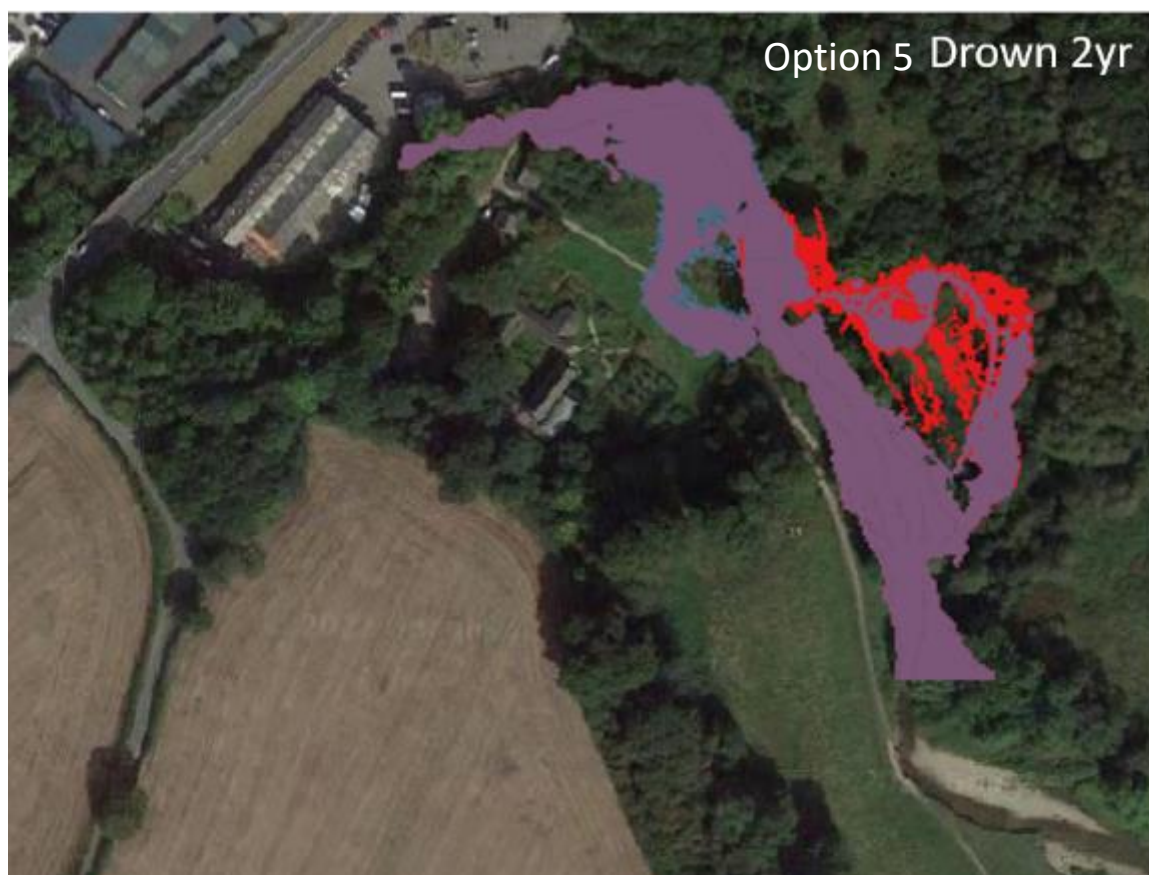
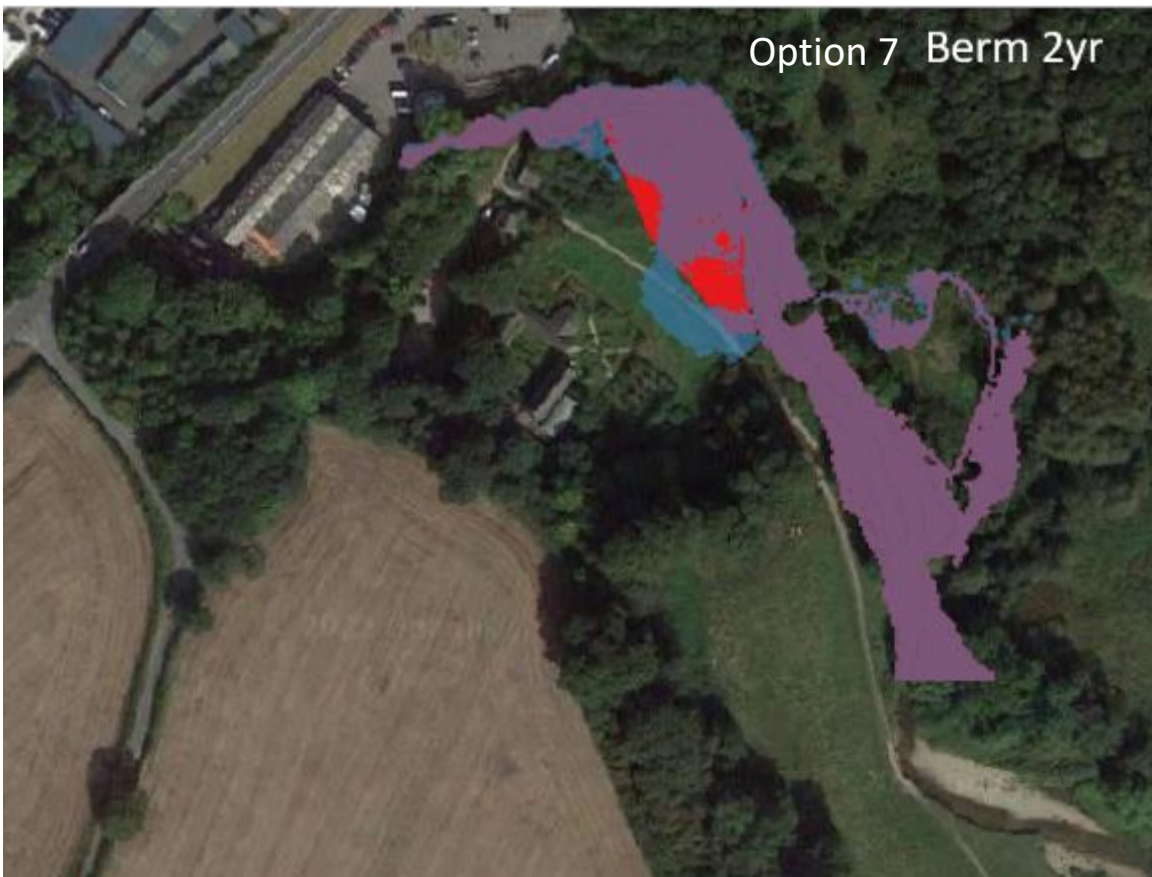
Figure 3.11. 1 in 2yr flood extent change for Option 2, 5, 6 and 7, blue = baseline, red = restored (where red is visible indicates flood extent increase compared to baseline, purple shows no change, visible blue shows flood extent reduction compared to baseline).

Figure 3.11 shows the impact to flood extents for all modelled options (2, 5, 6 and 7), compared to baseline, for the 1 in 2yr return period flood event (baseline shown in red and option in blue – visible red shows a flood extent increase compared to baseline, visible blue and flood extent reduction and purple showing no change). For the inset berm (Option 7) and bypass channel (Option 6) options, increases in flood extent are confined to the right bank floodplain area, with small reductions elsewhere as a result. For the reprofiling (Option 2) and lower with drowning out (Option 5) options, there are increases in flood extent over the left-hand bank as a result of the introduction of the proposed features for these options that push water over the left-hand bank.

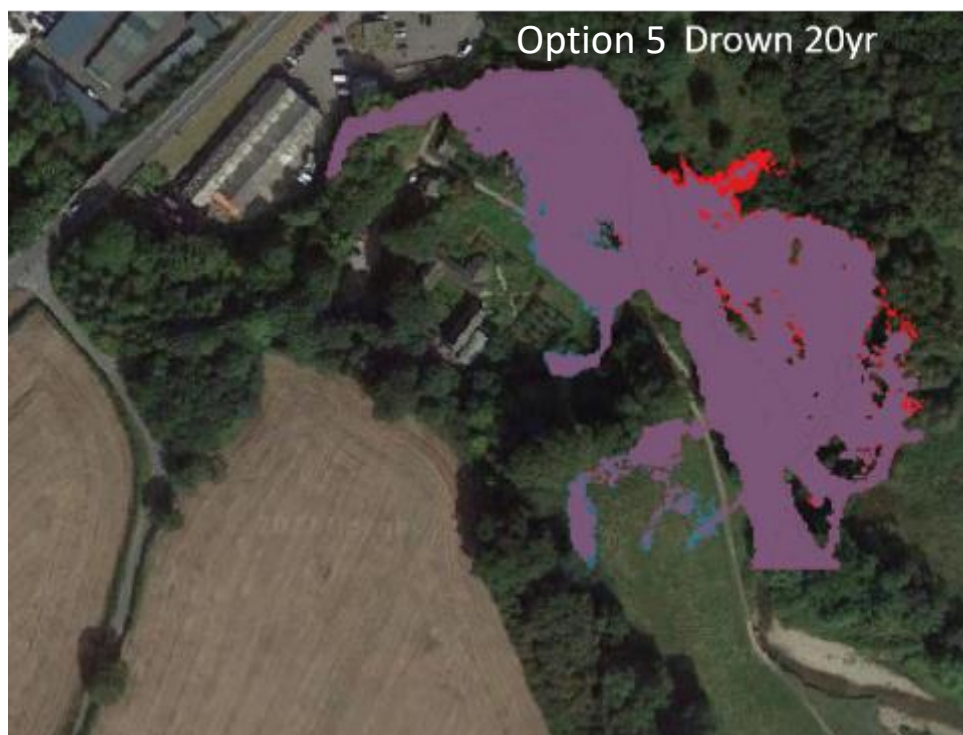
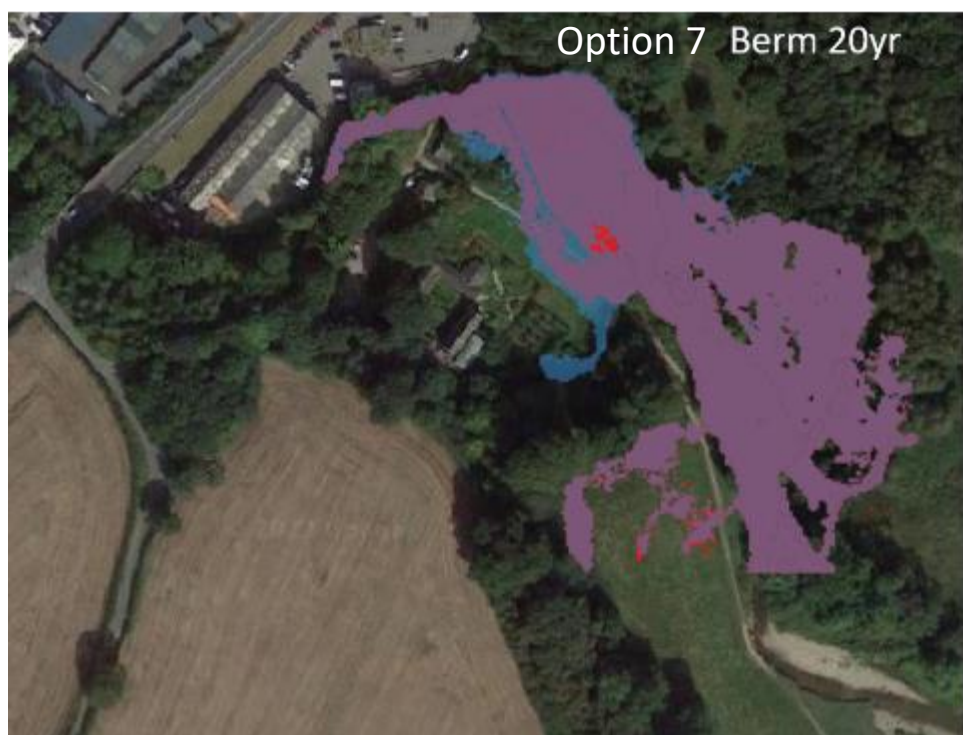
Figure 3.12. 1 in 20yr flood extent change for berm (Option 7) and drown out (Option 5) options, blue = baseline, red = restored (where red is visible indicates flood extent increase compared to baseline, purple shows no change, visible blue shows flood extent reduction compared to baseline).

For Options 5 (lowering with drowning out) and 7 (inset berm), further return periods were run through the model following initial consultation with the client and landowner. Figures 3.12 and 3.13 show the outputs and for Option 5 (lowering and drowning out), there are small increases in flood extent compared to baseline as a result of the proposed option for the 1 in 20yr and 1 in 100yr plus allowances for climate change events. For Option 7 (inset berm), for the 1 in 20yr event, increases are generally contained within the inset berm area. There are no significant increases for the 1 in 100yr event plus allowances for climate change, with some minor reductions as a result of the storage created by the feature.

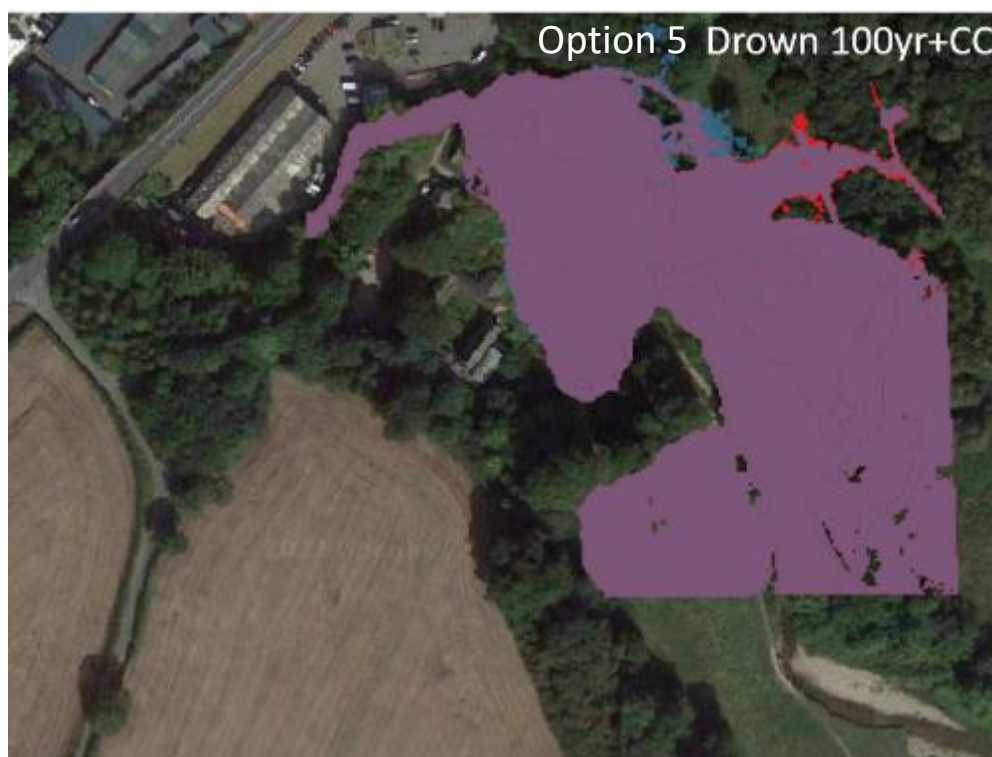
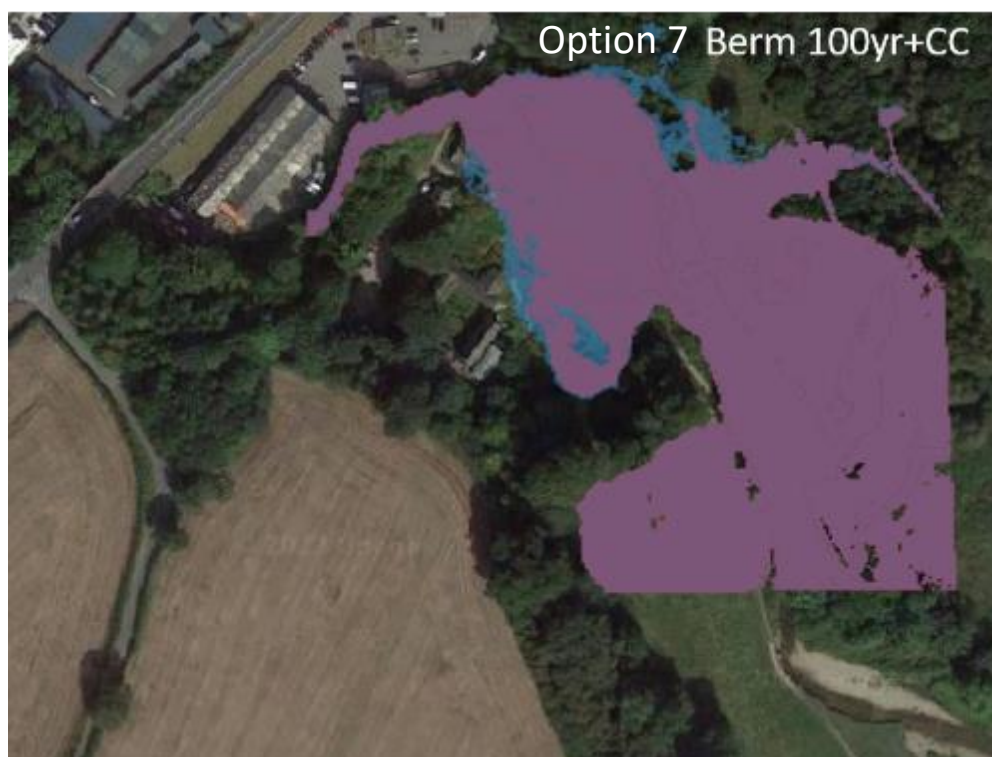
Figure 3.13. 1 in 100yr+CC flood extent change for berm (Option 7) and drown out (Option 5) options, blue = baseline, red = restored (where red is visible indicates flood extent increase compared to baseline, purple shows no change, visible blue shows flood extent reduction compared to baseline).

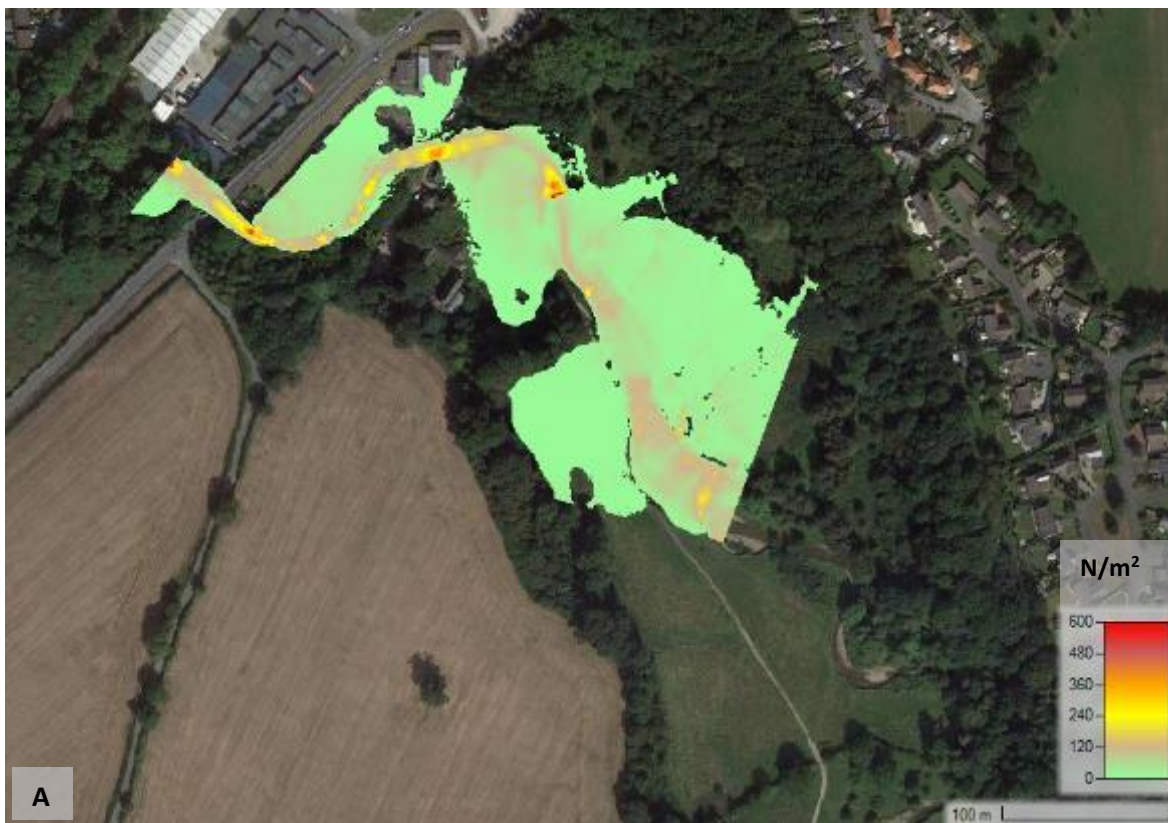
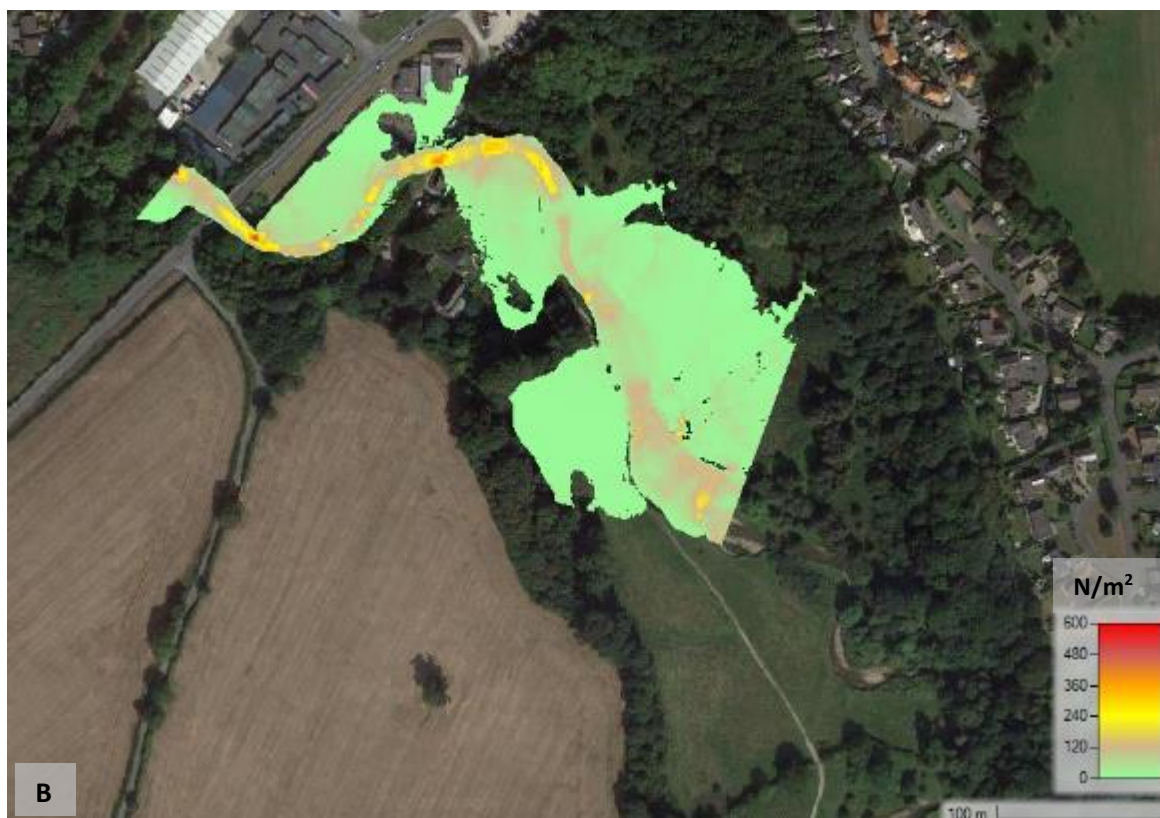
Figure 4.2. Predicted extreme shear stress (N/m^2) levels across the baseline (A) and restored (B) along the River Clywedog study reach.

Baseline bed shear stress model outputs show that generally under extreme and lower order flood flows values range between 10-600 N/m² (Figure 4.2 and 4.3) with the majority of these falling within the lower estimate of this range, particularly across the wetted floodplain area. Values within the channel are generally around 100-300 N/m² under extreme flows, with a concentration in bed shear stress over the existing weir, peaking at around 600 N/m². Once the weir is removed, bed shear stress in the channel

generally peaks at around 300-400 N/m² across the introduced rapid features for extreme flows, with sizing of material for these features being guided by these figures. There are no significant changes to bed shear stress values upstream of the footbridge as a result of the influence of the rapids and bed check features for either the lower order or extreme floods modelled.
