Felin Puleston Weir Optioneering DRAFT Report

Welsh Dee Trust

Document name	Prepared by	Date	Reviewed by	Approved By
Felin Puleston Weir Optioneering and Design DRAFT Report v1.0	Seb Bentley and Rob Williamson	11 th November 2022	George Heritage	George Heritage

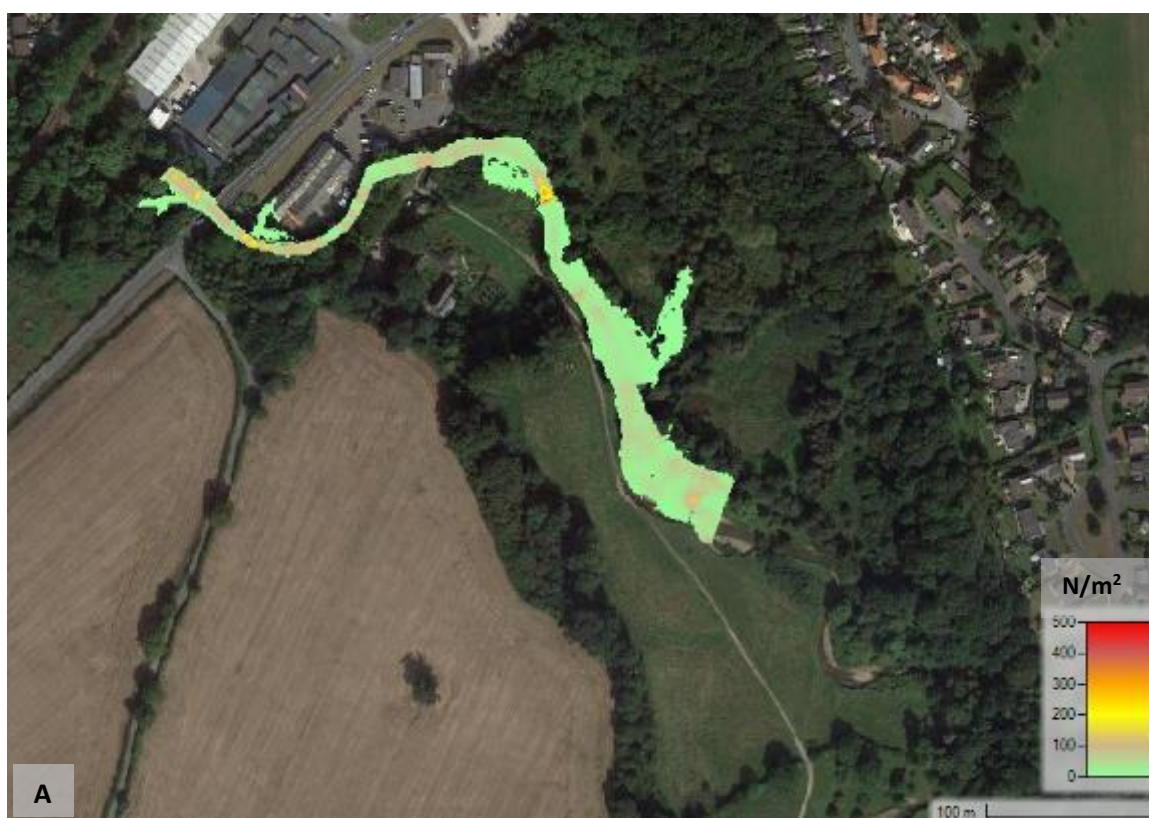
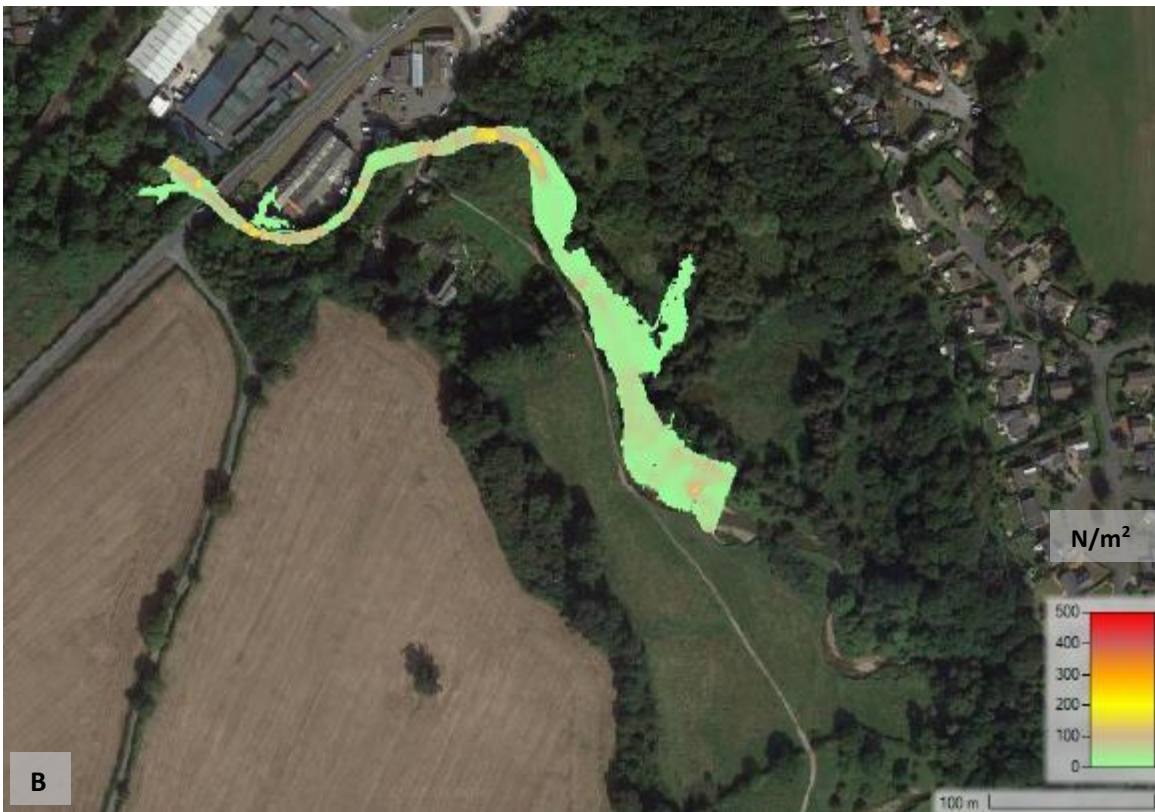
Figure 4.3. Predicted low order flood shear stresses (N/m^2) across the baseline (A) and restored (B) along the River Clywedog study reach.

Baseline bed shear stress model outputs show that generally under extreme and lower order flood flows values range between 10-600 N/m² (Figure 4.2 and 4.3) with the majority of these falling within the lower estimate of this range, particularly across the wetted floodplain area. Values within the channel are generally around 100-300 N/m² under extreme flows, with a concentration in bed shear stress over the existing weir, peaking at around 600 N/m². Once the weir is removed, bed shear stress in the channel

generally peaks at around 300-400 N/m² across the introduced rapid features for extreme flows, with sizing of material for these features being guided by these figures. There are no significant changes to bed shear stress values upstream of the footbridge as a result of the influence of the rapids and bed check features for either the lower order or extreme floods modelled.

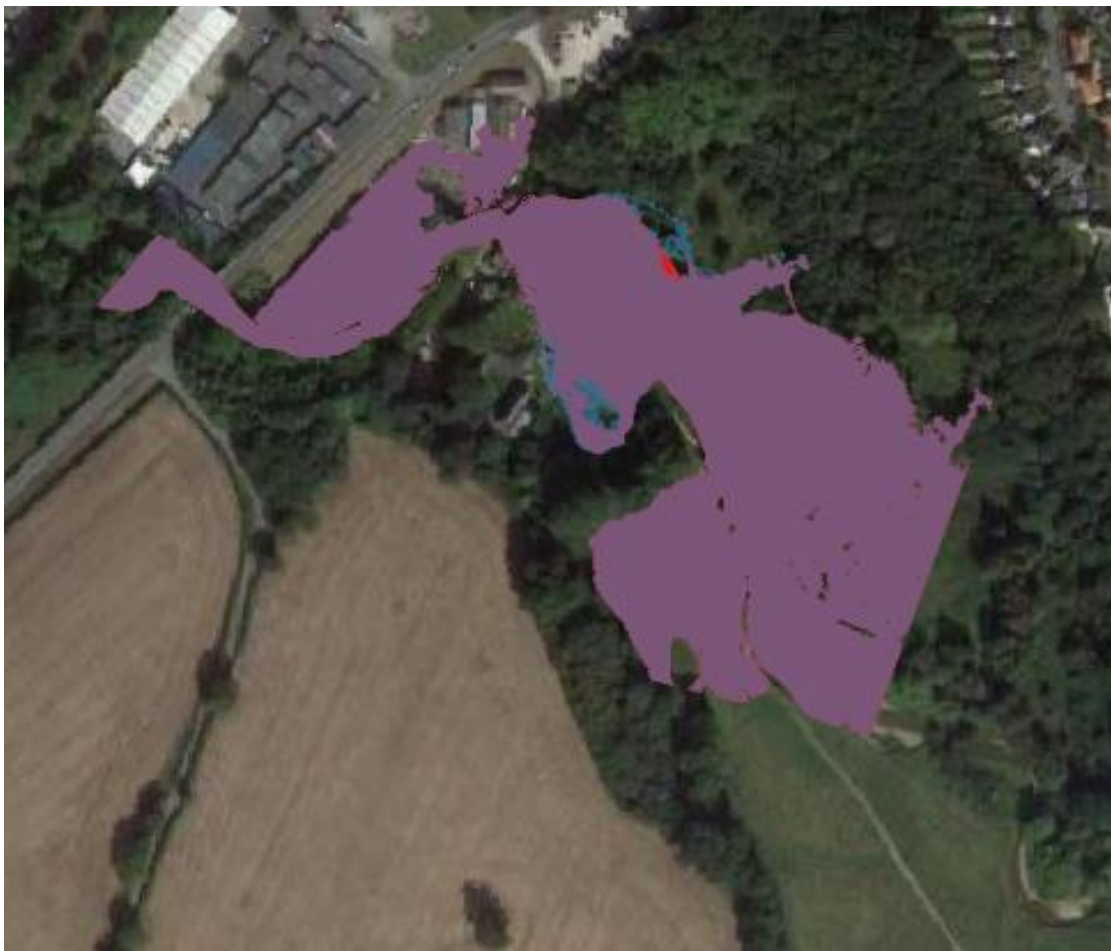
Figure 4.4. 1 in 100yrCC flood extent change, blue = baseline, red = restored (where red is visible indicates flood extent increase, purple indicates no change and blue indicates reduction in flood extent).

Figures 4.4 to 4.6 demonstrate the flood extent changes for each of the flood return periods listed above, with baseline shown in blue and the restored scenario shown in red (no change areas are shown in purple). The figures show some flood extent decreases as a result of the weir removal option for each return period modelled (visible blue areas) and small extent increases within the overall works area (mainly as a result of the widening proposed), as a result of the restored option (visible red areas). All these changes are within the overall works area. Visible purple regions indicate no change in flood extents within reasonable model and DTM tolerance and error.

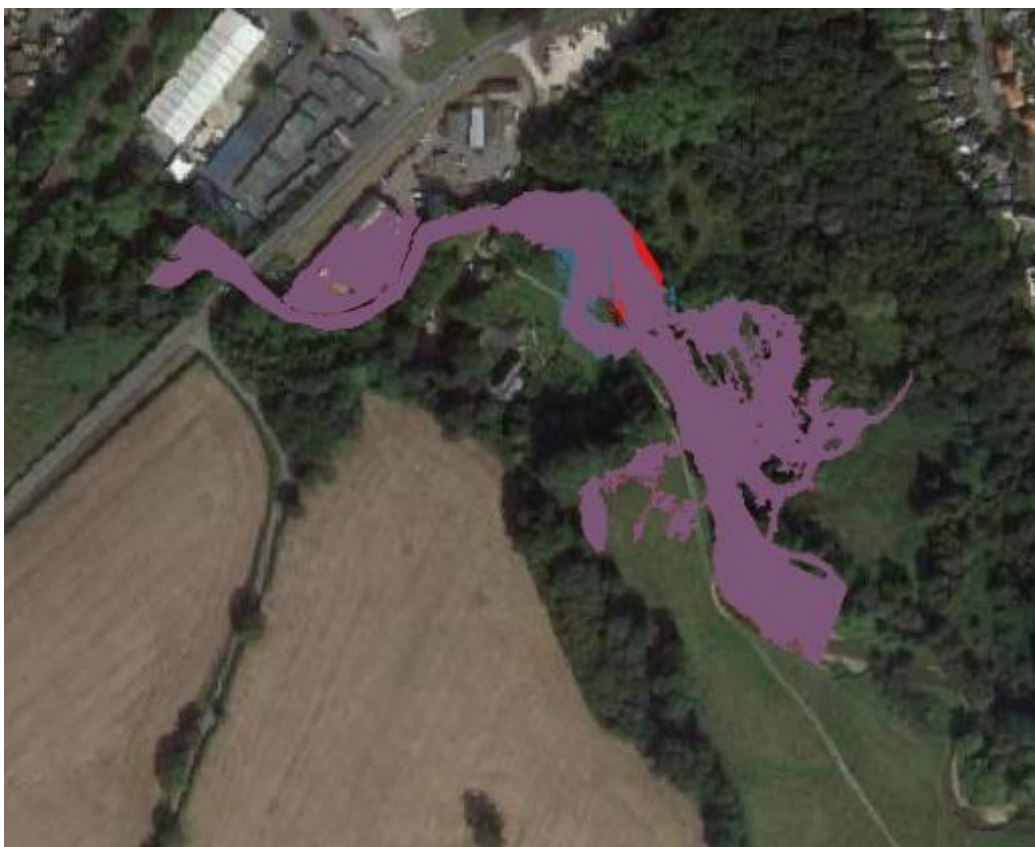
Figure 4.5. 1 in 20yr flood extent change, blue = baseline, red = restored (where red is visible indicates flood extent increase, purple indicates no change and blue indicates reduction in flood extent).

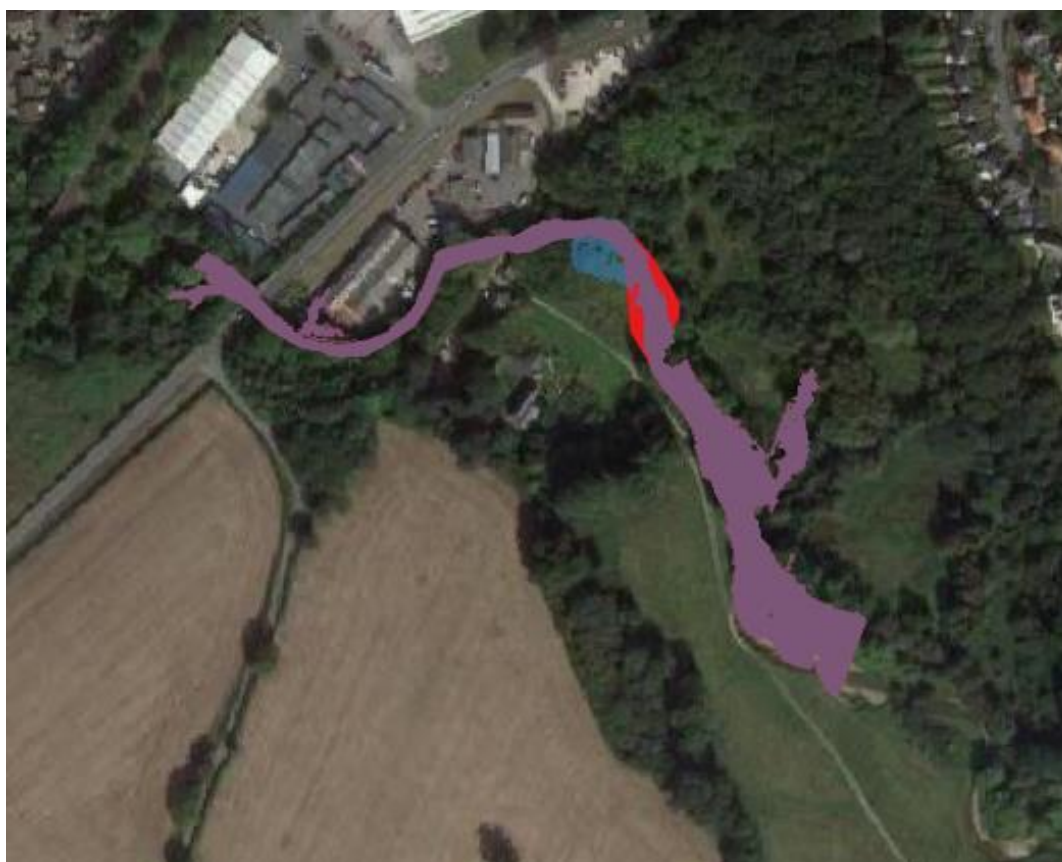
Figure 4.6. 1 in 2yr flood extent change, blue = baseline, red = restored (where red is visible indicates flood extent increase, purple indicates no change and blue indicates reduction in flood extent).
