## Compliance Assessment Report CAR\_NRW0043263

**Permit being assessed:** AG0009201

For: Llancarfan Wastewater Treatment Works, held by DWR CYMRU CYFYNGEDIG

**Type of assessment carried out:** Site Inspection, Reason: Routine.

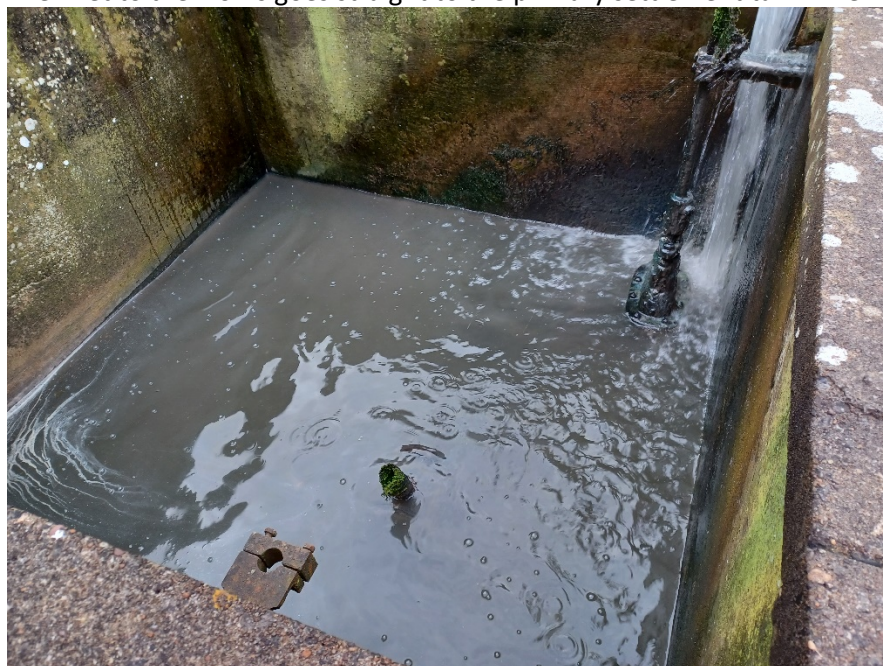
### Inlet

The inlet to the works goes straight to the primary settlement tank. The inlet appeared in good order.

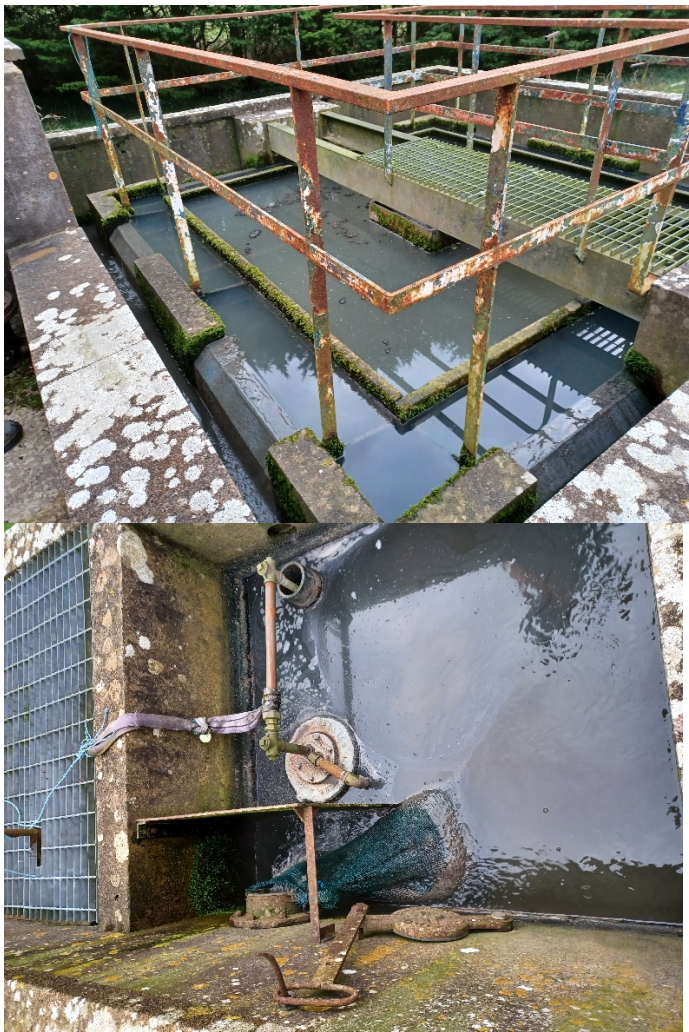
### Primary settlement

After the inlet is the primary settlement tank, this also appeared in good order. The outlet to the primary tank has a Copa sac screen.

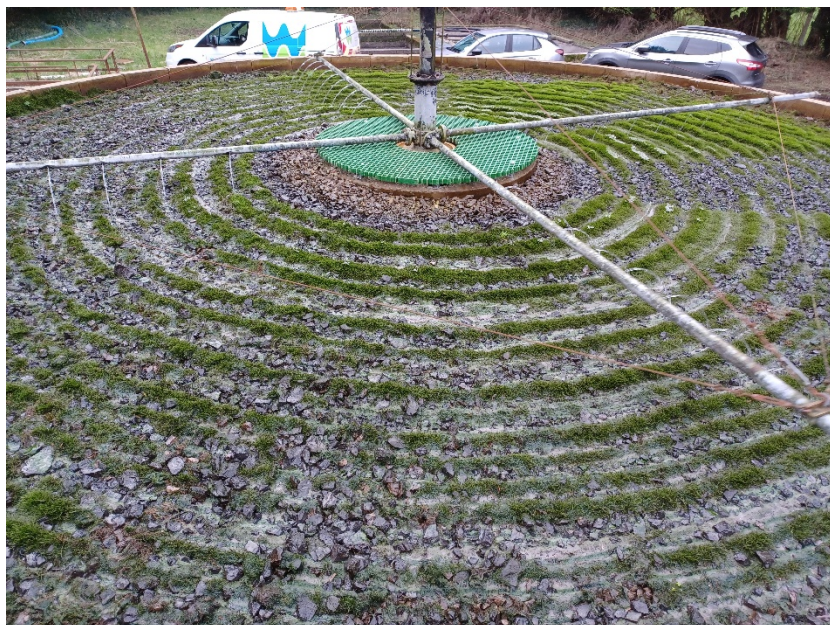
**Filter bed**

Following the primary tank the effluent then goes through the percolating filter bed. The bed had even distribution, however there is quite heavy moss growth on the filter media.

1. Please explain the layout and the reasoning behind the over pumping on site, as well as how long it has been going on for and what plans are in place to improve this situation.
2. Please also explain where the effluent from the sludge beds goes after it is pumped into them.
3. There is quite significant moss growth on the filter bed media, please can this be removed.

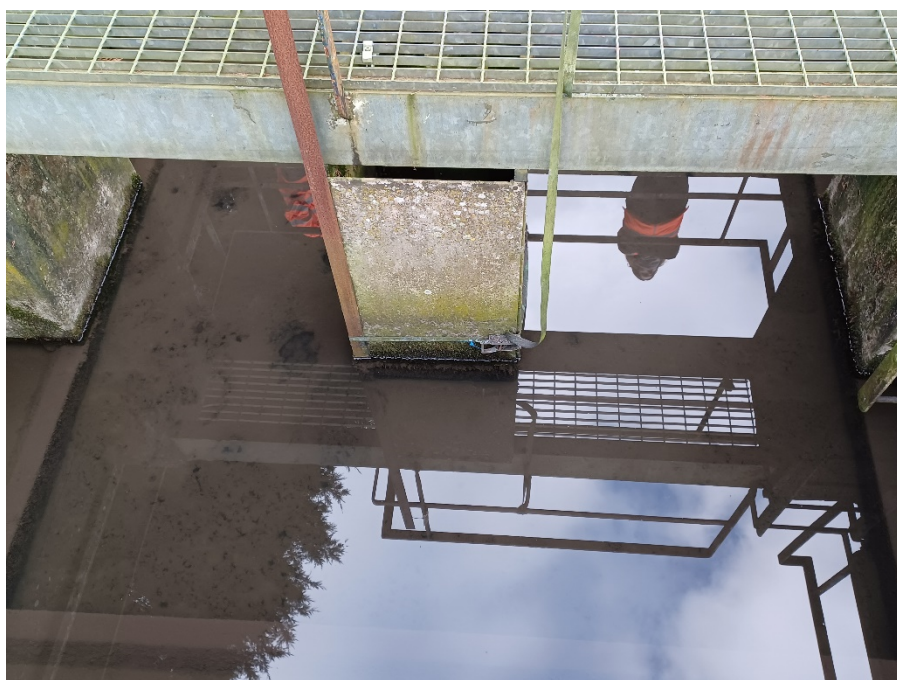
### **Humus tank**

The humus tank appeared in good working order with no carry over of solids.

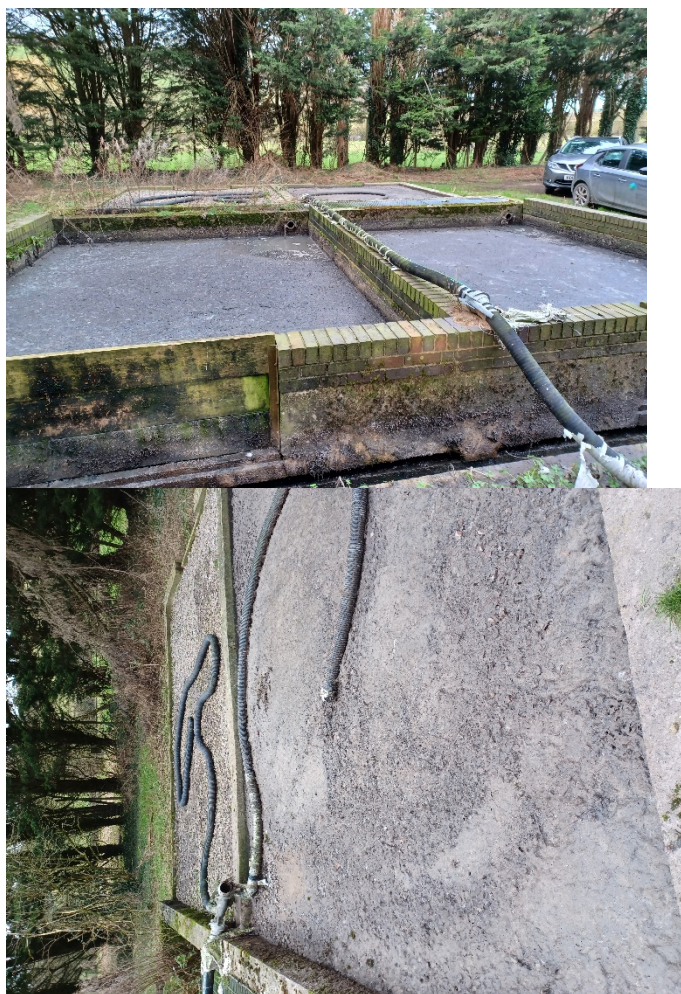
### **Sludge drying beds**

There are four sludge drying beds located at the back of the site. There was sludge on the ground around all the drying beds indicating that they had overtopped. There were pipes going over and into the sludge beds, with evidence of scouring on the surface of the sludge bed, which shows effluent has been pumped into the sludge beds, which seems to be the cause the overtopping.

The sludge beds also have drainage channels for the settled sludge.

| Criteria | Action needed | Complete by |
|---|---|---|
| WQ-B1 | Effluent has overtopped the sludge drying beds due to them being used as improvised and improper use as storm storage. This has caused a spill to the land surrounding the beds. Provide information as to how long the drying beds have been used like this and what it being done to resolve the issue. | 20/05/2024 |

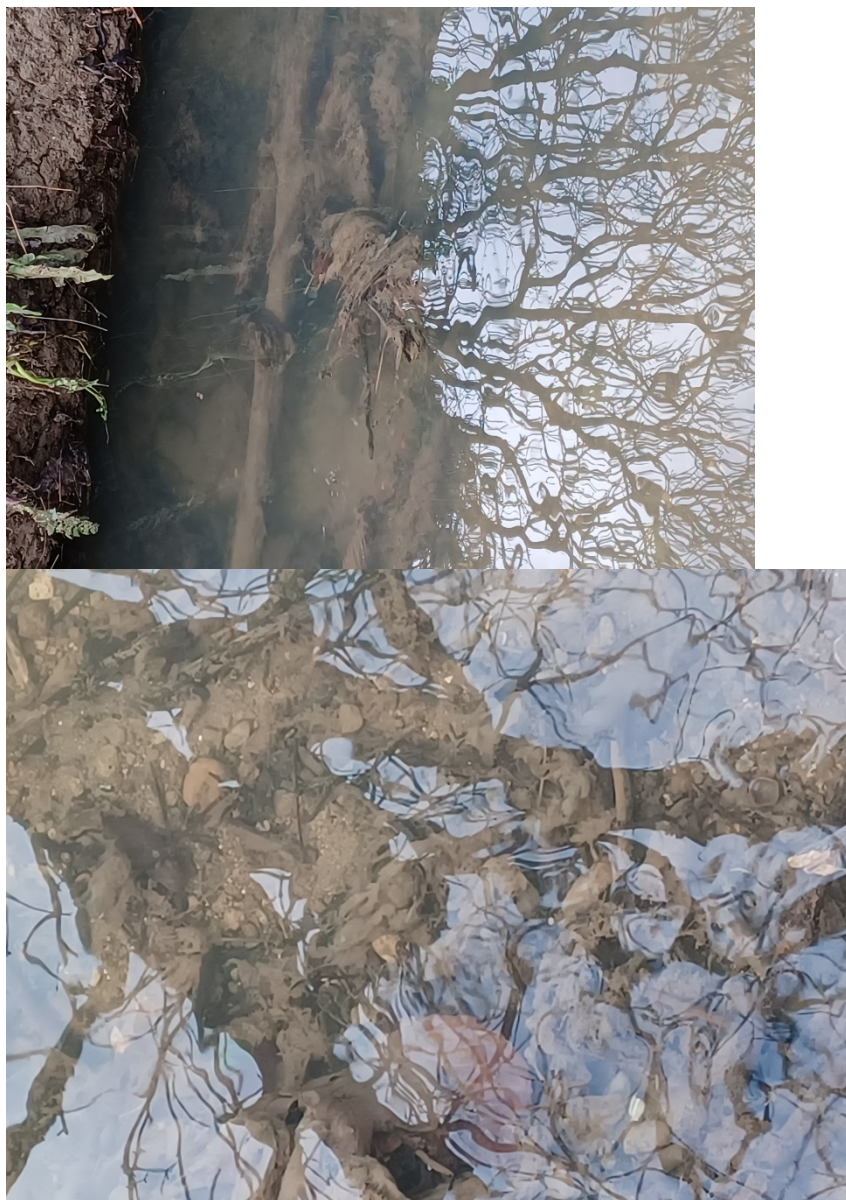
### **Sampling point and outfall**

There is a labelled sampling chamber on site. The effluent discharges to the Nant Llancarfan. At multiple points downstream of the outfall sewage fungus was visible. Due to this a sample was taken of the discharge from the sampling point. The results came back as: BOD 7.14mg/l, suspended solids at 19mg/l, and ammonia at 4.03mg/l.
