**NANT Y CAWS  
PHASE 1  
CLOSED LANDFILL**

**ENVIRONMENTAL  
PERMIT EA WML 34183**

**2019 Annual Environmental  
Monitoring Report**

*Report Number 1981r1v1d0120*

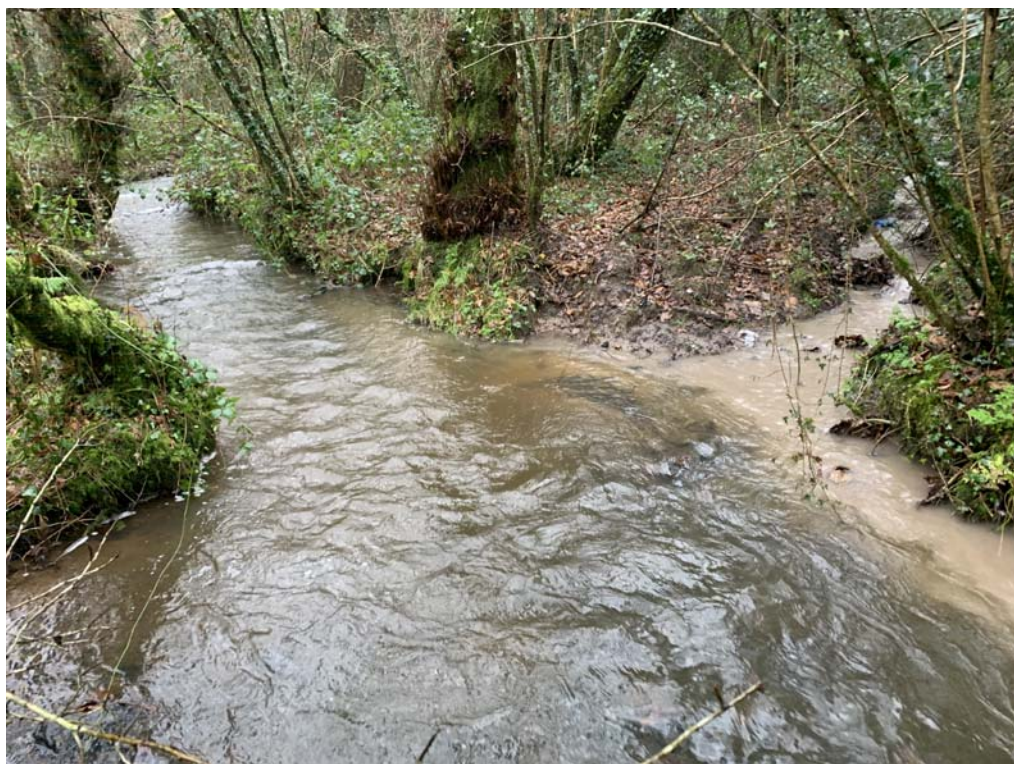
**Plate 1. View north over confluence just above sample point SW1**

Increased suspended solids at SW1 is, however, due to input from run-off that enters the stream just above the sample point. This run-off enters from the north and can be traced back to sources upgradient of the Phase I landfill – primarily mobilisation of sediment from access tracks / open areas. This input can be clearly seen in Plate 1.

All surface water quality was below the emission limits in 2018 and 2019, as summarised in Table 7-1, apart from elevated ammonia. As can be seen by reviewing the graph above, the cause of the increased ammonia at SW1 is due to elevated ammonia upstream of the landfill at SW4. Again, this is linked to the discharge from the lagoons to the west of the site.
