**NANT Y CAWS  
PHASE 1  
CLOSED LANDFILL**

**ENVIRONMENTAL  
PERMIT 34183**

**Environmental Monitoring  
Review**

*Report Number 2396r1v1d1123*

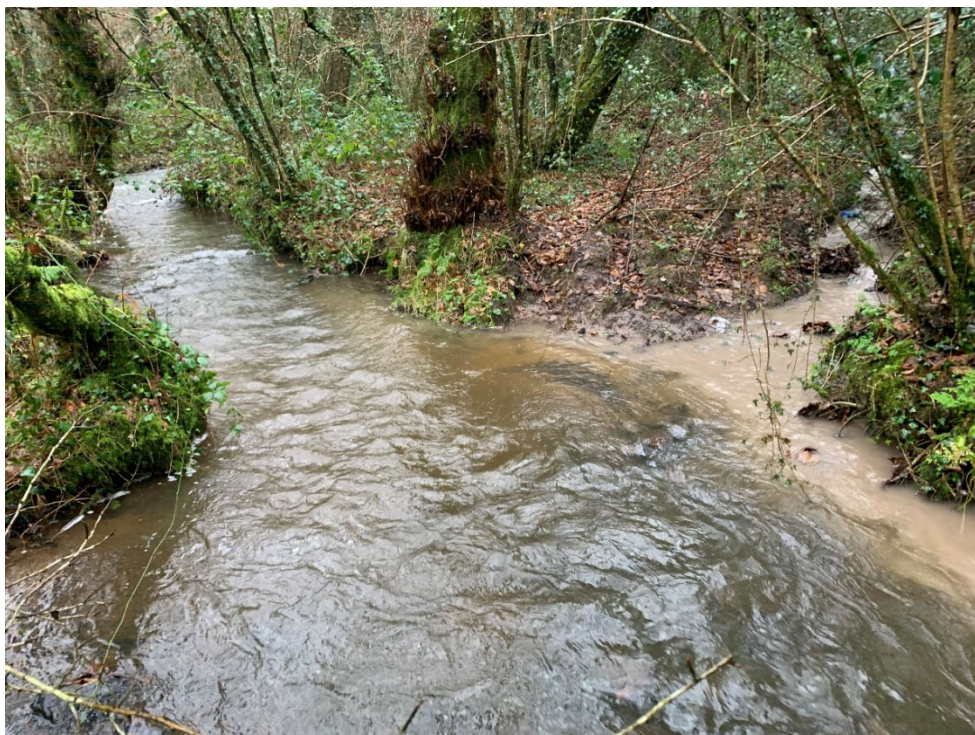
**Plate 7-2 View north over confluence just above sample point SW1**

Increased concentrations of suspended solids, potassium and chloride are sometimes observed at SW1. This is considered to be due to run-off from the upgradient phases of landfill that enters the stream just above the sample point. This run-off enters from the north and can be traced back to sources upgradient of the Phase I landfill – primarily mobilisation of sediment from access tracks / open areas. This input can be clearly seen in Plate 7-2.
