Compliance Assessment Report CAR_NRW0040745

Permit being assessed: AD0018101

For: GROESFFORDD STW, held by DWR CYMRU CYFYNGEDIG

Type of assessment carried out: Site Inspection, Reason: Routine.

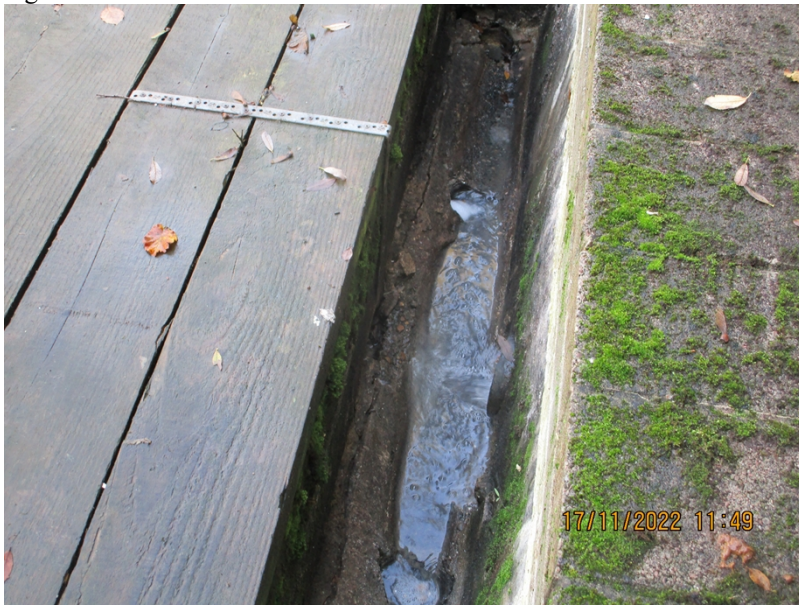
Inlet

The incoming flow to the site is from a gravity sewer. There is no screening in place at the inlet before flows pass to primary settlement. At the time of our visit there was only a minimal flow entering the works, and no signs of solids or rags around the inlet.

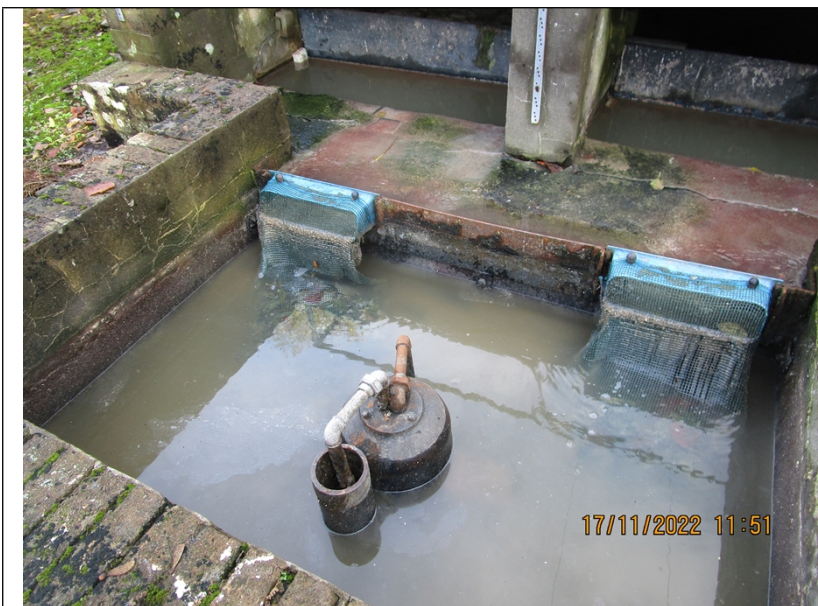
Primary Settlement

The primary settlement tank at the works is an undercover square shaped tank, with a lower outlet height for retaining solids, similar in design to a septic tank. There were COPA sacks installed on the outfall channels of the primary settlement tank, which appeared in good working order and only contained minimal solids.

There is a syphon in place at the outfall of primary settlement tanks. This is to allow water levels to build up to a suitable level before flows are sent through to the filter beds. This is due to the works being gravity powered and needing to make sure there is ample hydrological pressure for the filter bed arms to function correctly.

Overall, the settlement system appeared to be operating effectively. There were no signs of significant solids passing through to secondary treatment.

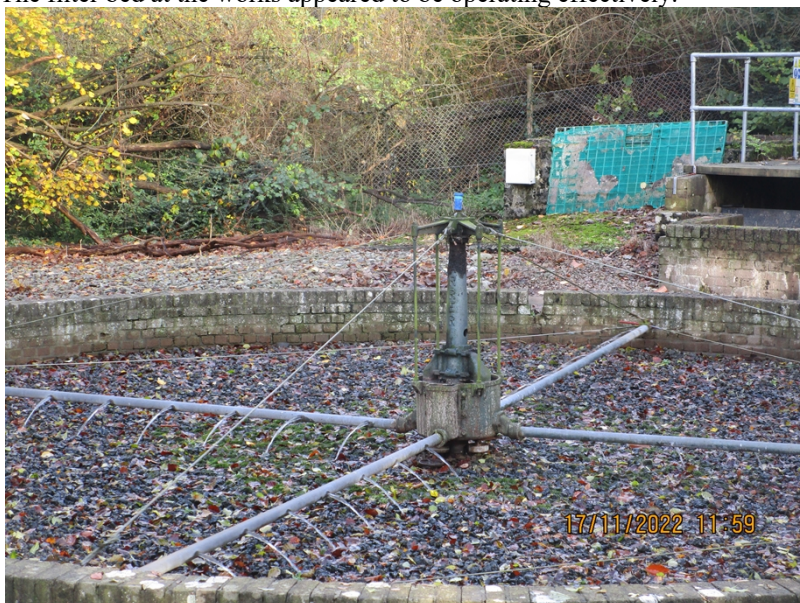
Filter Bed

The works contains a single filter bed of stone media. On arrival at the works the filter arm was not rotating, as the syphon had not yet sent flow into the filter bed system. Once levels reached the set amount, flows were sent through to the filter bed. The rotation arm was moving free and unhindered. There were no signs of blocked outlets and the rotating arm appeared to be distributing effectively. There were no signs of ponding or dry patches across the filter bed and no excessive vegetation growth.

The filter bed at the works appeared to be operating effectively.

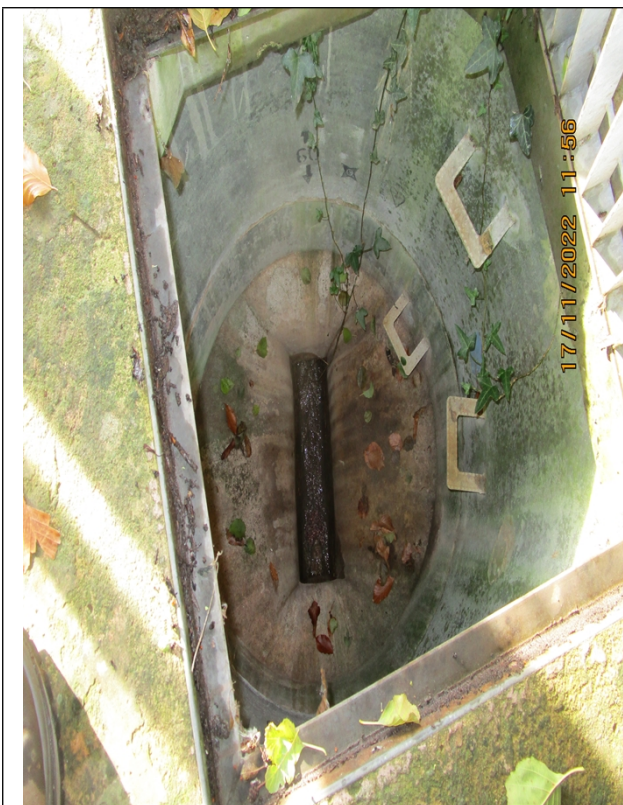
Outfall

The outfall of the works at the time of inspection was flowing with only a minimal amount of liquid, which appeared clear of solids or fungal growth. The inspection chamber is covered and in good working order.

We checked the outfall into the river (Brynych). The river was running clear and showed no signs of negative environmental impact around the outfall.
