Dŵr Cymru Welsh Water

Menai Strait - Shellfish Waters Project

Hydrogeological Impact Assessment for Temporary Construction Dewatering

Rev 2 | 20 June 2024

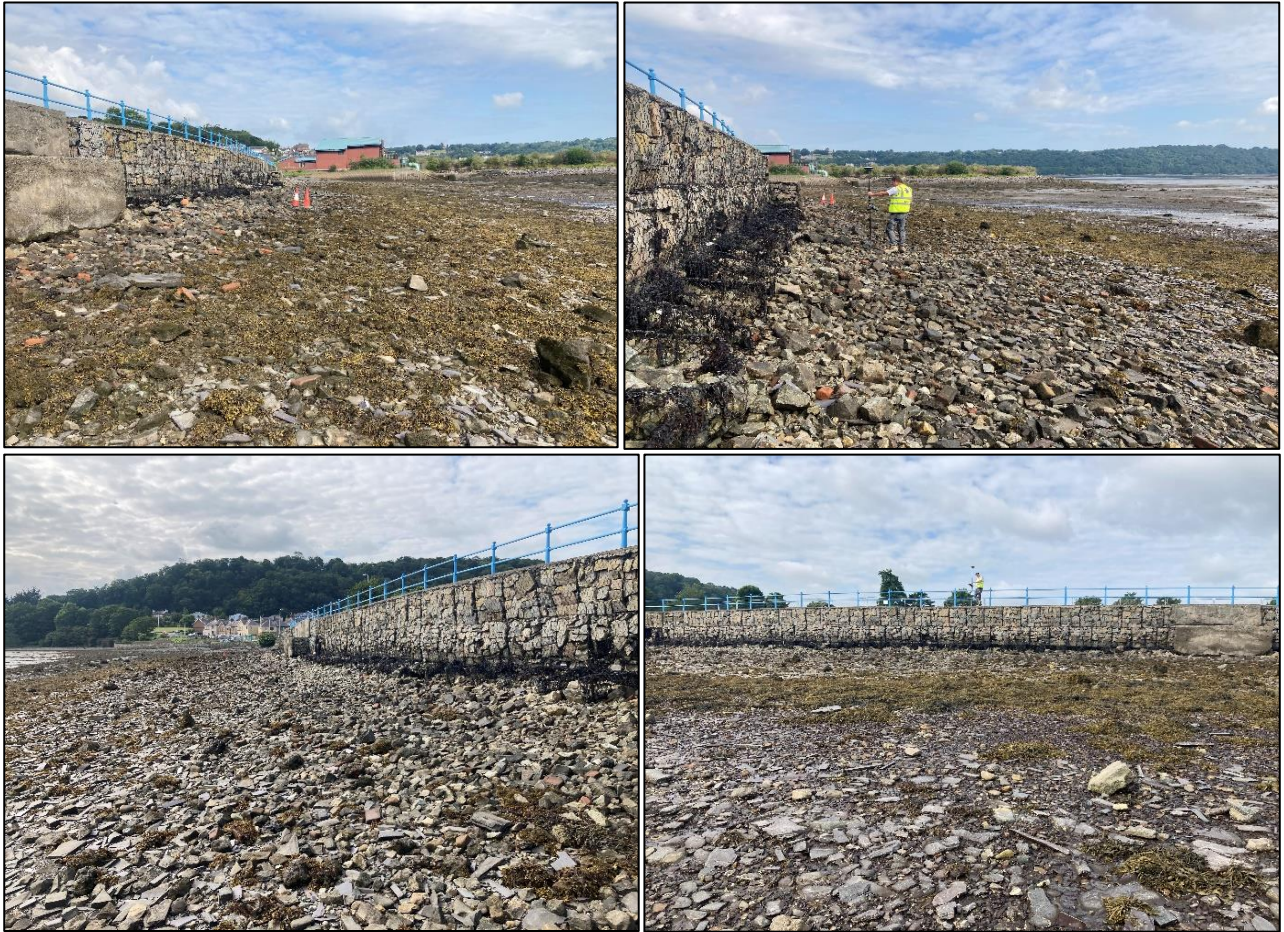
Feature Photo(s) 1

Results
Location	E: 258724.84 N: 372802.25 5.432m OD at top of wall, 3.115m OD at base of wall
Date and Time	20 th July 2023 at 09:00
Weather	Warm and cloudy. Heavy persistent rain over past two weeks.
Feature Type	Bangor Flats – Beach.
Use	N/A
Feature Dimensions	N/A
Water depth	N/A – Survey undertaken at low tide
Water flow observations	N/A
Water quality observations	N/A – No obvious signs of pollution.
Bed/base material/lining	Pebbly beach
Vegetation	Seaweed in places
General setting	Bangor flats adjacent to proposed location of SPS.
Other notes	No discharges visible in area.

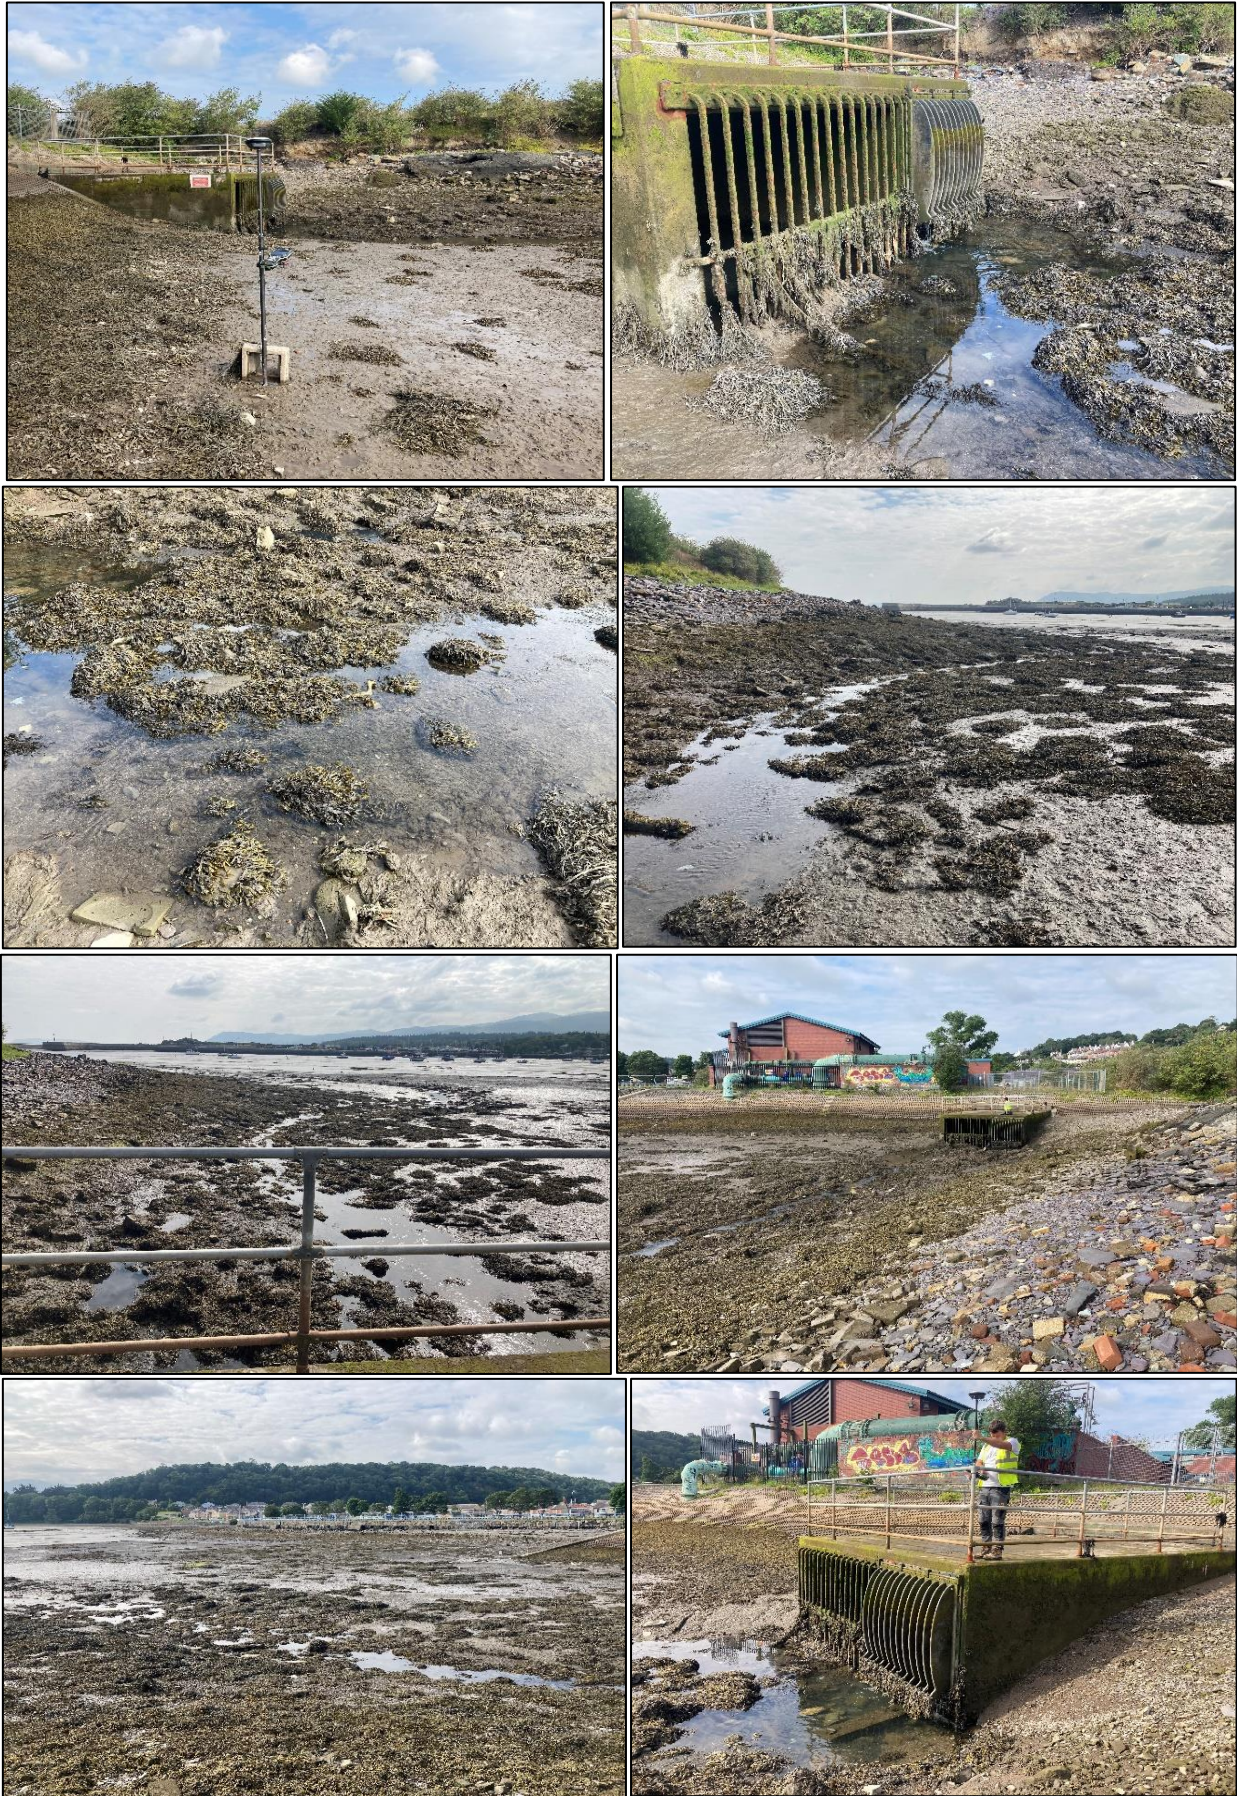
Feature Photo(s) 2

Results
Location	E: 258660 N: 372931
Date and Time	20 th July 2023 at 09:30
Weather	Warm and cloudy. Heavy persistent rain over past two weeks.
Feature Type	Discharge from culverted watercourse onto Bangor Flats.
Use	N/A
Feature Dimensions	Culvert circa 5m wide. Channel circa 300mm deep after exiting culvert (at time of survey but tidal mud flats, so varies)
Water depth	Level 1.114m OD
Water flow observations	Gentle
Water quality observations	Clear, no discolouration present
Bed/base material/lining	Sand/Mud after exiting concrete culvert.
Vegetation	Seaweed in places
General setting	Bangor flats adjacent to proposed location of SPS. Culverted water course discharge.
Other notes

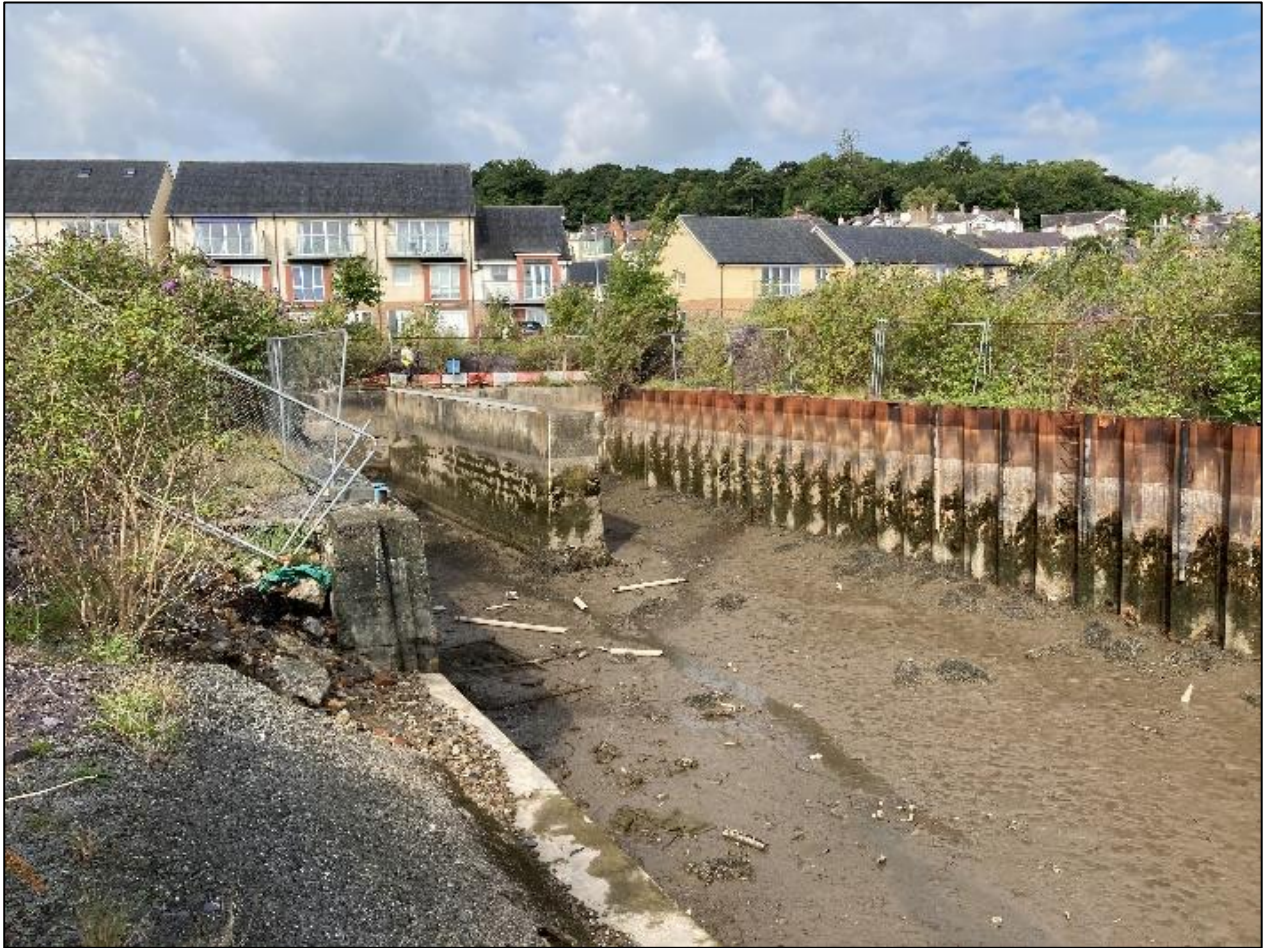
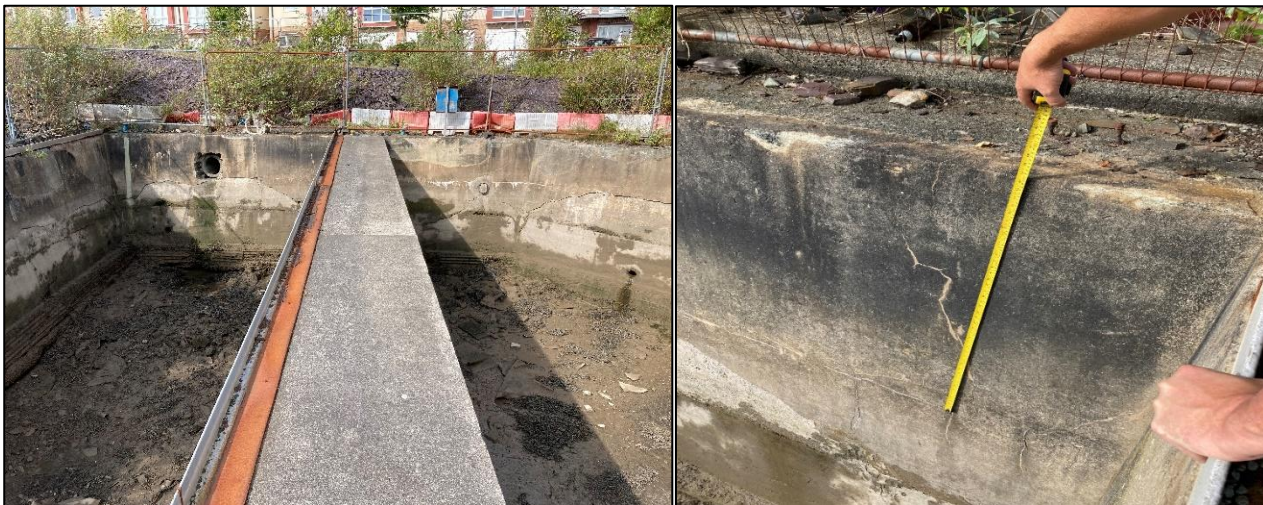
Feature Photo(s) 3

Results
Location	E: 258563.52 N: 372956.55 Top of wall: 4.836m OD
Date and Time	20 th July 2023 at 10:00
Weather	Warm and cloudy. Heavy persistent rain over past two weeks.
Feature Type	Outlet into sea from harbour wall in disused dock.
Use	Disused dock. Outfall source unknown (potentially surface water runoff)
Feature Dimensions	N/A
Water depth	Low tide – limited water in dry dock. No water from outfall
Water flow observations	None from outlet
Water quality observations	N/A
Bed/base material/lining	Muddy, Cobbles, Wood
Vegetation	Overgrown vegetation surrounding dry dock.
General setting	Disused dock. Overgrown vegetation and Heras fencing surrounding dock. Residential area beyond
Other notes

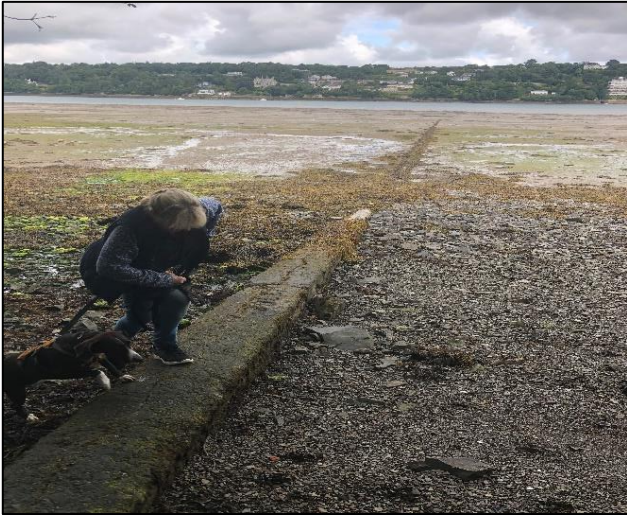
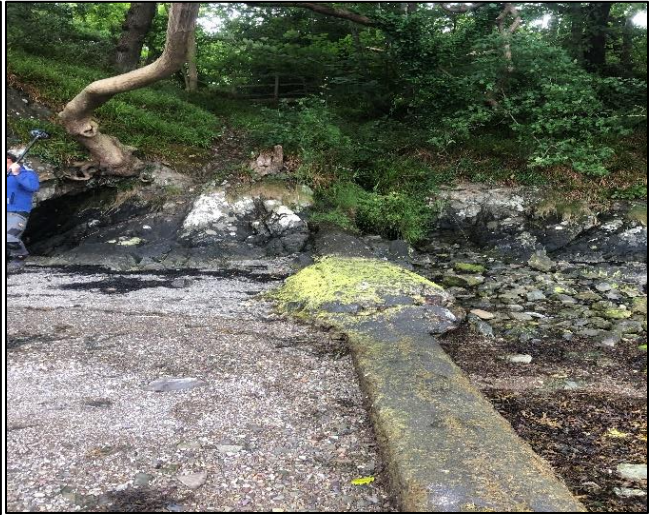
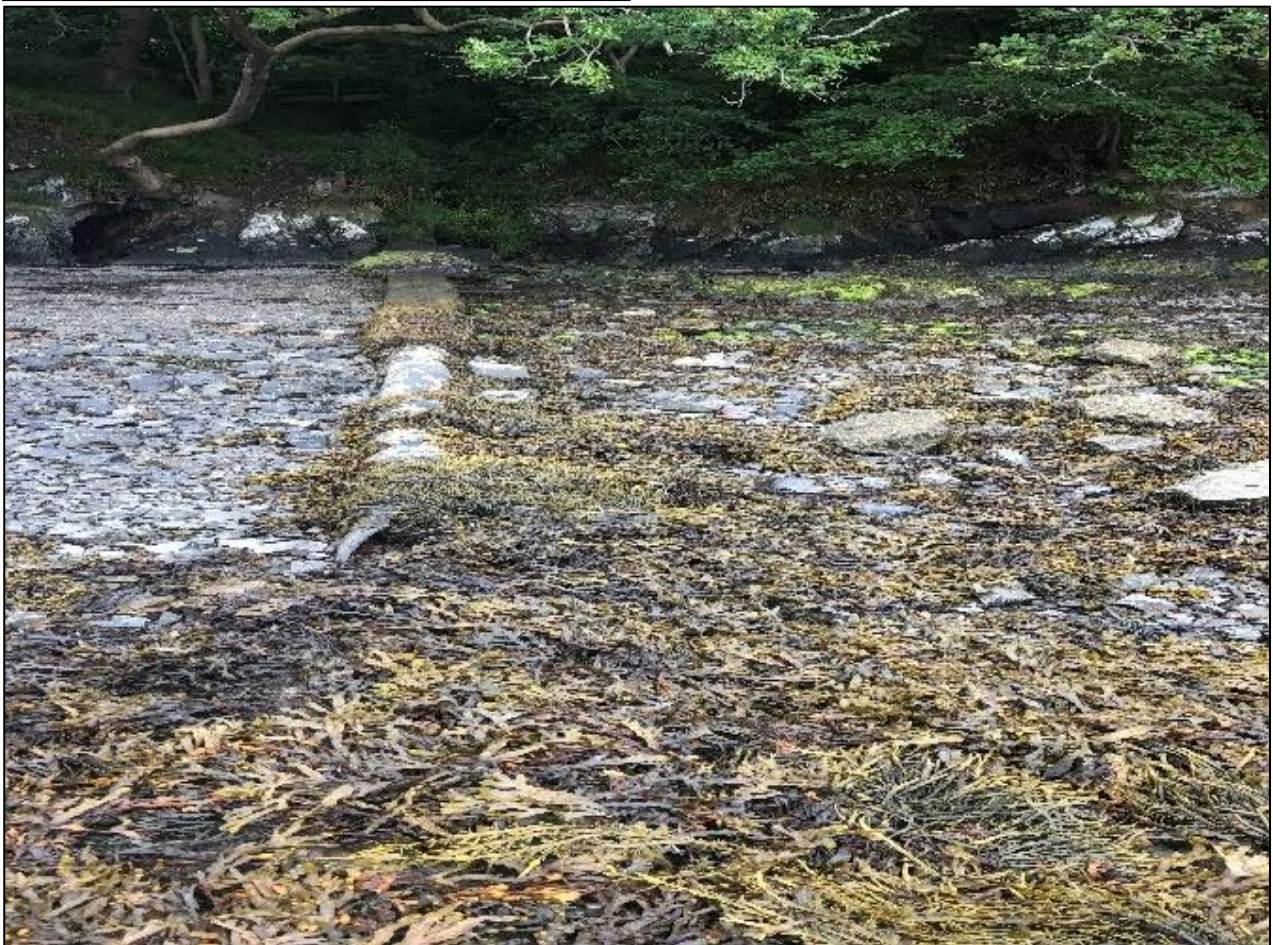
Feature Photo(s) 5

Results
Location	E: 257700.56 N: 372760.66 Elevation: 1.021m OD E: 257707.45 N: 372750.39 Elevation: 2.579m OD
Date and Time	21 st July 2023 at 09:00
Weather	Sunny.
Feature Type	Outfall into sea
Use	N/A
Feature Dimensions	Circa 50cm diameter
Water depth	N/A
Water flow observations	N/A – None visible
Water quality observations	N/A – No clear signs of pollution
Bed/base material/lining	Towards land – cobbles/pebbles/gravels. Towards sea – sand and mud
Vegetation	Seaweed surrounding culvert. Wooded area at landside end of culvert.
General setting	Beach
Other notes	Pipe damaged

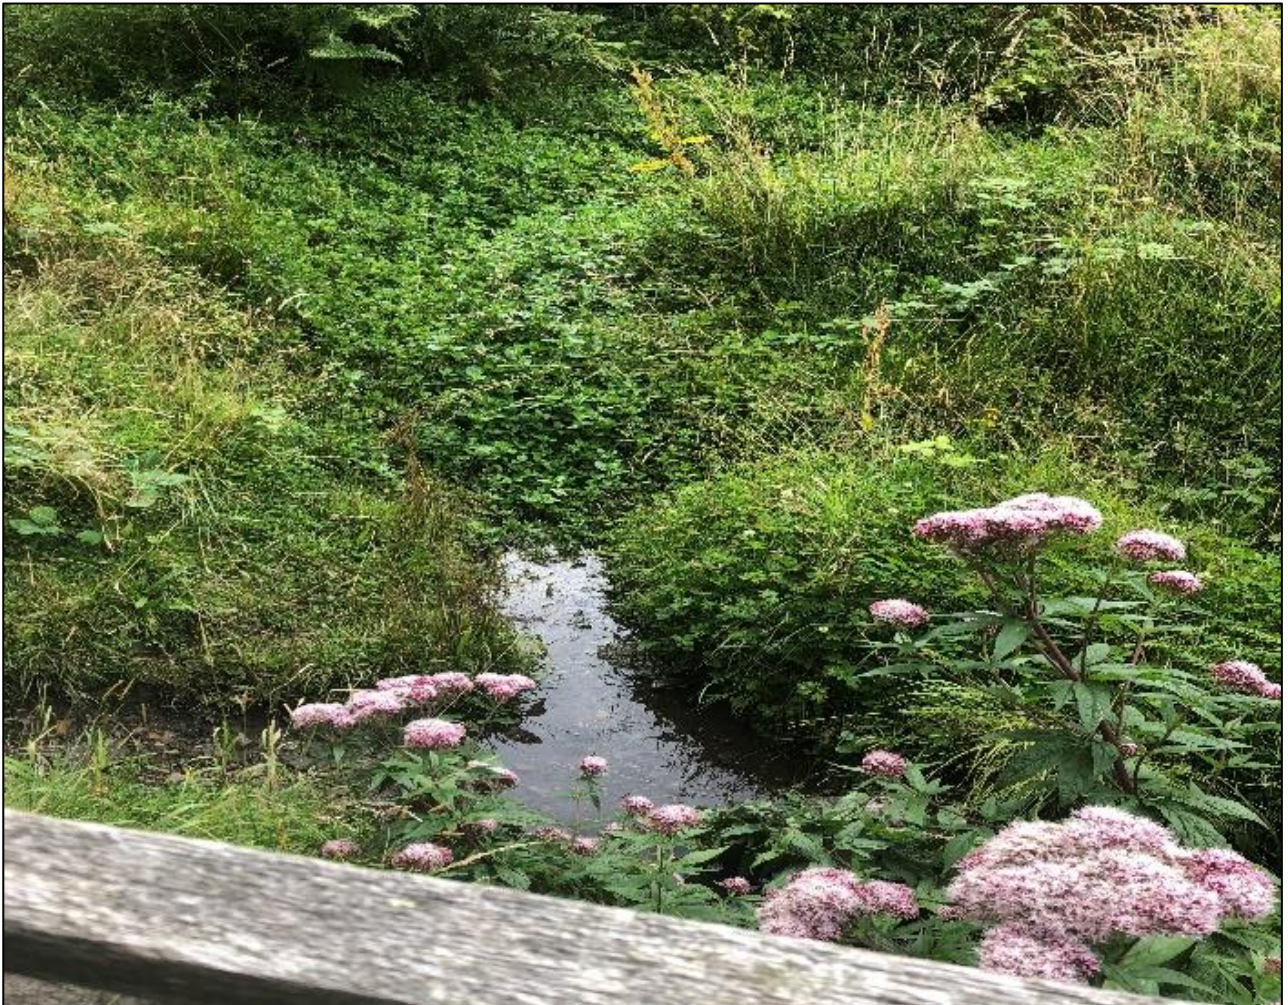
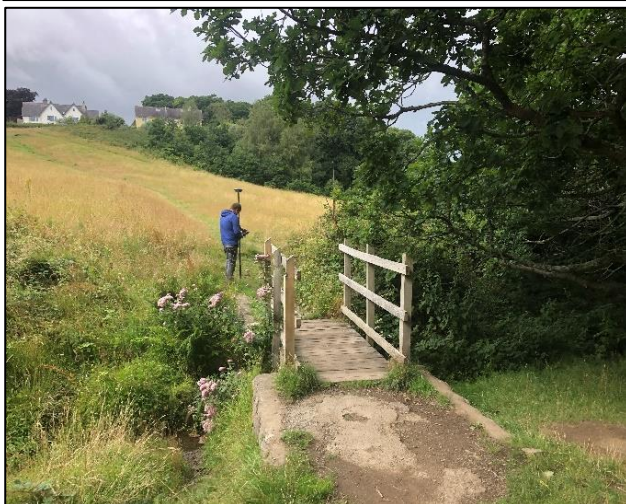
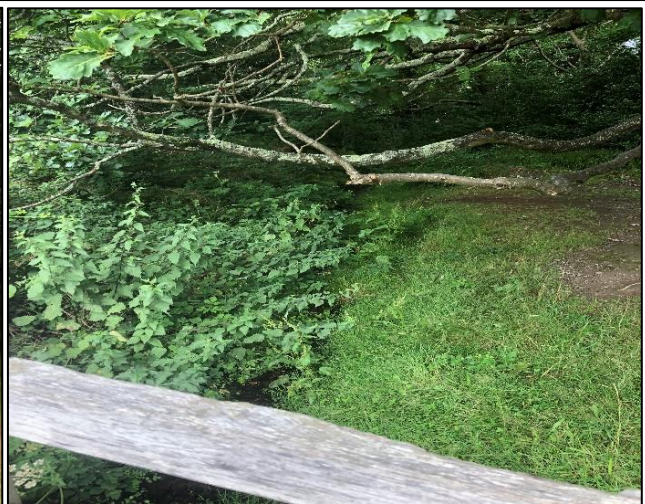
Feature Photo(s) 6

Results
Location	E: 257764.32 N: 372706.76
Date and Time	21 st July 2023 at 09:30
Weather	Cloudy
Feature Type	N/A
Use	N/A
Feature Dimensions	600/700mm wide
Water depth	Water depth c400mm. Level 16.686m OD
Water flow observations	Steady – slow.
Water quality observations	Clear – no sign of pollution
Bed/base material/lining	Unknown - vegetated
Vegetation	Dense vegetation along embankment. Trees.
General setting	Bridge over water course within public area
Other notes

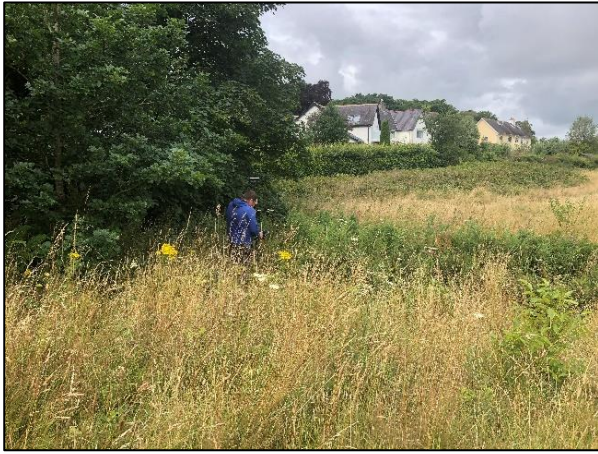
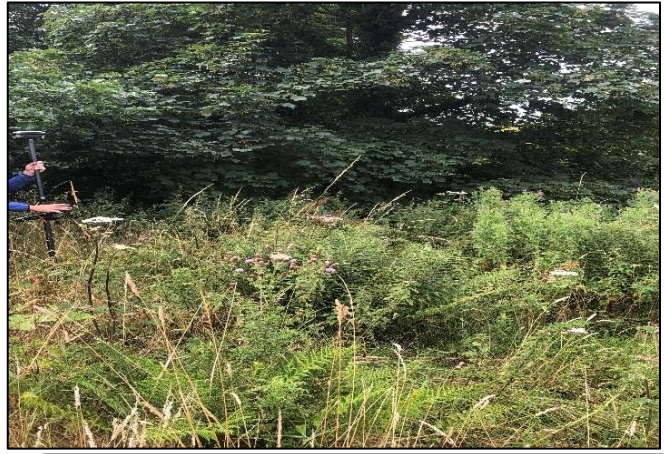
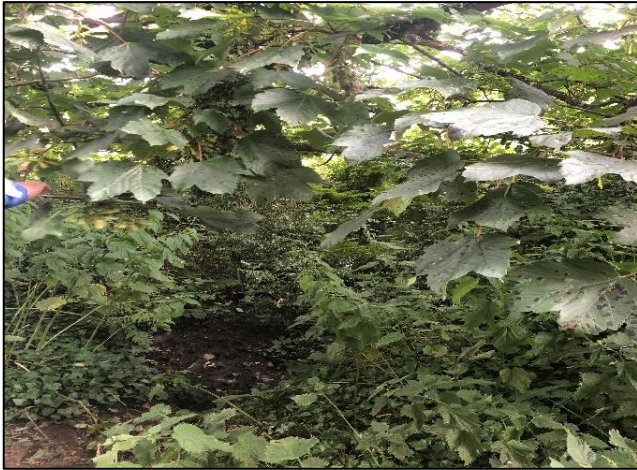
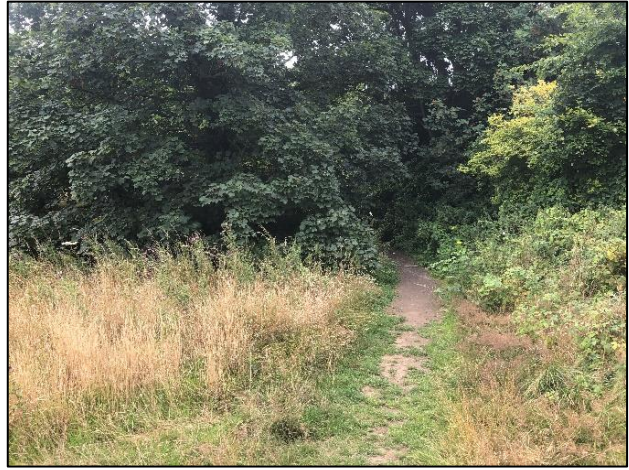
Feature Photo(s) 7

Results
Location	E: 257759.81 N: 372565.95 Elevation: 30.851m OD
Date and Time	21 st July 2023 at 10:00
Weather	Cloudy
Feature Type	Signs of spring. Wet, boggy ground.
Use	N/A – natural feature
Feature Dimensions	N/A
Water depth	<1cm where water visible – mainly boggy/wet ground
Water flow observations	Slow, diffuse spring flow.
Water quality observations	Clear, where visible
Bed/base material/lining	Mud/vegetation – geology not visible
Vegetation	Dense vegetation
General setting	Vegetated public open space
Other notes

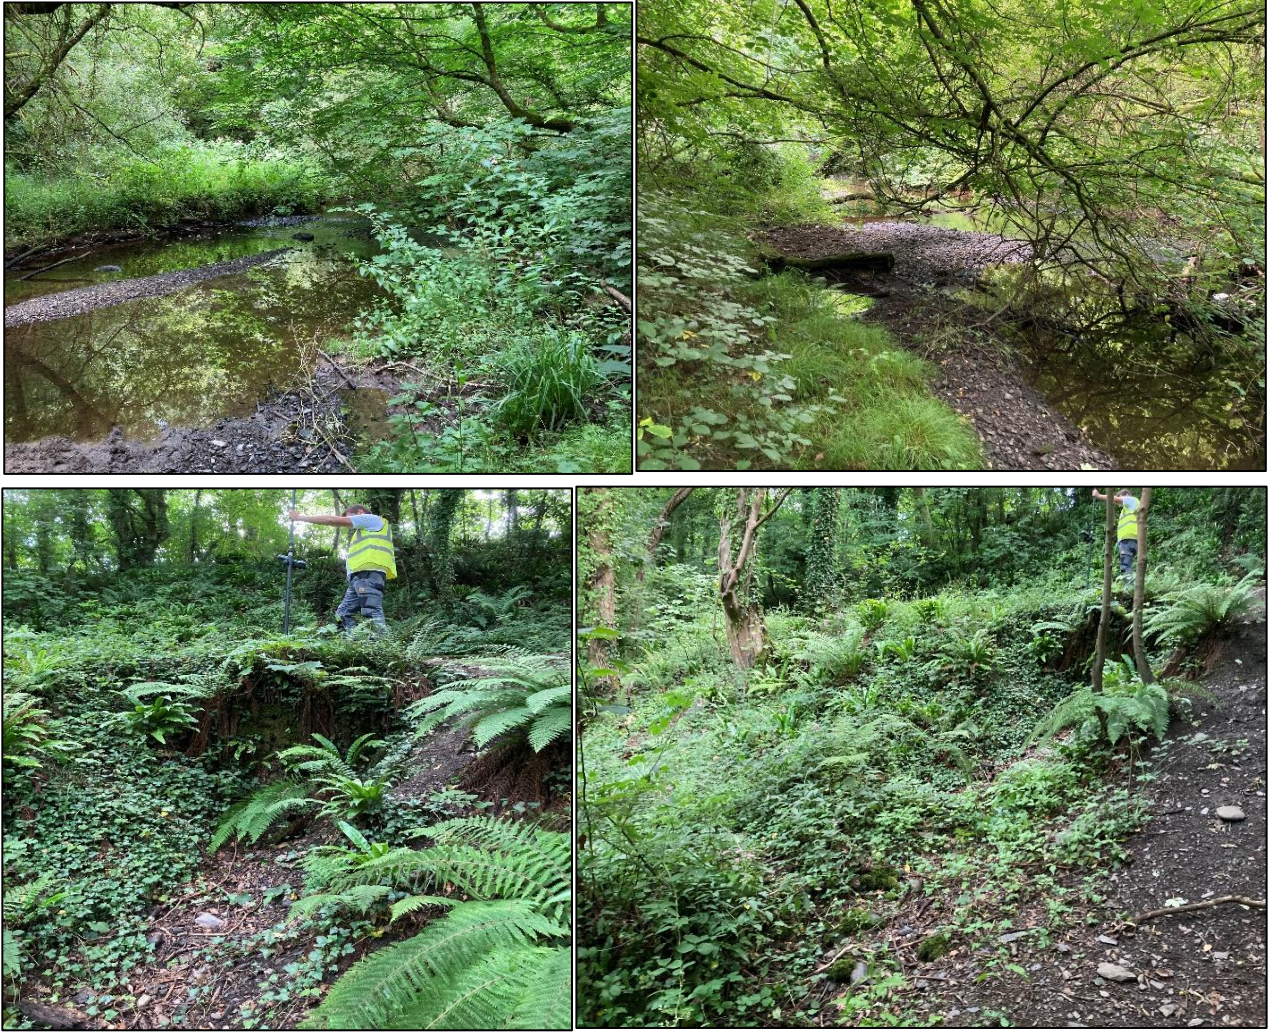
Feature Photo(s) 8

Results
Location	E: 259080 N: 371859
Date and Time	20 th July 2023 at 11:00
Weather	Sunny
Feature Type	Watercourse (Afon Cegin)
Use	N/A
Feature Dimensions	Couple of metres
Water depth	300-400mm
Water flow observations	Steady (non-turbulent flow)
Water quality observations	Muddy – poor visibility. No contamination visible
Bed/base material/lining	Mud and cobbles.
Vegetation	Vegetation on either bank and trees
General setting	Woodland
Other notes

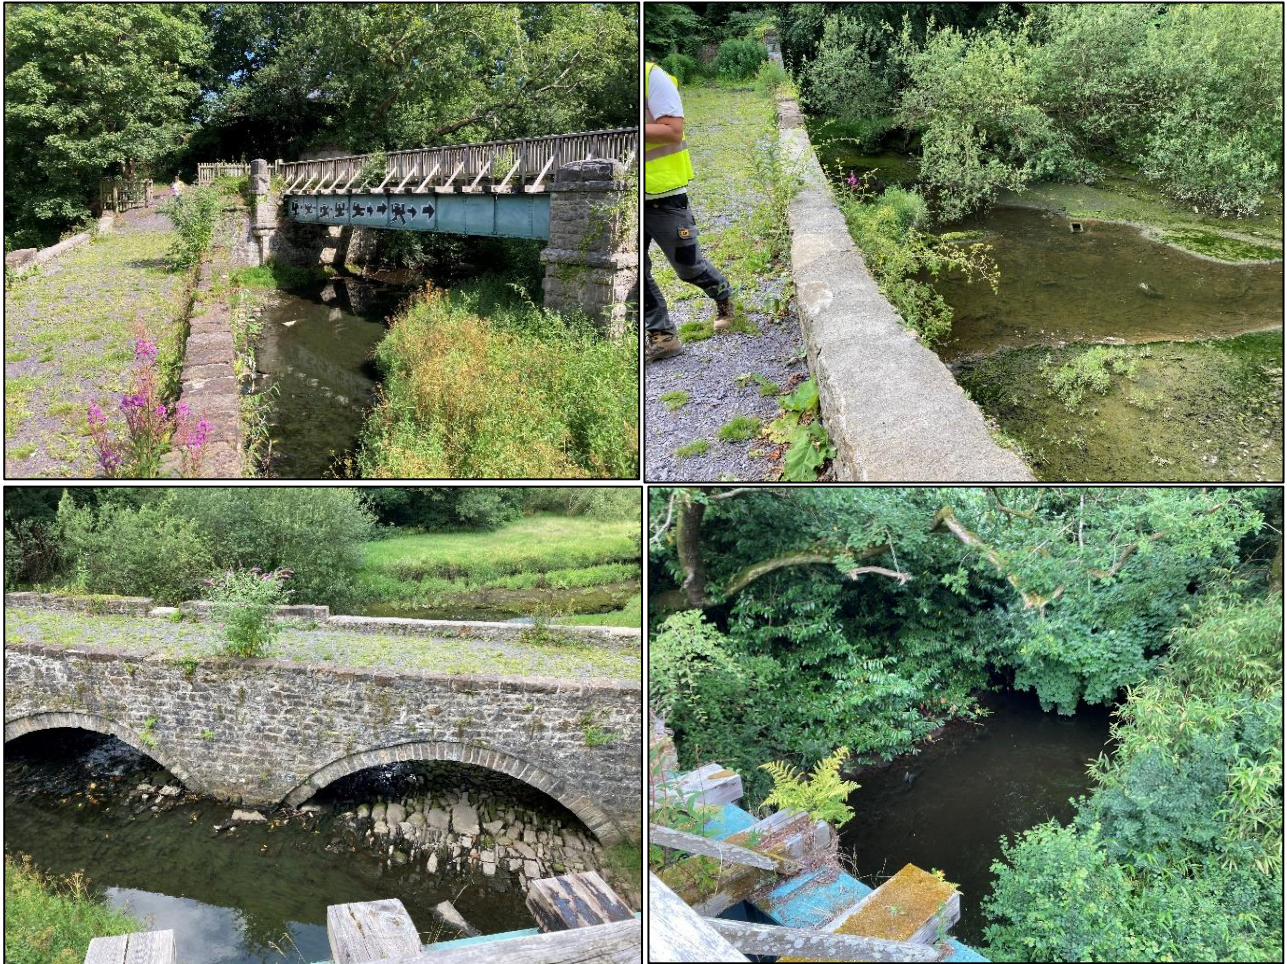
Feature Photo(s) 9

Results
Location	E: 259276.99 N: 372391.14 Elevation 8.241m OD (Lower Bridge)
Date and Time	20 th July 2023 at 11:30
Weather	Sunny
Feature Type	Watercourse - Two bridges (pedestrian and old cattle bridge) over Afon Cegin, upstream of Cegin Pool
Use	N/A
Feature Dimensions	Bridge >20m long.
Water depth	Fairly shallow (bottom visible)
Water flow observations	Steady water flow (non-turbulent)
Water quality observations	Clear generally – murky in areas. No clear pollution.
Bed/base material/lining	Mud, gravels and cobbles.
Vegetation	Dense vegetation + trees on verges. Grassland on verges downstream. Algae in water in areas.
General setting	Woodlands.
Other notes

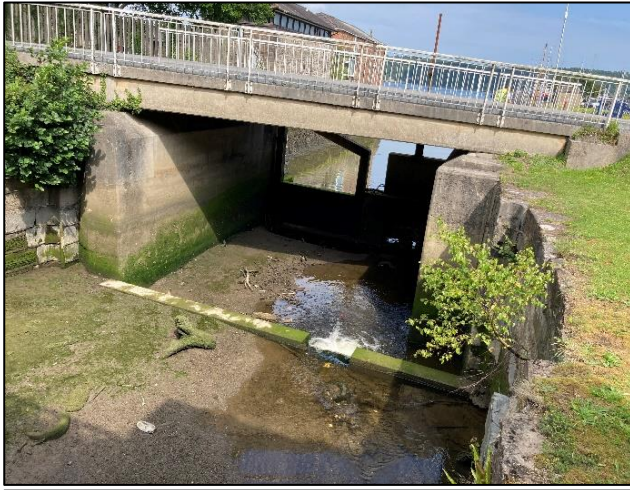
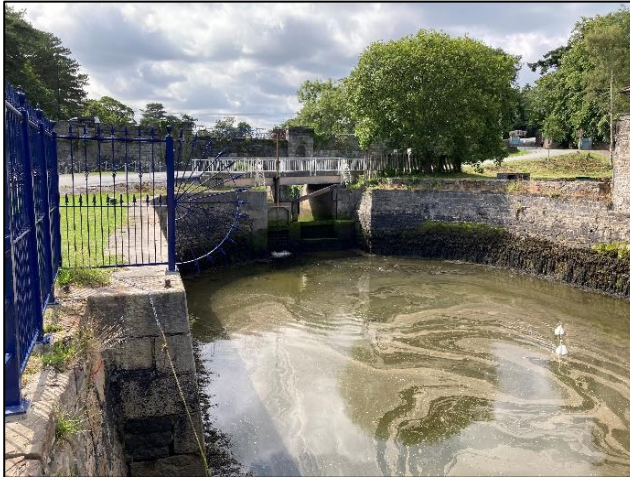
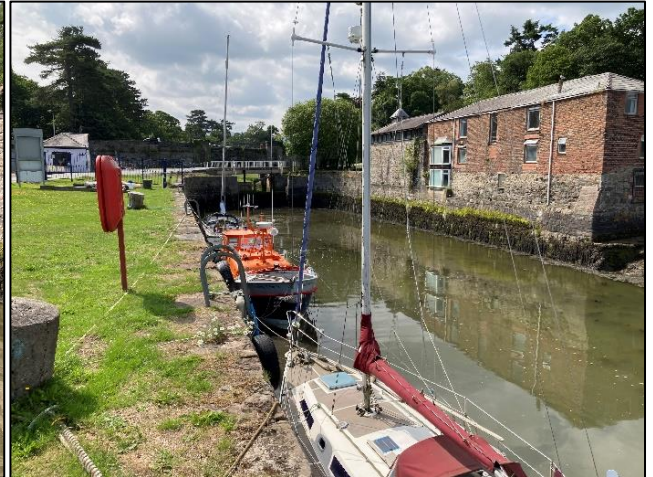
Feature Photo(s) 10

Results
Location	E: 259192 N: 372586
Date and Time	20 th July 2023 at 12:30
Weather	Sunny
Feature Type	Watercourse flowing underneath bridges into harbour area
Use	N/A
Feature Dimensions	Watercourse circa 5m wide under bridge
Water depth	Tidal (low tide during survey) Upstream of bridge shallow. Downstream depth not visible
Water flow observations	Steady water flow from upstream
Water quality observations	Very murky downstream of bridge. Clear upstream of bridge
Bed/base material/lining	Muddy sandy bed. Gravels in places
Vegetation	Cut grass, occasional trees/shrubs
General setting	Harbour, adjacent to Porth Penrhyn. Upstream of bridge meandering river through field.
Other notes

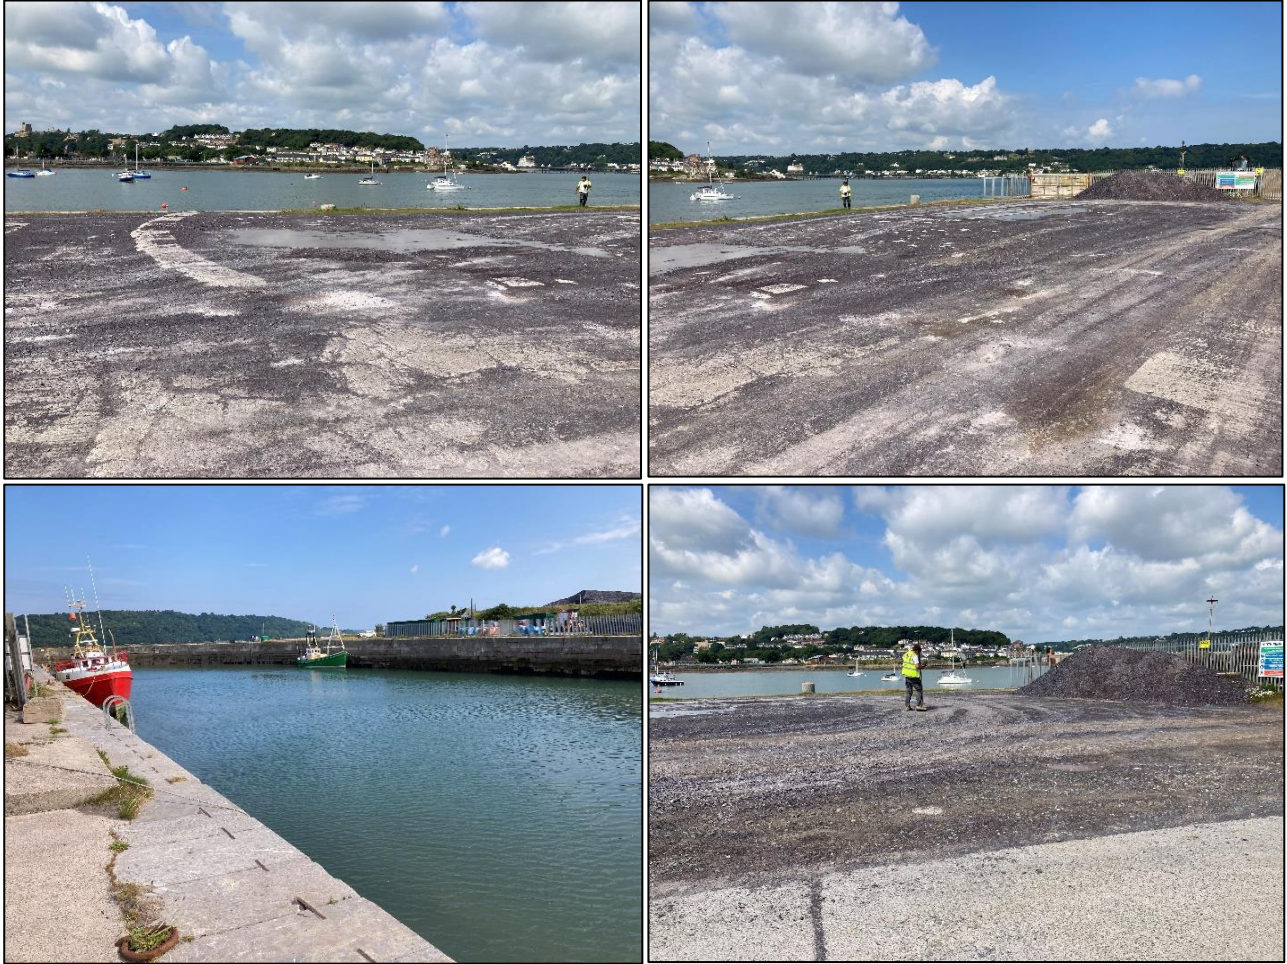
Feature Photo(s) 11

Results
Location	E: 259108.00 N: 373002.00
Date and Time	20 th July 2023 at 13:30
Weather	Sunny
Feature Type	Menai Strait at Porth Penrhyn (Harbour)
Use	N/A
Feature Dimensions	N/A
Water depth	Unknown (deep)
Water flow observations	N/A
Water quality observations	Clear water conditions. No clear contamination
Bed/base material/lining	Not visible – assume sands to gravels
Vegetation	N/A
General setting	On Wharf at Porth Penrhyn
Other notes	No signs of discharge or outlets (potentially submerged)

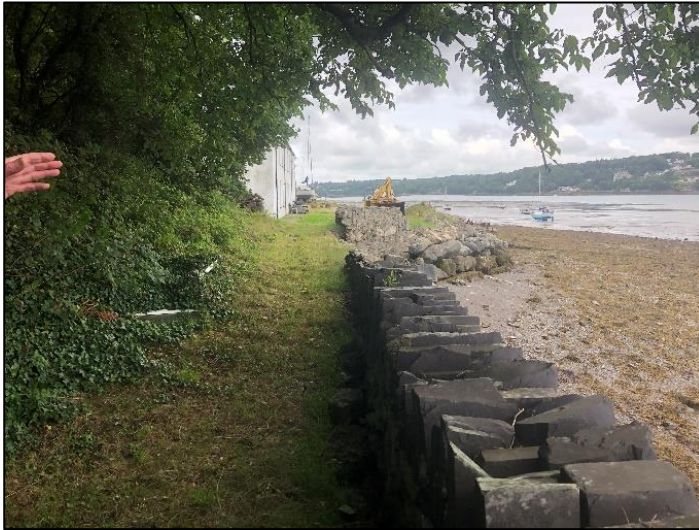
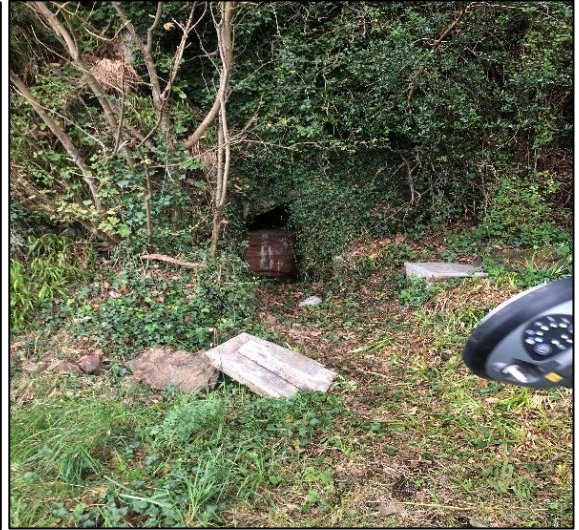
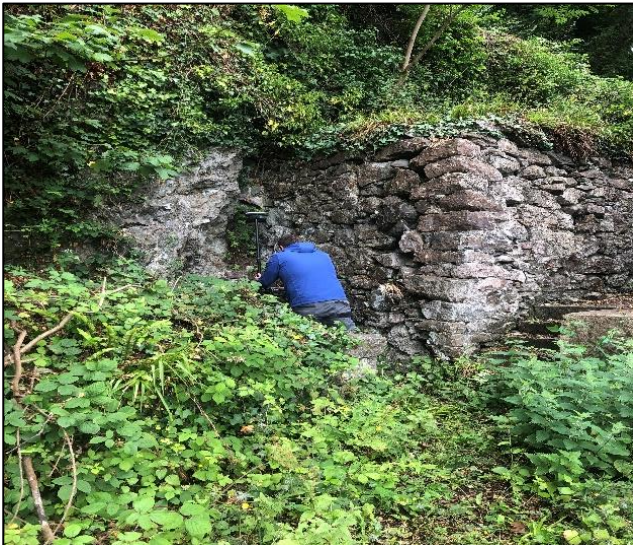
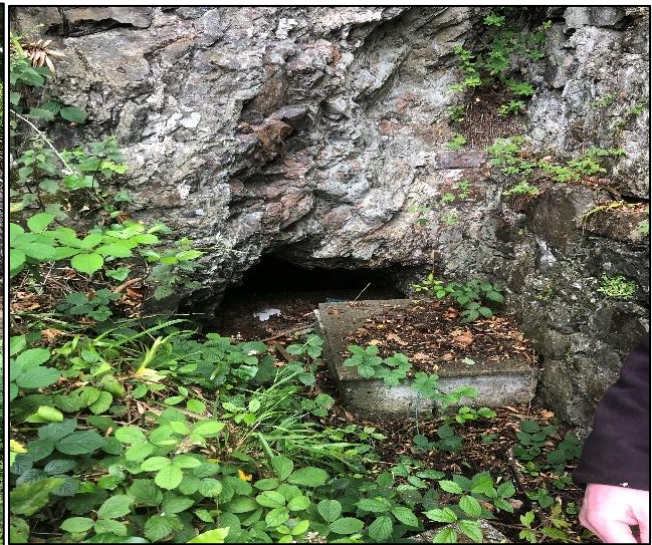
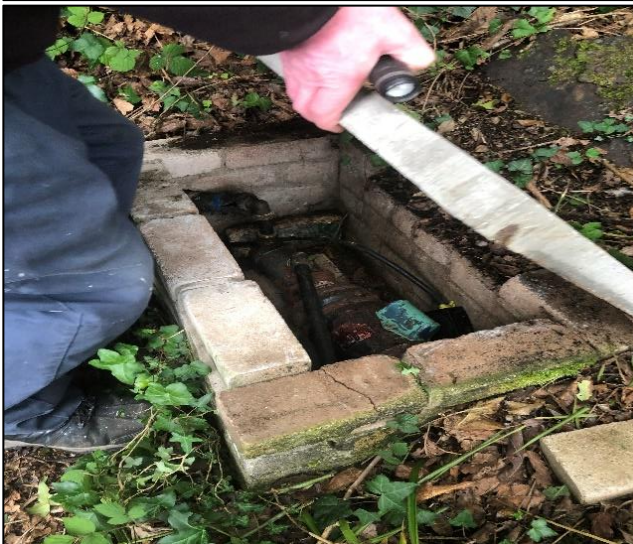
Feature Photo(s) 12

Results
Location	E: 258164.11 N: 373082.91 Elevation: 3.02m OD E: 258189.79 N: 373091.59 Elevation: 2.80m OD
Date and Time	21 st July 2023 at 12:30
Weather	Cloudy
Feature Type	Two wells – first inaccessible, second in brick chamber. Local resident has pumps setup and is using as water source.
Use	Private supply
Feature Dimensions	Well 1 - Unable to access Well 2 - Brick chamber circa 1.0m long x 0.5m wide containing pump
Water depth	Well 1 – Unable to access Well 2 – Water circa 1.0m below ground level
Water flow observations	Unknown
Water quality observations	Well 1 - Unable to access Well 2 - Crystal clear
Bed/base material/lining	N/A
Vegetation	Dense vegetated area
General setting	Close to Menai Strait, in wooded area near to Old Baths.
Other notes

- **Licensed and unlicensed groundwater abstractions:** There are no licensed groundwater abstractions within 1km of the Site. During the water features survey, two unlicensed abstraction wells (feature 12) were found to the northwest of Bangor, close to the Menai Strait. The wells are approximately 400m-500m distance from the Site and are understood to supply a local resident. No information is available on the depth of the wells or which strata they are pumping from. Given the proximity to the Menai Strait it is likely that the wells extract water from deeper bedrock strata.

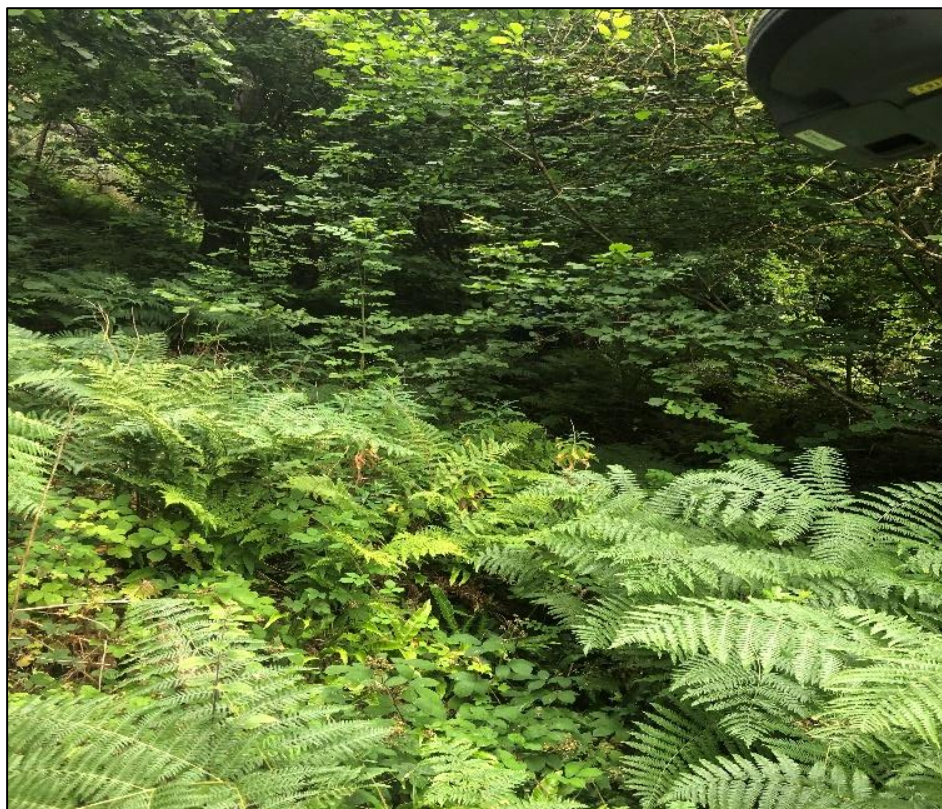
Feature Photo(s) 13

Results
Location	E: 258298.48 N: 372041.51 GL: 37.808m OD
Date and Time	21 st July 2023 at 13:30
Weather	Cloudy
Feature Type	Potential spring – unable to locate any signs.
Use	N/A
Feature Dimensions	N/A
Water depth	N/A
Water flow observations	N/A
Water quality observations	N/A
Bed/base material/lining	Muddy underfoot
Vegetation	Dense overgrown vegetation
General setting	Back of housing estate on Bangor Mountain
Other notes

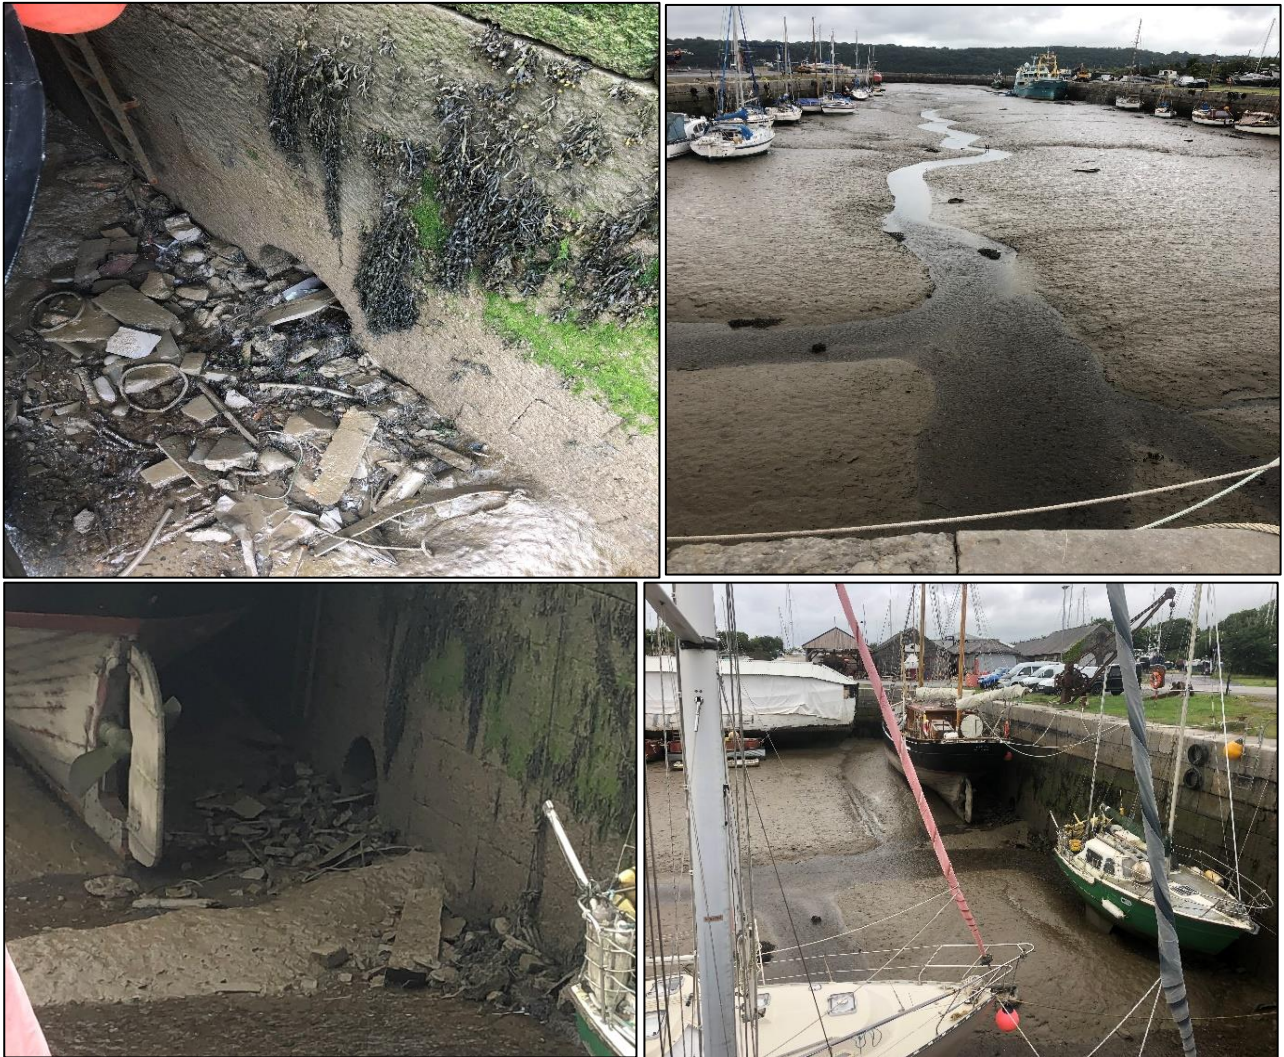
Feature Photo(s) 14

Results
Location	E: 259227.54 N: 372802.14
Date and Time	21 st July 2023 at 08:30
Weather	Cloudy
Feature Type	Outfall/discharge onto Bangor Flats from harbour wall (marked as issues on map)
Use	N/A
Feature Dimensions	Unable to measure
Water depth	Tidally dependent Outfall Invert: -0.793m OD
Water flow observations	No discharge visible, but a lot of debris at outlet location.
Water quality observations	Unknown
Bed/base material/lining	Lots of debris. Muddy/sandy seabed
Vegetation	None
General setting	Penrhyn Wharf
Other notes

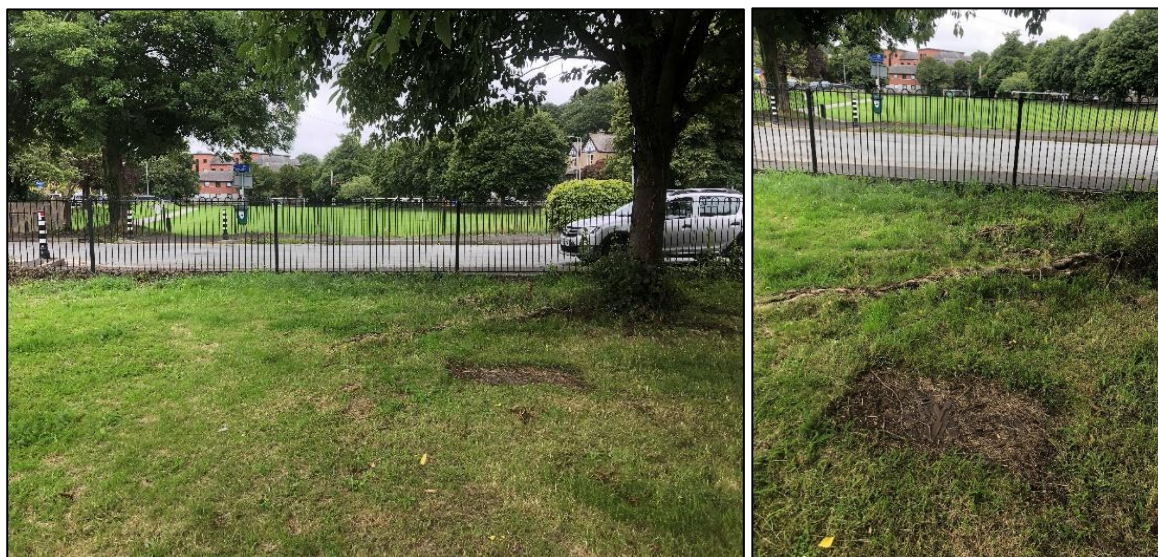
Feature Photo(s) 15

Results
Location	E: 258331.66 N: 372626.69 Elevation: 6.635m OD (Manhole)
Date and Time	21 st July 2023 at 14:00
Weather	Cloudy
Feature Type	Culverted watercourse.
Use	N/A
Feature Dimensions	N/A
Water depth	N/A
Water flow observations	Could hear flows under manhole cover.
Water quality observations	N/A
Bed/base material/lining	N/A
Vegetation	N/A
General setting	In field by Bangor swimming baths
Other notes	Could not find any visible culvert/ watercourse upstream or downstream of location
