Enw a Rhif y Proiect CNC / NRW Project Name and Number  
**CE0603-507**

**SALMON FOR TOMORROW  
PHASE 2  
LLANFAIR TALHAIARN**

Tell Llundain / Drawing Title  
**EXISTING WEIR PLAN AND SECTIONS**

Graddfa yn A1 / Scale at A1	
As Shown	
Rhan / Role	
<b>General</b>	
Addasrwyddi / Suitability	Status / Status
For Information	S2
Rhif y Proiect Arup / Arup Project Number	Adolygiad / Rev
290013	P02
Rhif y Llundain / Drawing Number	
<b>290013-ARP-IZ-LF-DR-ZX-0003</b>

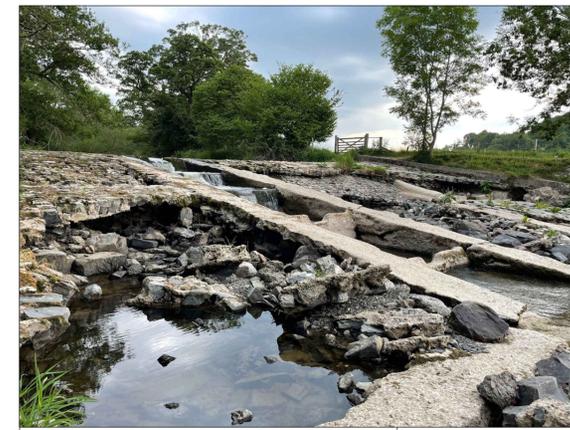
Photo, taken from the right hand bank, immediately downstream of the weir, showing its poor condition [15/06/2023]
