## Tir John (Phase 1) Landfill

Annual Monitoring Review January - December 2023

Report No. 14-K6065-ENV-  
R040

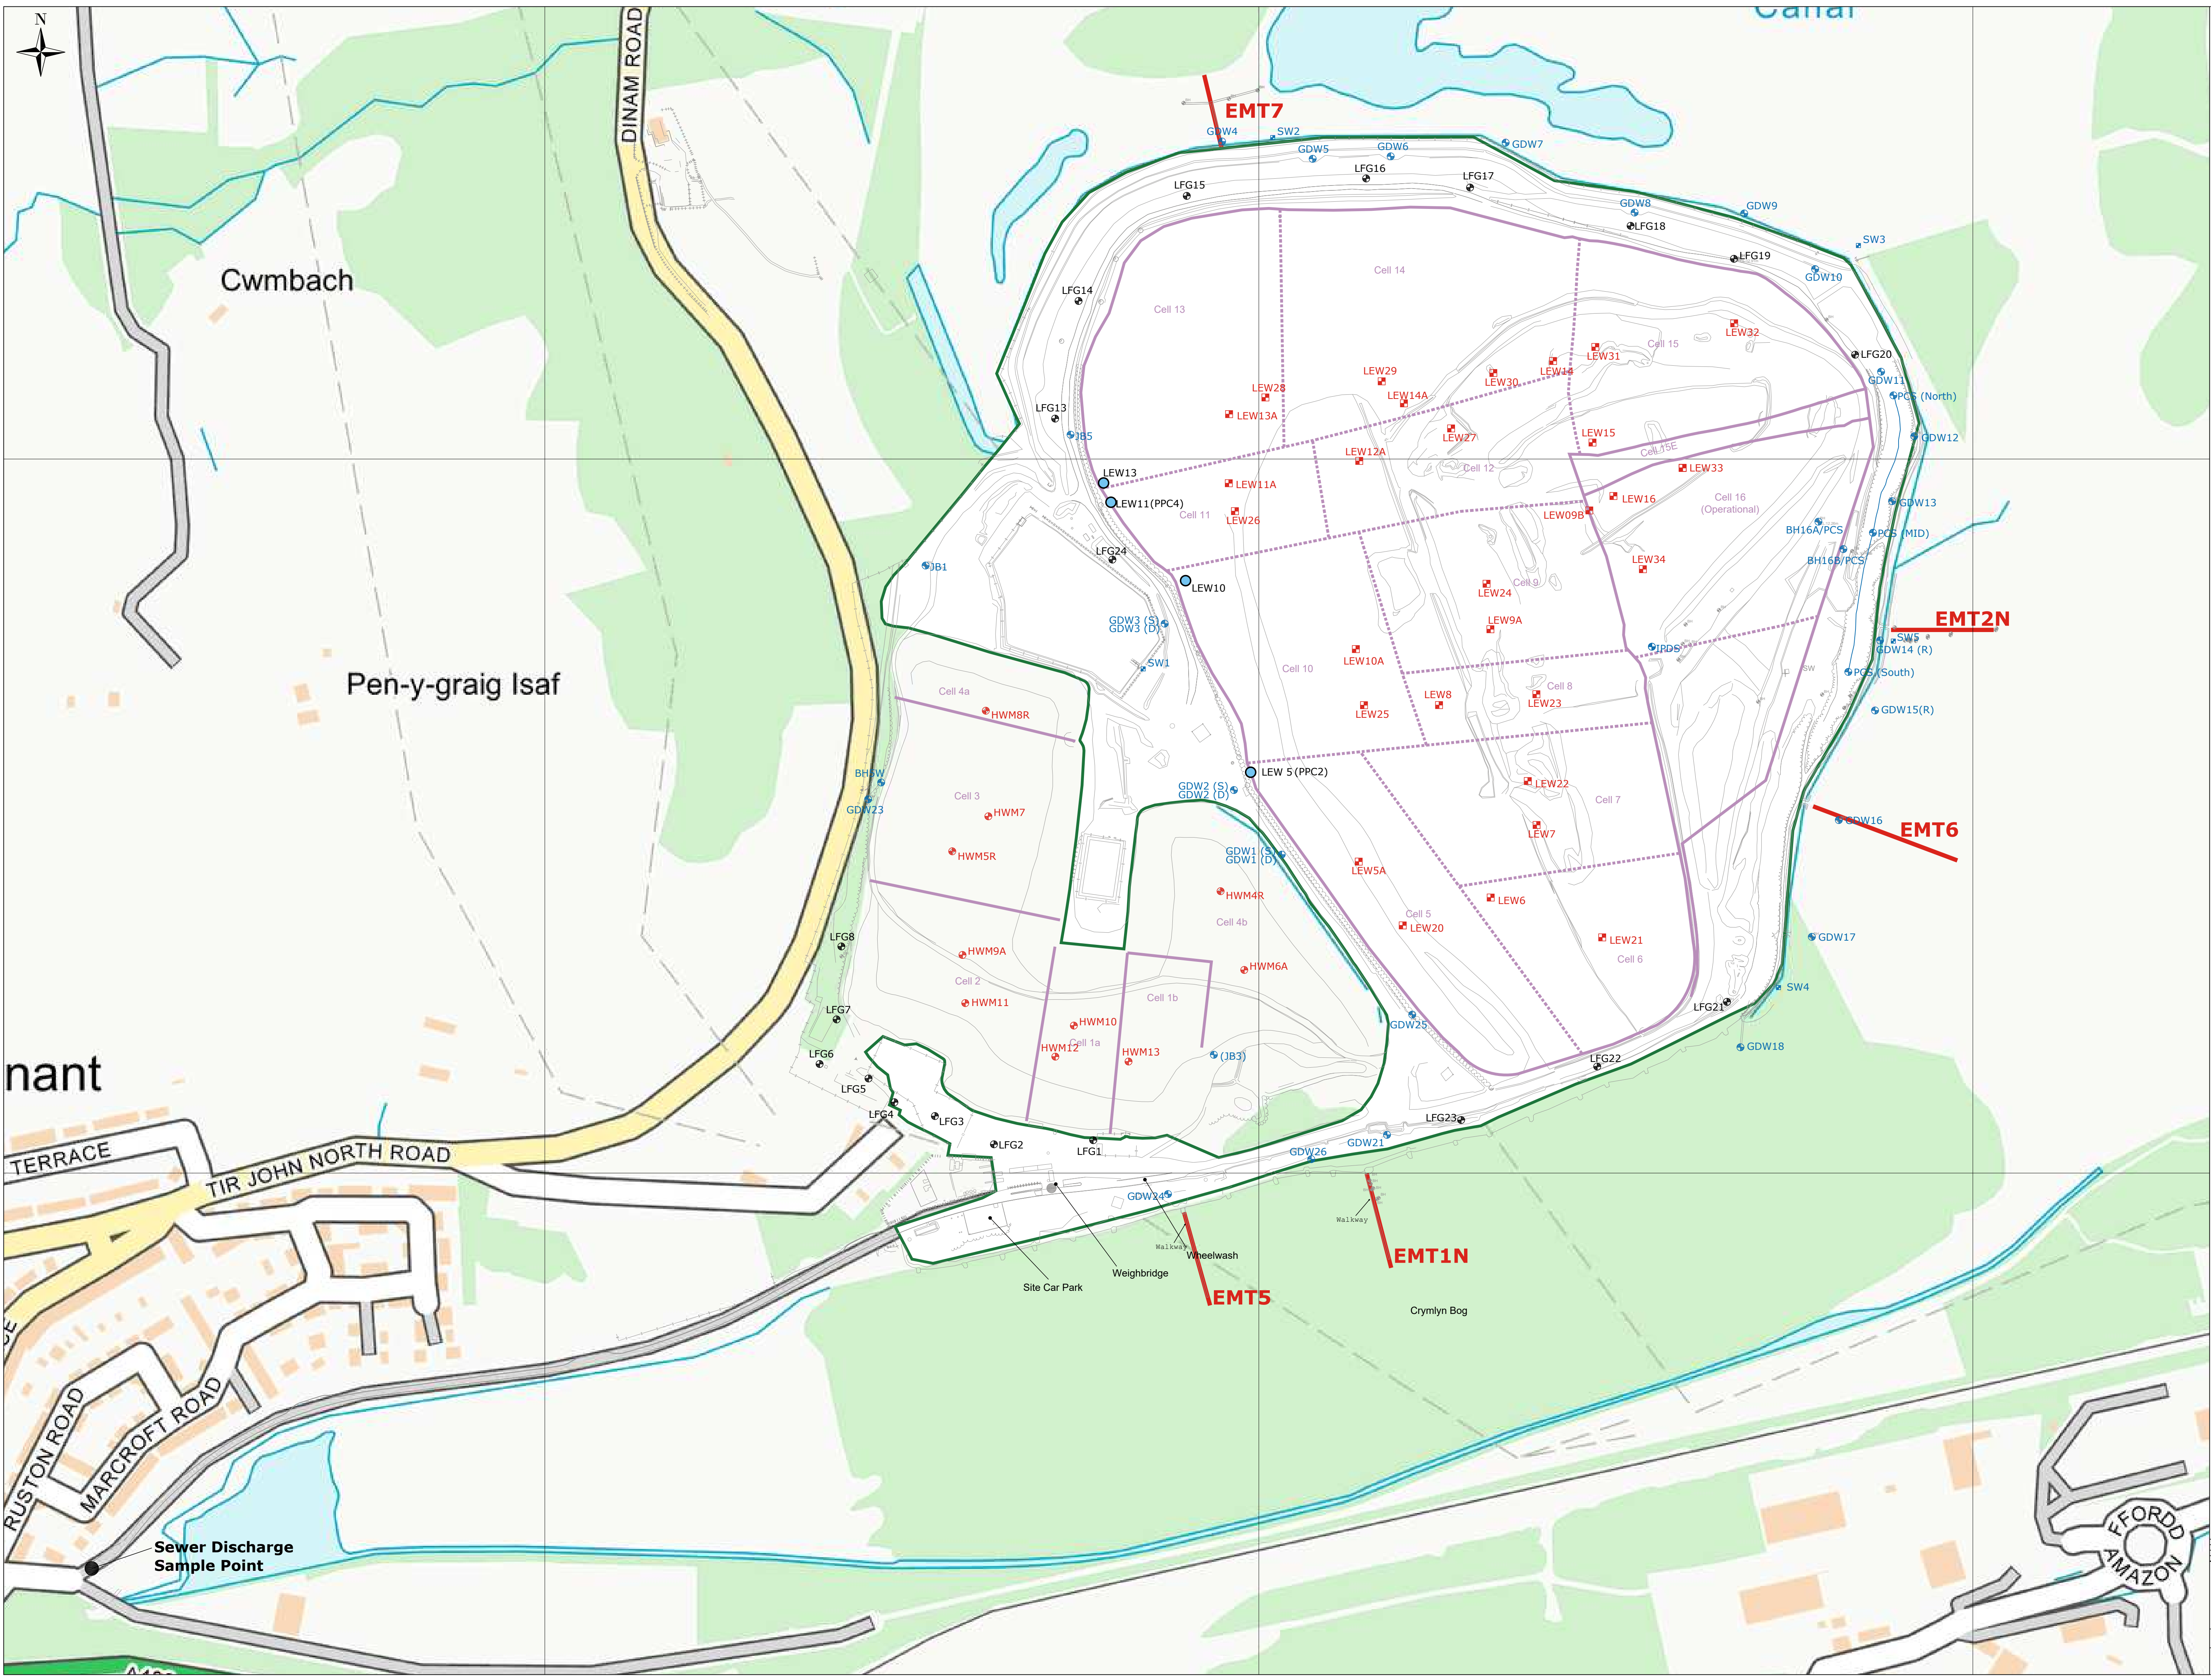
| Drawing number | | TJ74 | |

Enovert South Limited staff carried out environmental monitoring during 2023 at the locations shown on Drawing TJ87 in accordance with the site's Environmental Permit.

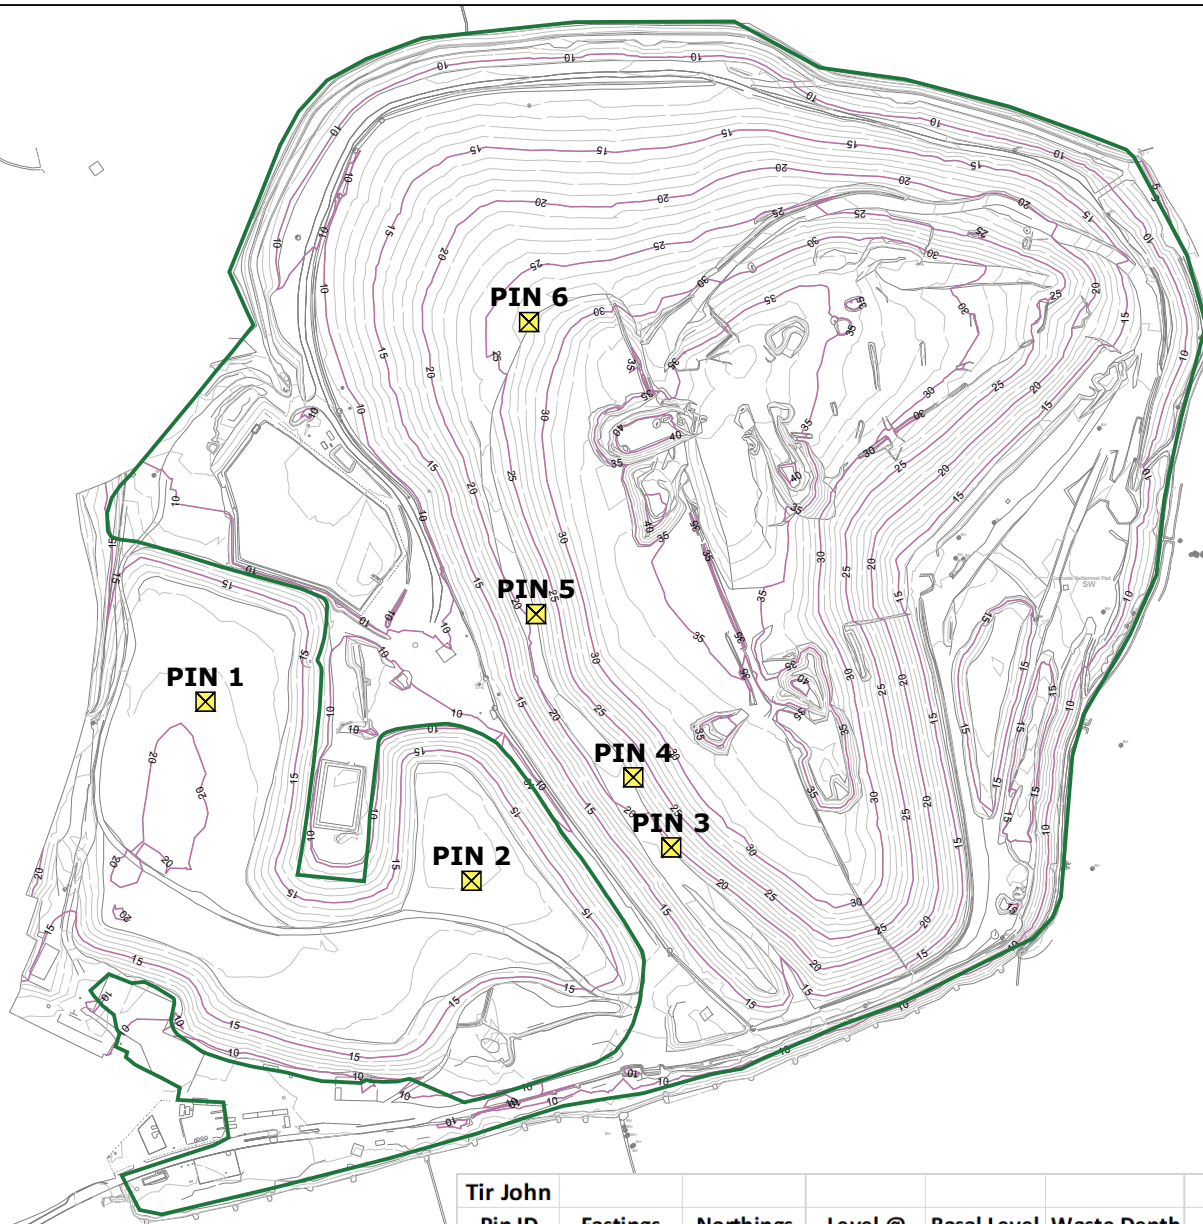
| Drawing number | | <b>TJ87</b> |

This Site is closed and there is no remaining void space. A site survey is attached as Drawing Ref. TJ87 which illustrates settlement data collected for the site in 2023.
