# Carmarthen Swing Bridge – Fender Removal Habitat Regulations Assessment

| DOCUMENT INFORMATION | | | |
|---|---|---|---|
| Project | Carmarthen Swing Bridge – Fender Removal | | |
| Title | Habitat Regulations Assessment | | |
| Document Ref | EV000991/HRA-1 | Issue / Revision | 1 |

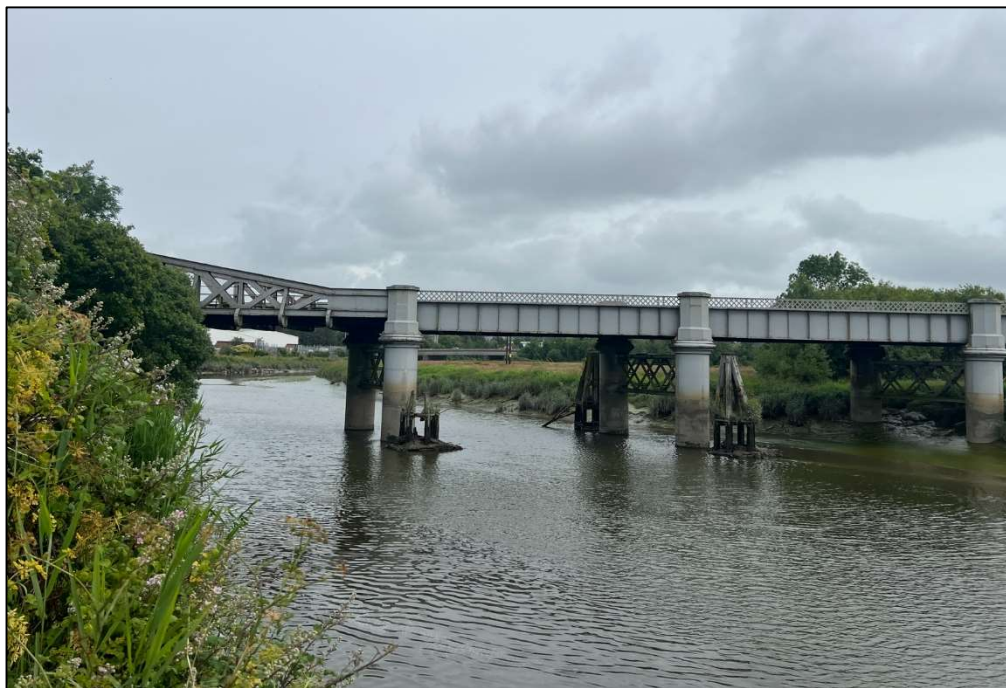
**Figure 2: View of swing bridge and timber fenders (Downstream of structure).**

- 1.2.1 Known as the White Railway Bridge, the rail structure is a standard metallic pier support rail bridge in combination with a Bascule component situated on the western shore of the Tywi. Up and down stream of the structure are now redundant timber constructed fenders. Once important as an additional defence and navigation aide during periods of high vessel traffic along the Tywi. These fenders are no longer required and present a navigational hazard and potential constriction point for debris flowing from upstream sections of the Tywi. Dyer & Butler Rail Division, working with Kaymac have been commissioned by Network Rail to remove the fenders at the earliest opportunity.

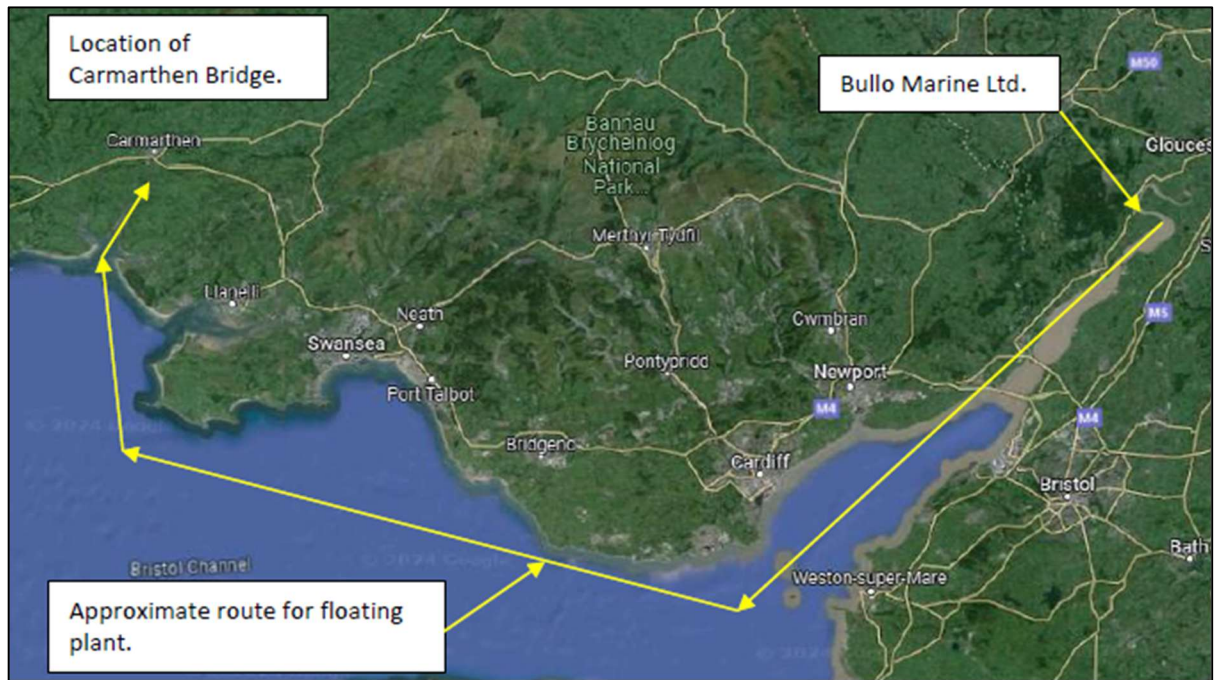
**Figure 6: Indicative route of Bullo Marine Vessel, chartered by Kaymac.**

- 4.3.1 Upon receipt of marine license and confirmation from Network Rail to proceed. Weather dependant Bullo Marine Ltd. Will mobilise from Bullo Pill, Newham (GL14 1ED) on the, with the view of arriving at Carmarthen Swing Bridge two days later.
