**TRANSFER LICENCE**

**ABERGELE QUARRY**

**Supporting information 3047/TL  
April 2024**

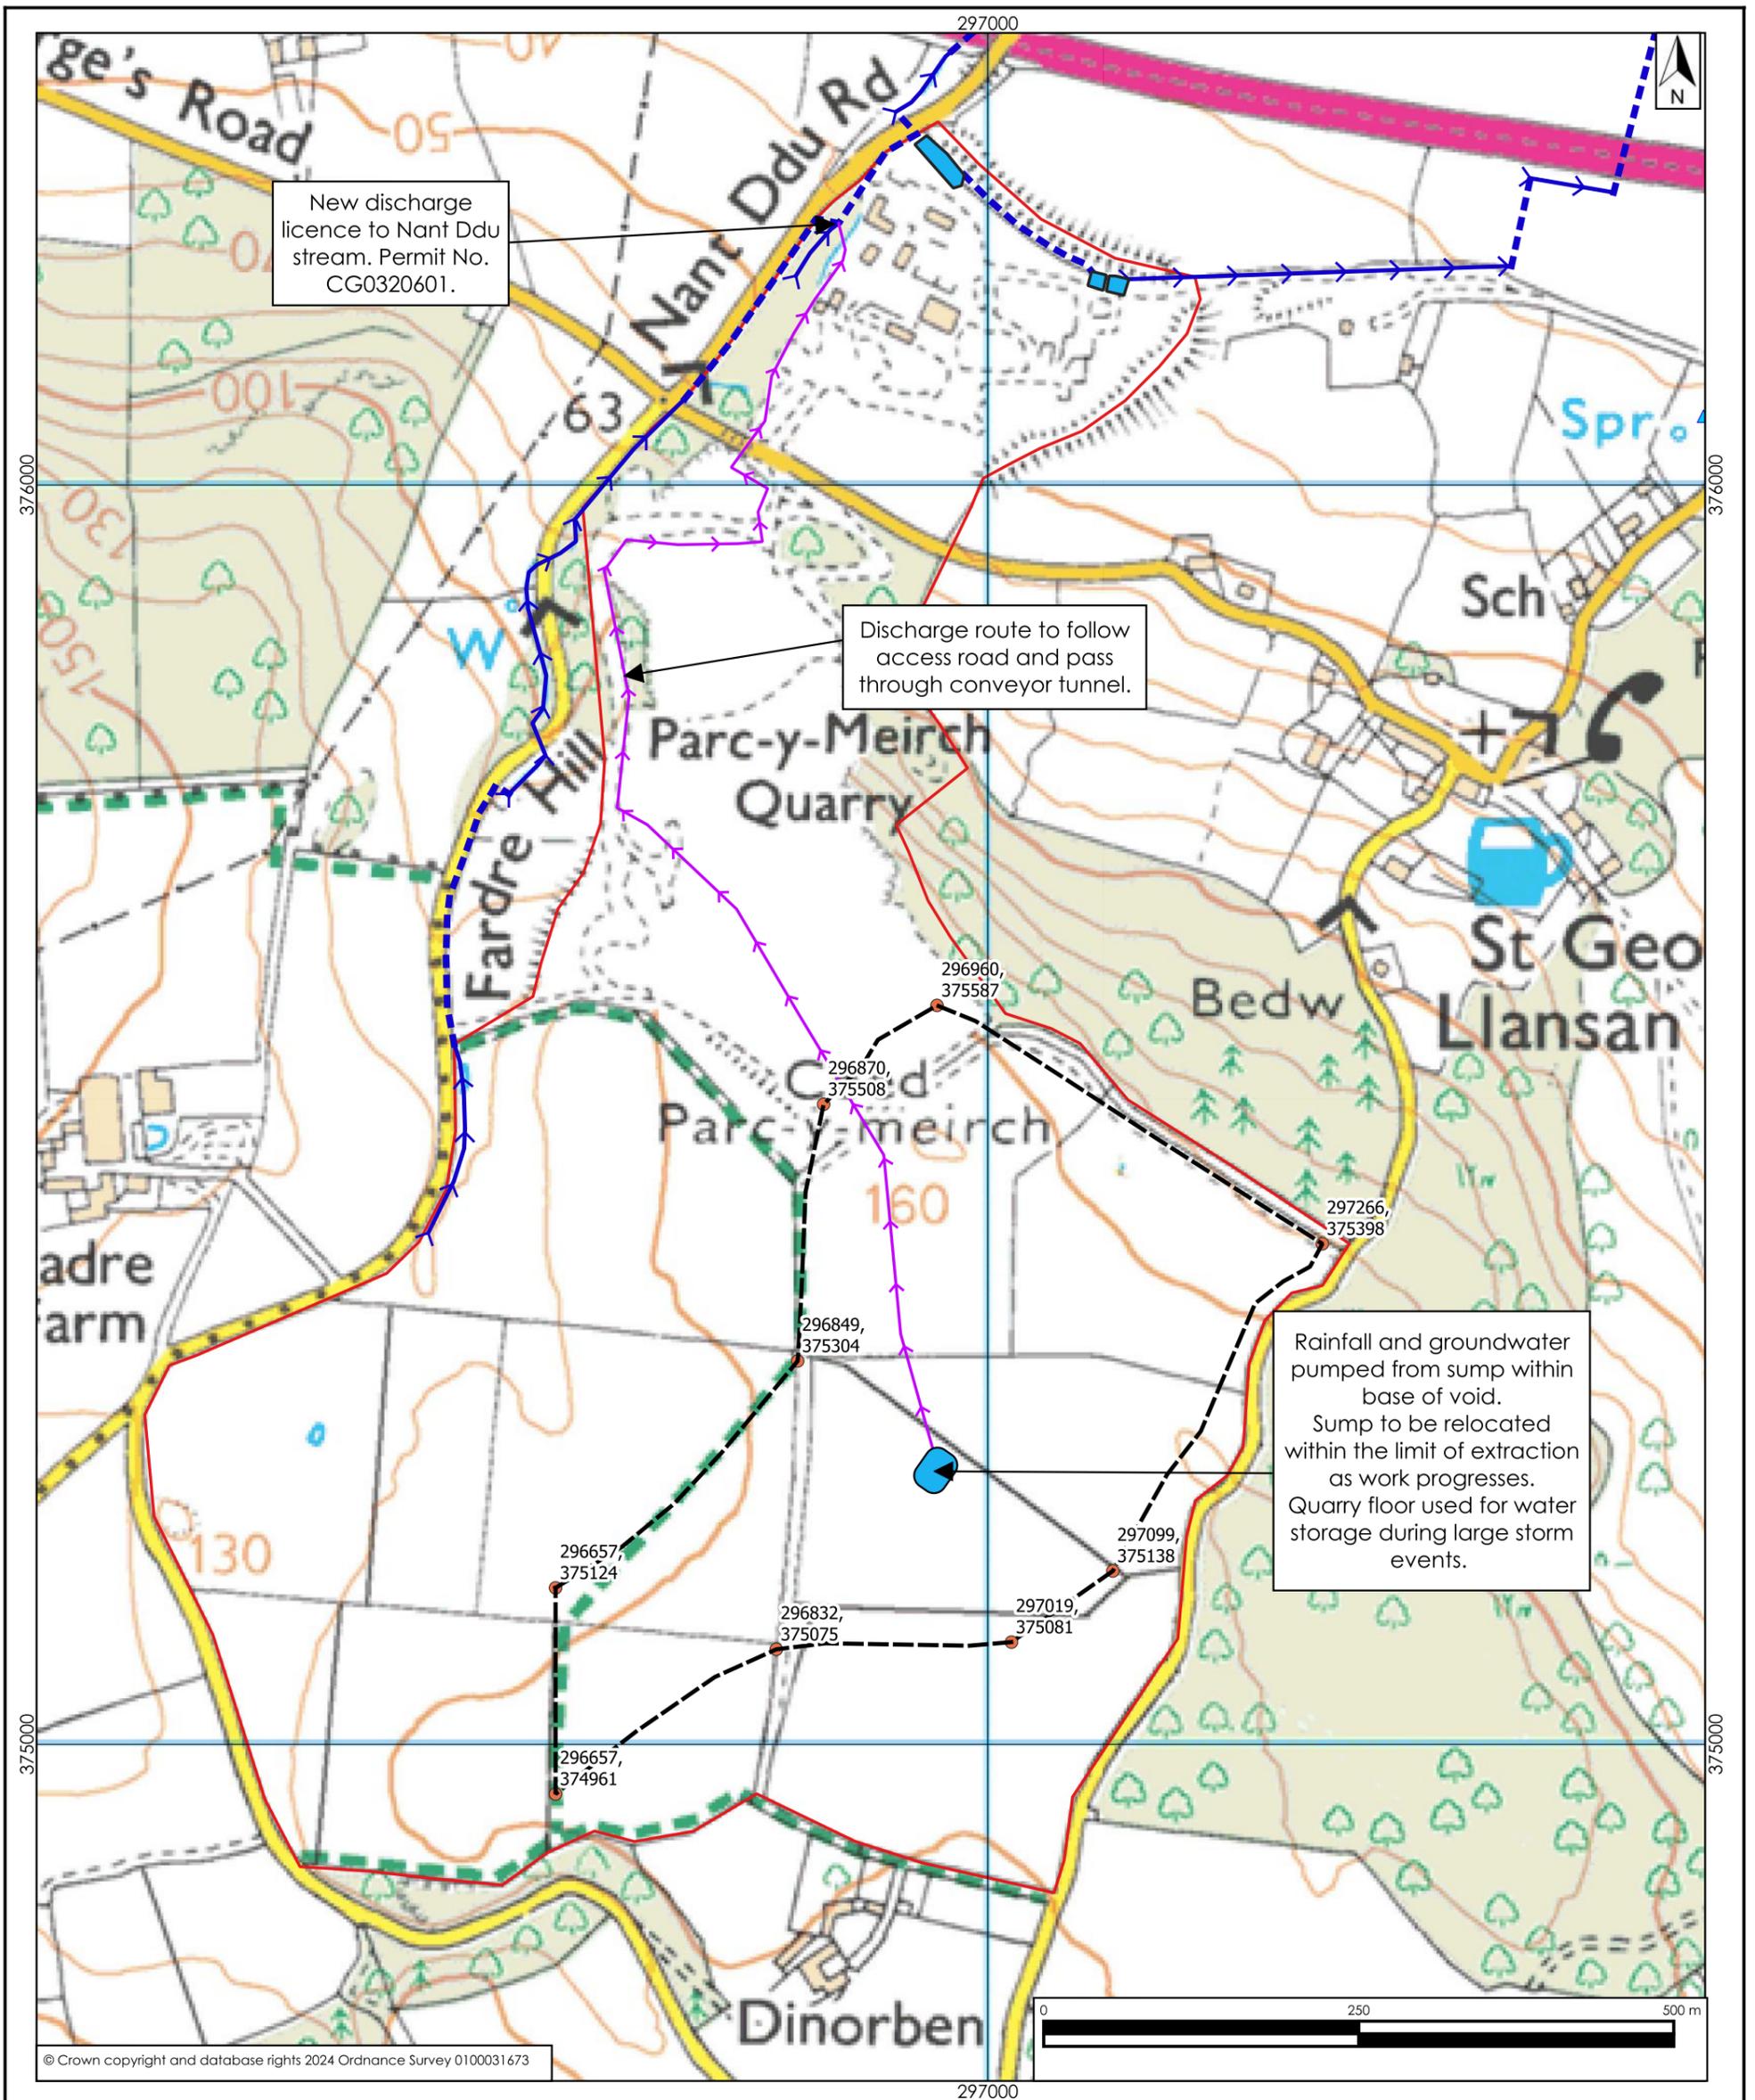
The proposed water management system is shown on *Drawing 3047/TL/01*. Groundwater inflow and incident rainfall will be directed to a sump at the base of the quarry void. Water will be pumped from the sump and out of the quarry void using a 6 inch pump. Water will then flow under gravity through pipes via the conveyor tunnel to the mineral processing area where it will be discharged off-site to the Nant Ddu watercourse.

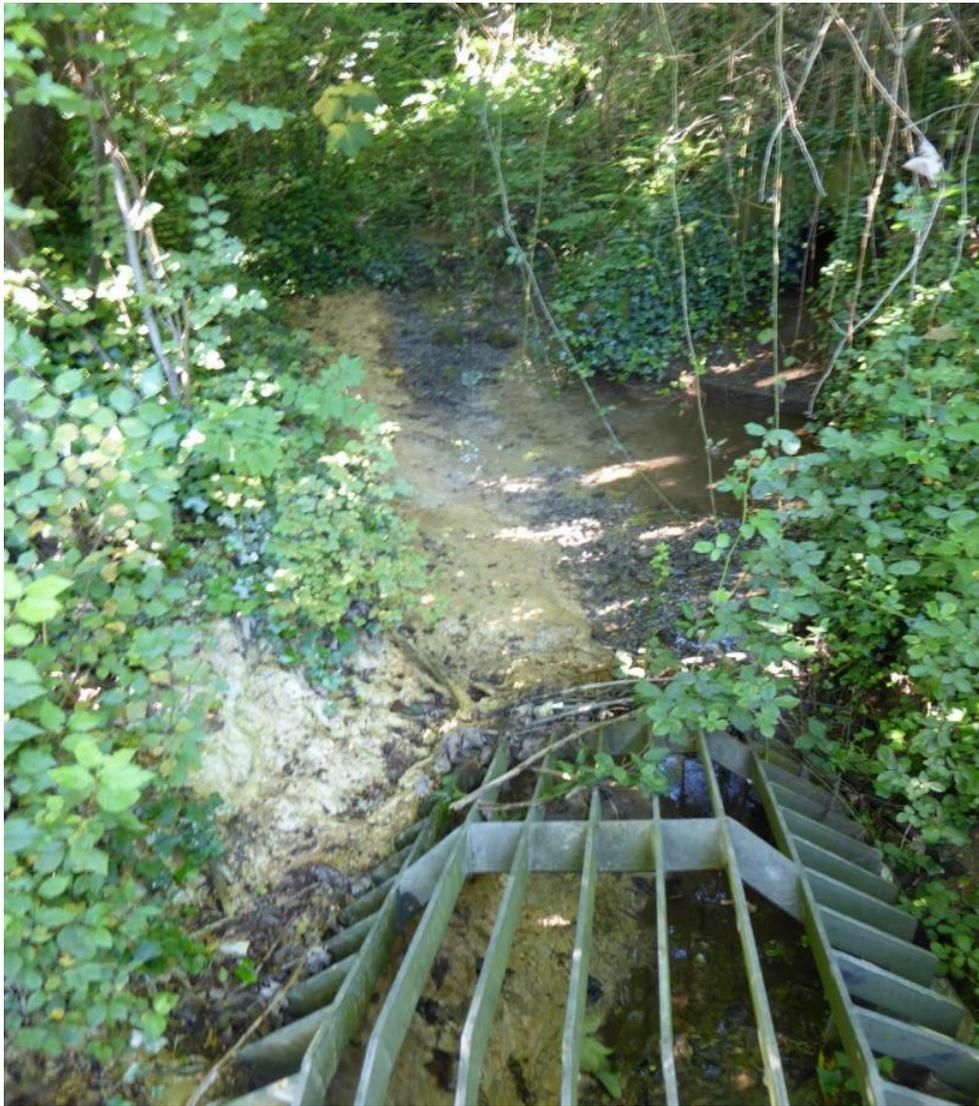
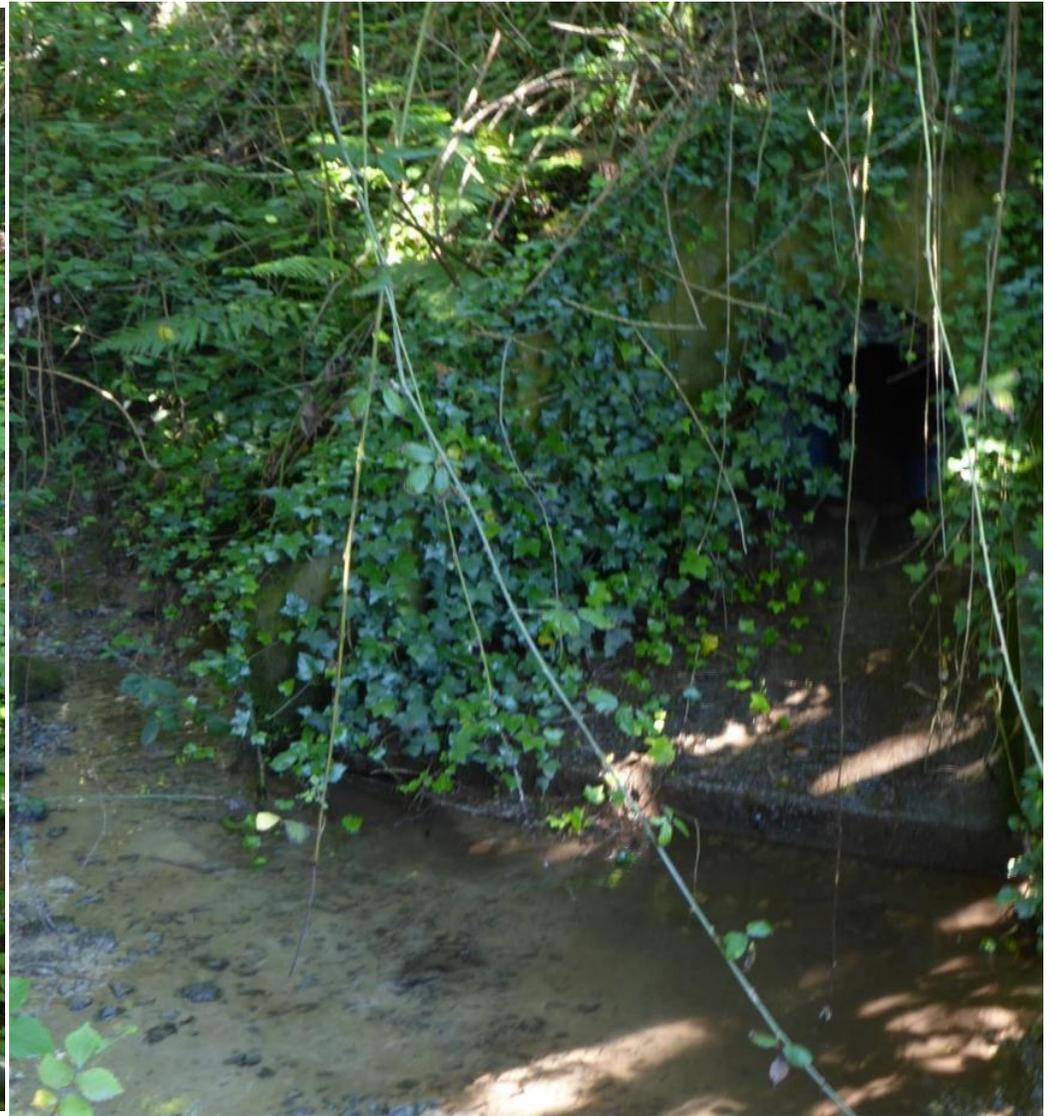
Photographic monitoring location	Date: 14 <sup>th</sup> July 2021
	Antecedent conditions: Warm and dry with occasional heavy rainfall Weather on site was warm and clear
One	Culvert containing Nant Ddu stream releasing less than ¼ l/s. Similar amount of flow along streambed. Precipitation from the east bank has continued and has started to encroach on the grated culvert.
Two	Slow trickle/ trace of flow in watercourse. Some pooling of water in places. Bits of fly tipping in stream.
Three	Some boggy/moist soil but also areas of baked/dried soil. No standing water.
Four	Standing water c.5cm deep. No flow out of depression. Live grass at base of depression indicating no prolonged flooding.
Five	Completely dry. Channel fully vegetated.
Six	Depression filled to rim with water. Duckweed established across surface of water.
Seven	Damp/moist soil. No standing water. Moist/boggy ground along outflow route.
Eight	Up to ½ l/s flow. Precipitation within culvert and on streambed. Precipitation on the concrete supporting the culvert (mainly above the outlet) indicating calcium rich water flow around the culvert.

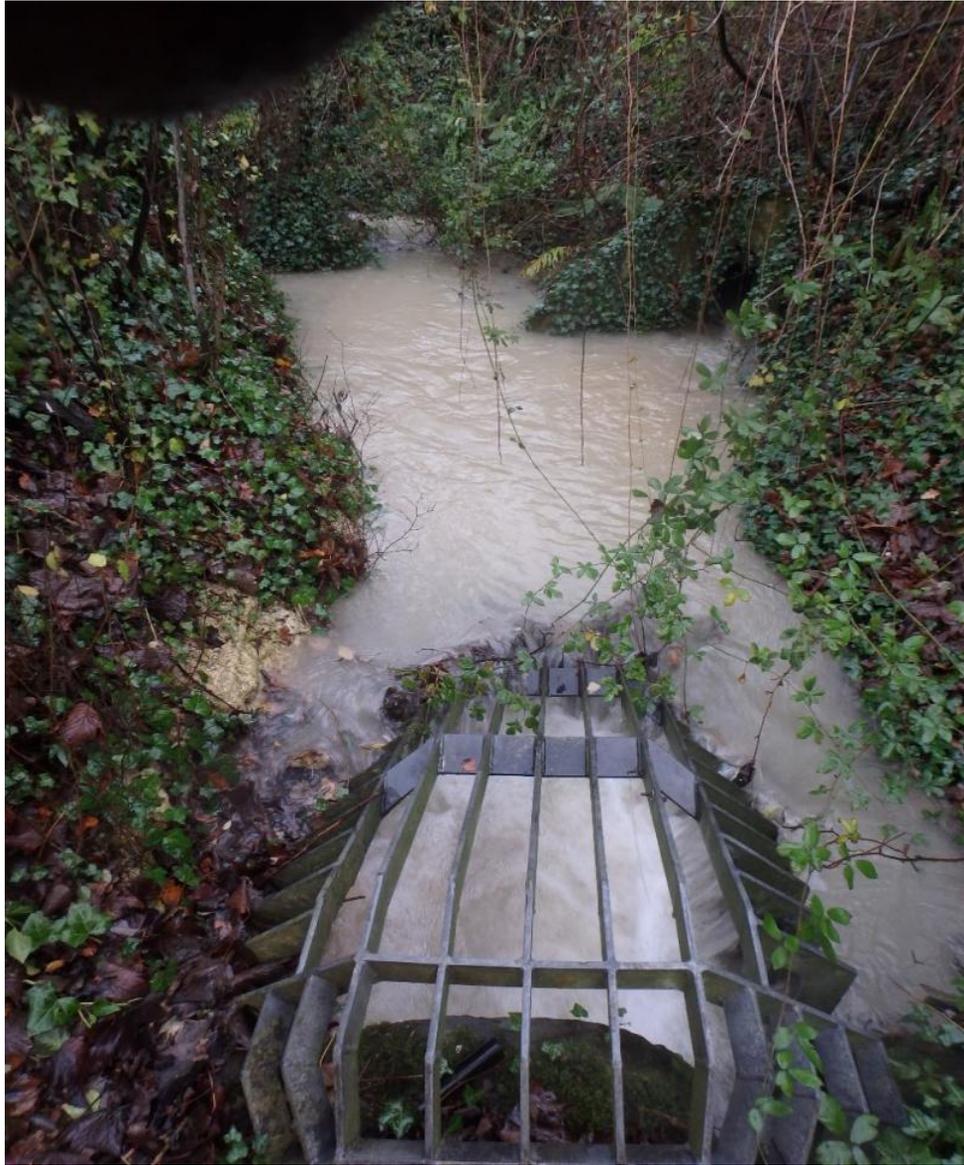
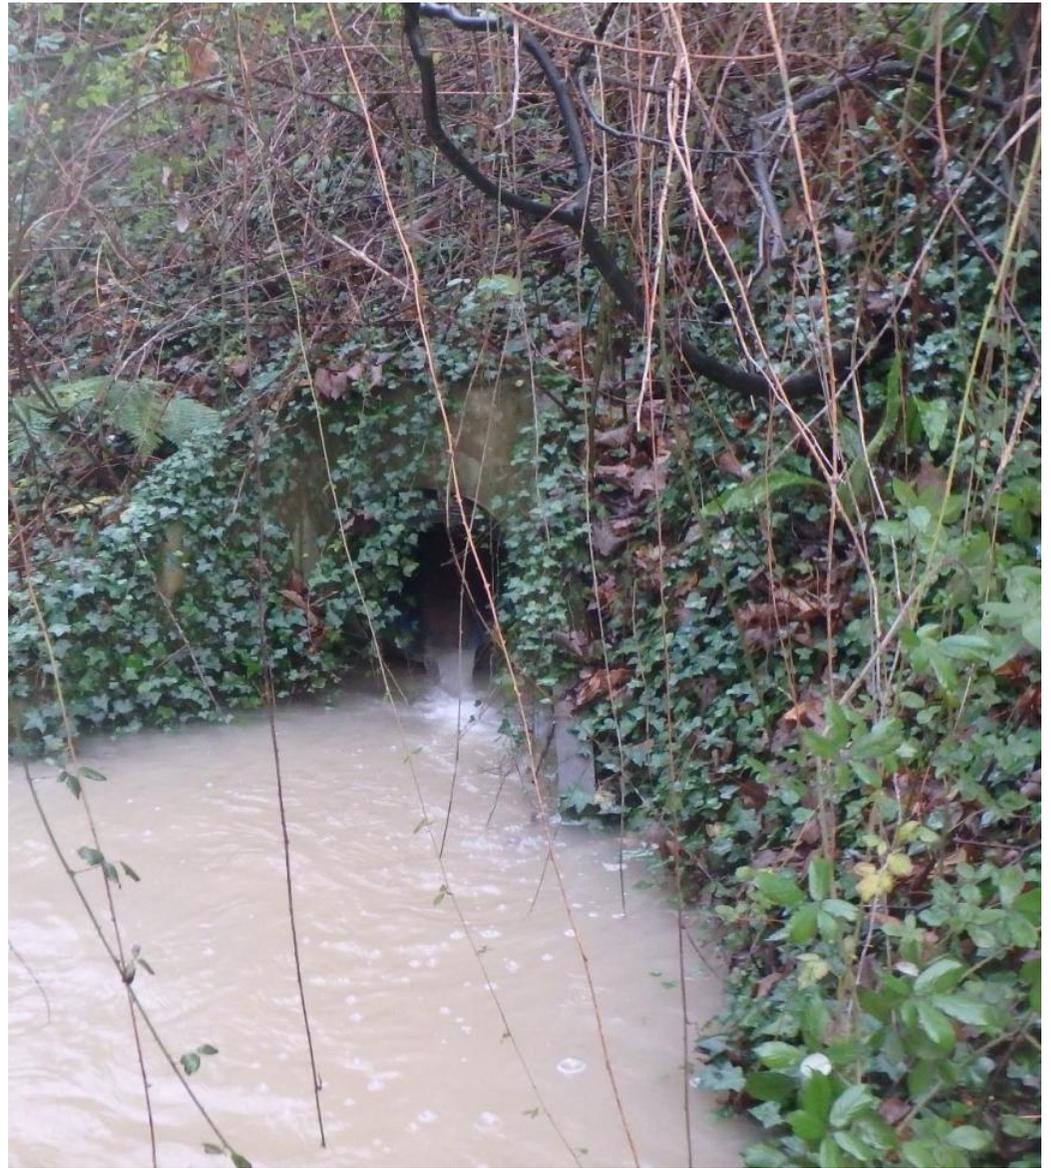
Photographic monitoring location	Date: 8 <sup>th</sup> December 2021
	Antecedent conditions: Wet and windy (Storm Barra) Weather on site rain showers and strong wind
One	Plastic culvert contributing c. 0.5 l/s flow consistently, with larger flows sloshing down culvert. Flow of c. 60 l/s through larger culvert. Water very discoloured within both the streambed and from the plastic culvert. Water depth c. 20cm. Plant debris around trash screen causing some raising of the water level.
Two	Steady flow of approximately 5l/s. Some discoloration of water.
Three	Steady flow of water of c. 2 l/s. Grass at base of channel. Water is clear.
Four	Water level at rim of depression. Flow out of depression beginning to occur. Live grass at base of depression indicating no prolonged flooding.
Five	Boggy ground and some standing water within channel. Slow flowing water towards top of channel.
Six	Depression filled to rim with water. Duckweed and grass present across waterbody. Boggy ground surrounding feature.

Seven	Single body of standing water within feature. No flow out of waterbody. Boggy ground in surrounding area.
Eight	Flow of c. 60 l/s. Water depth approximately half diameter of culvert, partly due to leaves caught within screen. Water discoloured. Fallen tree within channel downstream causing ponding, but not restricting flow.

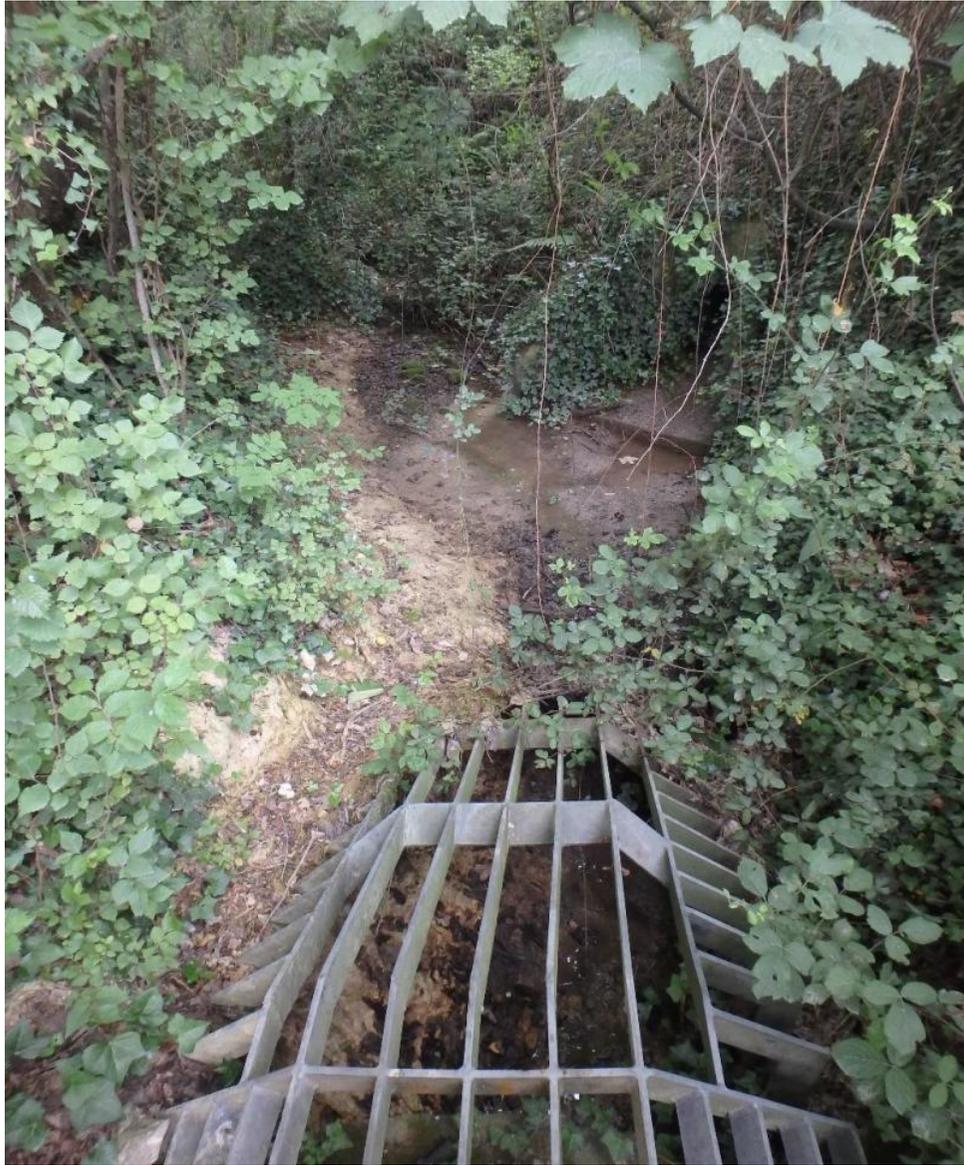
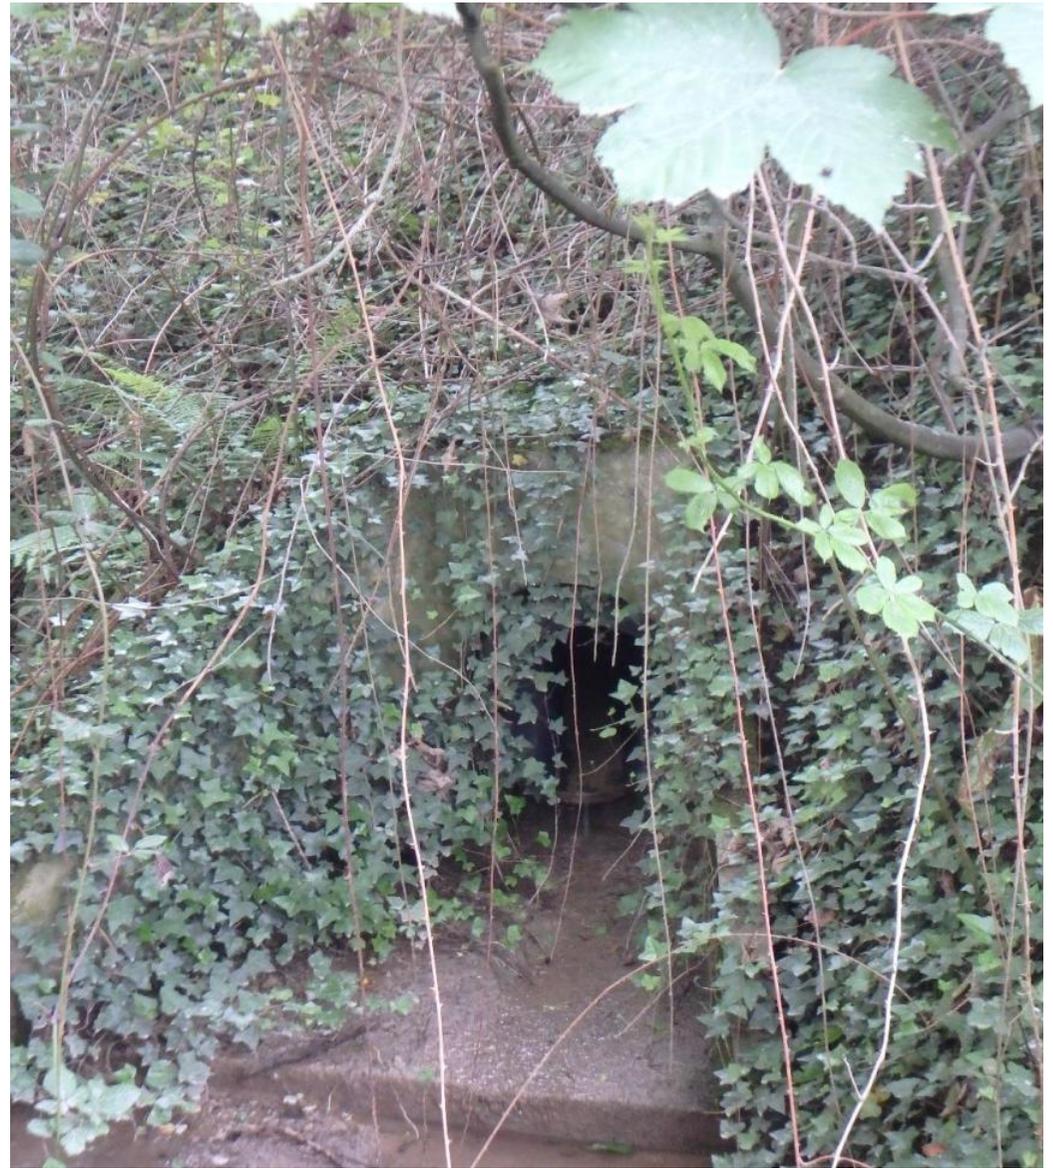
Photographic monitoring location	Date: 14 <sup>th</sup> June 2022
	Antecedent conditions: Warm and dry Weather on site was warm and overcast
One	<0.25 l/s flow. Flow equally from old course of stream and plastic culvert.
Two	Approx 0.1 l/s flow. Areas of standing water within channel. Soil within channel saturated.
Three	Densely vegetated with grass. Soil saturated at base. No flowing water.
Four	No water within depression. Feature completely covered in grass.
Five	Channel vegetated. No running water and soil within channel dry.
Six	Standing water approx. 10 – 20 cm deep.
Seven	Some small areas of standing water and saturated soils.
Eight	<0.25 l/s flow. Carbonate being deposited at base of channel.

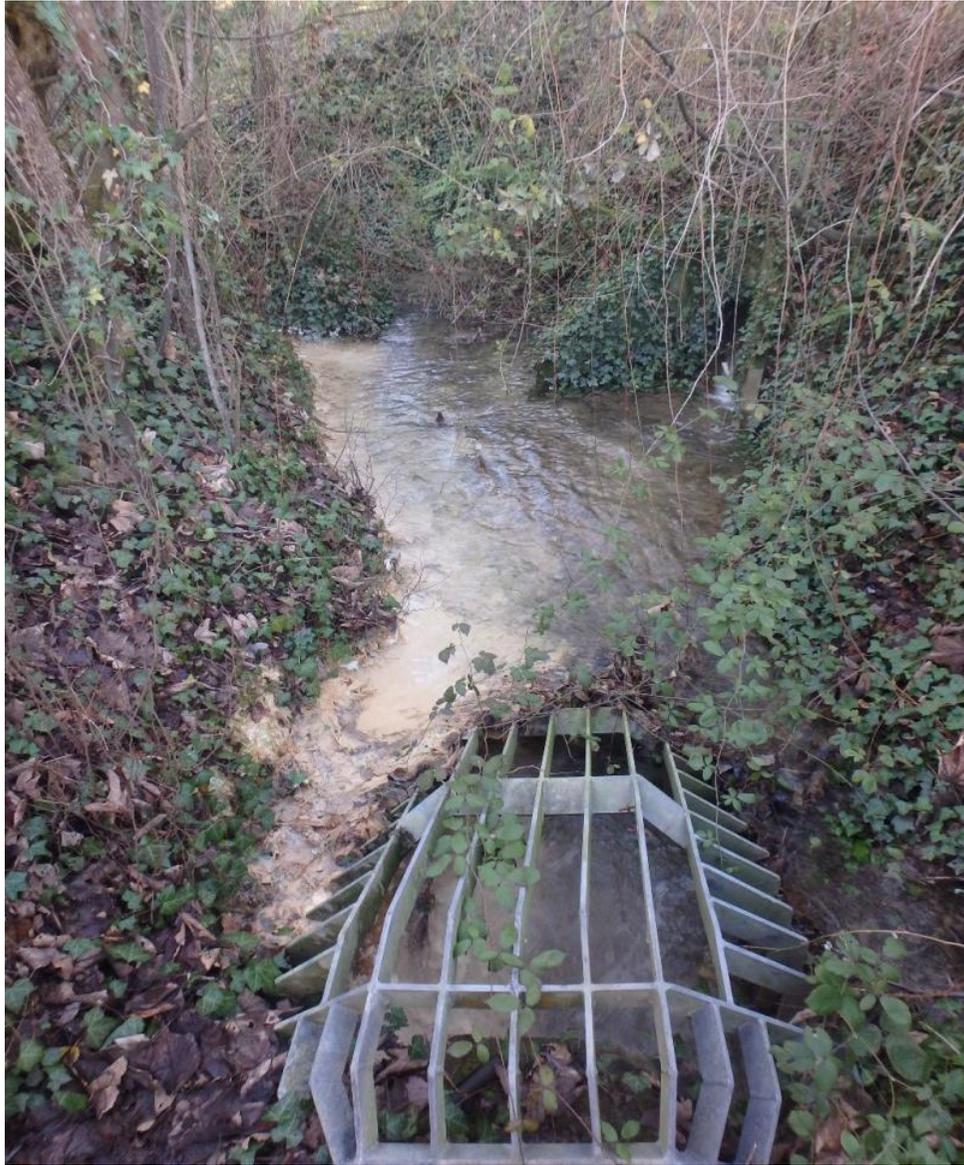
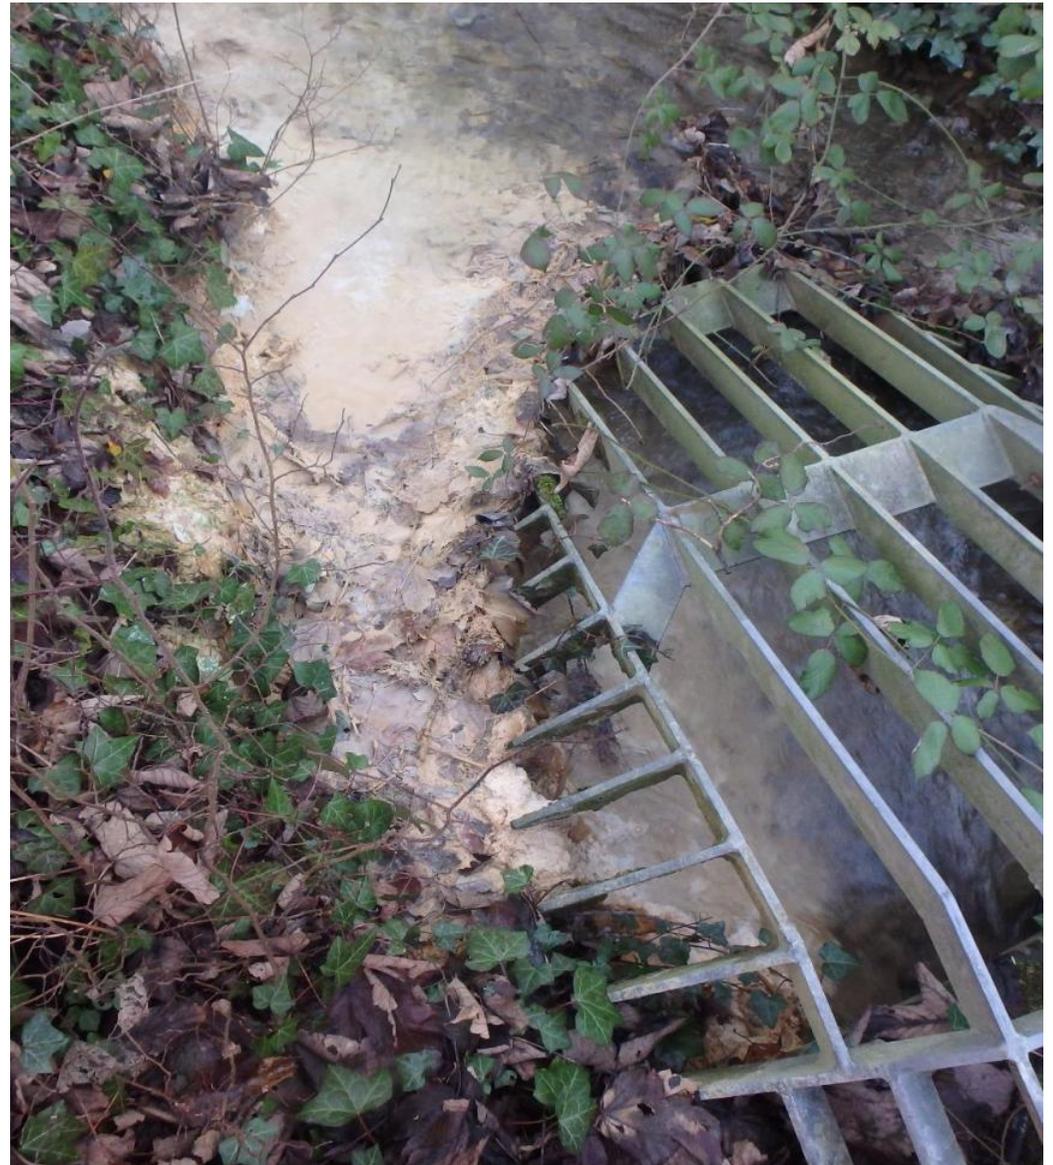
Photographic monitoring location	Date: 16 <sup>th</sup> January 2023
	Antecedent conditions: Cold and dry with occasional heavy rainfall Weather on site was cold and dry
One	Culvert containing Nant Ddu stream releasing approximately 3 l/s. Flow estimated at 10 l/s along streambed. Precipitation from the east bank has continued and has started to encroach on the grated culvert. This created a damming effect with water pooling behind the eastern side and passing through the culvert via the western bank.
Two	A continuous gentle flow in the watercourse, approximately 1 m/s. Bits of fly tipping in across the bank and in the stream.
Three	Continuous flow of clear water. Vegetation debris occupying areas of the channel.
Four	Standing water occupying the capacity of the waterbody. No flow out of depression. Small areas of standing water in the wider vicinity, with much of the soil saturated across the field.

Five	Completely dry. Channel fully vegetated.
Six	Depression filled to rim with water. Surrounding areas very wet under foot.
Seven	Some standing water within the spring, saturated soil in the outflow route. No overflowing water.
Eight	Up to 15 l/s flow. Precipitation within culvert and on streambed. Channel looks like it has been cleared near to the culvert. Water flow was clear. Precipitation on the concrete supporting the culvert (mainly above the outlet) indicating calcium rich water flow around the culvert.

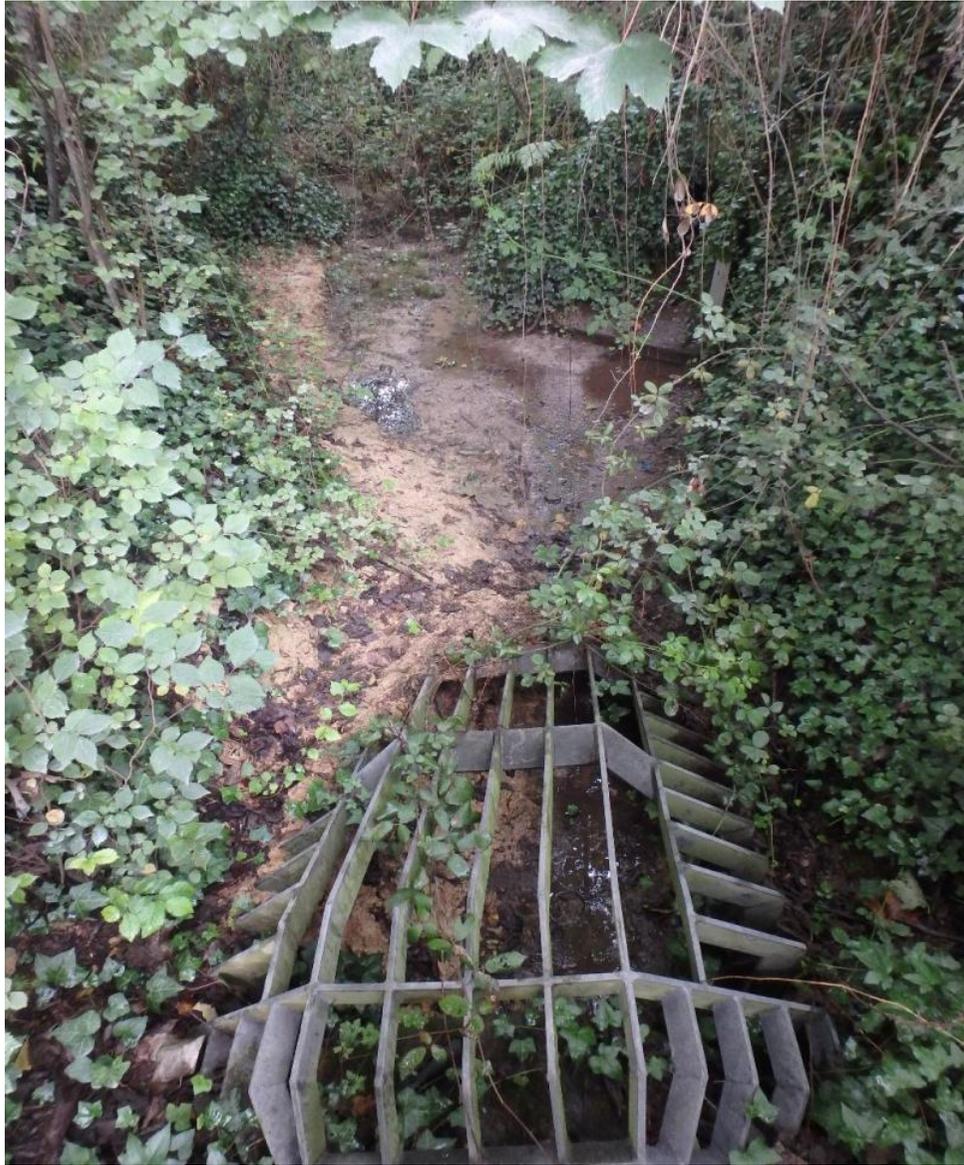
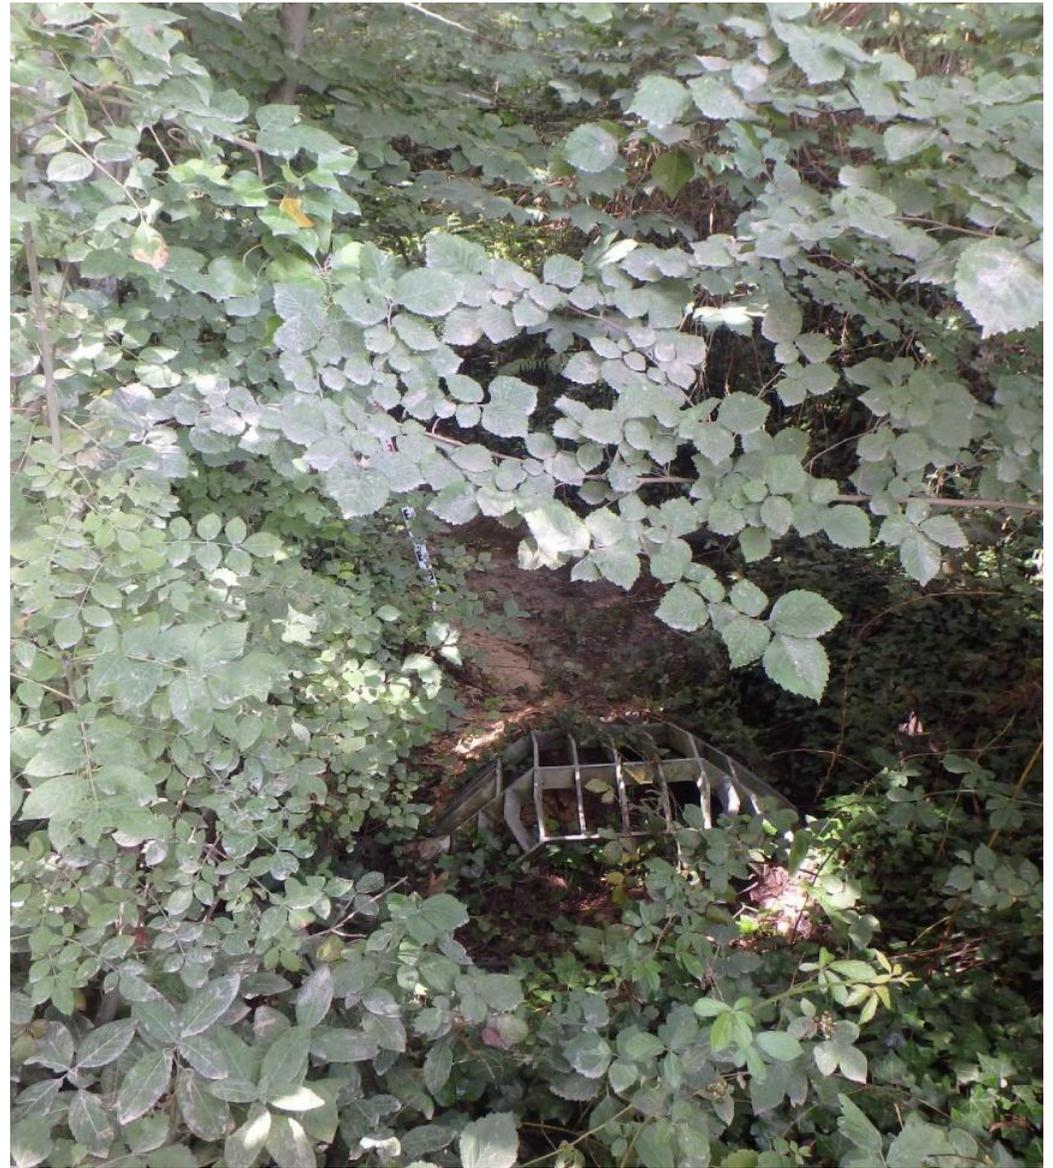
Photographic monitoring location	Date: 19 <sup>th</sup> July 2023
	Antecedent conditions: Warm and dry with strong downpours Weather on site was warm and overcast, gradually clearing
One	Culvert containing Nant Ddu stream discharging approximately 0.25 l/s. No other flow into streambed. Soils deposited along western side of channel likely due to runoff from fields adjacent to Nant Ddu Road discharging through culvert. Lime material from east bank forming 'cake' on trash screen – appears to have been in place since Jan 23 visit.
Two	No continuous flow or standing water. Sediment in riverbed is saturated. Channel overgrown.
Three	No running or standing water. Bed is dry and grassed over.
Four	Depression is predominantly dry and grassed. Very small area of standing water at edge, likely due to ponding of rainwater due to intensity of antecedent storms.
Five	Completely dry. Channel fully vegetated.

Six	Depression partly filled with water covered by duckweed. Surrounding soil saturated.
Seven	Soils in area saturated, but no standing water present.
Eight	Approximately 0.25l/s flow. Channel is very overgrown, with lime rich material deposited on riverbed. Material is present to approximately 2m into the culvert.

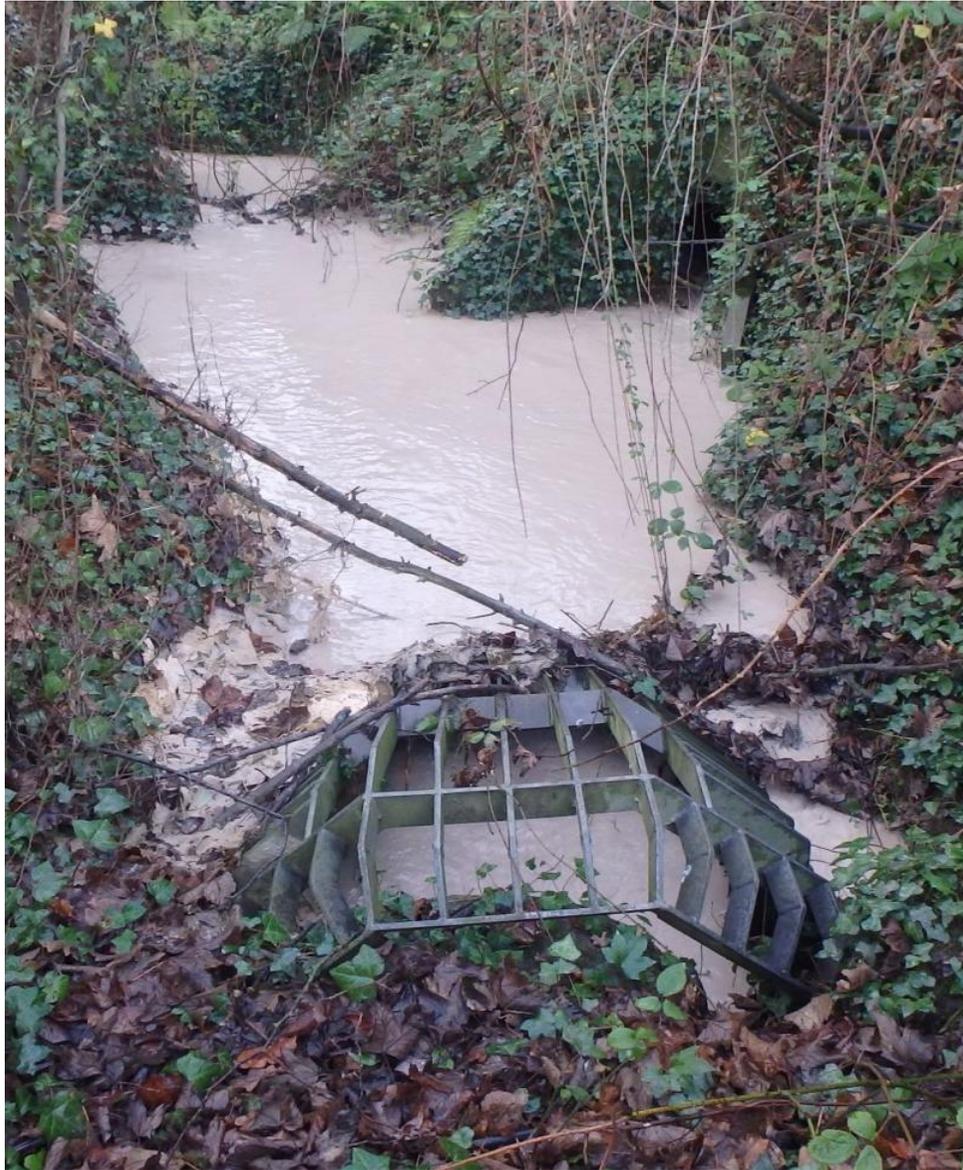
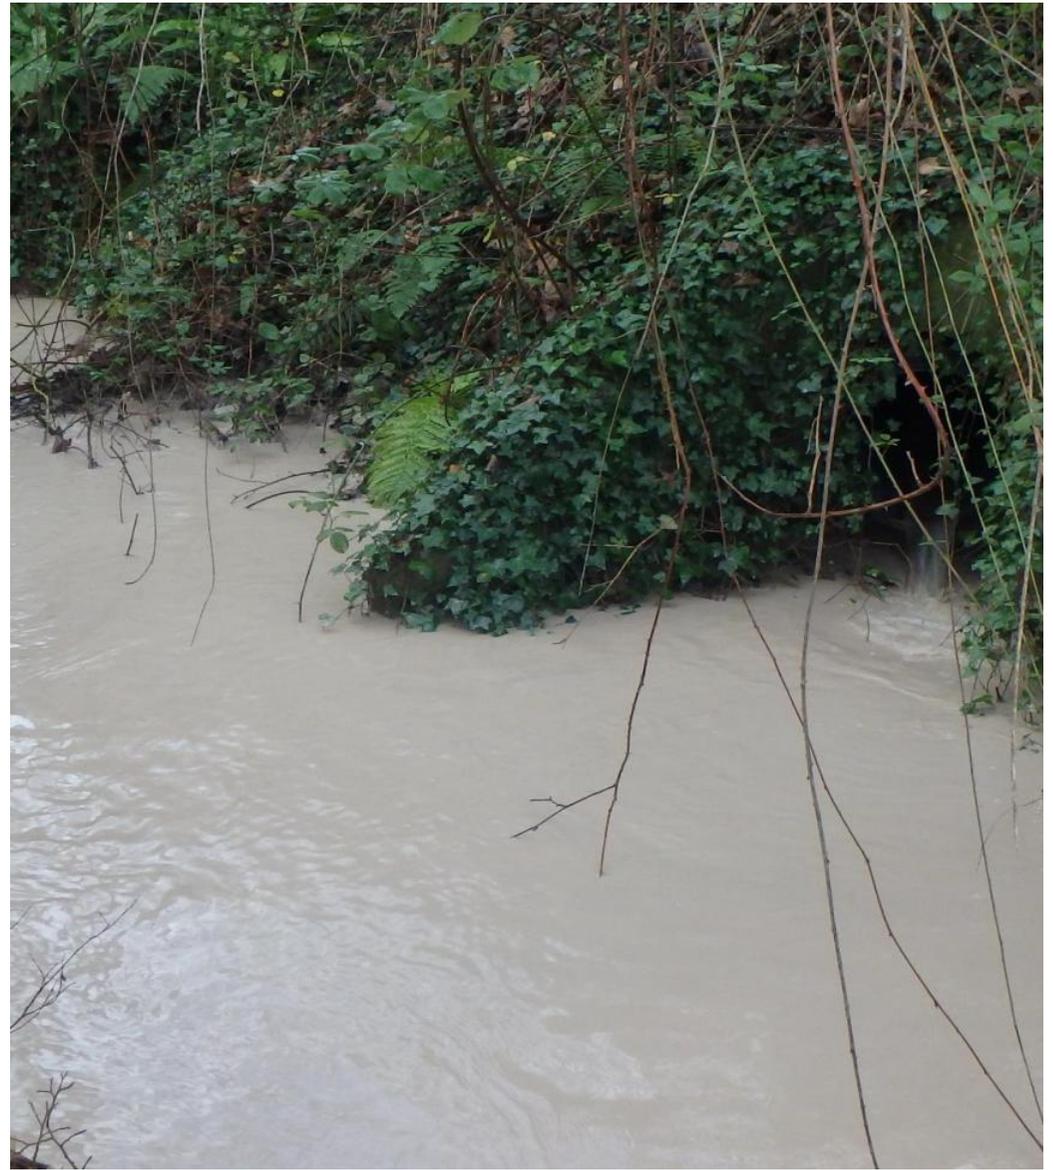
Photographic monitoring location	Date: 21 <sup>st</sup> December 2023
	Antecedent conditions: Cold and strong winds with spells of heavy rainfall
One	Culvert containing Nant Ddu stream releasing approximately 2 l/s. Flow estimated at 10 l/s along streambed. Precipitation from the east bank has continued and has started to encroach on the grated culvert. This created a damming effect with water pooling behind the eastern side and passing through the culvert via the western bank.
Two	A continuous gentle flow in the watercourse. Bits of fly tipping across the bank and in the stream.
Three	Continuous flow of clear water. Vegetation debris occupying areas of the channel.
Four	Standing water occupying the capacity of the waterbody. No flow out of depression. Small areas of standing water in the wider vicinity, with much of the soil saturated across the field.
Five	Completely dry. Channel fully vegetated.

Six	Depression filled to rim with water. Surrounding areas very wet under foot.
Seven	Some standing water within the spring, saturated soil in the outflow route. No overflowing water.
Eight	Up to 15 l/s flow. Precipitation within culvert and on streambed. Vegetation debris surrounding culvert casing. Water flow was cloudy. Precipitation on the concrete supporting the culvert (mainly above the outlet) indicating calcium rich water flow around the culvert.
