**TRANSFER LICENCE**

**ABERGELE QUARRY**

**Supporting information 3047/TL  
April 2024**

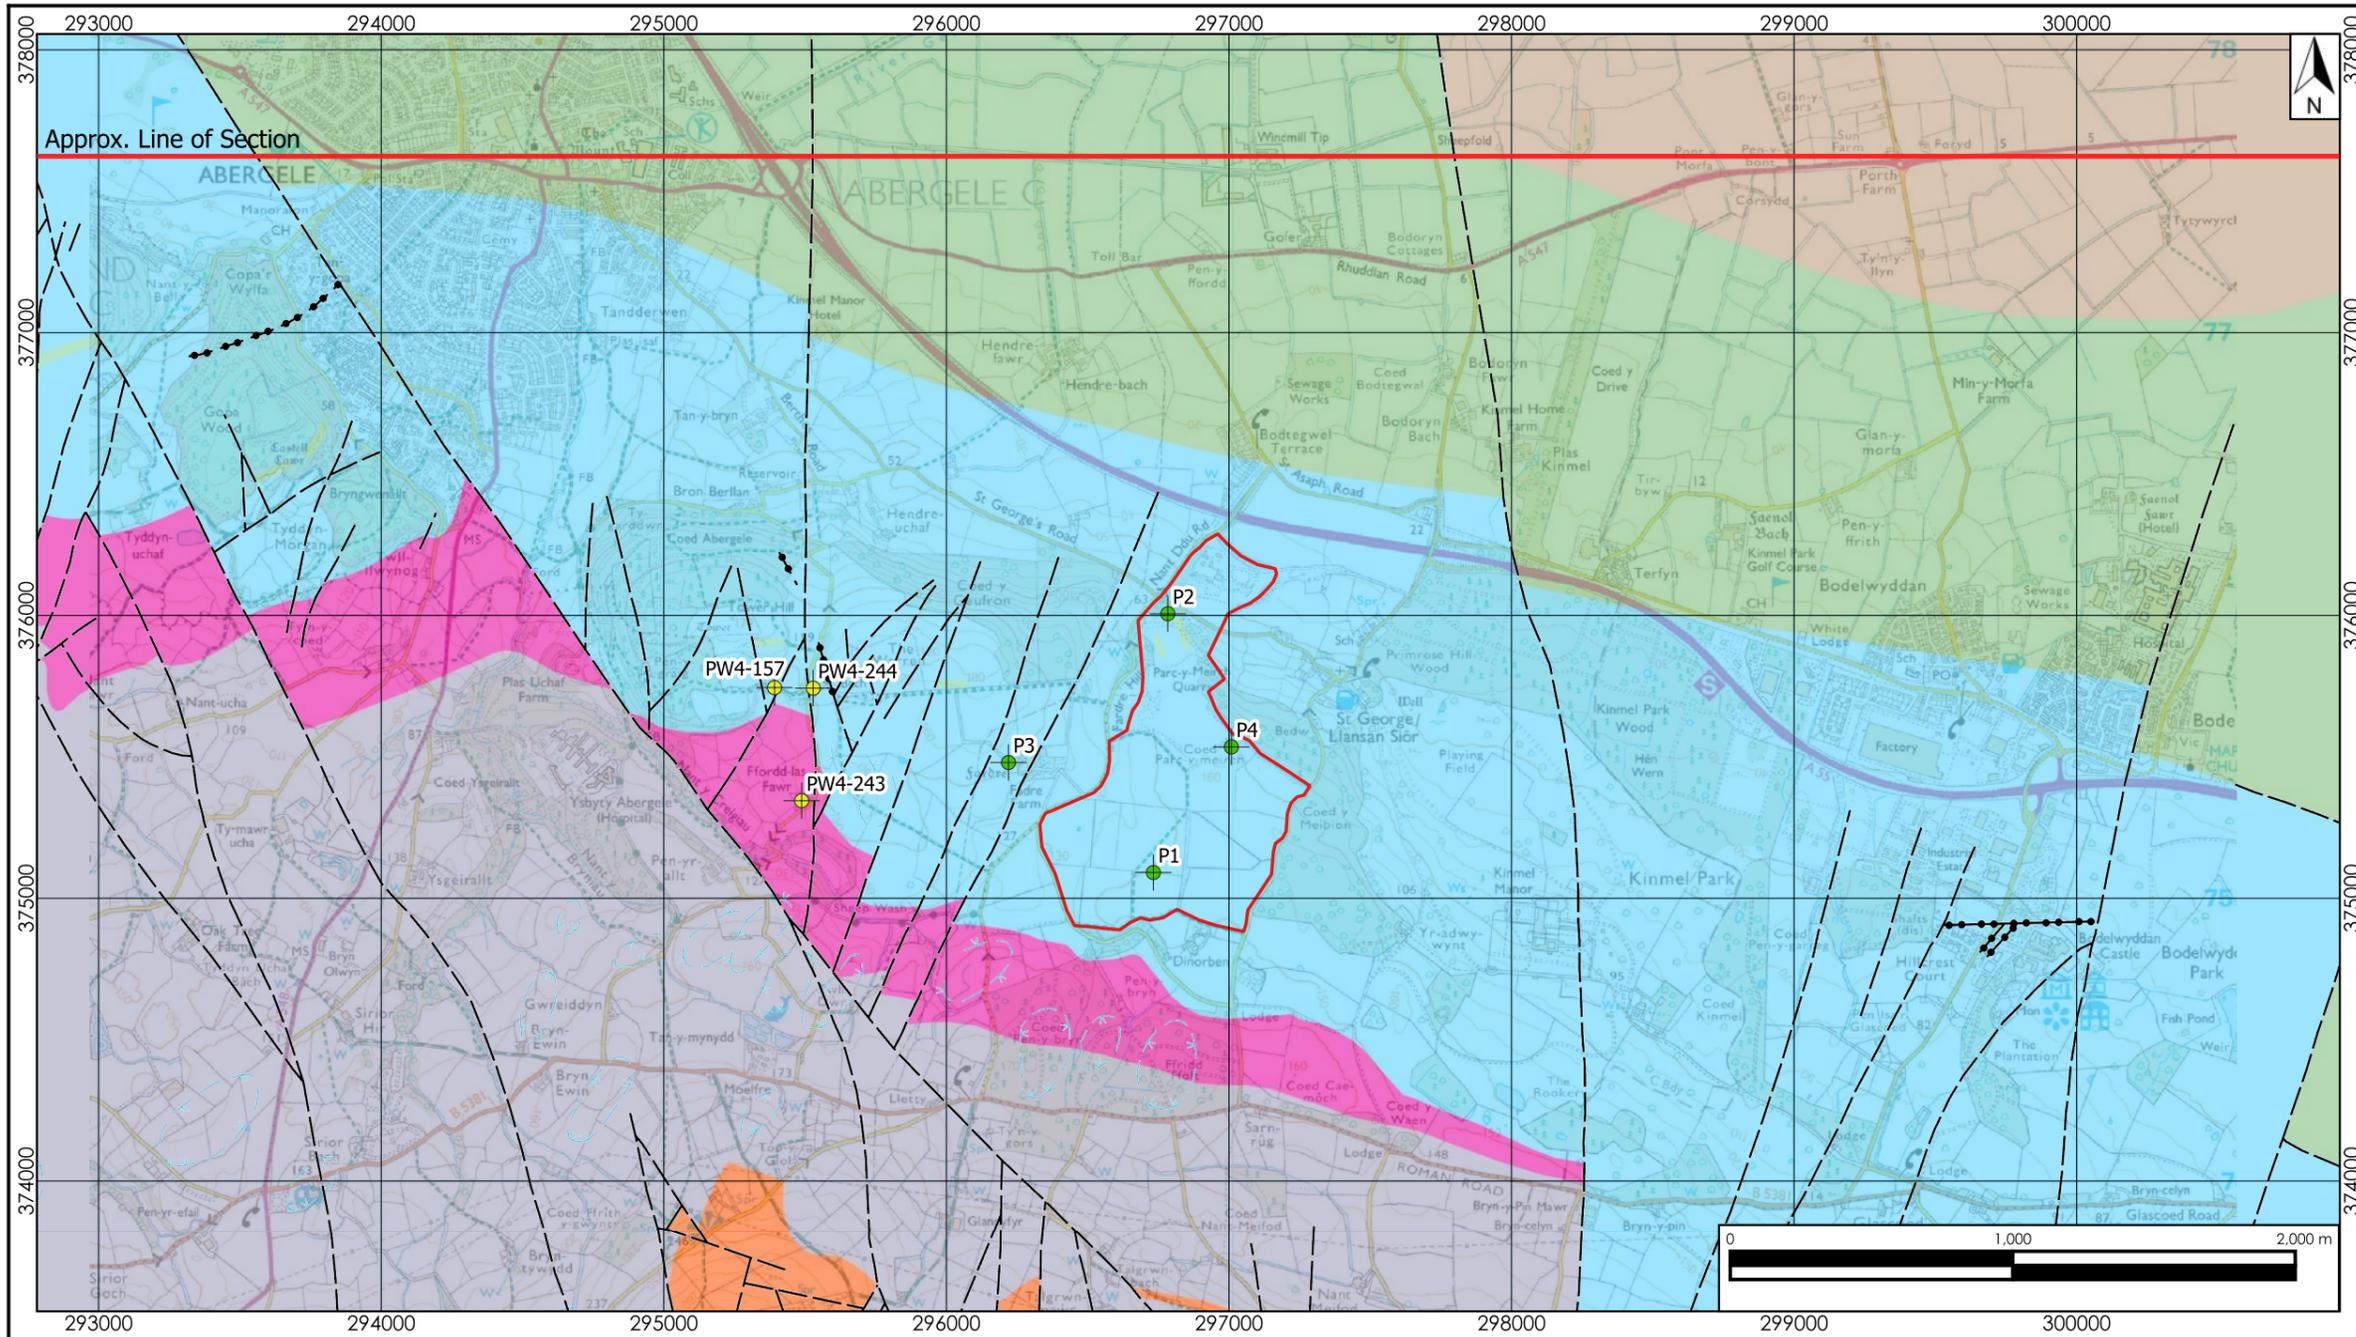
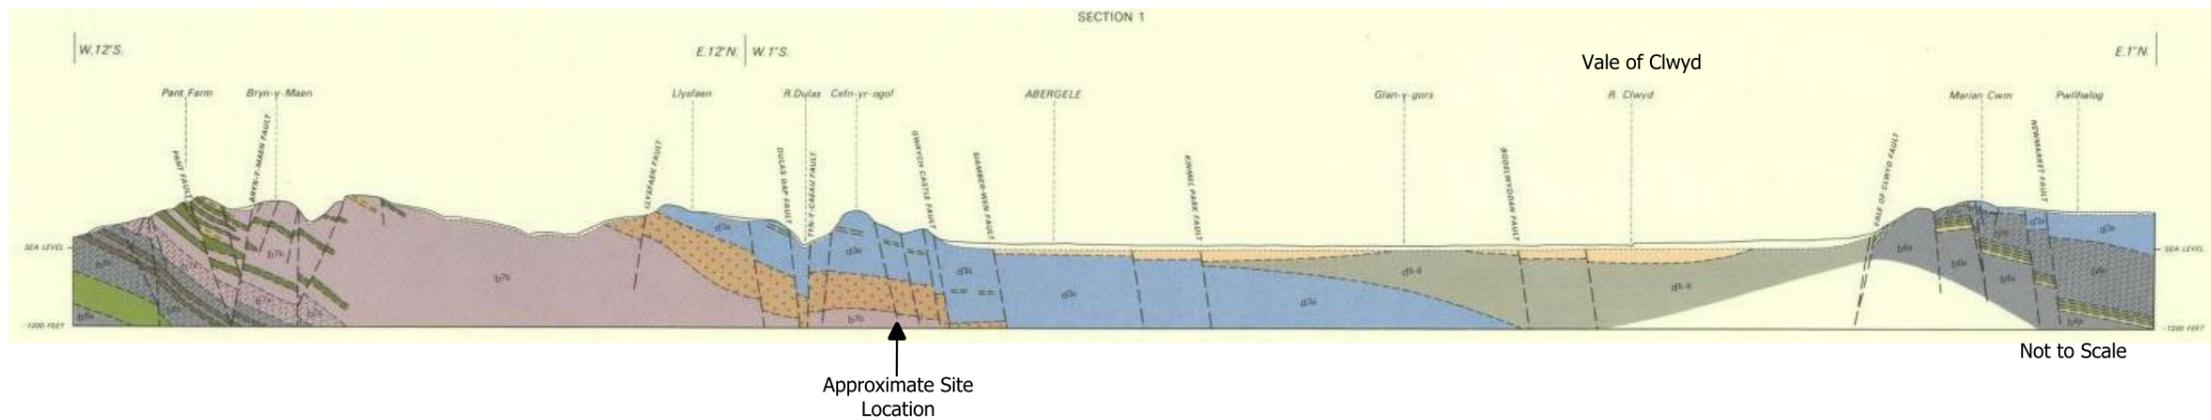
**Cross Section Key**

- d5-6 - Coal Measures
- d3a - Clwyd Limestone Group
- b7a - Elwy Formation
- b6a - Denbigh Grits Formation

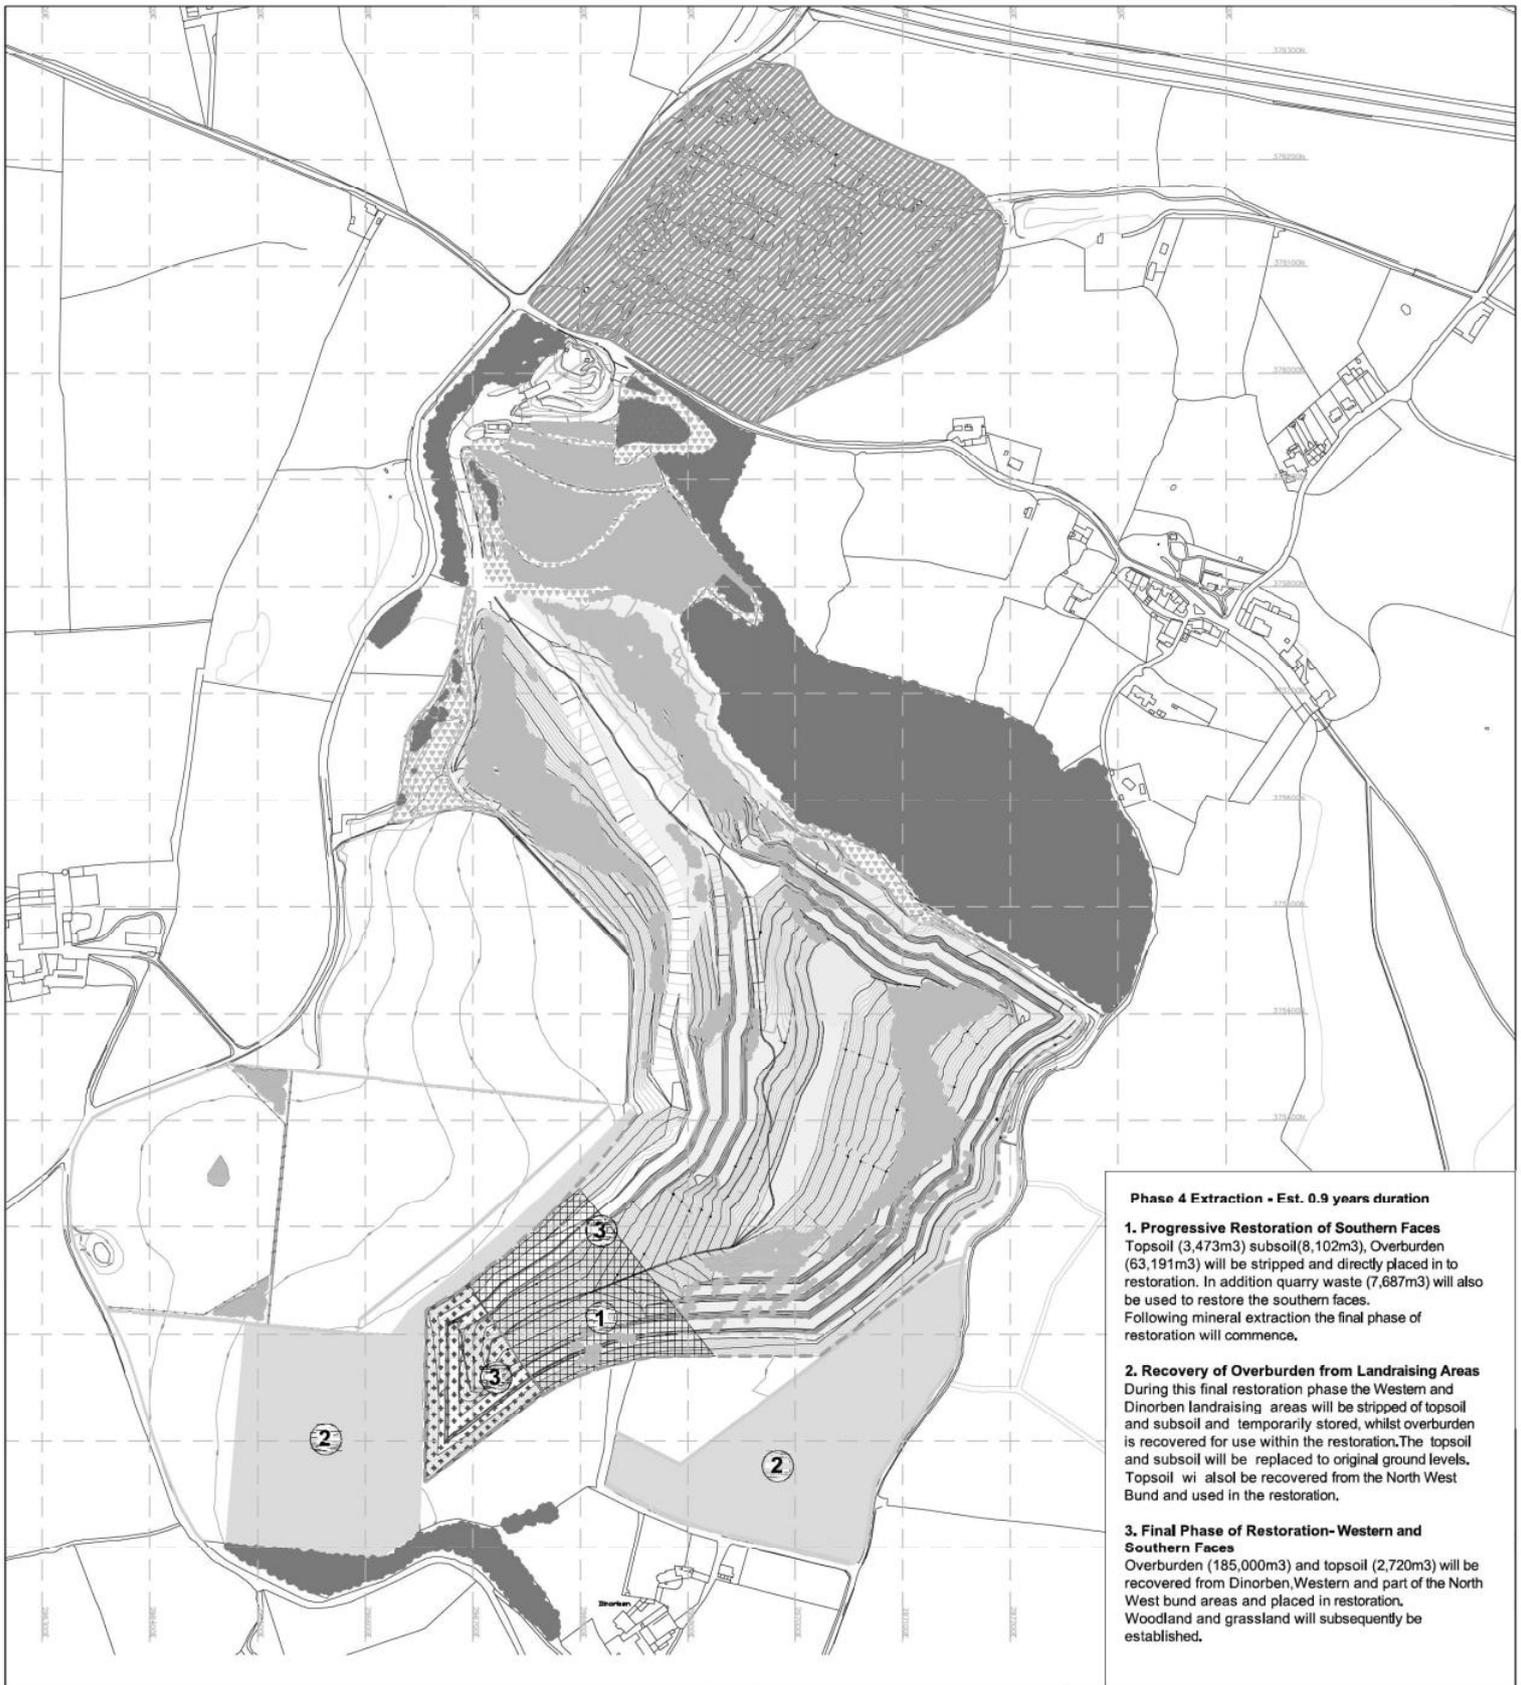
**APPENDIX 3047/HIA/A2**  
**Updated Working & Restoration Phase 2**

**Phase 4 Extraction - Est. 0.9 years duration**

**1. Progressive Restoration of Southern Faces**  
 Topsoil (3,473m<sup>3</sup>) subsoil(8,102m<sup>3</sup>), Overburden (63,191m<sup>3</sup>) will be stripped and directly placed in to restoration. In addition quarry waste (7,687m<sup>3</sup>) will also be used to restore the southern faces. Following mineral extraction the final phase of restoration will commence.

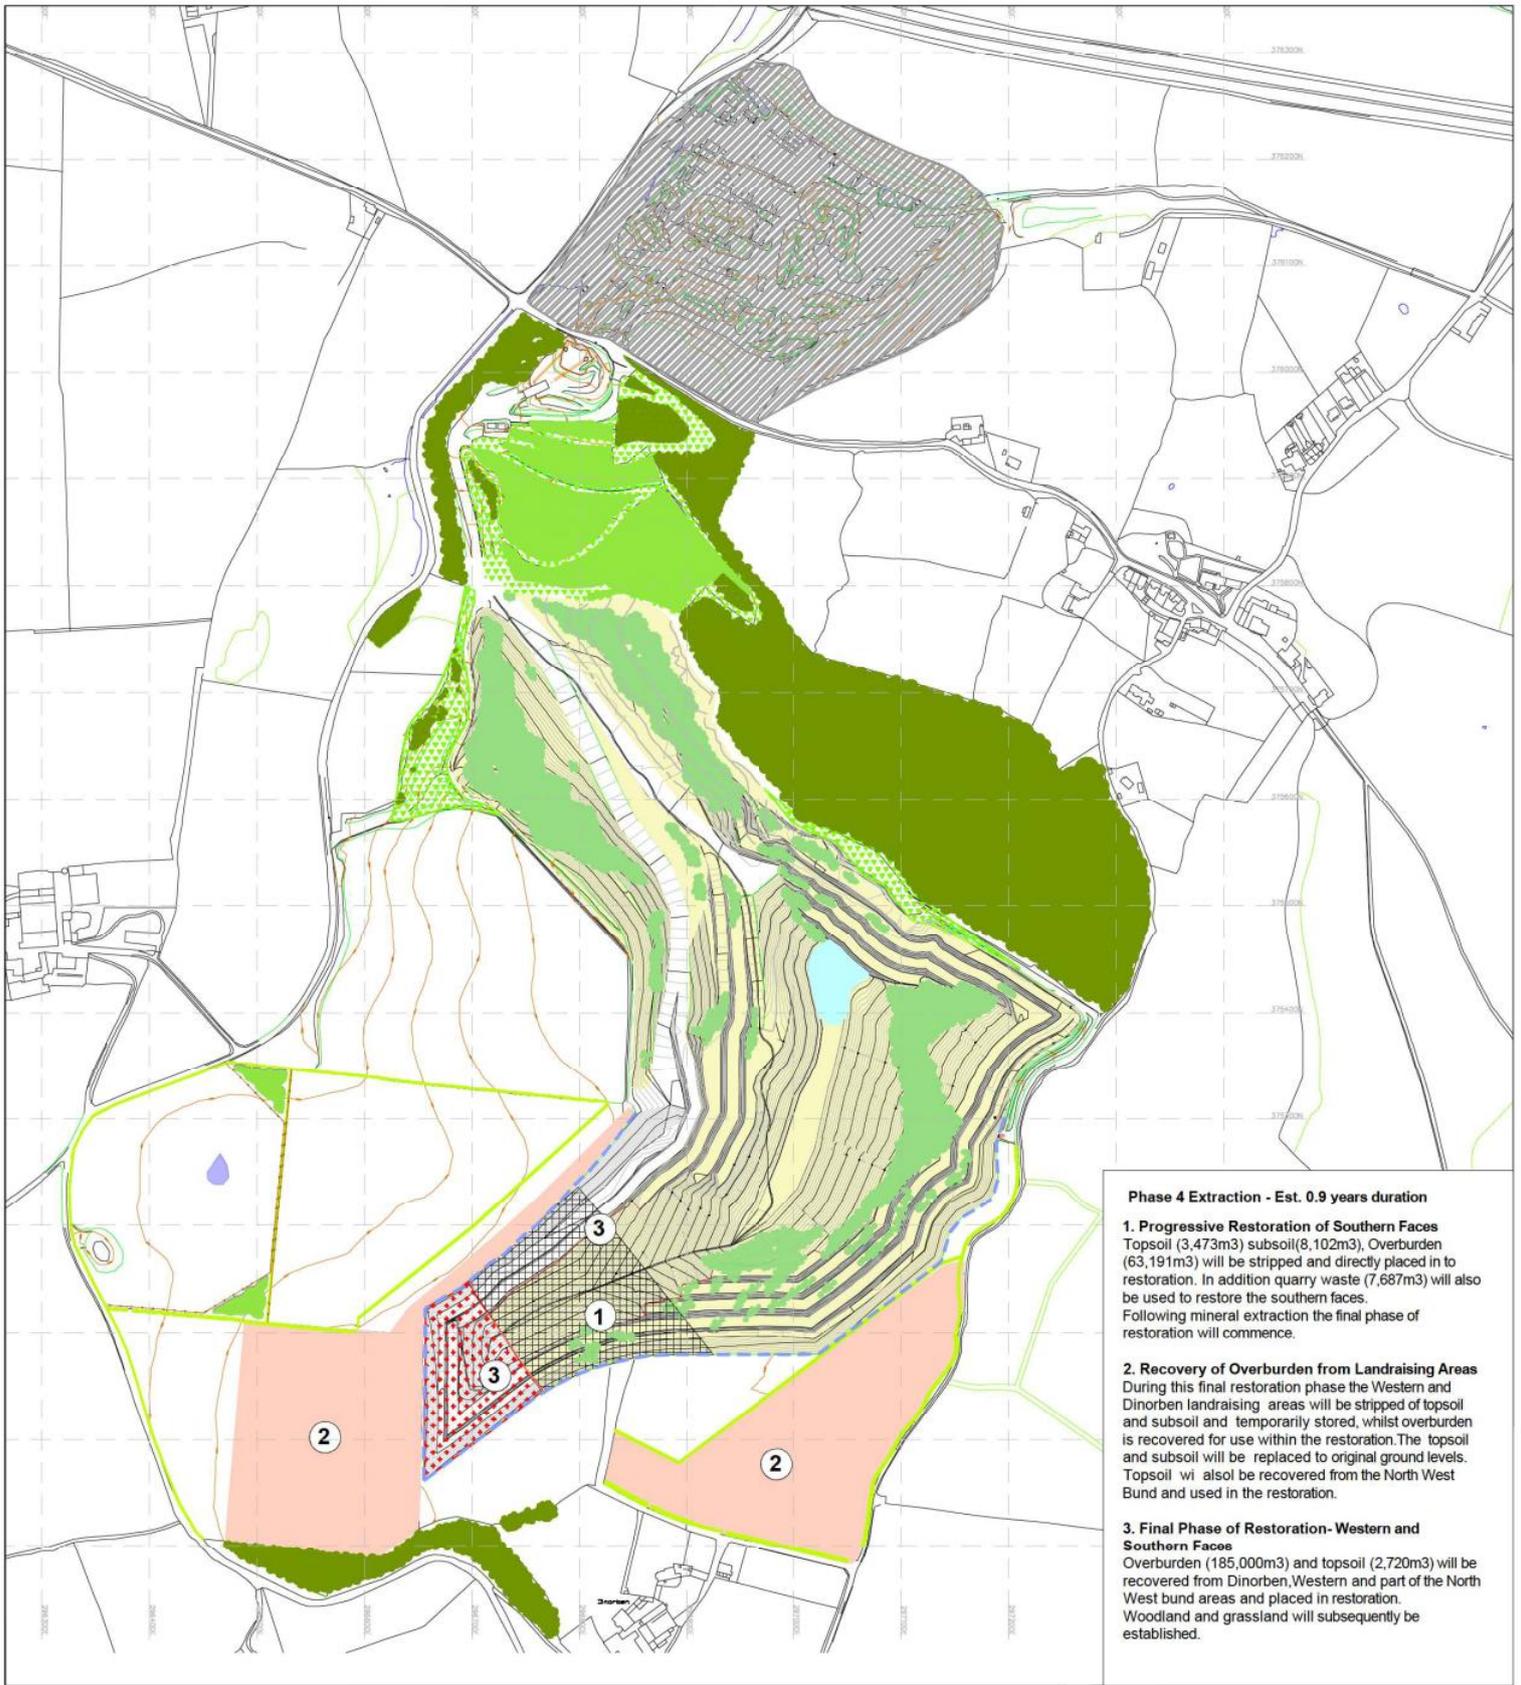
**APPENDIX 3047/HIA/A3**  
**Updated Working & Restoration Phase 4**

**Phase 4 Extraction - Est. 0.9 years duration**

**1. Progressive Restoration of Southern Faces**  
 Topsoil (3,473m<sup>3</sup>) subsoil(8,102m<sup>3</sup>), Overburden (63,191m<sup>3</sup>) will be stripped and directly placed in to restoration. In addition quarry waste (7,687m<sup>3</sup>) will also be used to restore the southern faces. Following mineral extraction the final phase of restoration will commence.

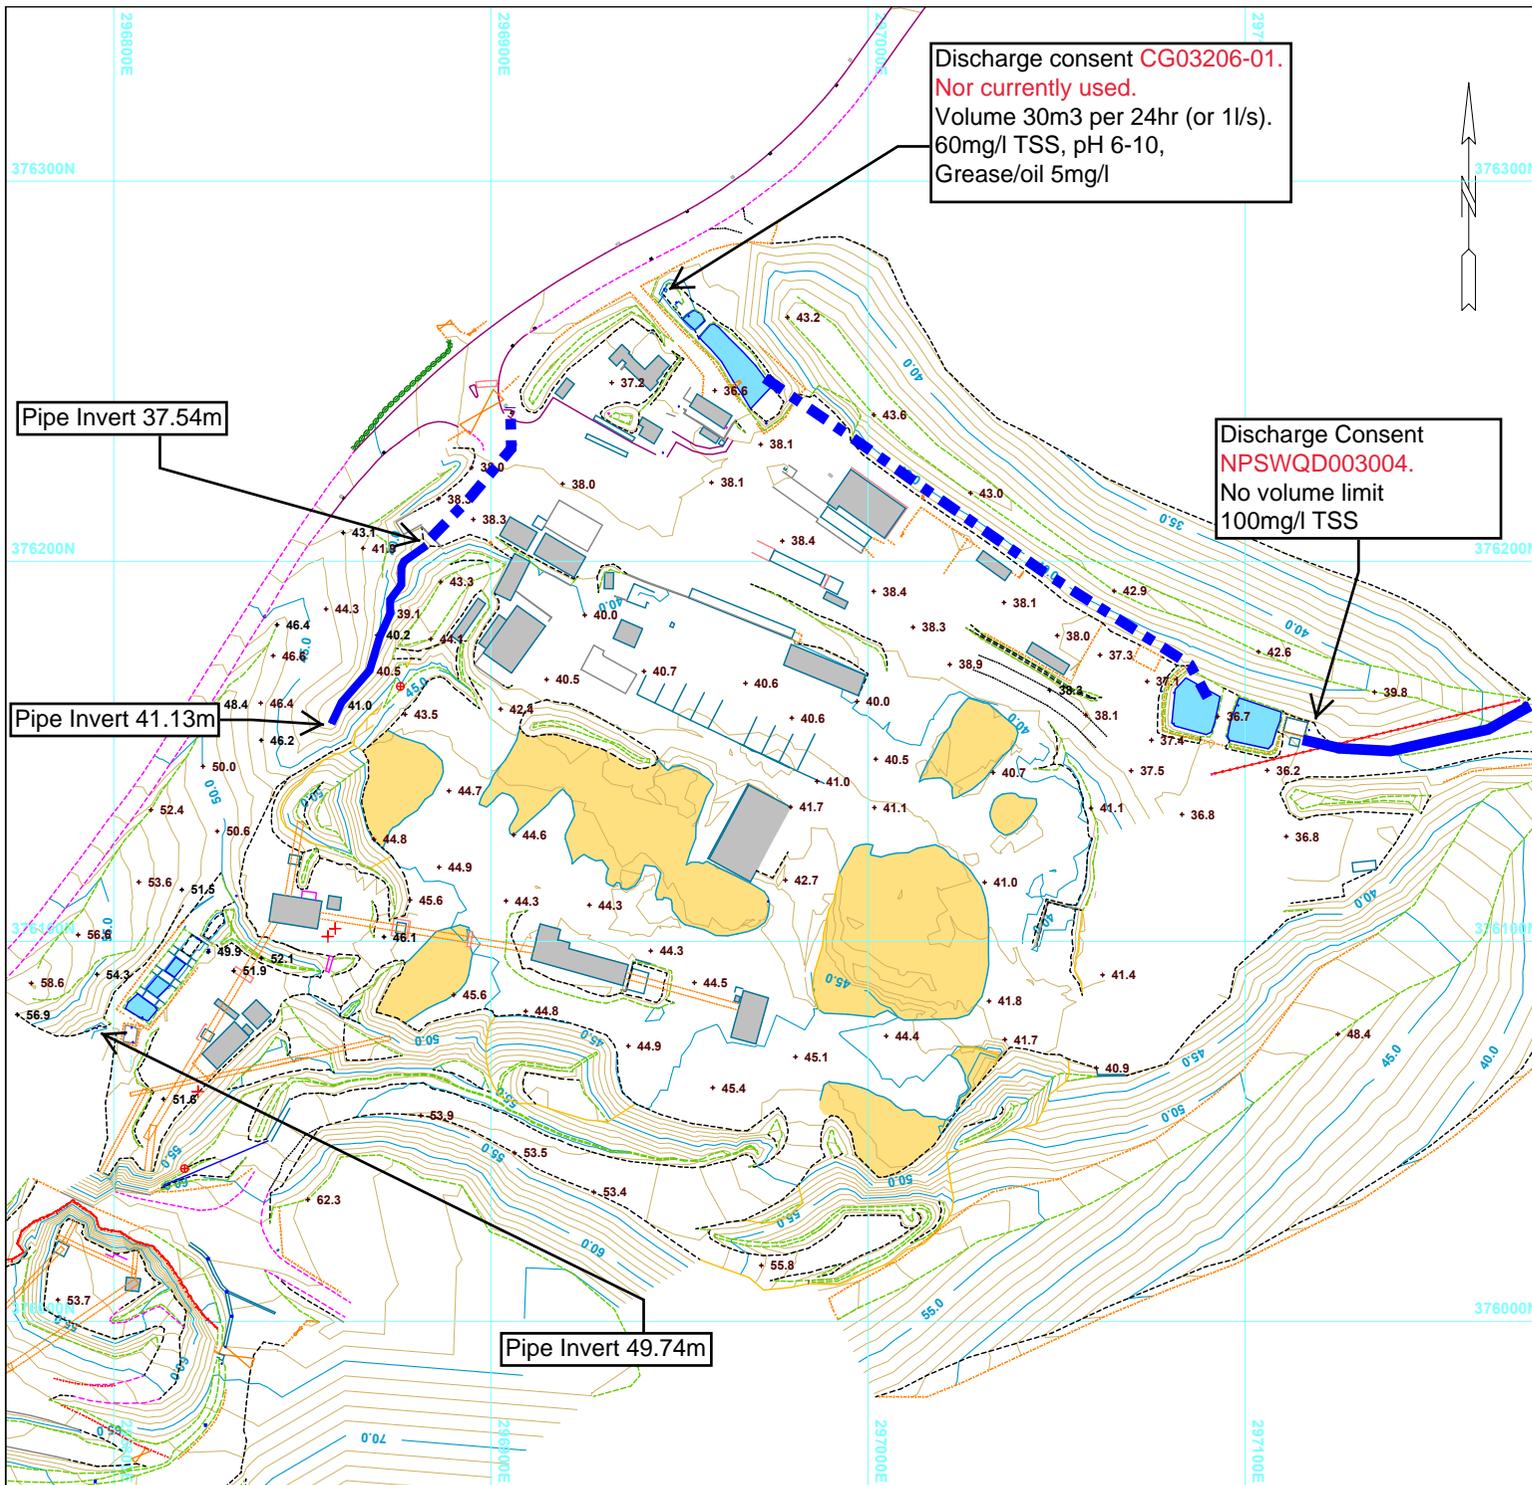
**Water management**

Discharge consent **CG03206-01**.  
 Not currently used.  
 Volume 30m<sup>3</sup> per 24hr (or 1l/s).  
 60mg/l TSS, pH 6-10,  
 Grease/oil 5mg/l

Discharge Consent  
**NPSWQD003004**.  
 No volume limit  
 100mg/l TSS
