Pengarnddu Industrial Estate Transfer Station

Report No: CRM.0127.001.PE.R.006

## Operational Techniques and Monitoring Plan

*Volume 1 - Environmental Assessment Report*

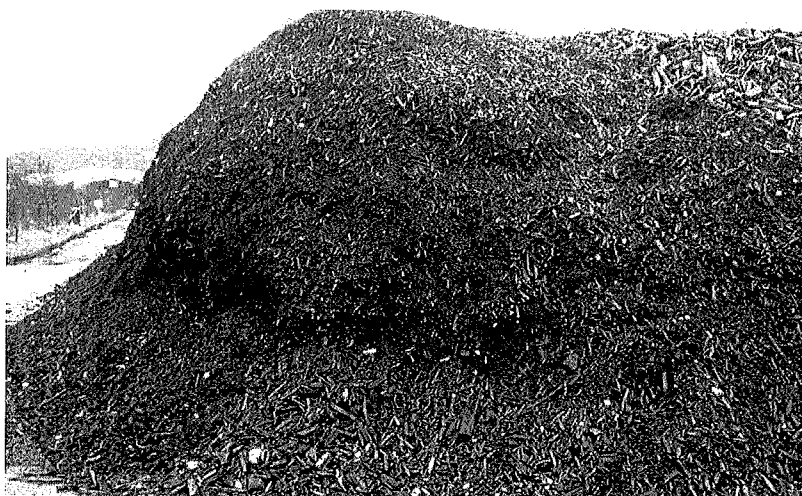
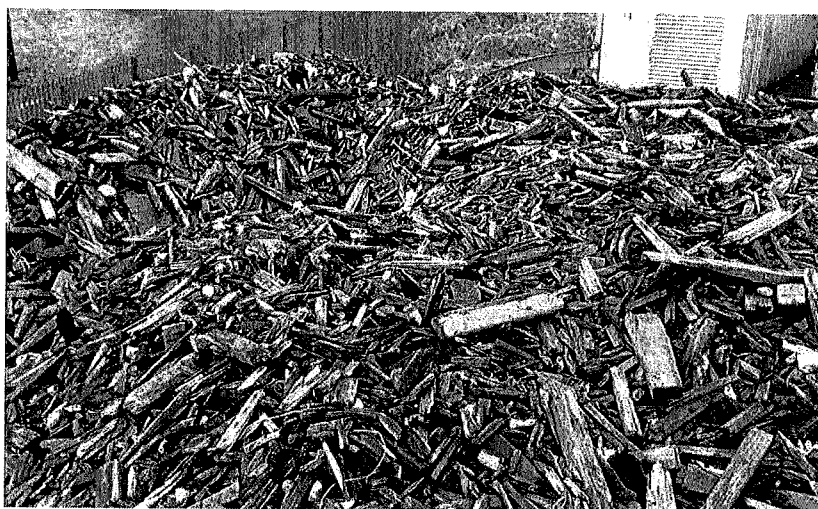
4.3.3 **Stockpile 1** appears to have been placed more recently against the chipped / screened material of Stockpile 2 and appears to represent the previously identified screened oversize wood. The material comprised broken pieces of timber, from approximately 700mm long down to 50mm long, with occasional pieces of plastic, metal and brick. The timber was noted to contain nails and was previously noted to include pieces of tannellised timber.

4.3.4 Stockpile 1 has been assessed to comprise a volume of approximately 572m<sup>3</sup>. The percentages of the different fractions from a random sample of the stockpile are summarised below in tabular and graphical form:

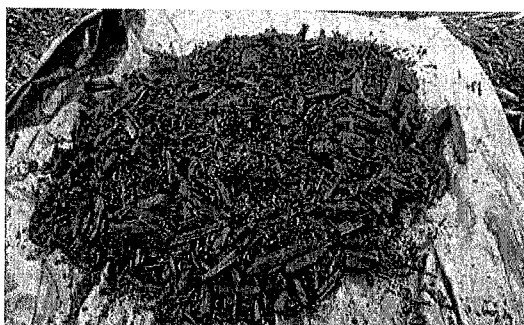
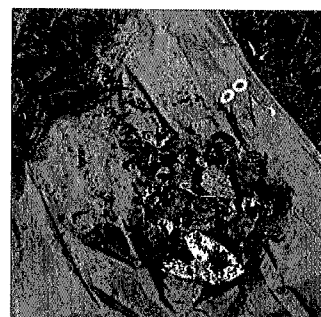
- 4.3.6 Stockpile 3 comprises some general waste materials which currently block / restrict the flow of a drainage ditch around the external yard to the north and west of the building. The waste materials include concrete pieces (cobble and boulder size) with reinforcement bars attached, rubble and some small and large pieces of plastic, metal and general waste (photograph below).

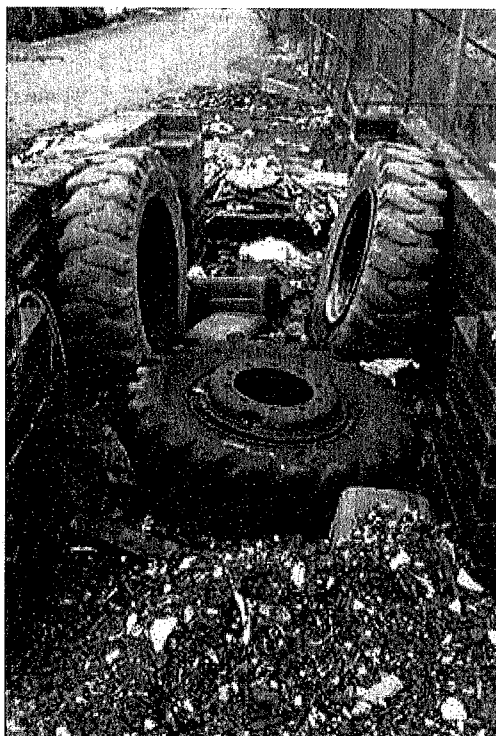
4.3.5 **Stockpile 2** has been assessed to comprise a volume of approximately 1,087m<sup>3</sup>. The percentages of the different fractions from the random samples of the stockpile are summarised below in tabular and graphical form:

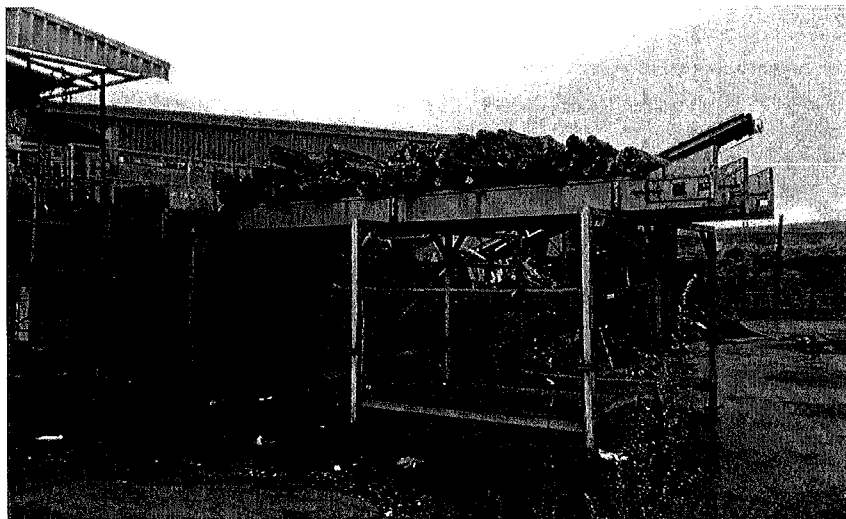
- 4.3.14 In addition, a further 70-75 logs of different diameters, but all approximately 3 m long, are present upon the adjacent rack structure.

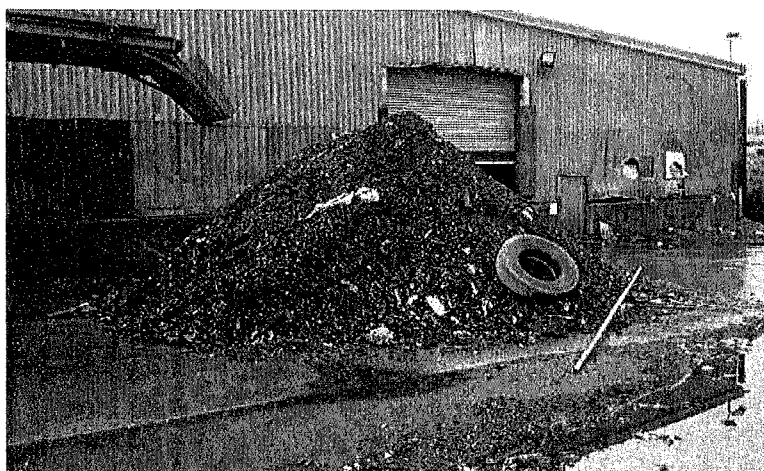
- 4.3.15 Stockpile 7 is located adjacent to the eastern side of the building, immediately south of the roller shutter door. The stockpile is in the region of 2.5-2.7m high and has been assessed as comprising a volume of 73m<sup>3</sup>.

- 4.3.16 The stockpile comprises wood chippings, in varying degrees of degradation, with some dark brown sand and occasional pieces of brick and plastic. The timber fragments appear to be 100mm long and smaller, probably previously classified as screened wood (less than 40mm). Plastic debris and a large tyre appear to have been added to the stockpile. A photograph of the stockpile is shown below.

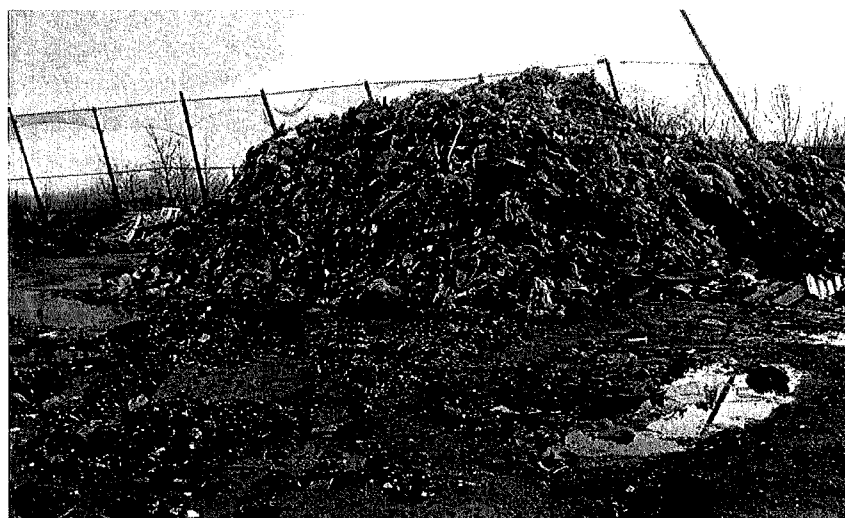
- 4.3.17 Stockpile 8 comprises what has previously been identified as 'household waste', however it appears to predominantly comprise builders / contractors general waste containing large amounts of plastic, carpet / material and some timber, metal, rubber and dark brown sand. Two areas of chipped wood have been placed against the western side of the mound and UPVC doors and windows against the eastern side (photographs below).

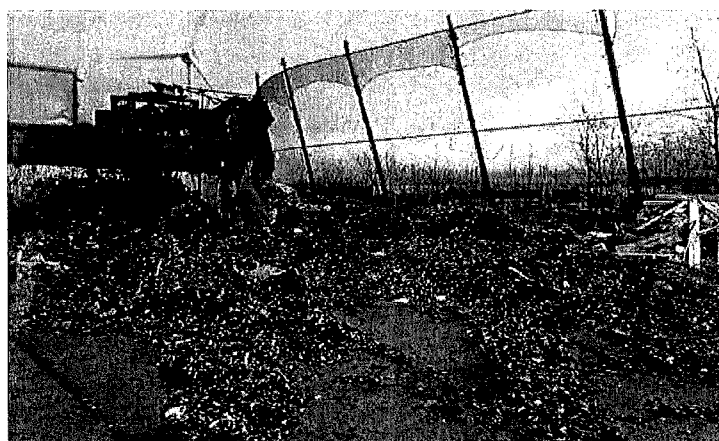
- 4.3.20 Stockpiles 9 and 10 comprise a series of small irregular mounds located around an old screen with blower, magnet and 2 man picking station. The materials predominantly comprise finer material of dark brown sand but with large quantities of plastic, and occasional rubber and glass. Further UPVC doors and windows were also present.
- 4.3.21 The stockpiles together comprise an estimated volume of 44m<sup>3</sup> although waste material is also present on the screening machinery.

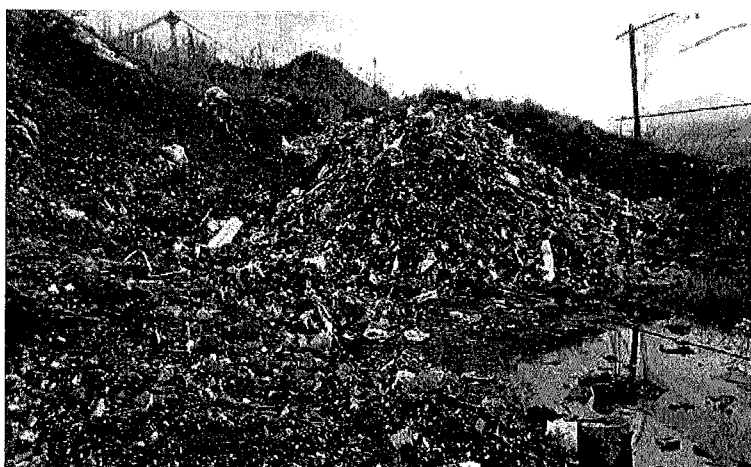
- 4.3.22 Stockpile 11 comprises a small mound of general waste (builders / contractors waste), approximately 3m high. The stockpile comprises mixed waste of dark brown sand with much plastic, wood chippings, material, metal and some large boulders of concrete / sandstone. A photograph of the stockpile is presented below.

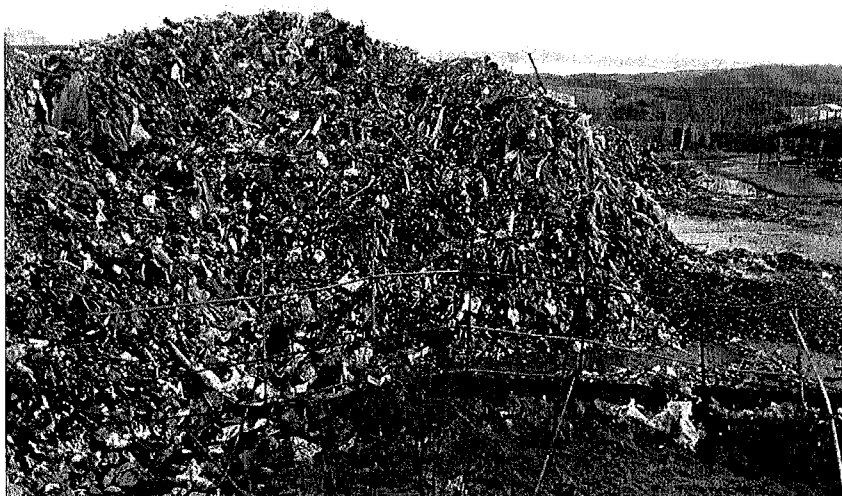
- 4.3.24 Stockpile 12 also comprises builders / contractors general waste (formerly recorded as 'household waste'), containing large volumes of plastic, carpet / material and some wood, pieces of concrete and brick, some dark grey sand and wood chippings. Occasional tyres are also evident. An area of concrete fragments with reinforcing bars (rebars) attached is present on the southern side of the pile. It is understood that this stockpile, along with stockpile 8 have recently been moved / turned and a significantly quantity of rubble removed.

- 4.3.25 The mound is approximately 7m high and has an estimated volume of 3,302m<sup>3</sup>.

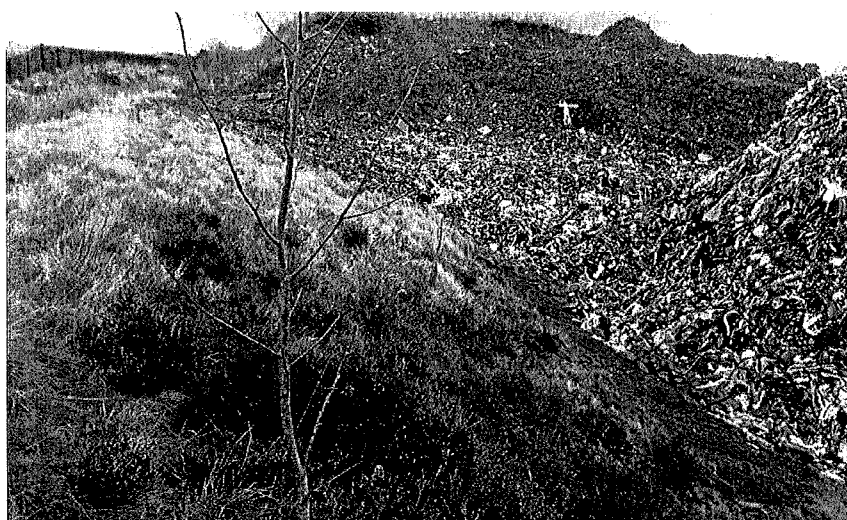
4.3.26 A section on the eastern side of the pile appears to contain a large amount of brick and concrete along with much plastic and general waste.

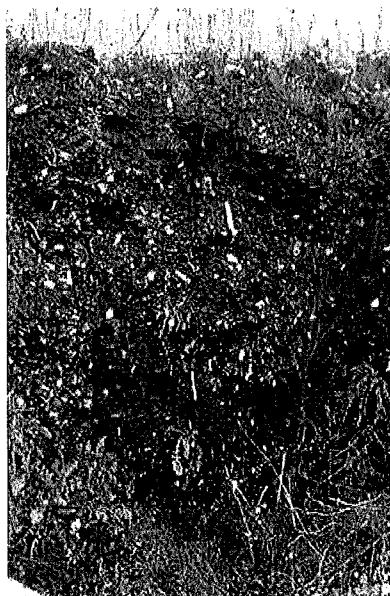
- 4.3.29 Stockpile 13 is a large mound on finer material. It generally comprised dark brown and grey fine to coarse sand with some to many gravel sized fragments of plastic, some concrete, brick and pottery and occasional timber (photographs below).

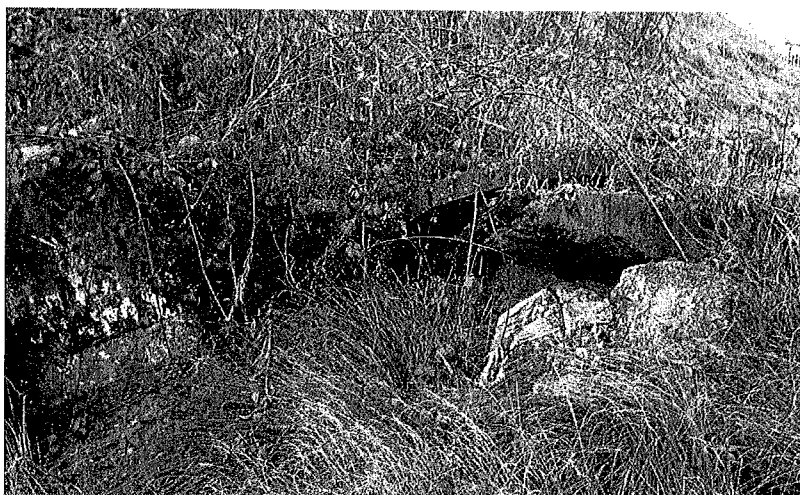
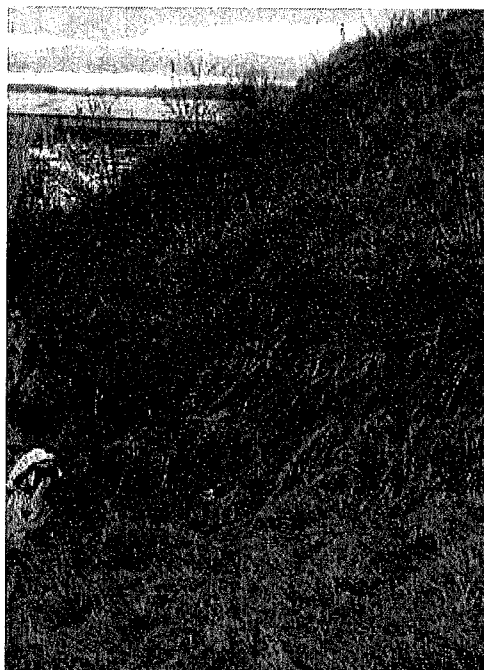
- 4.3.30 Boulders of concrete, brickwork and sandstone, occasionally bituminous material, are evident along the vegetated northern slope of the mound. In addition, large concrete boulders including concrete 'L' sections and a manhole 'biscuit', are present on the lower slopes on the eastern edge of the mound, below the 408.0m contour. (Photograph below).

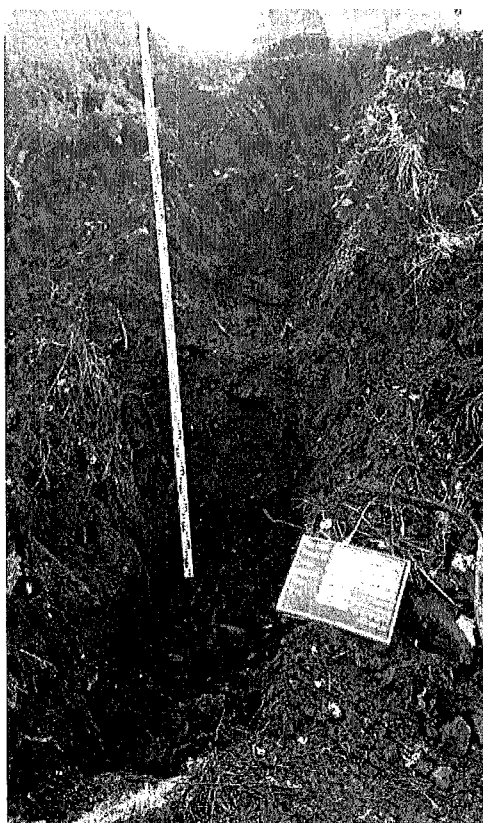
Plate 1 above shows the excavated trial pit TP201

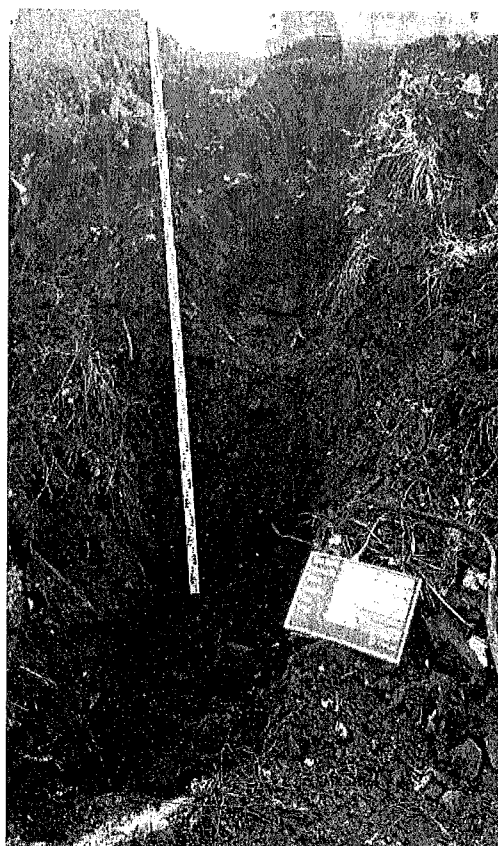
Plate 2 above shows the excavated trial pit TP202

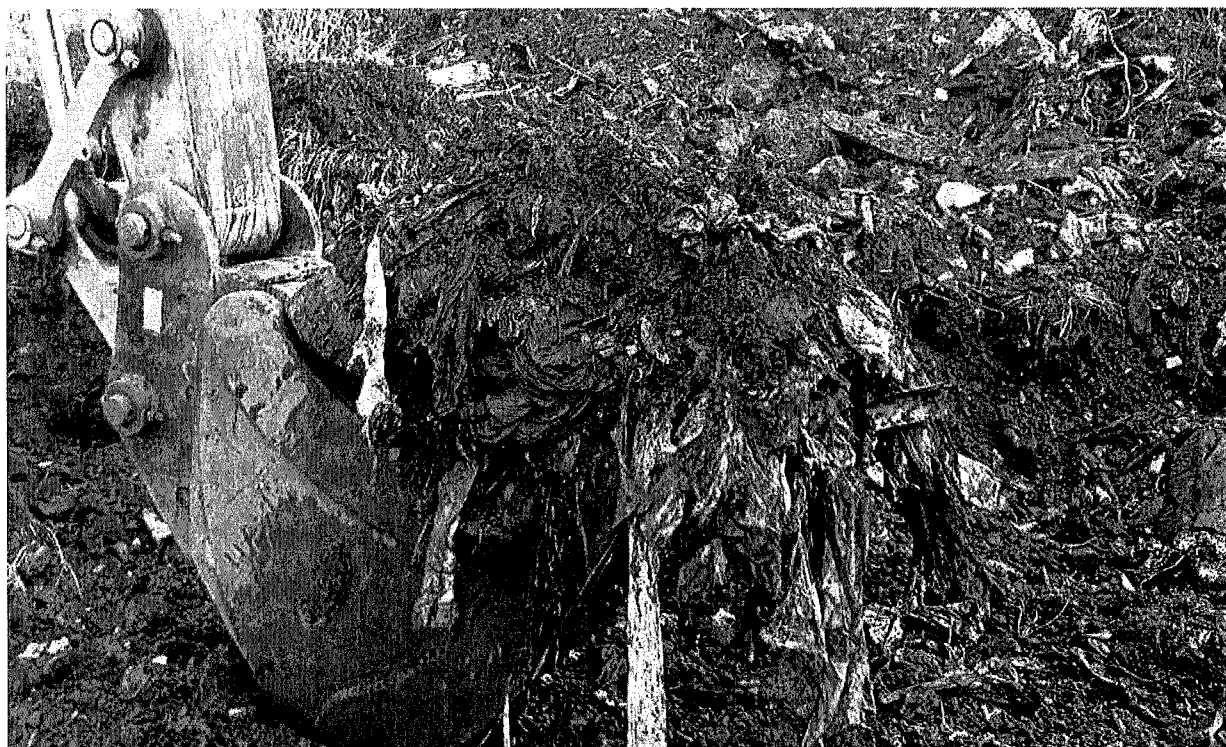
Plate 3 shows a bucket of excavated material from circa 2.00m from TP203

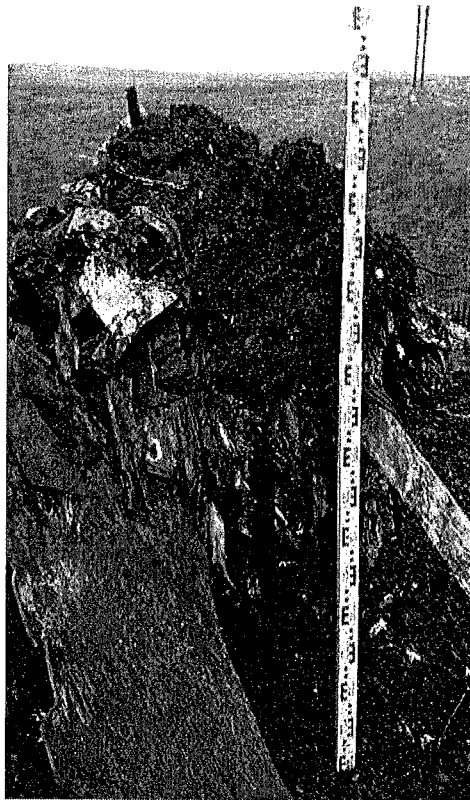
Plate 4 shows a bucket of excavated material from TPO4 at circa 2.00m

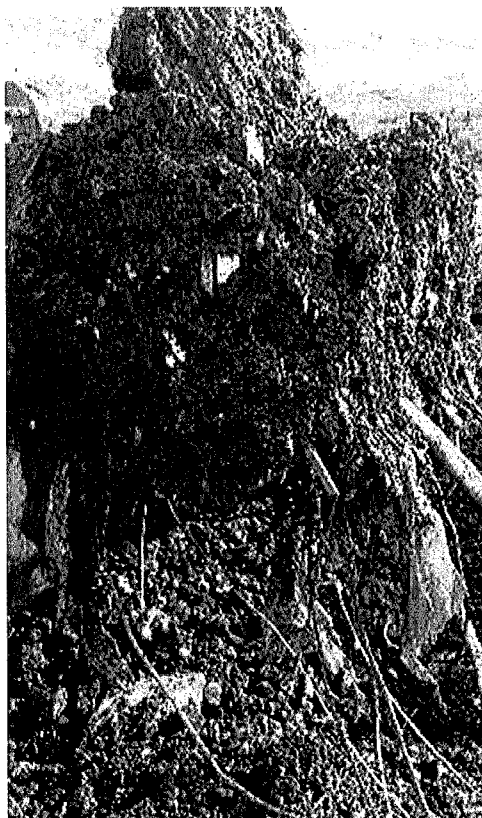
Plate 5 above shows a bucket of excavated material from TPO4 at circa 3.00m
