Compliance Assessment Report CAR_NRW0044679

Permit being assessed: PP3993VS.

For: Atlantic Recycling Limited, **held by:** Atlantic Recycling Limited

Type of assessment: Site Inspection,

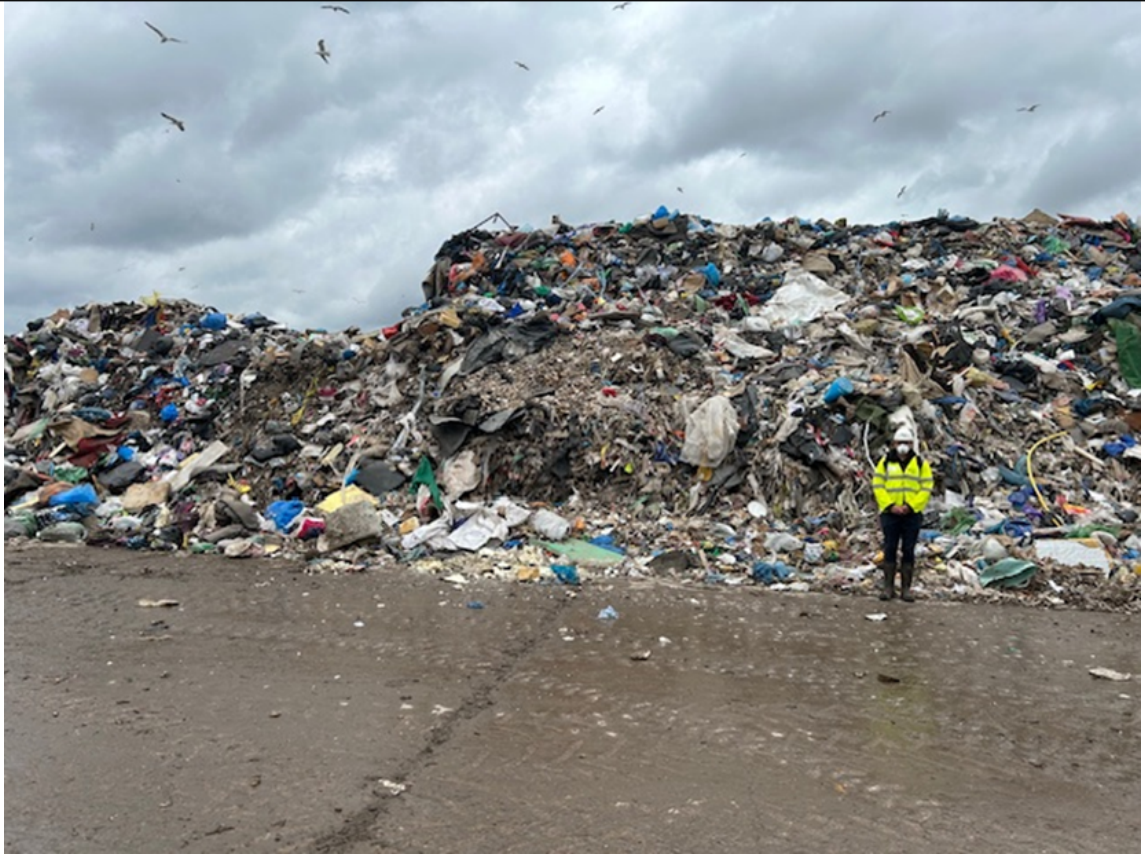
On the transfer station pad, there were stockpiles of different waste materials i.e., wood, plasterboard and stone material. There was seen to be a large stockpile of incoming third-party waste material which had a height clearly above the recommended 4m NRW FPMP guidance. The storage heights of the waste are an ongoing issue and will be assessed at a later date.

The picture below shows Officer HARRIS standing next to the waste material on the transfer station for size reference.

Receiving waste material was seen in stockpiles greater than 4m which were due to be processed. The DDEG estimated that there was a couple of days' worth of waste stockpiled in this area.

ACTION 1: Can you provide details on how long this waste has been on site for and the tonnage of this waste by the 5th of August 2024.

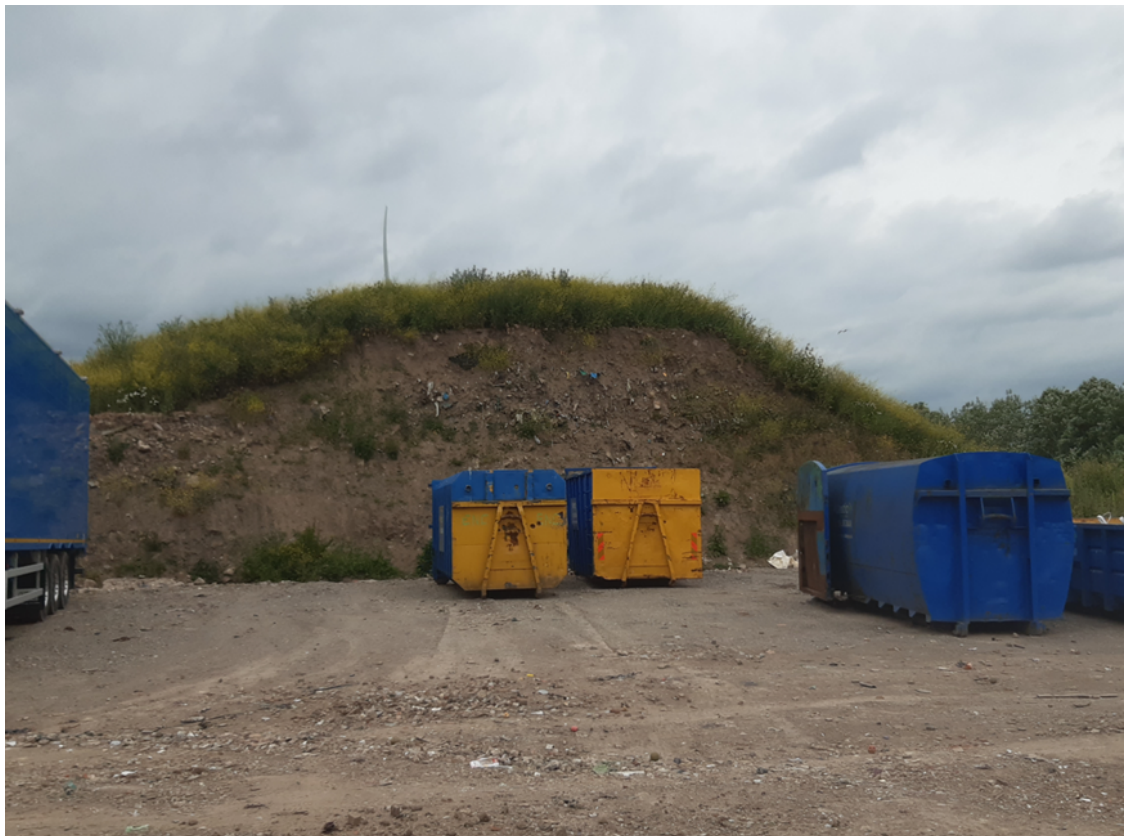
There was also a large pile of large historic waste. DDEG acknowledged that they did not know where this waste material has originated from and that it is unknown when this waste was stockpiled on site.

ACTION 5: Please submit to NRW the information you hold on this waste material on Field 2 by the 5th of August 2024.

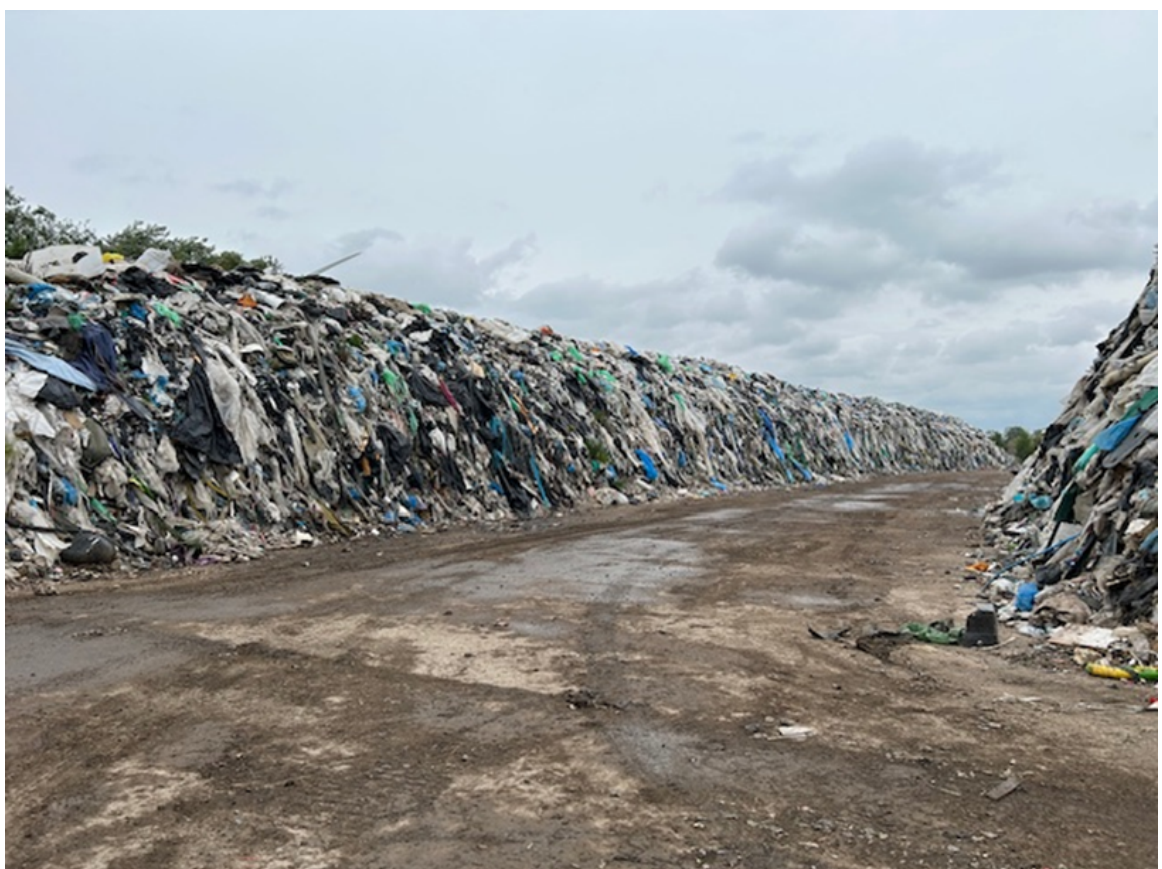
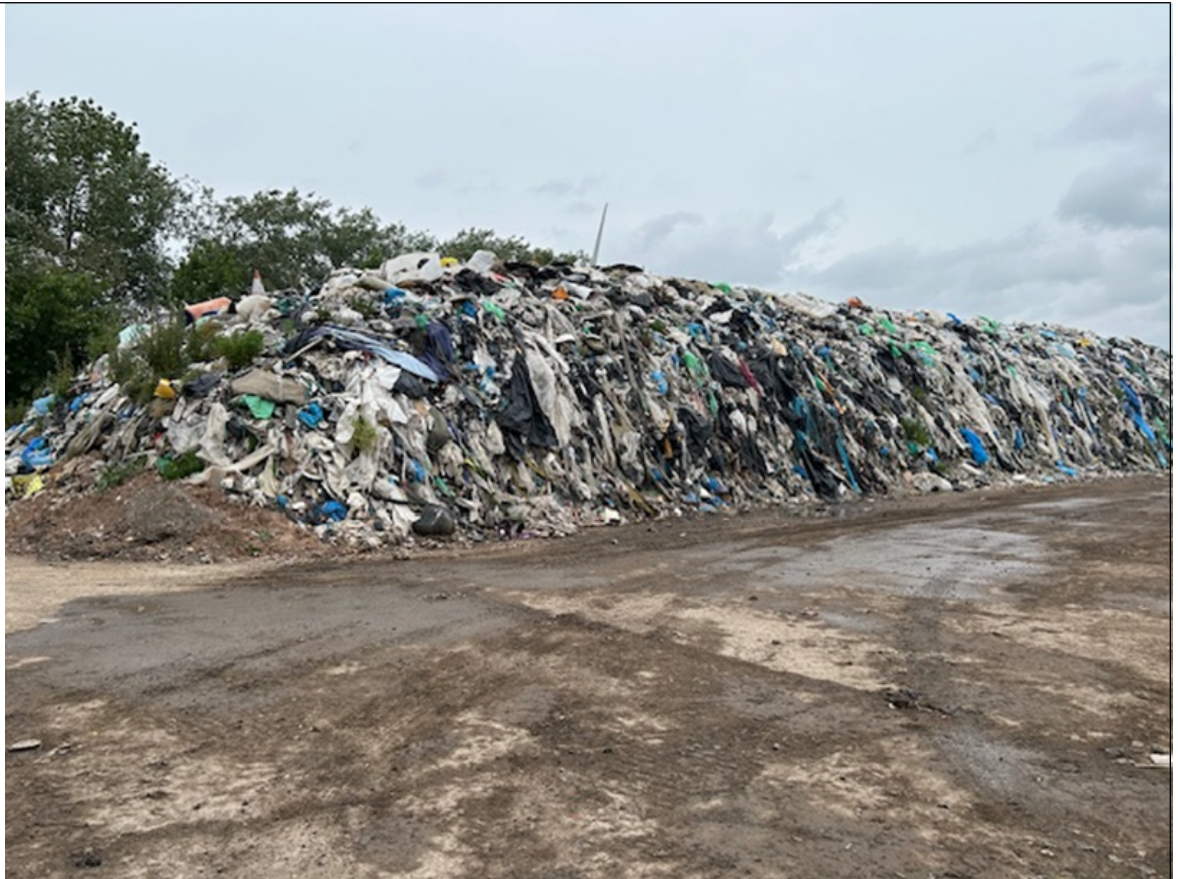
Field 1 was visited next and consisted of three large waste piles that were almost the entire length of the storage pad. (see pictures below). In addition to the above there were stockpiles of plasterboard, waste wood and green waste on the east side of the pad. It was stated from the DDEG that the waste has been on site for approximately 6 months.

As officers walked around the field, intermittent leachate puddles were observed around the base of the waste stockpiles.

This leachate is caused by the waste stockpile breaking down, likely due to the waste being “held” on site, prior to onward transfer.

Questions were raised on the integrity of the concrete pad on Field 1, especially where the leachate puddles were observed it shows that it was eroding the concrete. However, due to the waste stockpiles being in place, no assessment could be made on the condition of the pad under these waste piles.

ACTION 6: Please can you submit the log of the movements of the waste located on Field 1 from when it has arrived on site, the timeline of the processing of the waste and the expected departure dates of this waste, furthermore the mass balance of current held tonnage by the 5th of August 2024.

ACTION 7: Please provide NRW with evidence of surface integrity checks of the concrete underneath the waste stockpiles, and across the concrete structure on Field 1. To include but not limited to depth, wear, ensure proper run off/ drainage fall to the sealed drainage leachate lagoon by the 5th of August 2024.

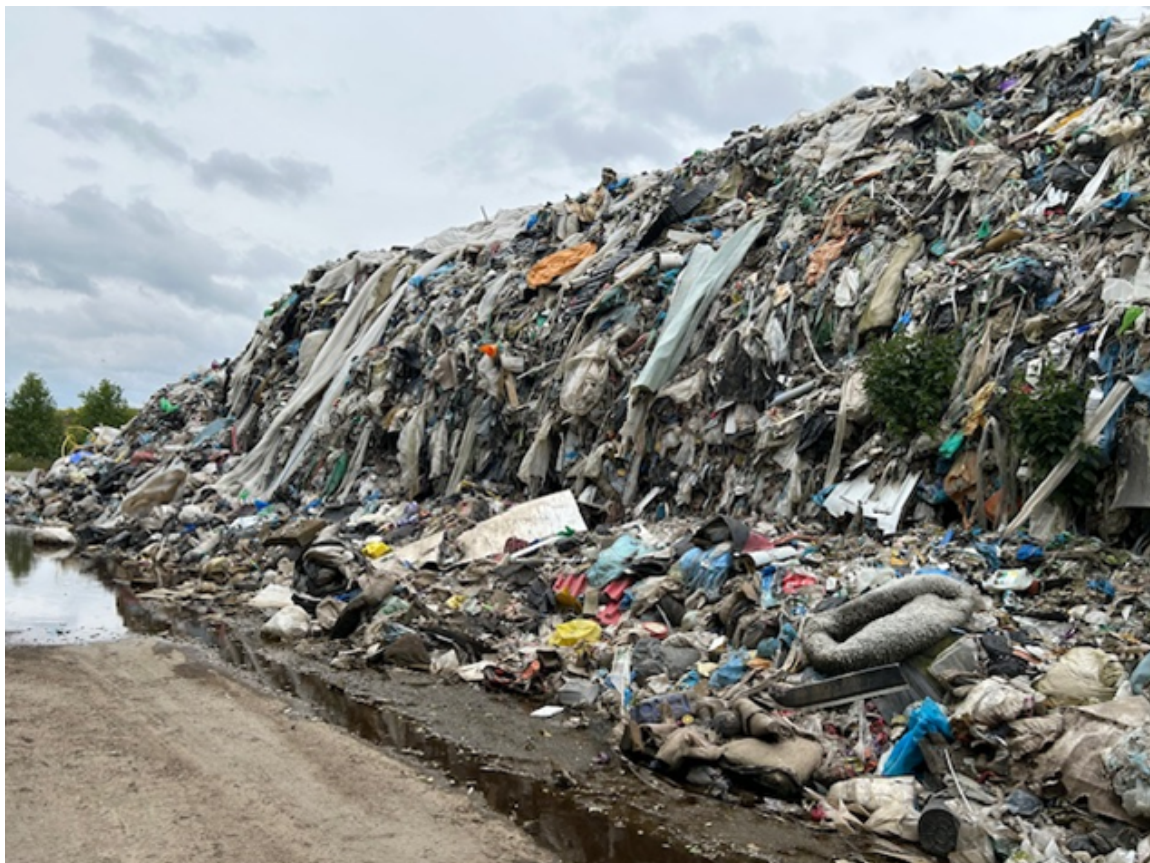
Upon closer inspections, there was a significant fly presence in these areas. On the day it was said that pesticides used to control the flies which was said to be sprayed on the waste piles. As the waste piles

have been sprayed with the pesticide this waste will need to have representative sampling analysis prior to be moved forward to ensure the correct waste coding has been assigned.

ACTION 8: Please submit to NRW your Pest Management Plan by the 5th of August 2024.

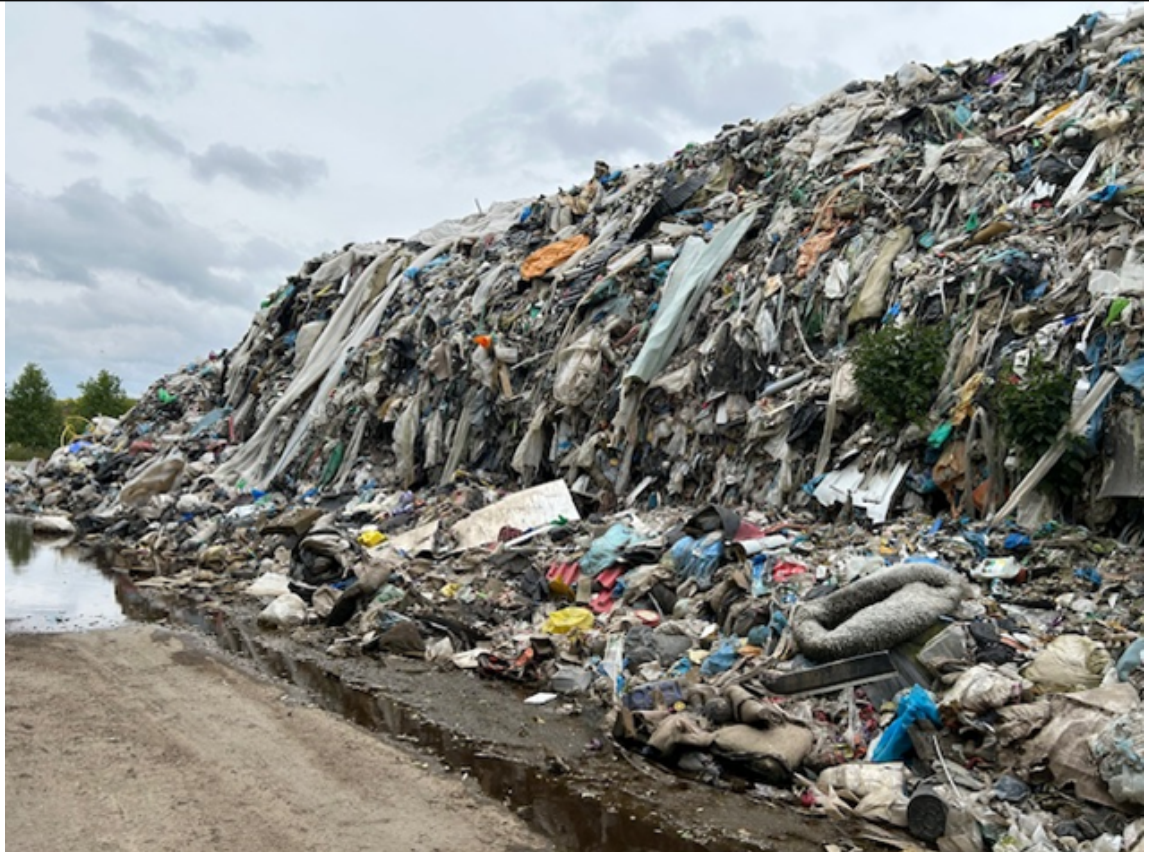
Above picture shows how the standing leachate from the decomposing waste pile has pitted and eroded the concrete pad. This picture was taken after a number of dry days. The waste stockpiles were seen to have the temperature probes in place, when the visit to the security office was done, works were being carried out and the CCTV and InfraRed (IR) was unable to be brought up on screen.

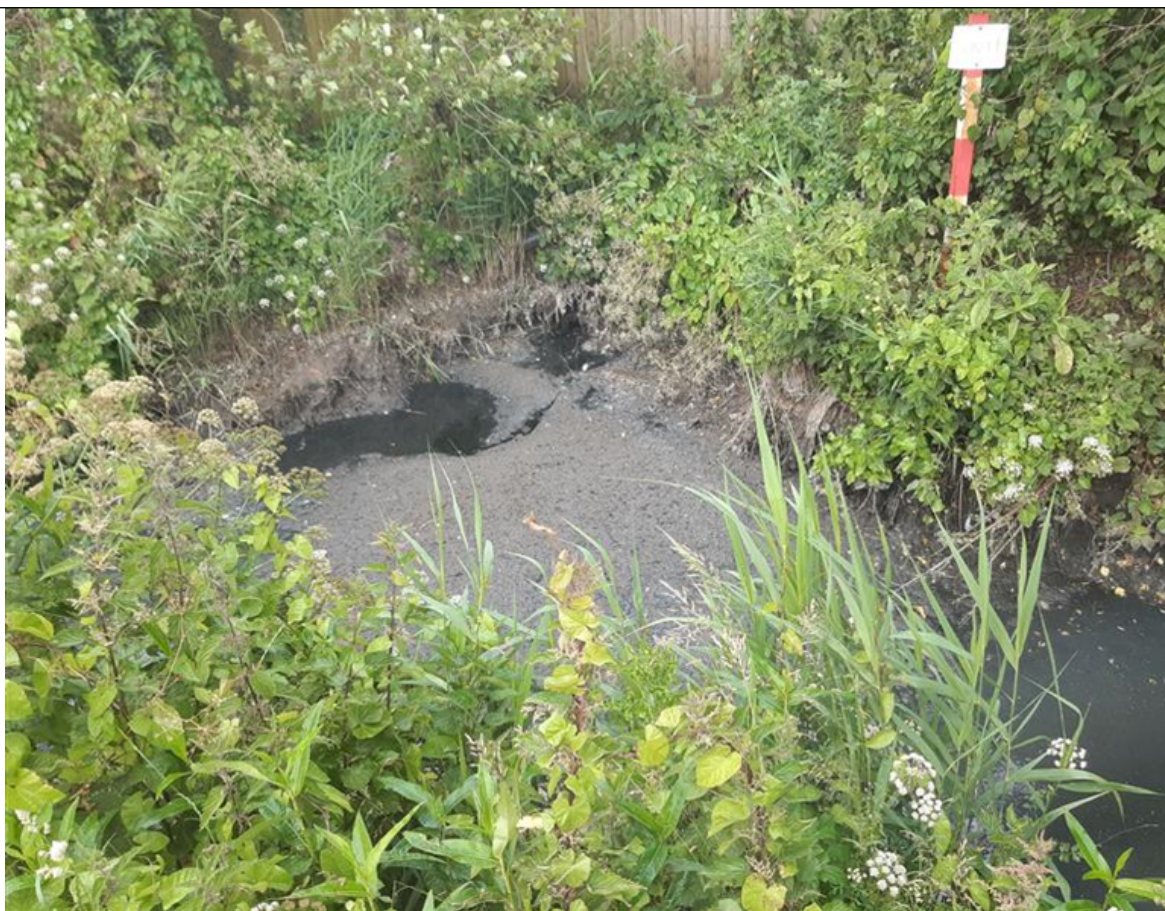
All of the surface water drainage on site runs to a culvert just in front of the transfer station and then is discharged to a ditch. NRW Officers

were told that the ditches are clay lined and are totally sealed so to act formally as “Sealed Drainage” as required throughout your permit. Officers asked for leachate tankering documentation, but DDEG stated that the drainage ditch never needs to be discharged via SW09 point or tankered off site as it is used on site as suppression/dampening. All the surface water drainage on site, including the leachate material on field 1, runs to a culvert just in front of the transfer station and then is discharged to a purpose-built ditch. To get a better view of the ditch, officers walked along the road to the discharge point and when stood adjacent to the surface water ditch a strong rotten egg like odour was noticed. Upon looking through a hole in the wooden fence the surface water ditch appeared black in colour (pictured below). The leachate is used to dampen down the dust on the roads and to spray on waste piles, which may be adding to the pest issue and may cause an odour issue if the leachate becomes highly concentrated. There was a very strong noxious egg/sulphur smell noted alongside the leachate ditch.

Permit condition 3.2.3 states that “All liquids in containers, whose emission to water or land could cause pollution, shall be provided with secondary containment, unless the operator has used other appropriate measures to prevent or where that is not practicable, to minimise, leakage and spillage from the primary container”.

Action 11: Take representative samples of the liquid held in ditch, as pictured above and submit the independent analysis to NRW. Additionally, can you provide to NRW an assessment on how the storage ditches meets the requirements of Ciria736.

This should be submitted to NRW by the **2nd of September 2024**.
