## FACTUAL REPORT ON GROUNDWATER MONITORING INVESTIGATION

### Plot B The Airfields Deeside

**4671-JPG-XX-XX-RP-G-0660-S2-P01**

**March 2023**

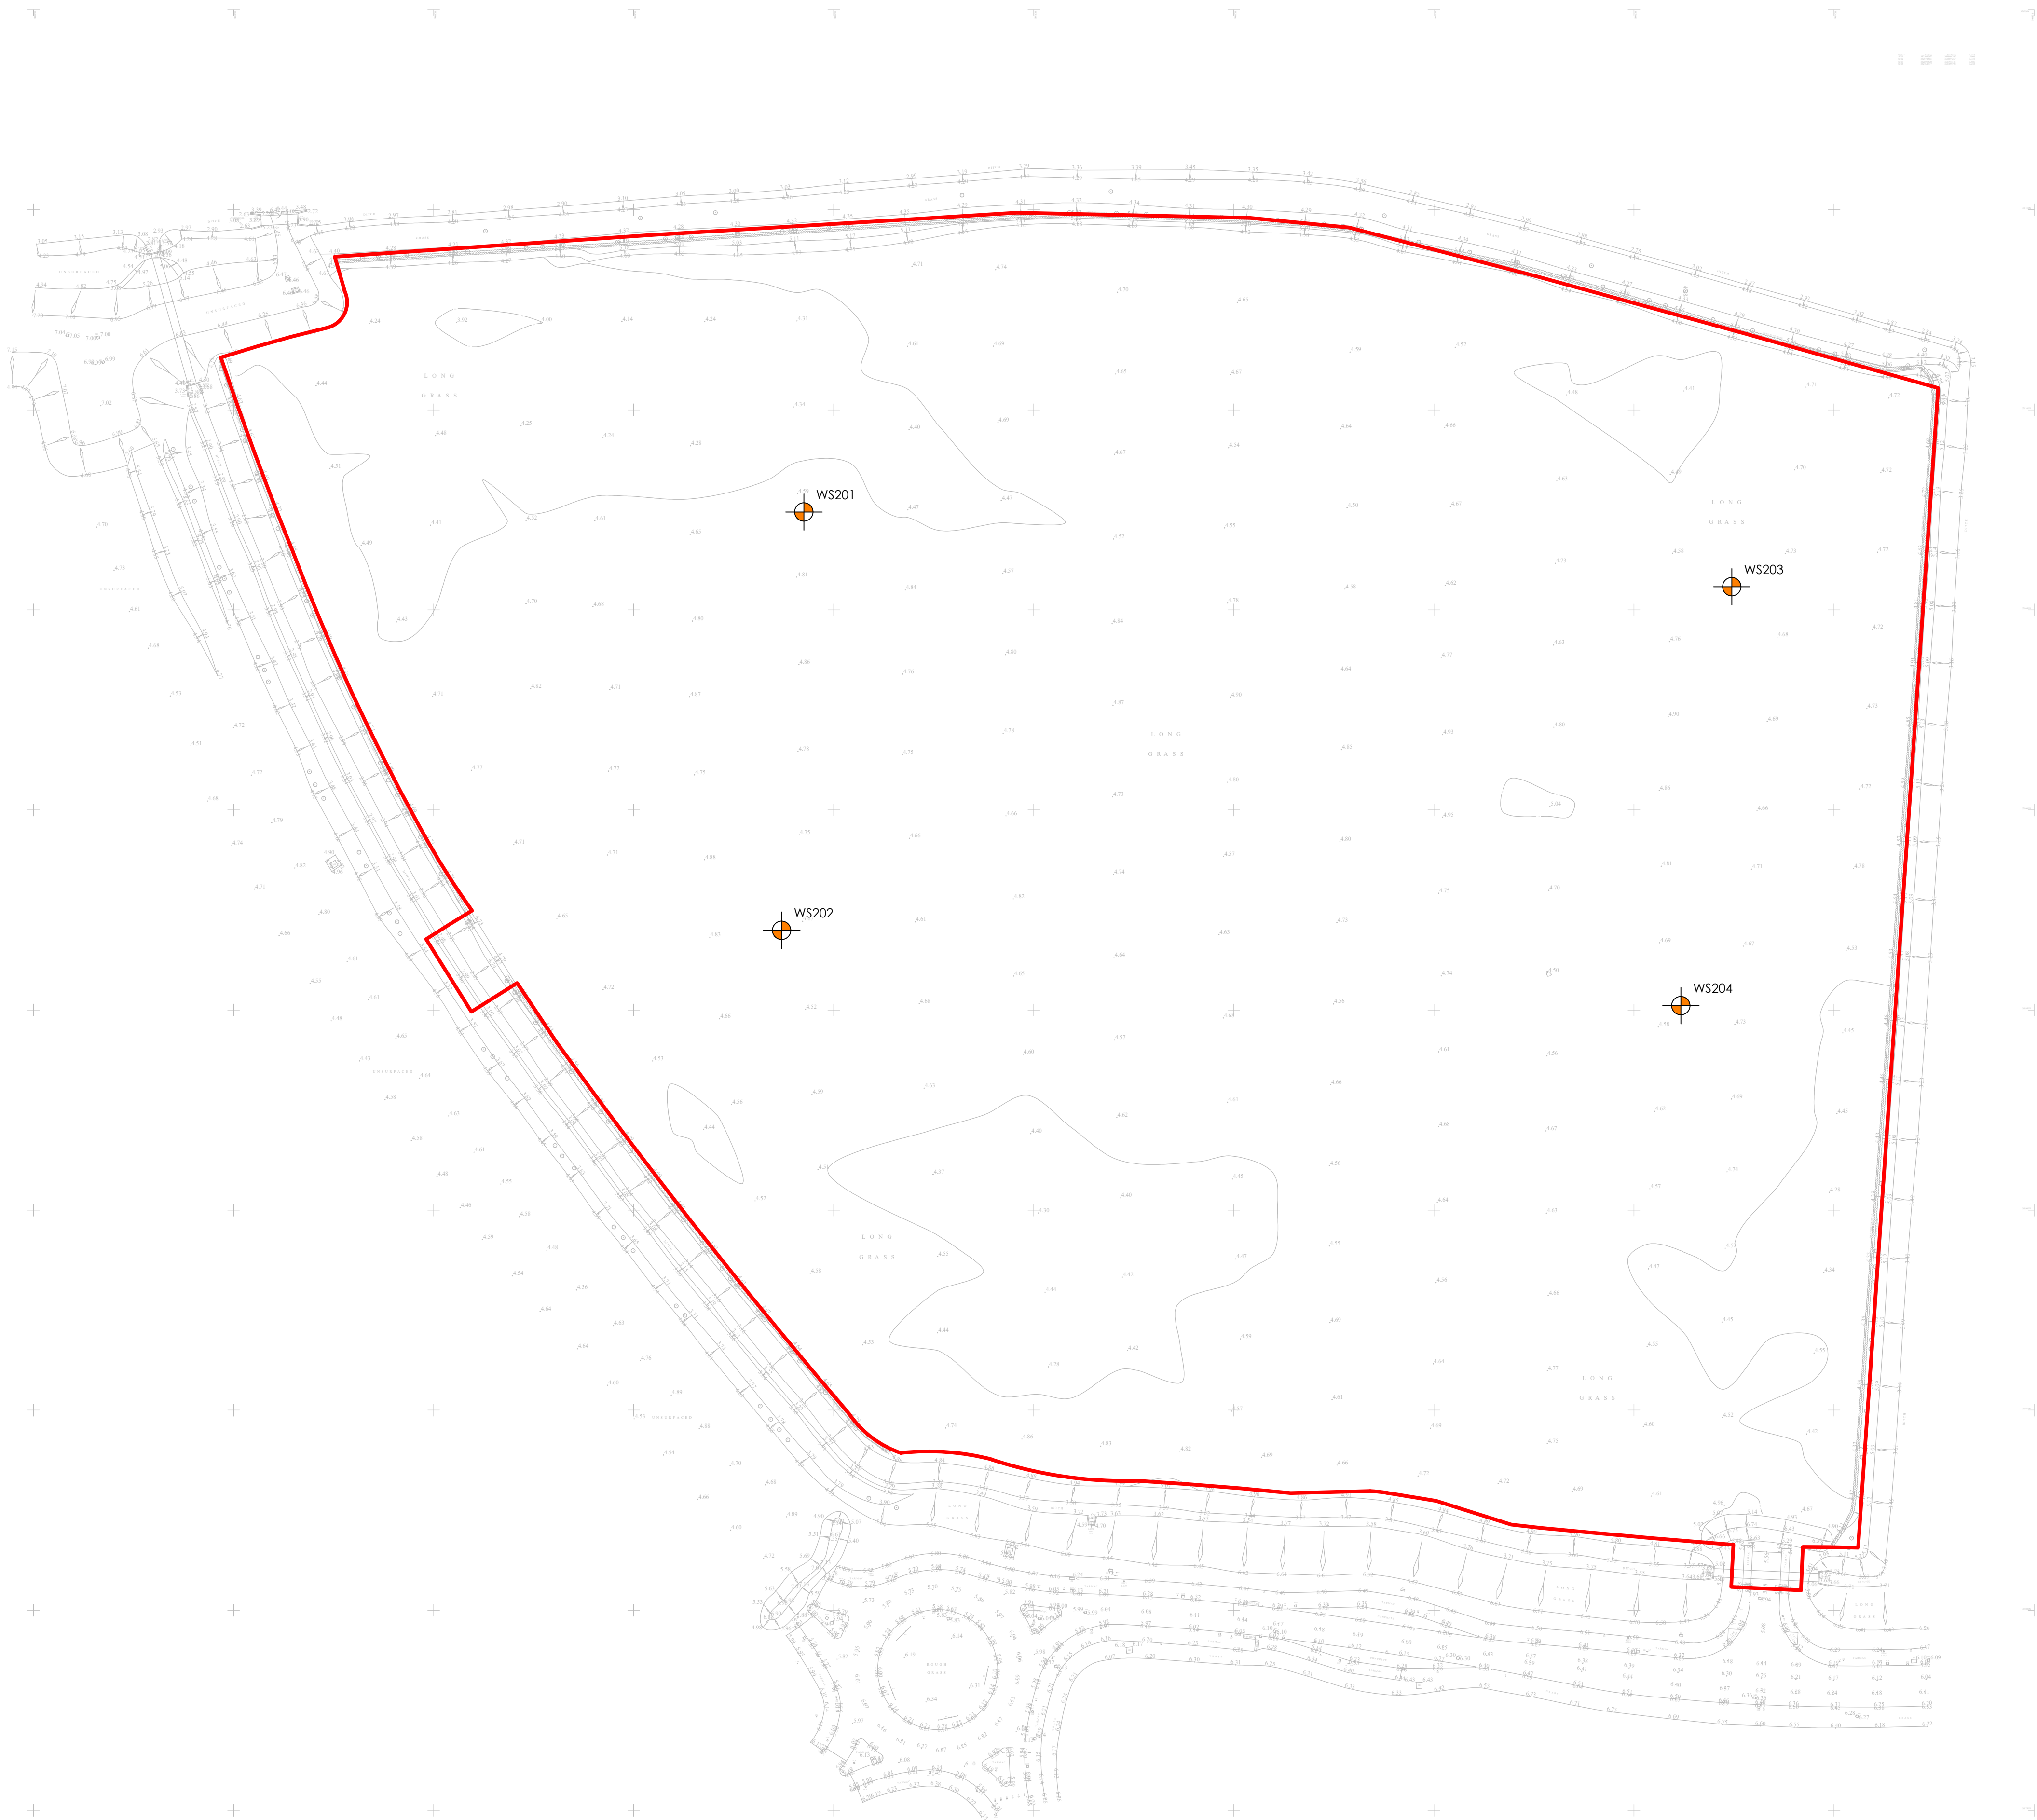
Drawing Title  
EXPLORATORY HOLE LOCATION PLAN  
(AS BUILT)

JPG SITE INVESTIGATION  
FEBRUARY 2023

WS201

WINDOW SAMPLE BOREHOLE

RED LINE BOUNDARY

JPG (Leeds) Limited. Plot B, The Airfields, Deeside. Exploratory Hole Location Plan (AS BUILT). Drawing Ref. 4671-JPG-ZZ-ZZ-DR-G-1102-S2-P01, dated March 2023.

The exploratory hole location plan (as-built) is provided in Appendix A and copies of the exploratory hole logs are provided in Appendix B.
