Compliance Assessment Report CAR_NRW0044646

Permit being assessed: AB0056501

For: READYMIX BATCHING PLANT TRAM RD, PO, held by Breedon Trading Limited
At: Pinnacle Construction Materials, Tram Road, Pontllanfraith, Blackwood, Caerffili, NP12 2JF.

Type of assessment carried out: Site Inspection, Reason: Routine.

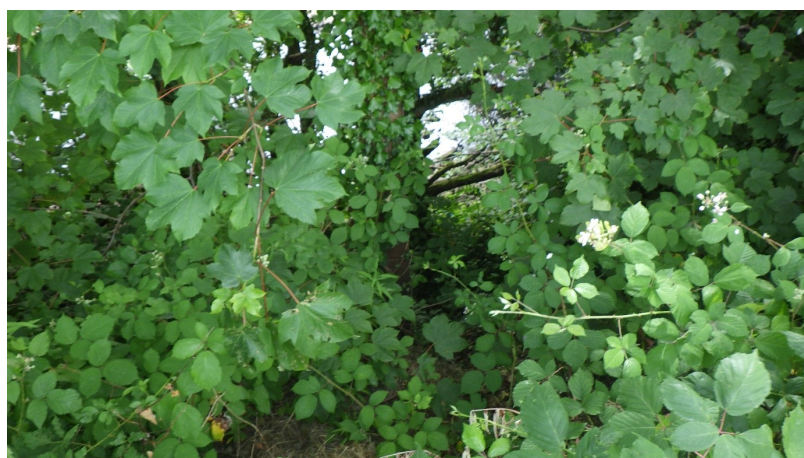
The listed discharge point location was checked (ST1806095890) but no discharge or pipe were seen at this location at the time of the visit. Figures 4 and 5 evidence this observation.

Figure 5 – Site visit photo: A view of the River Sirhowy from the permitted discharge/sampling point. No discharges or pipes were seen.

1. Undertake a permit variation to change the sample/discharge point from ST1806095890 to ST1800095600. This can be done via:
<https://naturalresources.wales/permits-and-permissions/installations/apply-to-vary-change-a-permit-for-installations/?lang=en>.

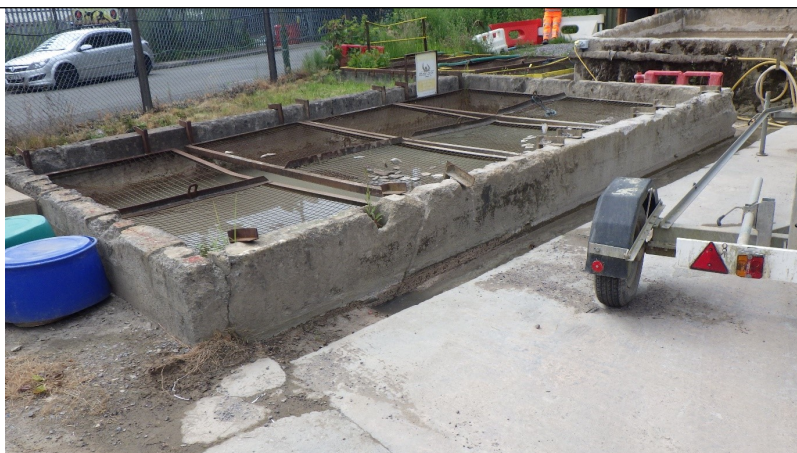
The site water management system was checked. It was noted that the majority of site drainage water is recycled and used for production/processing of concrete on site. This includes rainwater as well as washdown water. It enters a settlement tank where suspended solids settle and water is abstracted as needed. Operators stated the only time water is pumped out of the tanks and discharged off site is during periods of site closure during the Christmas holidays. During the visit this system appeared to be working as designed with no off site runoff or pollution noted. This is evidenced in Figure 6.

Figure 6: Site visit photo – Settlement tanks on site at the time of the visit working as designed.

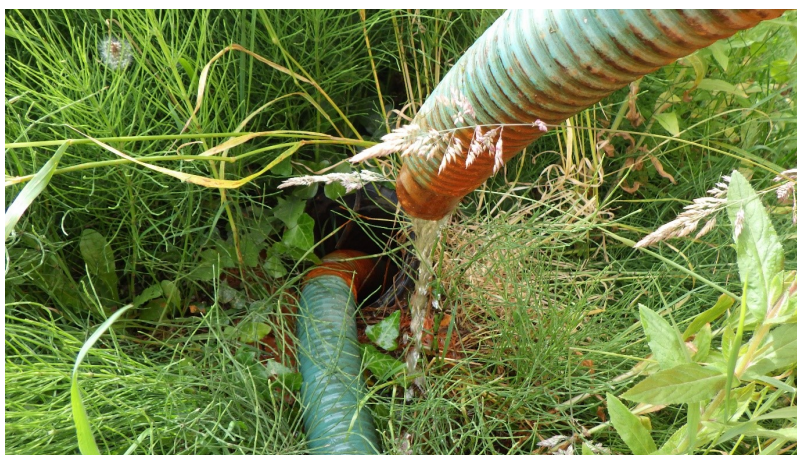
The mine water upwelling was located and observed at ST1798795721. As stated, the water is pumped directly out of the disused shaft and is discharged off site via a culvert. This was the only discharge at the time of the visit. The quality of the discharge was visually checked and it appeared clear without any visible suspended solids, oils or other pollutants. There was some orange staining on the pipework as expected from the accumulated deposition of iron ore from the mine water, but there did not appear to be particulate iron in the discharge itself. This is evidence in Figure 7.

Figure 7: Site visit photo – The discharge of pumped mine water observed during the visit.
