Compliance Assessment Report CAR_NRW0044954

Permit being assessed: YP3937SH.

For: Amex Park, **held by:** Mekatek Limited

Type of assessment: Site Inspection,

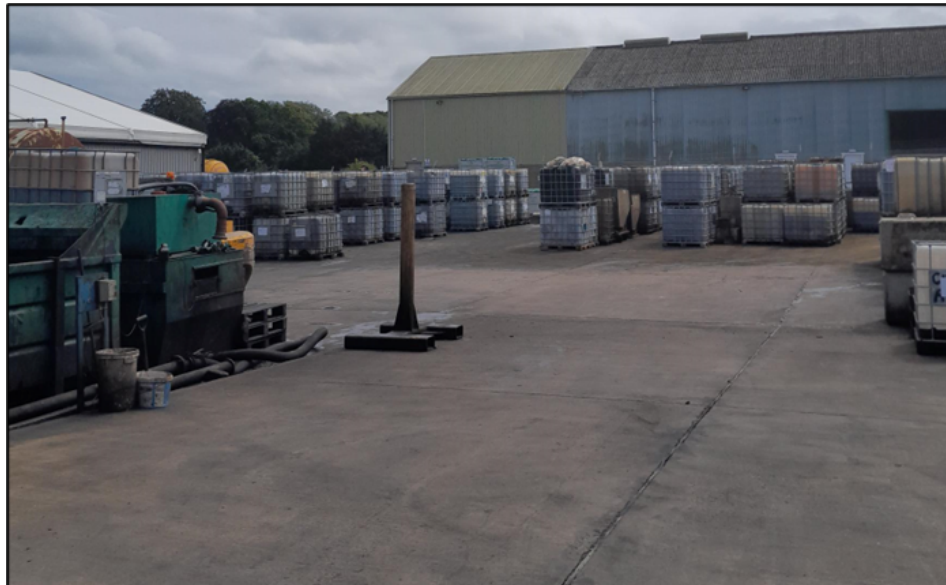
Oils are separated using an ultrafiltration unit. Oil is then stored in secure IBCs on site for around six months to naturally separate the oils from liquids. The infrastructure in the area is built to industry standard specifications and was in decent condition displaying no signs of weakness or fracture. There were no issues noted with the drainage at the time of inspection.

Image 1 – showing oil storage and separation area, taken on 19 July 2024

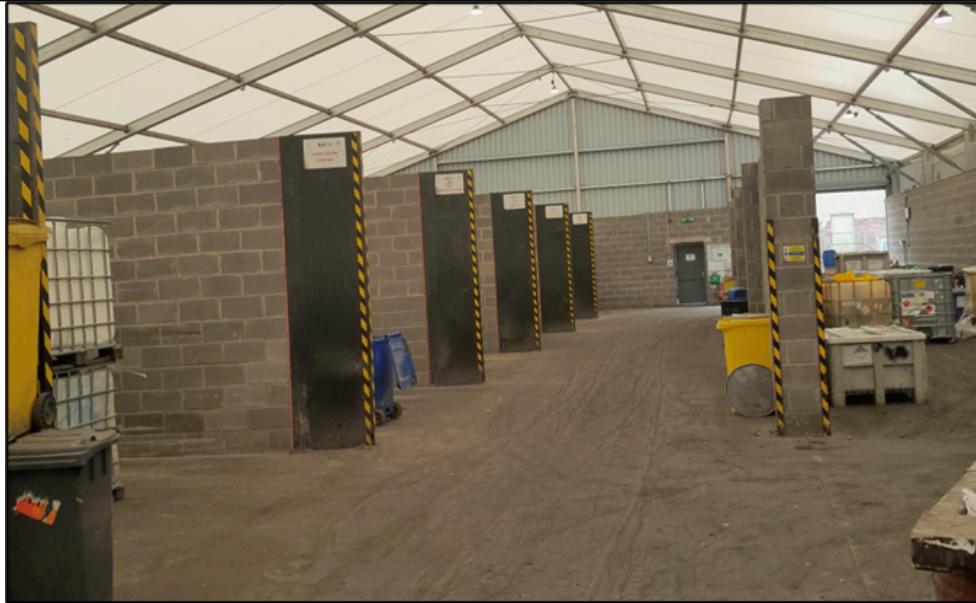
Activities in this area are undercover within a unit and benefit from a sealed drainage system. Waste materials enter the unit via an inspection bay and are sorted / segregated into the appropriate waste streams ready for removal from site. There is CCTV coverage of the various bays accessible via various IT mediums. It was mentioned how the unit's drainage system can be isolated from joining primary network is there was a containment issue or spill.

Image 2 – showing bays inside the transfer station unit, taken on 19 July 2024

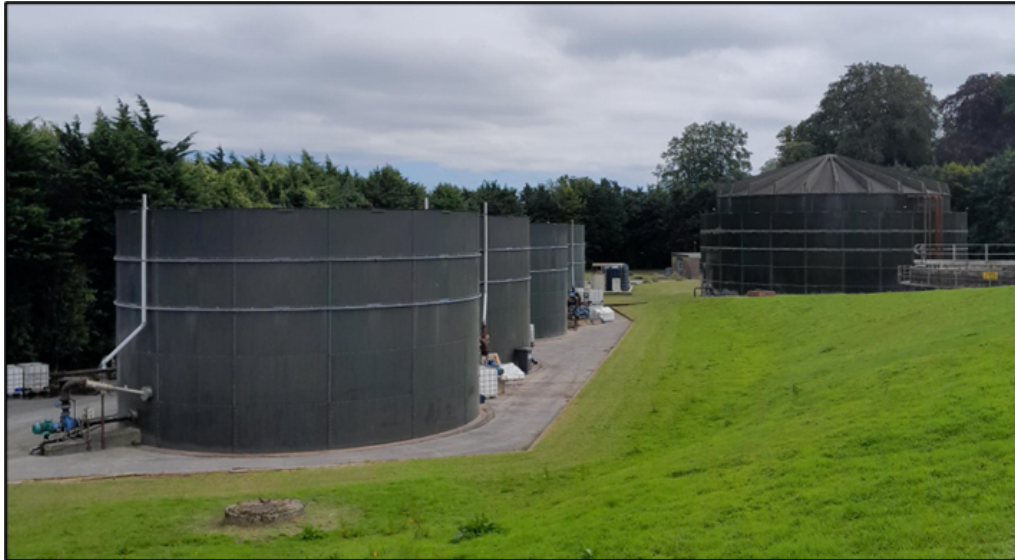
Tanks 5, 6, 8, and 9 are located sequentially situated on an impermeable surface with bunded edges, as seen in image 3. There are two filter beds present in this area of the site – it was discussed how maintenance is done annually to turn the surface stones to counter the organic growth and optimise the filtration mechanism. This area is also on impermeable surface with bunded edges for containment. The final stage of the treatment in the humus chamber allows the removal of any last remaining solid waste particles.

Image 3 – showing tanks 5, 6, 8, and 9 on the left, taken on 19 July 2024

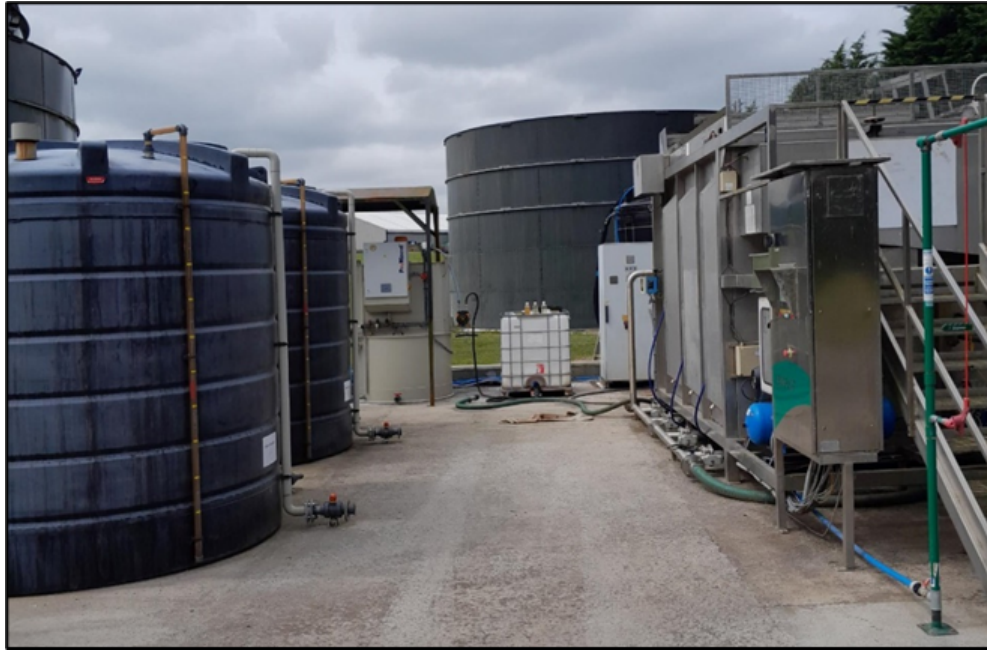
Officer BOWDER inspected the Dissolved Air Flootation (DAF) unit with associated storage vessels for phosphate, coagulant polymer, and sodium hydroxide - this area is afforded with an impermeable surface. Then proceeded to the sludge filter cake production area - this process will be examined further on future inspections.

Image 4 – showing the DAF unit and chemical dosing vessels, taken on 19 July 2024

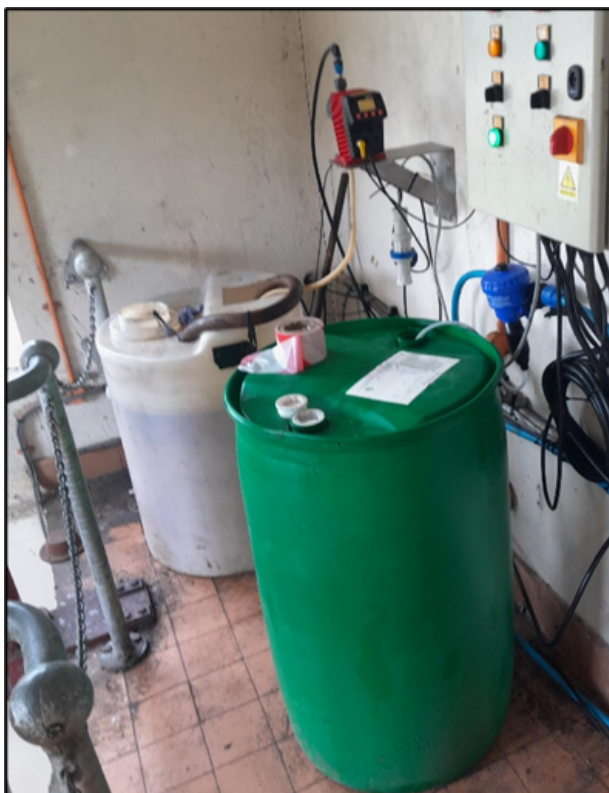
An anti-foam additive is injected into the treated final effluent prior to discharge to disperse bubbles in the foam; this activity was added to the permit in 2018. In this instance of the foam witnessed on 27 June, this was caused by an intermittent fault on the operator's anti-foam dosing system. This contributed to the higher level of foam being seen in the discharge, which the operator has since corrected and implemented measures to monitor as part of its routine inspection.

The operator identified that, overtime a sediment layer would develop on the surface of the antifoam liquid within the vessel, which affected the proper dosage of antifoam to be injected into the effluent. This was attributed to the root cause of the foam witnessed on 27 June. The operator has since implemented a stirring mechanism within the vessel set on a timer to prevent layers from forming and interfering with the dilution of the antifoam additive and pumped final effluent.

Image 5 – showing the antiffoam dosing system housed in a unit, taken on 19 July 2024

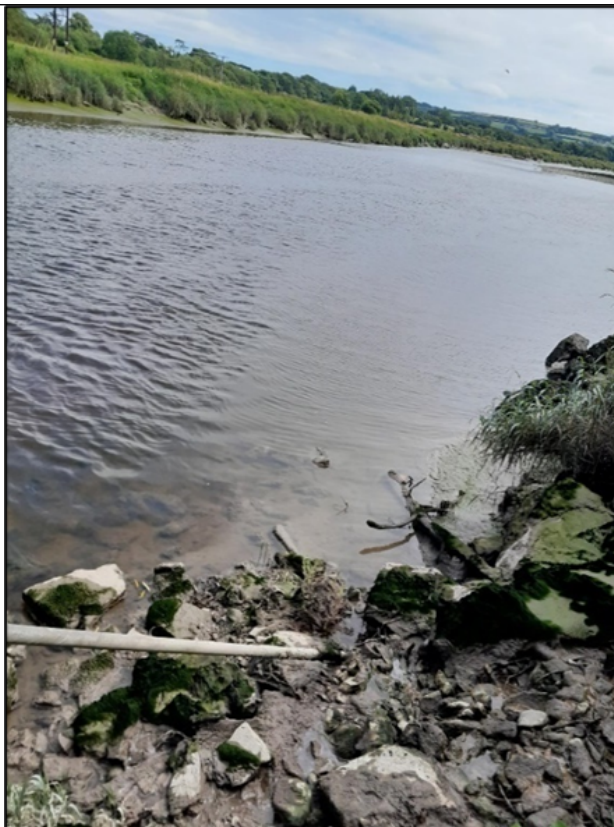
The Officer walked outside of the permit boundary down to the outfall point on the Tywi. The operator detailed how it had recently erected fencing above the outfall along the public footpath to stabilise the walk path perimeter. No odour or discolouration was witnessed at the outfall during the time of inspection. Based on the results submitted by the operator, in Quarter 1 of 2024 (January to March) the discharge was compliant with all emission limit parameters in the permit.

Image 5 – showing permitted discharge point W1 to the River Tywi, taken on 19 July 2024
